**Haweswater Aqueduct Resilience Programme -
Proposed Bowland Section
Supplementary Environmental Information**

Off-Site Highways Works – TR3 Hedgerows Report

January 2022

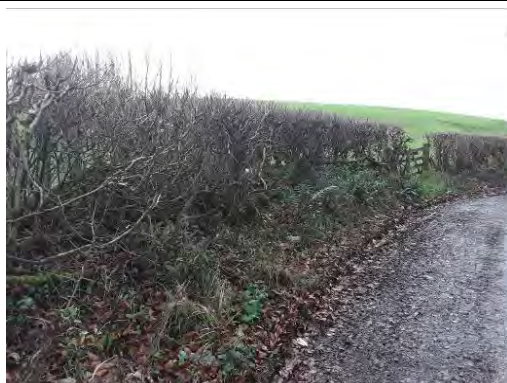
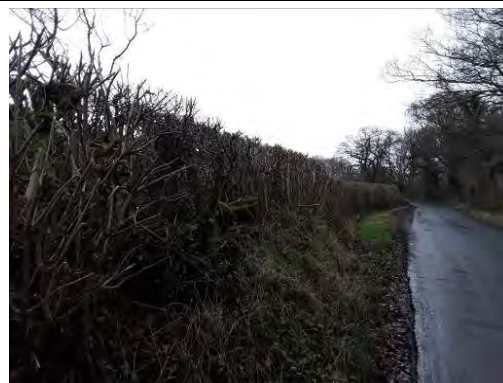
TR3.HH1

The hedgerow is approximately 247 m long and 1.5 m in height and 1.5 m wide. There is one gap within the hedgerow which is less than 5% of the entire hedge and there are two associated mature trees. There is an associated dry ditch on the western side of the hedgerow. The hedgerow connects to one other hedgerow (TR3.HH46) but connections with other hedgerows or woodlands do not score four or more points. The canopy is species rich, being dominated by blackthorn (*Prunus spinosa*), with smaller amounts of hazel (*Corylus avellana*), hawthorn (*Crataegus monogyna*), elder (*Sambucus nigra*) and holly (*Ilex aquifolium*) (five woody species). The ground flora has notable species of lady fern (*Athyrium filix-femina*), herb Robert (*Geranium robertianum*), wood avens (*Geum urbanum*) and dog's mercury (*Mercurialis perennis*). Also noted within the ground flora were additional species including; bramble (*Rubus fruticosus* agg.), cow parsley (*Anthriscus sylvestris*), common nettle (*Urtica dioica*), ivy (*Hedera helix*), wood melick (*Melica uniflora*), ribwort plantain (*Plantago lanceolata*), tufted hairgrass (*Deschampsia cespitosa*), ground ivy (*Glechoma hederacea*), cleavers (*Galium aparine*), false oat grass (*Arrhenatherum elatius*), greater stitchwort (*Stellaria holostea*), horsetail (*Equisetum* sp.), garlic mustard (*Alliaria petiolata*), red campion (*Silene dioica*), barren strawberry (*Waldsteinia fragarioides*) and nipplewort (*Lapsana communis*). The ground flora is also likely to include English bluebell (*Hyacinthoides non-scripta*). The hedgerow appears to be more than 30 years in age.

It is likely that the hedgerow supports one Wildlife & Countryside Act (1981 as amended) protected species (English bluebell) due to the composition of the ground flora and proximity to a nearby broadleaved woodland, however, due to the timing of the survey it was not possible to confirm presence. If English bluebells are present, this hedgerow would be classified under ecological criteria as 'Important' under The Hedgerow Regulations 1997.

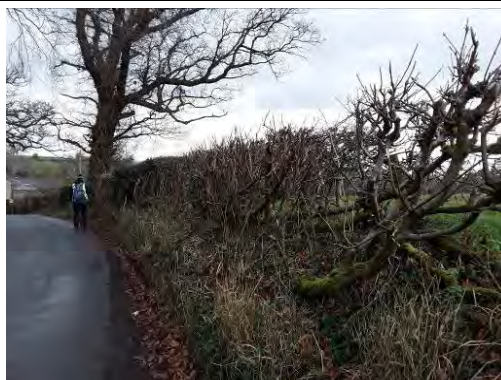
TR3.HH2

The hedgerow is 60 m long and 1 m in height and 0.5 m wide. There are three gaps within the hedgerow, which constitute more than 10% of its length and there are no associated mature trees. Connections with other hedgerows or woodlands do not score four or more points. The canopy is dominated by sycamore (*Acer pseudoplatanus*) with smaller amounts of hazel, beech (*Fagus sylvatica*), ash (*Fraxinus excelsior*) and blackthorn (four woody species; excluding sycamore). The ground flora has notable species including; dog's mercury, hart's tongue (*Asplenium scolopendrium*), herb Robert and wood avens. Also noted within the ground flora were additional species including; foxglove (*Digitalis purpurea*), cow parsley, false oat grass, ivy, crosswort (*Cruciata laevipes*), cock's foot grass (*Dactylis glomerata*) and stitchwort sp. (*Stellaria* sp.). The hedgerow appears to be more than 30 years in age.

No Wildlife & Countryside Act protected species have been identified to be present. This hedgerow is not classified under ecological criteria as 'Important' under The Hedgerow Regulations 1997.

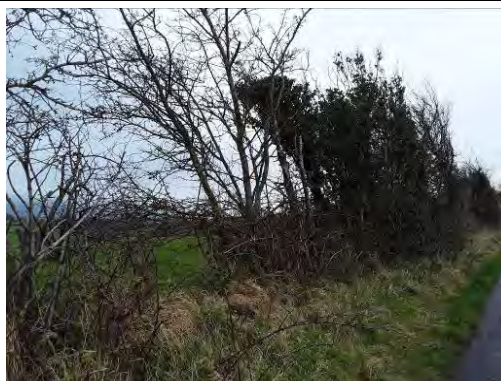
TR3.HH4

The hedgerow is 103 m long and 1.5 m in height and 1.5 m wide. There is one gap within the hedgerow which is less than 5% of the hedgerow length and there are no associated mature trees. One parallel hedge lies within 15 m of the hedgerow (TR3.HH5). Connections with other hedgerows or woodlands do not score four or more points. The canopy is species rich with dominant hawthorn and smaller amounts of holly, blackthorn, ash and rose (*Rosa* sp.) also present (five woody species). Dog's mercury is the only notable species found within the ground flora, with additional species including; bramble, cow parsley, meadow sweet (*Filipendula ulmaria*), common nettle, bush vetch (*Vicia sepium*) and creeping bent (*Agrostis stolonifera*). The hedgerow is more than 30 years in age.

No Wildlife & Countryside Act protected species have been identified to be present. **This hedgerow is classified under ecological criteria as 'Important' under The Hedgerow Regulations 1997.**

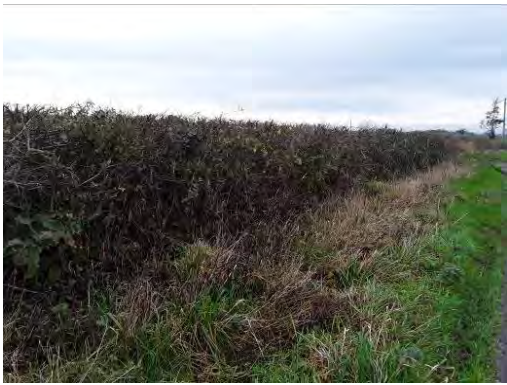
TR3.HH5

<p>The hedgerow is 106 m long and 1.5 m in height and 1.5 m wide. There is one gap within the hedgerow which forms approximately 5% of the hedgerow length and there are two associated mature trees. A parallel hedge lies within 15 m of the hedgerow (TR3.HH4). Connections with other hedgerows or woodlands do not score four or more points. The canopy is species rich, with abundant hawthorn. Hazel, holly, blackthorn, whitebeam and rose sp. are also present (six woody species). The ground flora has notable species of lady fern, broad buckler fern (<i>Dryopteris dilatata</i>) and herb Robert. Noted within the ground flora were additional species including; foxglove, meadow sweet, bush vetch, common nettle, creeping bent, bramble, black knapweed (<i>Centaurea nigra</i>), cleavers, bracken (<i>Pteridium aquilinum</i>), stitchwort sp., cow parsley and nipplewort. The hedgerow appears to be more than 30 years in age.</p> <p>No Wildlife & Countryside Act protected species have been identified to be present. This hedgerow is classified under ecological criteria as 'Important' under The Hedgerow Regulations 1997.</p>

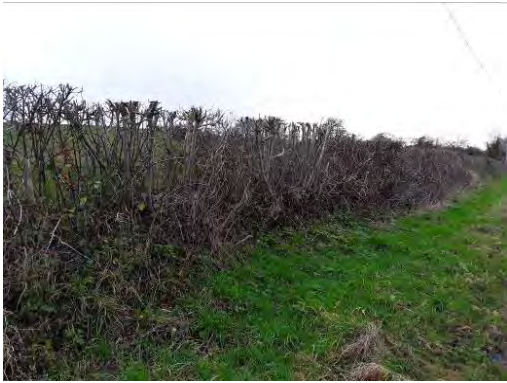
TR3.HH6

<p>The hedgerow is 75 m long and 1.5 m in height and 1.5 m wide. It does not have an associated bank, wall or ditch. There are no gaps within the hedgerow and there are no associated mature trees. Connections with other hedgerows or woodlands do not score four or more points. The canopy is species rich, with dominant hawthorn. Hazel, ash, holly and rose sp. are also present (five woody species). The ground flora has notable species of herb Robert. Also noted within the ground flora were additional species including; bramble, cow parsley, common nettle, common hogweed, cleavers, bracken, stitchwort sp. and crosswort. A parallel hedgerow is present within 15 m (TR3.HH7). The hedgerow appears to be more than 30 years in age.</p> <p>No Wildlife & Countryside Act protected species have been identified to be present. This hedgerow is classified under ecological criteria as 'Important' under The Hedgerow Regulations 1997.</p>

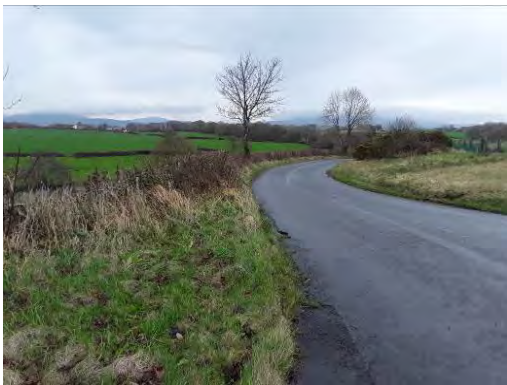
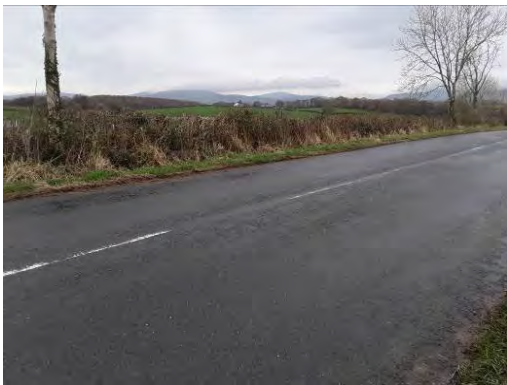
TR3.HH7

The hedgerow is 271 m long and 1 m in height and 1 m wide. There is one gap within the hedgerow which is less than 10% of the hedgerow length and there is one associated mature tree (there are 11 immature trees <20 cm diameter) within the hedgerow). Connections with other hedgerows or woodlands do not score four or more points. Two parallel hedgerows are present within 15 m (TR3.HH6 and TR3.HH8) and there is one connecting hedgerow (TR3.HH41). There is no associated ditch or bank. The canopy is species rich and dominated by hawthorn. Hazel, ash, holly, blackthorn and rose sp. are also present (six woody species). The ground flora has one notable species; herb Robert and other species present include; cow parsley, common hogweed, common nettle, bramble, cleavers, crosswort, ribwort plantain, yarrow (*Achillea millefolium*), meadow vetchling (*Lathyrus pratensis*), bush vetch and red fescue. The hedgerow appears to be more than 30 years in age.

No Wildlife & Countryside Act protected species have been identified to be present. **This hedgerow is classified under ecological criteria as 'Important' under The Hedgerow Regulations 1997.**

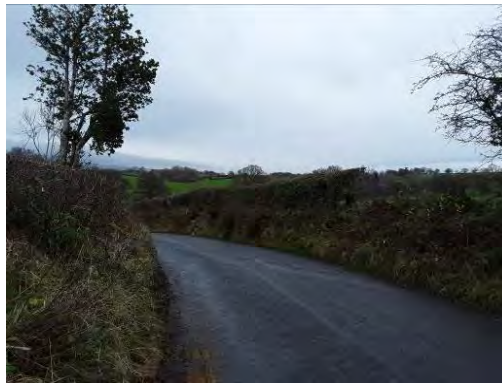
TR3.HH8

This hedgerow is 91 m in length, approximately 1.5 m in height and 2 m wide. There are no gaps or ditches along the length. There are no associated supporting banks or walls and there are no mature trees. The canopy is dominated by blackthorn, with hazel and holly also present (three woody species). Schedule 2 ground flora species recorded include male fern, lady fern, pignut (*Conopodium majus*), herb Robert, wood avens and dog's mercury. Additional ground flora species recorded include opposite leaved golden saxifrage (*Chrysosplenium oppositifolium*), cow parsley, bracken, meadow sweet, ivy, coltsfoot (*Tussilago farfara*), common hogweed, black knapweed and cleavers. Connections with other hedgerows or woodlands do not score four or more points, however there is a parallel hedgerow within 15 m (TR3.HH7). The hedgerow does not appear to be less than 30 years old.

No Wildlife & Countryside Act protected species have been identified to be present. This hedgerow does not classify under ecological criteria as 'Important' under The Hedgerow Regulations 1997.

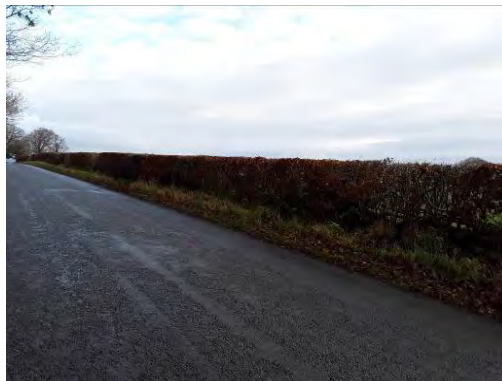
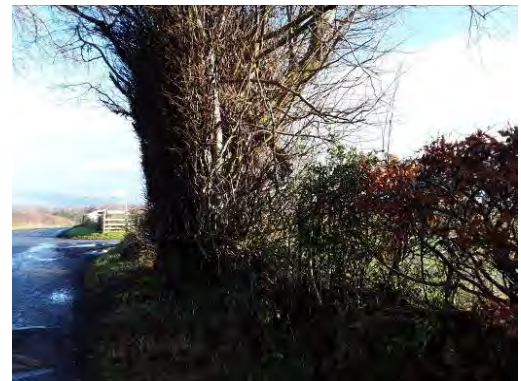
TR3.HH9

This hedgerow is 333 m in length, approximately 1.5 m in height and 2 m wide. There are no gaps in the hedgerow. There is no dry ditch associated with the hedgerow. The hedgerow is supported by a bank/wall. There is one mature tree associated with the hedgerow. The canopy is dominated by beech and with hazel, hawthorn, ash and holly also present (five woody species). Schedule 2 ground flora species present include male fern, lady fern, herb Robert, wood avens, dog's mercury, common polypody fern (*Polypodium vulgare*) and barren strawberry. Additional ground flora species recorded include; bramble, nipplewort, garlic mustard, ivy, cleavers, common nettle, common hogweed, reed canary grass (*Phalaris arundinacea*), meadow grass sp. (*Poa* sp.), meadowsweet, creeping buttercup, foxglove, cow parsley, dandelion (*Taraxacum officinale* agg.), sow thistle (*Sonchus* sp.), broadleaved dock (*Rumex obtusifolius*), hedge woundwort and sneezewort (*Achillea ptarmica*). Connections with other hedgerows or woodlands do not score four or more points, however there is a parallel hedgerow within 15 m (TR3.HH12). There are at least three woodland species within one metre, in any direction, of the outermost edge of the hedgerow. The hedgerow appears to be more than 30 years old.

No Wildlife & Countryside Act protected species have been identified to be present. **This hedgerow classifies under ecological criteria as 'Important' under The Hedgerow Regulations 1997.**

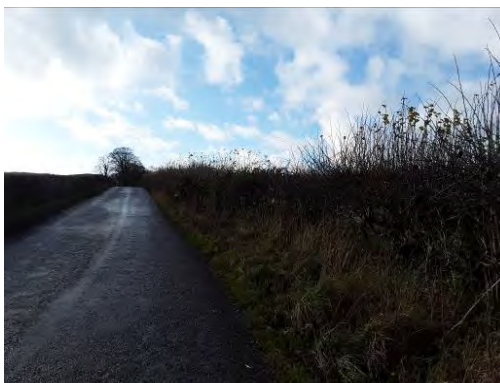
TR3.HH10

This hedgerow is 413 m in length, approximately 1.5 m in height and 1.5 m wide. There are no gaps in the hedgerow. There is no ditch associated with the hedgerow. The hedgerow is not supported by a bank/wall. There are four mature trees associated with the hedgerow. The canopy is dominated by hazel and blackthorn with hawthorn, ash, rose and holly also present (six woody species). Schedule 2 ground flora species present include; lady fern, herb Robert, wood avens, dog's mercury, broad-leaved helleborine (*Epipactis helleborine*) and barren strawberry. Additional ground flora species recorded include; bramble, garlic mustard, black knapweed, cleavers, common hogweed, false oat grass, sow thistle (*Sonchus* sp.), broadleaved dock, and stitchwort sp.. Connections with other hedgerows or woodlands do not score four or more points, however there are two parallel hedgerows within 15 m (TR3.HH11 and TR3.HH13). There are at least three woodland species within one metre, in any direction, of the outermost edge of the hedgerow. The hedgerow appears to be more than 30 years old.

No Wildlife & Countryside Act protected species have been identified to be present. **This hedgerow classifies under ecological criteria as 'Important' under The Hedgerow Regulations 1997.**

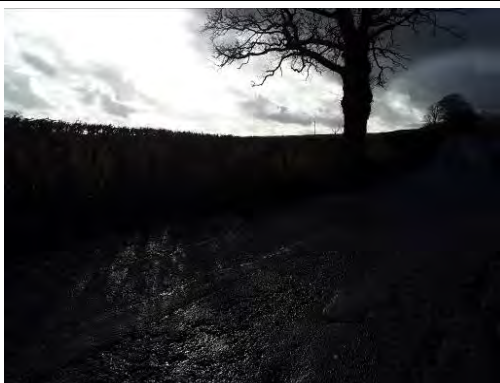
TR3.HH11

This hedgerow is 140 m in length, approximately 1.5 m in height and 1.5 m wide. There are no gaps in the hedgerow. There is no ditch associated with the hedgerow. The hedgerow is not supported by a bank/wall. There are two mature trees associated with the hedgerow. The canopy comprises a mix of blackthorn, beech, hawthorn, ash, rose and holly with no one species dominating the vegetation (six woody species). Schedule 2 ground flora species present include male fern, herb Robert, wood avens, dog's mercury and common polypody fern. Additional ground flora species recorded include; garlic mustard, common nettle, bramble, ivy, broadleaved dock, cow parsley, creeping buttercup, creeping thistle (*Cirsium arvense*), cleavers, meadowsweet, horsetail sp. and water avens (*Geum rivale*). Connections with other hedgerows or woodlands do not score four or more points, however there is a parallel hedgerow within 15 m (TR3.HH10). There are at least three woodland species within one metre, in any direction, of the outermost edge of the hedgerow. The hedgerow appears to be more than 30 years old.

No Wildlife & Countryside Act protected species have been identified to be present. **This hedgerow classifies under ecological criteria as 'Important' under The Hedgerow Regulations 1997.**

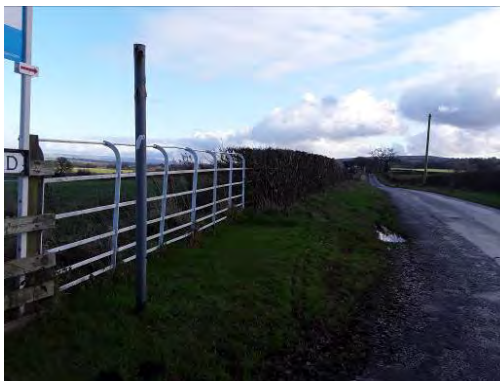
TR3.HH12

This hedgerow is 81 m in length, approximately 1.5 m in height and 2 m wide. There are no gaps in the hedgerow. There is no ditch associated with the hedgerow and it is not supported by a bank/wall. There are no mature trees associated with the hedgerow. The canopy is dominated by beech, with blackthorn, large leaved lime (*Tilia platyphyllos*), hawthorn, ash, rose and holly also present (seven woody species). Schedule 2 ground flora species present include dog's mercury and barren strawberry. Additional ground flora species recorded include; black knapweed, cow parsley, common nettle, meadowsweet, ivy, creeping buttercup and bramble. Connections with other hedgerows or woodlands do not score four or more points, however there is a parallel hedgerow within 15 m (TR3.HH9). The hedgerow appears to be more than 30 years old.

No Wildlife & Countryside Act protected species have been identified to be present. **This hedgerow classifies under ecological criteria as 'Important' under The Hedgerow Regulations 1997.**

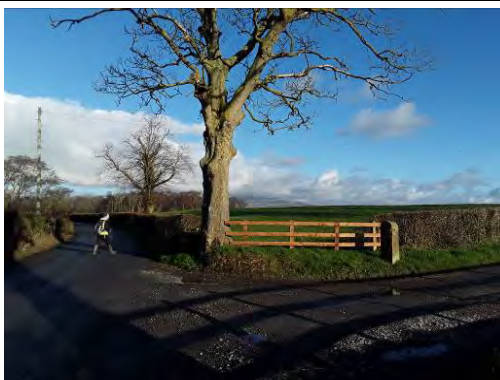
TR3.HH13

This hedgerow is 178 m in length, approximately 1.5 m in height and 3 m wide. There are no gaps in the hedgerow. There is no ditch associated with the hedgerow and it is not supported by a bank/wall. There are three mature trees associated with the hedgerow. The canopy comprises a mix of species with beech, blackthorn, hawthorn, ash, rose, large-leaved lime, elm sp. (*Ulmus* sp.), oak (*Quercus* sp.) and holly present with no species being dominant (nine woody species). Schedule 2 ground flora species present include lady fern, male fern, dog's mercury, common polypody and barren strawberry. Additional ground flora species recorded include; garlic mustard, cleavers, cow parsley, common nettle, common hogweed, creeping bent, dandelion, ivy, meadowsweet and coltsfoot. Signs of use by mammals, include paths through the hedgerow. Connections with other hedgerows or woodlands do not score four or more points, however there is a parallel hedgerow within 15 m (TR3.HH10). At least three Schedule 2 woodland ground flora species are present within one metre of the outermost edge of the hedgerow. The hedgerow appears to be more than 30 years old.

No Wildlife & Countryside Act protected species have been identified to be present. **This hedgerow classifies under ecological criteria as 'Important' under The Hedgerow Regulations 1997.**

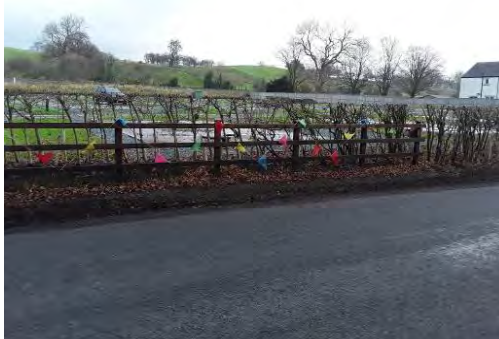
TR3.HH14

This hedgerow is 78 m in length, approximately 1 m in height and 0.5 m wide. There are no gaps in the hedgerow. There is no associated ditch and the hedgerow is not supported by a bank/wall. There are no mature trees associated with the hedgerow. The canopy is exclusively dominated by beech (one woody species). Ground flora species recorded include; cock's foot grass, meadow grass sp., common nettle, Yorkshire fog, ivy, and red fescue. Connections with other hedgerows or woodlands do not score four or more points. The hedgerow appears to be less than 30 years old.

No Wildlife & Countryside Act protected species have been identified to be present. This hedgerow does not classify under ecological criteria as 'Important' under The Hedgerow Regulations 1997.

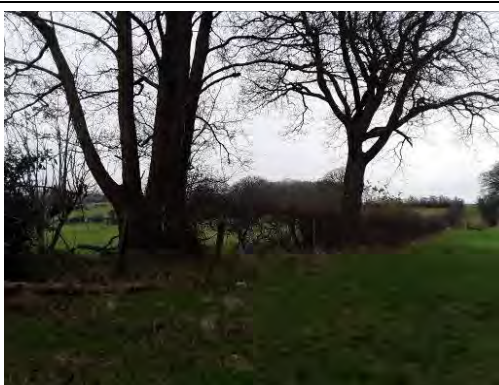
TR3.HH15

This hedgerow is 67 m in length, approximately 2 m in height and 2 m wide. There are no gaps in the hedgerow. There is a wet ditch along the western side of the hedgerow. The hedgerow is not supported by a bank/wall. There are two mature trees associated with the hedgerow. The canopy is dominated by hawthorn with hazel, ash, rose, elder and holly present (six woody species). Schedule 2 ground flora species present include male fern, herb Robert, wood avens and wild strawberry (*Fragaria vesca*). Additional ground flora species recorded include; bramble, cock's foot grass, meadow grass sp., common nettle, speedwell sp. (*Veronica* sp.), Yorkshire fog, ivy, foxglove, horsetail sp. and red fescue. Connections with other hedgerows or woodlands do not score four or more points. At least three woodland ground flora species are present within one metre of the outermost edge of the hedgerow. The hedgerow appears to be more than 30 years old and is adjacent to a footpath.

No Wildlife & Countryside Act protected species have been identified to be present. **This hedgerow classifies under ecological criteria as 'Important' under The Hedgerow Regulations 1997.**

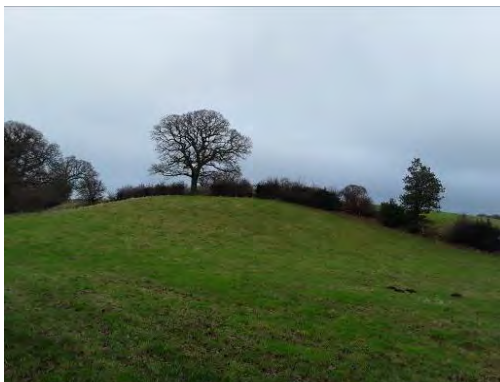
TR3.HH16

This hedgerow is 30 m in length, approximately 3 m in height and 2 m wide. There is one gap, which comprises more than 10% of the total length of the hedgerow. There is no associated ditch. The hedgerow is supported by a bank/wall along at least half of its length. There are two mature trees associated with the hedgerow. The canopy is dominated by hawthorn with rose, elder and holly present (four woody species). Schedule 2 ground flora species present include male fern and wild strawberry. Additional ground flora species recorded include; ground ivy and ivy. Connections with other hedgerows or woodlands do not score four or more points. The hedgerow appears to be more than 30 years old.

No Wildlife & Countryside Act protected species have been identified to be present. **This hedgerow classifies under ecological criteria as 'Important' under The Hedgerow Regulations 1997.**

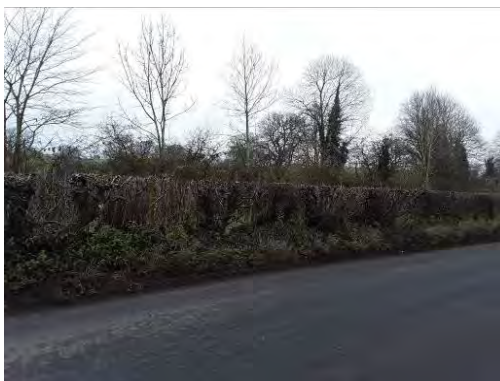
TR3.HH17

This hedgerow is 229 m in length, approximately 1 m in height and 1 m wide. There are no gaps within the hedgerow. There is no associated ditch. The hedgerow is supported by a bank/wall along at least half of its length. There is one mature tree associated with the hedgerow. The canopy is dominated by hawthorn with hazel, ash, blackthorn, rose, elder and holly present (seven woody species). Schedule 2 ground flora species present include male fern and dog's mercury. Additional ground flora species recorded include common nettle, cleavers and common hogweed. Connections with other hedgerows or woodlands do not score four or more points. The hedgerow appears to be more than 30 years old.

No Wildlife & Countryside Act protected species have been identified to be present. **This hedgerow classifies under ecological criteria as 'Important' under The Hedgerow Regulations 1997.**

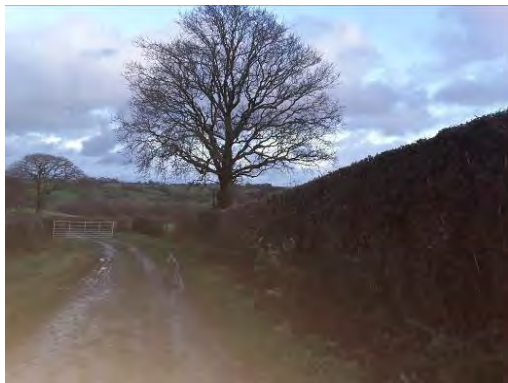
<p>This hedgerow is 260 m in length, approximately 2 m in height and 2 m wide. There is one gap within the hedgerow that is less than 10% of the total length. There is an associated wet ditch, located to the north of the hedgerow. The hedgerow is supported by a bank/wall along at least half of its length. There are three mature trees associated with the hedgerow. The canopy is dominated by hazel and hawthorn with ash, willow (<i>Salix</i> sp.), rowan (<i>Sorbus aucuparia</i>) and holly present (six woody species). Schedule 2 ground flora species present include lady fern, male fern, common polypody and dog's mercury. Additional ground flora species recorded include; bramble, common nettle, foxglove, cow parsley, vetch sp., cleavers and creeping buttercup. Connections with other hedgerows or woodlands do not score four or more points. There are two parallel hedgerows within 15 m (TR3.HH20 and TR3.HH22). The hedgerow appears to be more than 30 years old.</p> <p>No Wildlife & Countryside Act protected species have been identified to be present. This hedgerow classifies under ecological criteria as 'Important' under The Hedgerow Regulations 1997.</p>

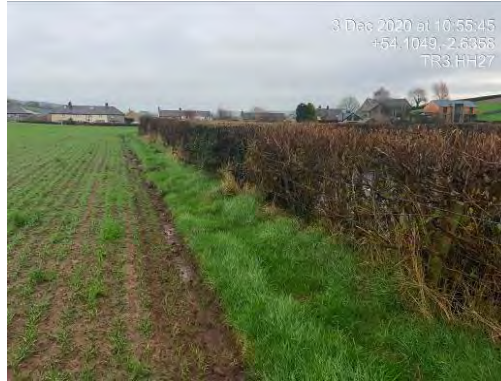
TR3.HH27

This hedgerow is 250 m in length, approximately 1.5 m in height and 1.5 m wide. There are no gaps within the hedgerow and there is no associated wet ditch. The hedgerow is not supported by a bank/wall along at least half of its length. There are no mature trees associated with the hedgerow. The canopy has abundant blackthorn, hawthorn and holly, with hazel, elder and oak also present (six woody species). Schedule 2 ground flora species present include; lady fern, wood avens and dog's mercury. Additional ground flora species recorded include; bramble, ivy, cleavers, common nettle and hedge woundwort. There is a parallel hedgerow within 15 m (TR3.HH31) and there are at least three woodland ground flora species within 1 m of the outermost edge of the hedgerow. Connections with other hedgerows or woodlands do not score four or more points. The hedgerow appears to be more than 30 years old.

No Wildlife & Countryside Act protected species have been identified to be present. **This hedgerow classifies under ecological criteria as 'Important' under The Hedgerow Regulations 1997.**

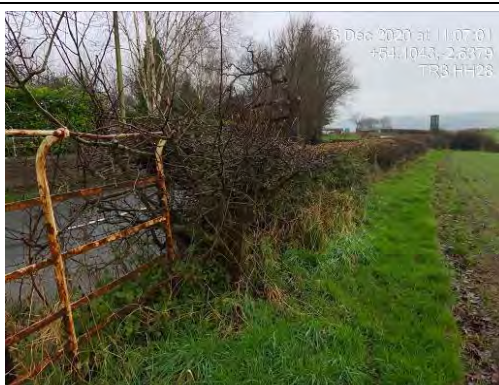
TR3.HH28

This hedgerow is 160 m in length, approximately 1 m in height and 2 m wide. There are no gaps within the hedgerow and there is no associated wet ditch. The hedgerow is not supported by a bank/wall along at least half of its length. There are no mature trees associated with the hedgerow. The canopy is dominated by hawthorn, with hazel, blackthorn, willow, elder and holly present (six woody species). Schedule 2 ground flora species present include; lady fern and dog's mercury. Additional ground flora species recorded include; bramble, ivy, cleavers, common nettle, ground ivy and hedge bindweed (*Calystegia sepium*). There is a parallel hedgerow within 15 m (TR3.HH30) and it connects to one other hedgerow (TR3.HH29). Connections with other hedgerows or woodlands do not score four or more points. The hedgerow appears to be more than 30 years old.

No Wildlife & Countryside Act protected species have been identified to be present. **This hedgerow classifies under ecological criteria as 'Important' under The Hedgerow Regulations 1997.**

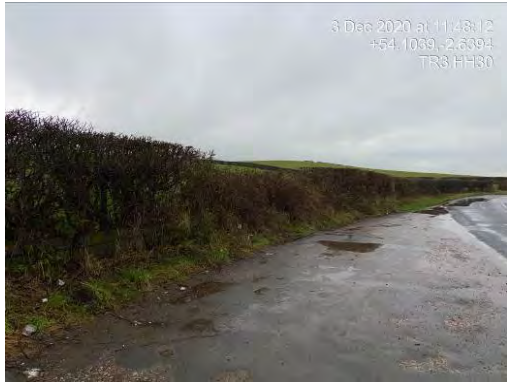
TR3.HH30

<p>This hedgerow is 56 m in length, approximately 2 m in height and 2 m wide. There are no gaps within the hedgerow and there is no associated wet ditch. The hedgerow is not supported by a bank/wall along at least half of its length. There are no mature trees associated with the hedgerow. The canopy is dominated by blackthorn, with hawthorn, rose, elder and elm sp. present (five woody species). Schedule 2 ground flora species present include; lady fern, wood avens and dog's mercury. Additional ground flora species recorded include; bramble, ivy, cleavers, common nettle and garlic mustard. There is a parallel hedgerow within 15 m (TR3.HH28). Connections with other hedgerows or woodlands do not score four or more points. The hedgerow appears to be more than 30 years old.</p> <p>No Wildlife & Countryside Act protected species have been identified to be present. This hedgerow does not classify under ecological criteria as 'Important' under The Hedgerow Regulations 1997.</p>

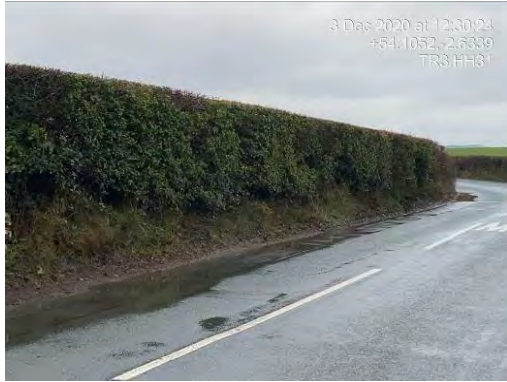
TR3.HH31

<p>This hedgerow is 166 m in length, approximately 1.5 m in height and 1 m wide. The gaps within the hedgerow aggregate to less than 10% of the total length and there is no associated wet ditch. The hedgerow is not supported by a bank/wall along at least half of its length. There are no mature trees associated with the hedgerow. The canopy is dominated by hawthorn, with elder also present (two woody species). Schedule 2 ground flora species present include; lady fern and wood avens. Additional ground flora species recorded include; bramble, ivy, cleavers, common nettle, cow parsley and garlic mustard. There is a parallel hedgerow within 15 m (TR3.HH27). Connections with other hedgerows or woodlands do not score four or more points. The hedgerow appears to be more than 30 years old.</p> <p>No Wildlife & Countryside Act protected species have been identified to be present. This hedgerow does not classify under ecological criteria as 'Important' under The Hedgerow Regulations 1997.</p>

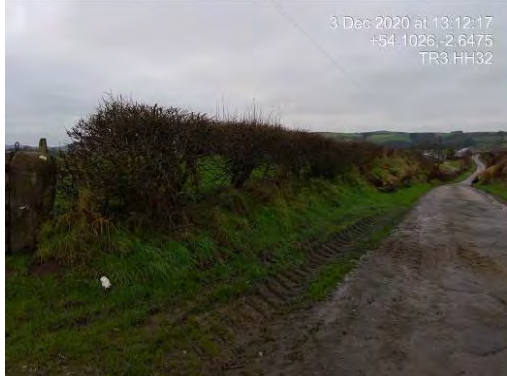
TR3.HH32

This hedgerow is 91 m in length, approximately 1.5 m in height and 1 m wide. The gaps within the hedgerow aggregate to less than 10% of the total length and there is no associated wet ditch. The hedgerow is supported by a bank/wall along at least half of its length. There are no mature trees associated with the hedgerow. The canopy is exclusively dominated by hawthorn (one woody species). Schedule 2 ground flora species present include; lady fern. Additional ground flora species recorded include; bramble, ivy, cleavers, common nettle, and garlic mustard. There is a parallel hedgerow within 15 m (TR3.HH33) and this hedgerow connects with one other (TR3.HH34). Connections with other hedgerows or woodlands do not score four or more points. The hedgerow appears to be more than 30 years old.

No Wildlife & Countryside Act protected species have been identified to be present. This hedgerow does not classify under ecological criteria as 'Important' under The Hedgerow Regulations 1997.

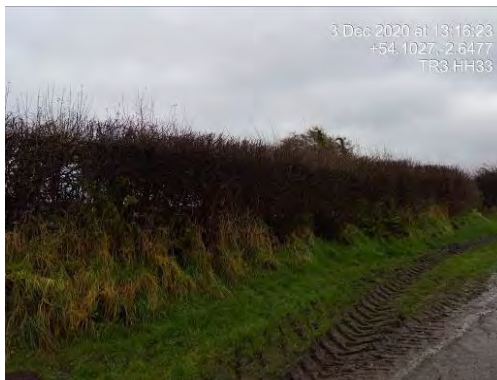
TR3.HH33

This hedgerow is 93 m in length, approximately 2.5 m in height and 1 m wide. The gaps within the hedgerow aggregate to less than 10% of the total length and there is no associated wet ditch. The hedgerow is supported by a bank/wall along at least half of its length. There are no mature trees associated with the hedgerow. The canopy is dominated by hawthorn and blackthorn, with rose sp. also present (three woody species). Schedule 2 ground flora species present include; lady fern. Additional ground flora species recorded include; bramble, ivy, cleavers and red campion. There is a parallel hedgerow within 15 m (TR3.HH32) and this hedgerow connects with one other (TR3.HH34). Connections with other hedgerows or woodlands do not score four or more points. The hedgerow appears to be more than 30 years old.

No Wildlife & Countryside Act protected species have been identified to be present. This hedgerow does not classify under ecological criteria as 'Important' under The Hedgerow Regulations 1997.

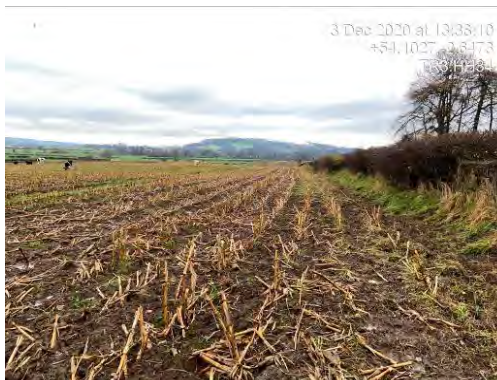
TR3.HH34

This hedgerow is 229 m in length, approximately 2.5 m in height and 1 m wide. The gaps within the hedgerow aggregate to less than 10% of the total length and there is no associated wet ditch. The hedgerow is supported by a bank/wall along at least half of its length. There are no mature trees associated with the hedgerow. The canopy is dominated by blackthorn, with hawthorn, rose sp. and elder also present (four woody species). Schedule 2 ground flora species present include; lady fern and wood avens. Additional ground flora species recorded include; bramble, cleavers, common nettle, red campion, garlic mustard, hedge woundwort, ground ivy and common hogweed. There are two parallel hedgerows within 15 m (TR3.HH35 and TR3.HH38) and this hedgerow connects with two others (TR3.HH32 and TR3.HH33). Connections with other hedgerows or woodlands do not score four or more points. The hedgerow appears to be more than 30 years old.

No Wildlife & Countryside Act protected species have been identified to be present. **This hedgerow classifies under ecological criteria as 'Important' under The Hedgerow Regulations 1997.**

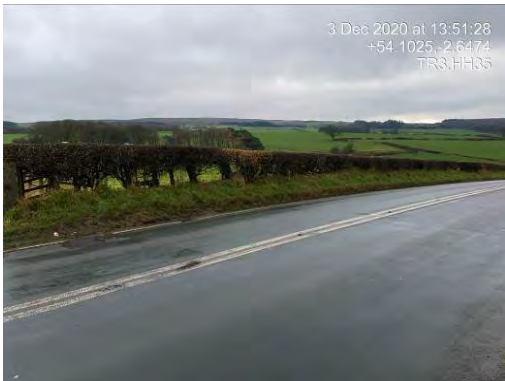
TR3.HH35

<p>This hedgerow is 98 m in length, approximately 1.5 m in height and 1 m wide. The gaps within the hedgerow aggregate to less than 10% of the total length and there is no associated wet ditch. The hedgerow is not supported by a bank/wall along at least half of its length. There are no mature trees associated with the hedgerow. The canopy is dominated by blackthorn with elder also present (two woody species). Schedule 2 ground flora species present include; lady fern. Additional ground flora species recorded include; common nettle, red campion, garlic mustard, hedge woundwort, ground ivy and common hogweed. There is a parallel hedgerow within 15 m (TR3.HH34). Connections with other hedgerows or woodlands do not score four or more points. The hedgerow appears to be more than 30 years old.</p> <p>No Wildlife & Countryside Act protected species have been identified to be present. This hedgerow does not classify under ecological criteria as 'Important' under The Hedgerow Regulations 1997.</p>

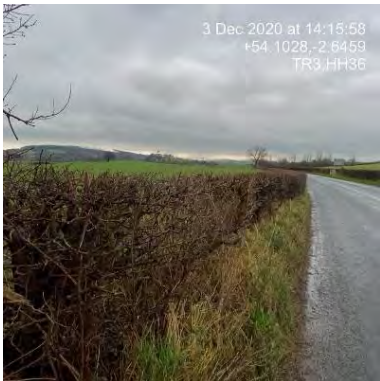
TR3.HH36

<p>This hedgerow is 35 m in length, approximately 1.5 m in height and 1 m wide. The gaps within the hedgerow aggregate to less than 10% of the total length and there is no associated wet ditch. The hedgerow is not supported by a bank/wall along at least half of its length. There are no mature trees associated with the hedgerow. The canopy is dominated by hawthorn with blackthorn, holly, rose and elder also present (five woody species). No Schedule 2 ground flora species were recorded. Additional ground flora species recorded include; common nettle, garlic mustard and common hogweed. There is a parallel hedgerow within 15 m (TR3.HH37). Connections with other hedgerows or woodlands do not score four or more points. The hedgerow appears to be more than 30 years old.</p> <p>No Wildlife & Countryside Act protected species have been identified to be present. This hedgerow classifies under ecological criteria as 'Important' under The Hedgerow Regulations 1997.</p>

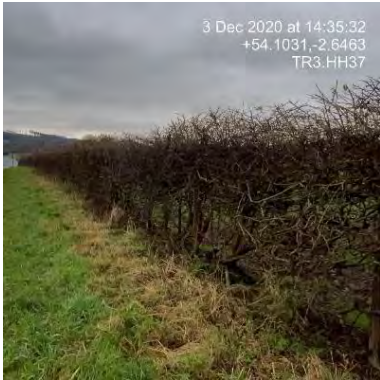
TR3.HH37

This hedgerow is 31 m in length, approximately 1 m in height and 1 m wide. The gaps within the hedgerow aggregate to less than 10% of the total length and there is no associated wet ditch. The hedgerow is not supported by a bank/wall along at least half of its length. There are no mature trees associated with the hedgerow. The canopy is dominated by blackthorn with hawthorn, and elder also present (three woody species). Schedule 2 ground flora species present include; lady fern and wood avens. Additional ground flora species recorded include; ground ivy, cow parsley, cleavers, common nettle, ivy, common hogweed and ground elder. There is a parallel hedgerow within 15 m (TR3.HH36). Connections with other hedgerows or woodlands do not score four or more points. The hedgerow appears to be more than 30 years old.

No Wildlife & Countryside Act protected species have been identified to be present. This hedgerow does not classify under ecological criteria as 'Important' under The Hedgerow Regulations 1997.

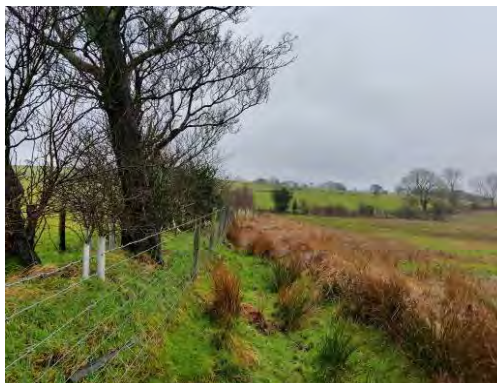
TR3.HH39

This hedgerow is 116 m in length, approximately 1.5 m in height and 1 m wide. The gaps within the hedgerow aggregate to less than 10% of the total length and there is no associated wet ditch. The hedgerow is supported by a bank/wall along at least half of its length. There are three mature trees associated with the hedgerow. The canopy is dominated by hawthorn with blackthorn, hazel and holly also present (four woody species). No Schedule 2 ground flora species were recorded. Other ground flora species recorded include; common nettle, ground ivy, common hogweed, cow parsley, hedge woundwort, cleavers and creeping buttercup. There is no parallel hedgerow within 15 m. Connections with other hedgerows or woodlands do not score four or more points. The hedgerow appears to be less than 30 years old.

No Wildlife & Countryside Act protected species have been identified to be present. This hedgerow does not classify under ecological criteria as 'Important' under The Hedgerow Regulations 1997.

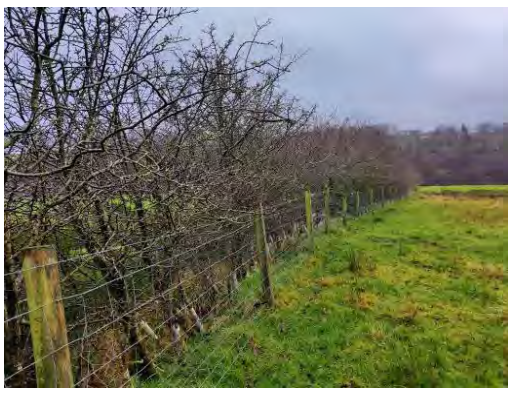
TR3.HH40

<p>This hedgerow is 95 m in length, approximately 2 m in height and 1 m wide. There are no gaps within the hedgerow and there are no mature trees associated with the hedgerow. A wet ditch is associated with the hedgerow, running along the southern side of the hedgerow. The hedgerow is not supported by a bank/wall along at least half of its length. The canopy is dominated by blackthorn with hawthorn, hazel and holly also present (four woody species). No Schedule 2 ground flora species were recorded. Other ground flora species recorded include; common nettle, common hogweed, cow parsley, cleavers and creeping buttercup. There is no parallel hedgerow within 15 m. Connections with other hedgerows or woodlands do not score four or more points. The hedgerow appears to be less than 30 years old.</p> <p>No Wildlife & Countryside Act protected species have been identified to be present. This hedgerow does not classify under ecological criteria as 'Important' under The Hedgerow Regulations 1997.</p>

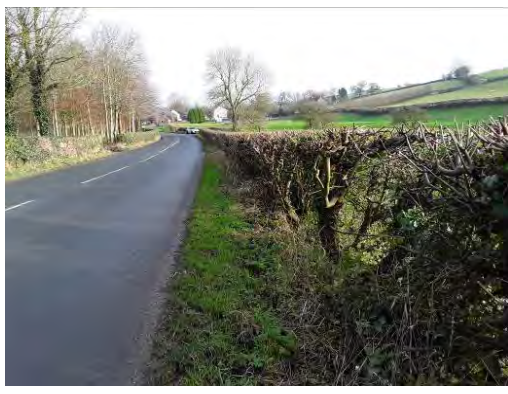
TR3.HH42

<p>This hedgerow is 213 m in length, approximately 1.5 m in height and 1 m wide. There is one gap within the hedgerow, which does not exceed 10% of the length of the hedgerow and there is one mature tree associated with the hedgerow. There is no ditch associated with the hedgerow. The hedgerow is not supported by a bank/wall along at least half of its length. The canopy has abundant hawthorn with blackthorn, hazel, elder and holly also present (five woody species). Schedule 2 ground flora species present include lady fern, herb Robert and wood avens. Other ground flora species recorded include; common nettle, bramble, cow parsley, cleavers and creeping buttercup. There is no parallel hedgerow within 15 m. Connections with other hedgerows or woodlands do not score four or more points. The hedgerow appears to be more than 30 years old.</p> <p>No Wildlife & Countryside Act protected species have been identified to be present. This hedgerow does not classify under ecological criteria as 'Important' under The Hedgerow Regulations 1997.</p>

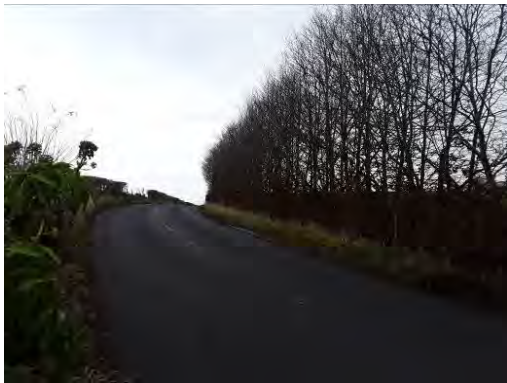
TR3.HH43

<p>This hedgerow is 56 m in length, approximately 7 m in height and 1.5 m wide. There are no gaps associated with the hedgerow, and there are no mature trees or ditches associated with the hedgerow. The hedgerow is not supported by a bank/wall along at least half of its length. The canopy is exclusively comprised of beech (one woody species). Schedule 2 ground flora species present include male fern, wood avens and barren strawberry. Other ground flora species recorded include; bramble, ivy and creeping buttercup. There is a parallel hedgerow within 15 m (TR3.HH44). Connections with other hedgerows or woodlands do not score four or more points. The hedgerow appears to be more than 30 years old.</p> <p>No Wildlife & Countryside Act protected species have been identified to be present. This hedgerow does not classify under ecological criteria as 'Important' under The Hedgerow Regulations 1997.</p>

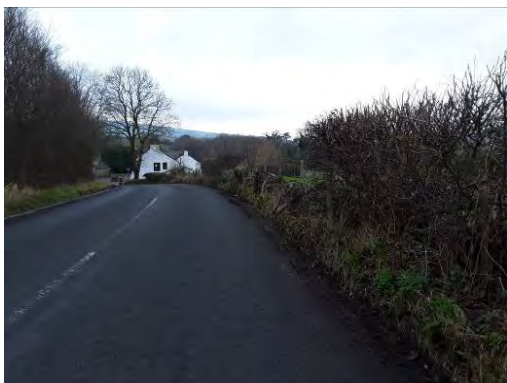
TR3.HH44

<p>This hedgerow is 49 m in length, approximately 1.5 m in height and 1 m wide. There are two gaps within the hedgerow, which exceeds 10% of the length of the hedgerow and there are no mature trees associated with the hedgerow. There is no ditch associated with the hedgerow. The hedgerow is not supported by a bank/wall along at least half of its length. The canopy has abundant hawthorn with blackthorn, hazel, ash, elder and rose also present (six woody species). Schedule 2 ground flora species were recorded as being absent. Other ground flora species recorded include; bramble, ivy, garlic mustard and cleavers. There is a parallel hedgerow within 15 m (TR3.HH43). Connections with other hedgerows or woodlands do not score four or more points. The hedgerow appears to be more than 30 years old.</p> <p>No Wildlife & Countryside Act protected species have been identified to be present. This hedgerow does not classify under ecological criteria as 'Important' under The Hedgerow Regulations 1997.</p>

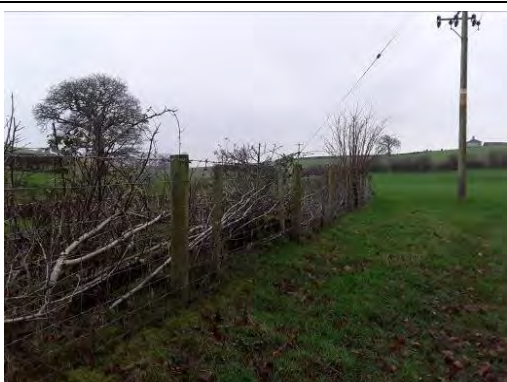
TR3.HH45

This hedgerow is 106 m in length, approximately 3 m in height and 2 m wide. There are no gaps within the hedgerow, and there are no mature trees associated with the hedgerow. There is no ditch associated with the hedgerow. The hedgerow is not supported by a bank/wall along at least half of its length. The canopy has abundant hawthorn and blackthorn with hazel, beech, rose, elder, elm and large-leaved lime also present (eight woody species). Schedule 2 ground flora species recorded as being present include; dog's mercury, lady fern and male fern. Other ground flora species recorded include; foxglove, red campion, hedge woundwort, bramble, creeping buttercup and soft rush (*Juncus effusus*). An old stone boundary wall runs adjacent to hedgerow, which has been recently laid. There is no parallel hedgerow within 15 m. Connections with other hedgerows or woodlands do not score four or more points. The hedgerow appears to be more than 30 years old.

No Wildlife & Countryside Act protected species have been identified to be present. **This hedgerow classifies under ecological criteria as 'Important' under The Hedgerow Regulations 1997.**

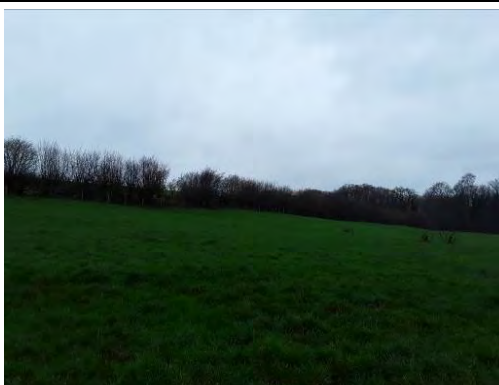
TR3.HH46

This hedgerow is 106 m in length, approximately 1.5 m in height and 3 m wide. There are no gaps within the hedgerow, and there is one mature tree associated with the hedgerow. There is no ditch associated with the hedgerow. The hedgerow is not supported by a bank/wall along at least half of its length. The canopy has abundant hawthorn and blackthorn, with hazel, beech, rose, large-leaved lime, elm and elder also present (eight woody species). Schedule 2 ground flora species were recorded as being absent. Other ground flora species recorded include; foxglove, red campion, hedge woundwort, bramble, creeping buttercup and soft rush. The hedgerow has been previously laid and has an adjacent old stone boundary wall. There is no parallel hedgerow within 15 m. Connections with other hedgerows or woodlands do not score four or more points. The hedgerow appears to be more than 30 years old.

No Wildlife & Countryside Act protected species have been identified to be present. **This hedgerow classifies under ecological criteria as 'Important' under The Hedgerow Regulations 1997.**

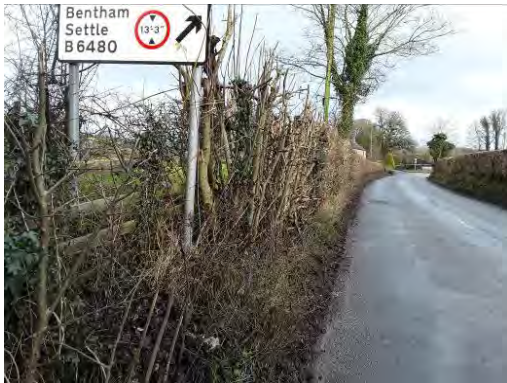
TR3.HH48

<p>This hedgerow is 82 m in length, approximately 2 m in height and 1.5 m wide. There are no gaps within the hedgerow, and there is one mature tree associated with the hedgerow. There is a no ditch associated with the hedgerow. The hedgerow is not supported by a bank/wall along at least half of its length. The canopy is dominated by ash with hawthorn, blackthorn, hazel, holly and elm also present (six woody species). Schedule 2 ground flora species recorded as being present include; lady fern, broad buckler-fern, herb Robert, wood avens and dog's mercury. Other ground flora species recorded include; meadow sweet, ivy, garlic mustard, creeping cinquefoil (<i>Potentilla reptans</i>), cow parsley and cleavers. There is a parallel hedgerow within 15 m (TR3.HH49). Connections with other hedgerows or woodlands do not score four or more points. The hedgerow appears to be more than 30 years old.</p> <p>No Wildlife & Countryside Act protected species have been identified to be present. This hedgerow classifies under ecological criteria as 'Important' under The Hedgerow Regulations 1997.</p>

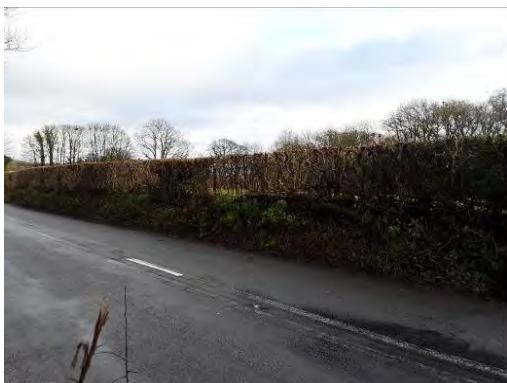
TR3.HH49

<p>This hedgerow is 87 m in length, approximately 1.5 m in height and 1 m wide. There are no gaps within the hedgerow, and there is one mature tree associated with the hedgerow. There is no ditch associated with the hedgerow. The hedgerow is not supported by a bank/wall along at least half of its length. The canopy has abundant ash with hawthorn, hazel, holly and elder also present (five woody species). Schedule 2 ground flora species recorded as being present include; male fern, wood avens and dog's mercury. Other ground flora species recorded include; ivy and garlic mustard. There is a parallel hedgerow within 15 m (TR3.HH48). Connections with other hedgerows or woodlands do not score four or more points. The hedgerow appears to be more than 30 years old.</p> <p>No Wildlife & Countryside Act protected species have been identified to be present. This hedgerow classifies under ecological criteria as 'Important' under The Hedgerow Regulations 1997.</p>

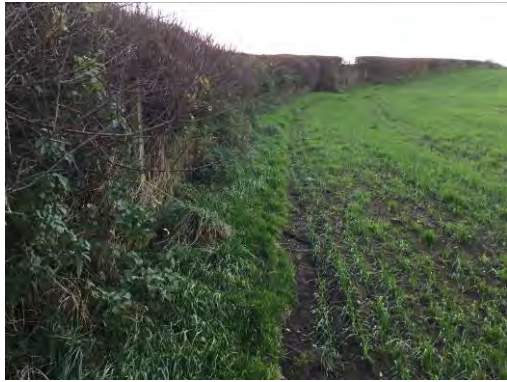
TR3.WH1

<p>This roadside hedge is approximately 500 m in length, 2 m wide and 2-3 m tall. There are no associated trees or ditch, and the hedgerow is situated on a bank. There is one gap in the hedgerow which accounts for <5% of the total length. Outside the survey area there are connections with two other hedgerows (scoring two connection points), and there are two parallel hedgerows (TR3.WH3 and TR3.WH4) within 15 m.</p> <p>The canopy is overall species-rich and includes dominant blackthorn, with additional hazel, hawthorn, ash, elder and sessile oak (<i>Quercus petraea</i>) (total six woody species). Schedule 2 ground flora recorded along the length of the hedgerow includes lady fern, dog's mercury and wood avens. Other ground flora recorded includes; cleavers, perennial rye grass (<i>Lolium perenne</i>), Yorkshire fog, garlic mustard, red campion, bramble, ivy and cock's foot grass. The hedgerow is established and mature and therefore obviously more than 30 years in age. It has previously been laid and recently cut / maintained.</p> <p>No Wildlife & Countryside Act protected species have been identified to be present. The hedgerow does not classify under ecological criteria as 'Important' under The Hedgerow Regulations 1997.</p>

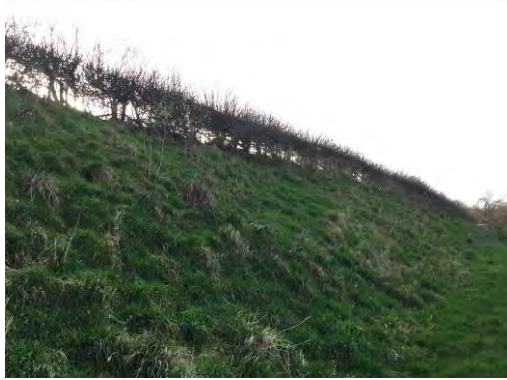
TR3.WH2

<p>This hedgerow is along a field boundary, is approximately 60 m in length, 3 m tall and 2 m wide. There are no associated trees or ditch, and the hedgerow is situated on a tall bank which slopes steeply down towards the north. There are no gaps along the hedgerow length. There are no connections to other hedgerows, ponds or woodland, and there are no parallel hedgerows within 15 m.</p> <p>The canopy comprises dominant blackthorn and rare hawthorn (total two woody species). Schedule 2 ground flora species recorded include dog's mercury and lady fern. Additional ground flora species recorded include; red campion, common hogweed, cock's foot grass, common nettle and meadow grass sp.. There were signs of use of the hedgerow by nesting birds and rabbit (<i>Oryctolagus cuniculus</i>). The hedgerow is established and mature and therefore obviously more than 30 years in age. Some parts of the hedgerow are growing out and becoming "leggy".</p> <p>No Wildlife & Countryside Act protected species have been identified to be present. This hedgerow does not classify under ecological criteria as 'Important' under The Hedgerow Regulations 1997.</p>

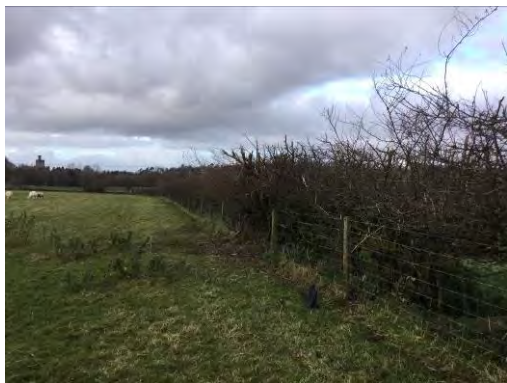
TR3.WH5

<p>This hedgerow delineates a field boundary and is approximately 100 m in length, 3 m in height and 2 m wide. There are no gaps along the length of the hedgerow. There are no associated trees or a ditch, and the hedgerow is not situated on a bank. This hedgerow does not connect to and is not parallel to any other hedgerows.</p> <p>The canopy is dominated by blackthorn, with additional species recorded including hazel, hawthorn, ash and willow (total five woody species). Schedule 2 ground flora species were absent. Other ground flora species recorded include cock's foot grass, common nettle, meadow grass and foxglove. The hedgerow has been previously laid, and recently felled. It is established and mature and therefore obviously more than 30 years in age.</p> <p>No Wildlife & Countryside Act protected species have been identified to be present. This hedgerow does not classify under ecological criteria as 'Important' under The Hedgerow Regulations 1997, however, it is possible that additional Schedule 2 ground flora species may be present during the optimal time period and this may incur a change in classification to 'Important'.</p>

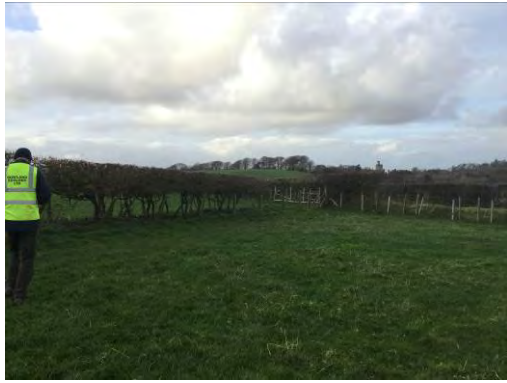
TR3.WH6

<p>This hedgerow delineates a field boundary and is approximately 110 m in length, 2 m in height and 2 m wide. There are two gaps along the length of the hedgerow, accounting for approximately 10% of the length. There are no associated trees or a ditch, and the hedgerow is not situated on a bank. This hedgerow connects to one other hedgerow (TR3.WH4).</p> <p>The canopy is dominated by hawthorn, with additional species recorded including blackthorn (total two woody species). Schedule 2 ground flora species were absent. Other ground flora species recorded include; cock's foot grass, common nettle, meadow grass, bittercress species (<i>Cardamine</i> sp.) and common mouse ear. The hedgerow is tall and "leggy" and is fenced on both sides. There are signs of use by nesting birds. It appears to be less than 30 years old.</p> <p>No Wildlife & Countryside Act protected species have been identified to be present. This hedgerow does not classify under ecological criteria as 'Important' under The Hedgerow Regulations 1997.</p>

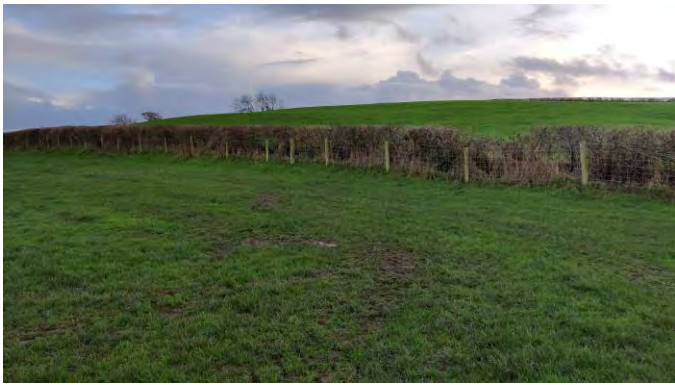
TR3.WH7

<p>This hedgerow follows a field boundary and is approximately 140 m in length, 2 m in height and 2 m wide. There are two gaps along the length of the hedgerow, accounting for approximately 10% of the length. There are no associated trees or a ditch. The hedgerow is situated on a bank. This hedgerow connects to one other hedgerow (TR3.WH4).</p> <p>The canopy is dominated by elder, with additional species recorded including blackthorn, rose species and hazel (total four woody species). Schedule 2 ground flora species present include lady fern and male fern. Other ground flora species recorded include; bramble, common nettle, meadow grass, red campion, cock's foot grass, cleavers and foxglove. The hedgerow has previously been laid, has recently been cut and is fenced. It is established and mature and therefore obviously more than 30 years in age.</p> <p>No Wildlife & Countryside Act protected species have been identified to be present. This hedgerow does not classify under ecological criteria as 'Important' under The Hedgerow Regulations 1997.</p>

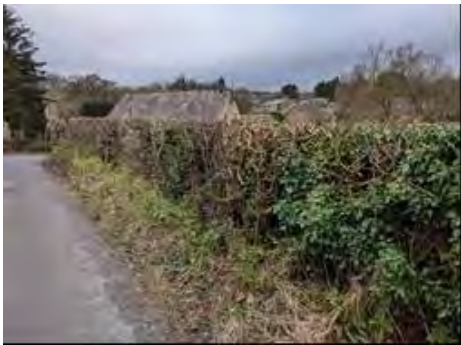
<p>The hedgerow is approximately 30 m long and 1 m in height and 1 m wide. There are no gaps within the hedgerow and no associated mature trees. Connections with other hedgerows or woodlands do not score four or more points. There is no associated ditch with the hedgerow, however, it is supported by a wall. The hedgerow is parallel with one other hedgerow; TR3.WCPH2). The canopy is species-poor, being dominated by sycamore, with smaller amounts of holly and elder (two qualifying woody species). The ground flora has notable species of dog's mercury. Also noted within the ground flora were additional species including; ivy and common hogweed. The hedgerow appears to be more than 30 years in age.</p> <p>No Wildlife & Countryside Act protected species have been identified to be present. This hedgerow does not classify under ecological criteria as 'Important' under The Hedgerow Regulations 1997.</p>
