**Haweswater Aqueduct Resilience Programme -
Proposed Bowland Section
Supplementary Environmental Information**

Off-Site Highways Works – TR3 Hedgerows Report

January 2022

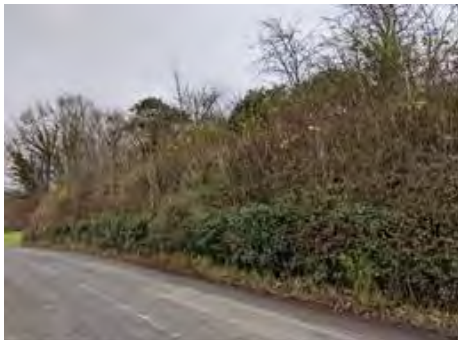
TR3.WCPH2

<p>The hedgerow is approximately 75 m long and 2 m in height and 2 m wide; it is supported on a wall. There are no gaps within the hedgerow and no associated mature trees. Connections with other hedgerows or woodlands do not score four or more points. The hedgerow is parallel with one other hedgerow; TR3.WCPH1). There is no associated ditch with the hedgerow. The canopy is species rich, being dominated by blackthorn, with smaller amounts of hawthorn, hazel, alder, ash and elder (six woody species). The ground flora has notable species of dog's mercury. Also noted within the ground flora were additional species including; ivy and bramble. The hedgerow appears to be more than 30 years in age.</p> <p>No Wildlife & Countryside Act protected species have been identified to be present. This hedgerow is classified under ecological criteria as 'Important' under The Hedgerow Regulations 1997.</p>

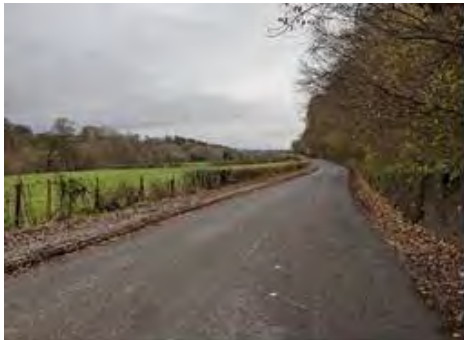
TR3.WCPH3

<p>The hedgerow is 90 m long and 1 m in height and 1 m wide. It is not supported upon a bank or wall. There is one large gap within the hedgerow, which comprises more than 15 % of the total length and there are no associated mature trees. Connections with other hedgerows or woodlands do not score four or more points. There is no associated wet ditch. The canopy is species-poor, with dominant hawthorn, abundant blackthorn and occasional elder (three woody species). The ground flora has notable species of dog's mercury and wood avens. Also noted within the ground flora were additional species including; bramble, raspberry, ivy, common nettle and black bryony sp. (<i>Dioscorea communis</i>). The hedgerow does not appear to be more than 30 years in age.</p> <p>No Wildlife & Countryside Act protected species have been identified to be present. This hedgerow is not classified under ecological criteria as 'Important' under The Hedgerow Regulations 1997.</p>

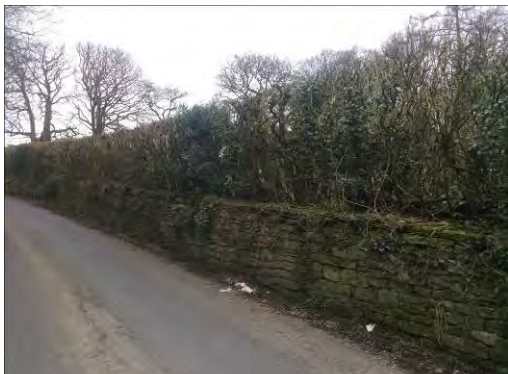
This hedgerow is 55 m in length and 1 m wide and located along a public road. The northern end of the hedgerow is located on top of a stone wall and appears to form the boundary of a residential dwelling - the height of the hedgerow above the top of the wall is approximately 1.5 m. The southern end of the hedgerow is located on a bank. There are no connections with other hedgerows. It is fenced from the adjacent field and appears to have been recently trimmed/flailed. The hedgerow is established and mature and therefore obviously more than 30 years in age.

The hedgerow has one associated sycamore mature tree, and no gaps. There is no associated ditch. The canopy comprises frequent hazel and hawthorn with occasional holly and more rarely yew (*Taxus baccata*) (four canopy species). There are several notable (Schedule 2) ground flora species as follows: lords-and-ladies (*Arum maculatum*), dog's mercury, hart's tongue and common polypody. Other ground flora noted includes ivy, cleavers, red campion, common chickweed (*Stellaria media*), common nettle, lesser celandine (*Ranunculus ficaria*), hedge mustard (*Alliaria petiolata*) and bramble. No Wildlife & Countryside Act protected species have been identified to be present.

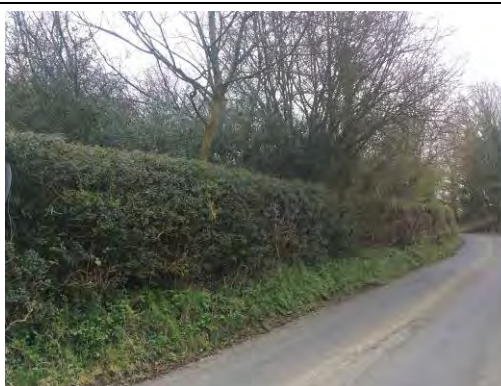
TR3.H2

This roadside hedgerow is 30 m in length and 1 m in height. It is 1.5 m wide and has one associated mature tree (sycamore). There is no associated ditch and no gaps but one connection to another hedgerow. There is an associated hedge bank. The hedgerow is of significant age (not less than 30 years).

The canopy comprises holly, hazel, hawthorn and elder (four canopy species). Notable (Schedule 2) ground flora species are frequent and comprise: lords-and-ladies, broad buckler fern, male-fern, herb Robert, dog's mercury, hart's tongue, barren strawberry and primrose (*Primula vulgaris*). Other ground flora present includes ivy, cleavers, red campion, common chickweed, common nettle, lesser celandine, hedge mustard, bramble, meadowsweet, greater stitchwort (*Stellaria holostea*), bush vetch and cow parsley. No Wildlife & Countryside Act protected species have been identified to be present.

This hedgerow classifies under ecological criteria as 'Important' under The Hedgerow Regulations 1997.

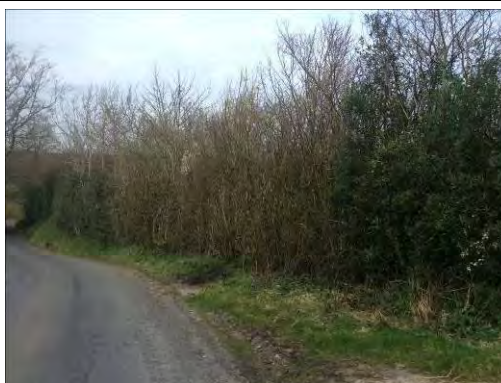
TR3.H3

This roadside hedgerow is 90 m in length, 1.5 m wide and 2.5 m in height. It is a roadside hedgerow with no gaps and one associated mature tree (sycamore). There is no associated ditch but an associated hedge bank. There is a connection to one other hedgerow. The hedgerow is mature and established has been historically laid and is over 30 years in age.

The canopy is dominated by holly with hazel, ash and rose, with smaller amounts of blackthorn (five canopy species). Notable (Schedule 2) ground flora species are lords-and-ladies, dog's mercury and barren strawberry. Other ground flora present at the time of survey was ivy, foxglove, cow parsley, meadowsweet, cleavers, dock (*Rumex* sp.), creeping buttercup, soft rush, common hogweed and dandelion. No Wildlife & Countryside Act protected species have been identified to be present.

This hedgerow classifies under ecological criteria as 'Important' under The Hedgerow Regulations 1997.

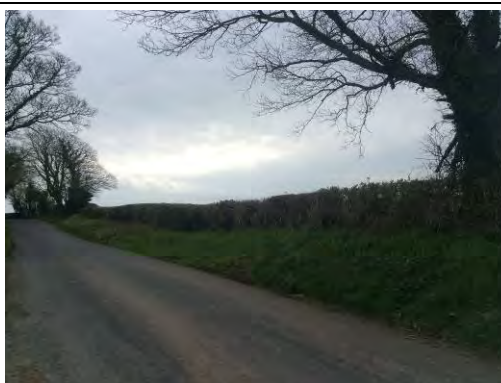
TR3.H4

A roadside hedgerow 145 m in length, 1 m in height and 1.5 m wide. It has no gaps, no ditch and five associated mature trees (sycamore). There are connections to two other hedgerows. It has been historically laid and is more than 30 years in age. It has been recently flailed and is fenced from the adjacent sheep grazed field. There is an associated hedge bank on the roadside.

The canopy comprises hawthorn, holly and elder, with additional blackthorn more rarely (four canopy species). The notable (Schedule 2) ground flora species are lords-and-ladies, dog's mercury and primrose. Other climbers and ground flora noted comprises honeysuckle, cleavers, rosebay willowherb (*Chamerion angustifolium*), common nettle, ivy, bracken and abundant bramble. No Wildlife & Countryside Act protected species have been identified to be present.

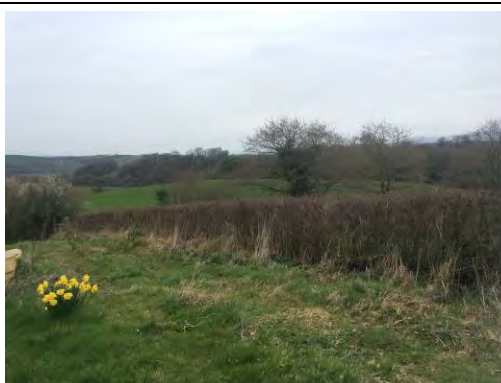
TR3.H5

A roadside hedgerow 100 m in length, 2 m in height and 2 m wide. There are no gaps or ditches and no associated mature trees. There is a connection to one other hedgerow. It has been recently trimmed/flailed and is a mature established hedgerow which is more than 30 years old. It is fenced from the adjacent sheep grazed field to the west. There is a small associated hedge bank.

The canopy is dominated by holly with hawthorn and more rarely hazel and elder (four canopy species). The notable (Schedule 2) ground flora species are lords-and-ladies, broad buckler fern, male-fern, common polypody and barren strawberry. Other climbers and ground flora noted include honeysuckle, cleavers, greater stitchwort, bracken, foxglove, bush vetch and garlic mustard. No Wildlife & Countryside Act protected species have been identified to be present.

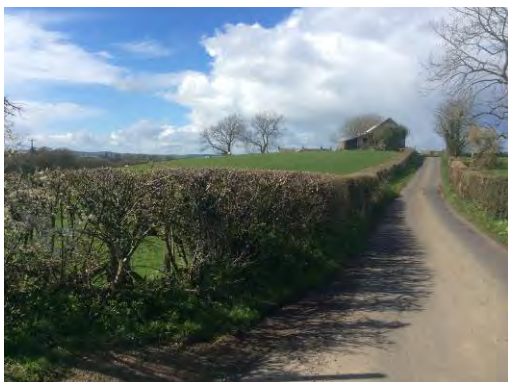
TR3.H7

<p>A roadside hedgerow which is 170 m in length, 1.5 m in height and 1.5 m wide. There are a small number of gaps totalling around 2% of the total length of the hedgerow, and no associated mature trees or ditches. The hedgerow has been historically laid in some sections and is more than 30 years old. It has been recently flailed/trimmed. There are no connected hedgerows but it connects to a block of broadleaved woodland.</p> <p>The canopy is composed of dominant hazel and abundant hawthorn and ash with smaller amounts of holly, blackthorn and gooseberry (<i>Ribes uva-crispa</i>; six canopy species). Notable (Schedule 2) ground flora species are relatively few and comprise lords-and-ladies and dog's mercury. Additional ground flora species are red campion, cleavers, common nettle, bramble, cow parsley, ivy, honeysuckle and garlic mustard. No Wildlife & Countryside Act protected species have been identified to be present.</p> <p>This hedgerow does not classify under ecological criteria as 'Important' under The Hedgerow Regulations 1997.</p>

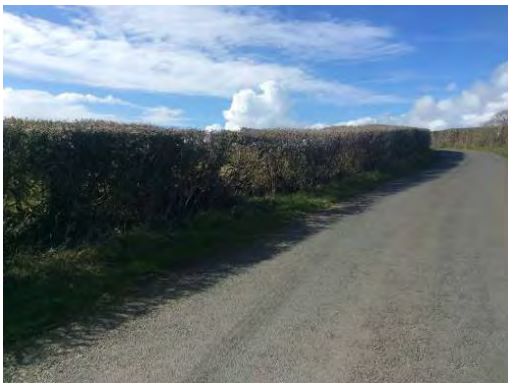
TR3.H8

<p>This roadside hedgerow is 450 m in length, 2 m in height and 1.5 m wide. There is one gap of approximately 10 m which is less than 5% of the overall length of the hedgerow. There are three associated mature trees (sycamore). There is no associated ditch but the hedgerow has a bank of approximately 1 m for much of its length. There is one connection to another hedgerow. It is fenced from the adjacent sheep grazed field and has been historically laid (more than 30 years old).</p> <p>The canopy is mixed and has no clear dominant with the following species noted: hazel, hawthorn, ash, holly, blackthorn, rose species, elder, rowan and gorse (<i>Ulex europaeus</i>; nine canopy species). Notable (Schedule 2) ground flora species are abundant and comprise lords-and-ladies, broad buckler fern, male-fern, wood avens, wild strawberry, herb Robert, common polypody and primrose. Other climber and ground flora species noted include greater stitchwort, honeysuckle (abundant), foxglove, bush vetch, cleavers and dock species. No Wildlife & Countryside Act protected species have been identified to be present.</p> <p>This hedgerow classifies under ecological criteria as 'Important' under The Hedgerow Regulations 1997.</p>

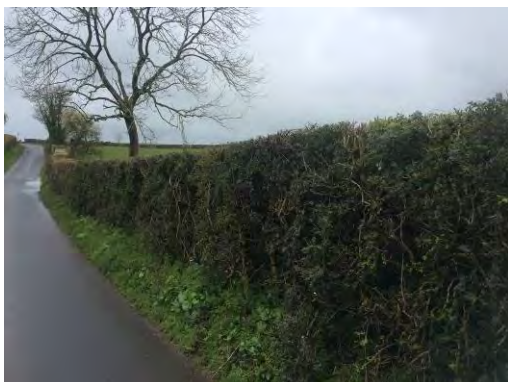
TR3.H9

<p>This roadside hedgerow is 380 m in length, 1.5 m in height and 2 m wide. There is only one small gap which is less than 1% of the total length of the hedgerow. There is no associated ditch or hedge bank. There are nine associated mature trees (predominantly oak). It has been recently trimmed/flailed and is more than 30 years old.</p> <p>The canopy is extremely mixed and comprises abundant holly and hawthorn with hazel, ash, blackthorn, pedunculate oak (<i>Quercus robur</i>), rose species, gooseberry, elder, and rowan (ten canopy species). Notable (Schedule 2) ground flora species are also abundant and diverse and comprise lords-and-ladies, male-fern, herb Robert, wild strawberry, wood avens, dog's mercury, hart's tongue, common polypody, barren strawberry, wood sage (<i>Teucrium scorodonia</i>) and common dog violet (<i>Viola riviniana</i>). Other climbers and ground flora are honeysuckle, cleavers, garlic mustard, ivy, common nettle, cow parsley, greater stitchwort, lesser celandine, meadowsweet, bush vetch, red campion and creeping buttercup. No Wildlife & Countryside Act protected species have been identified to be present.</p> <p>This hedgerow classifies under ecological criteria as 'Important' under The Hedgerow Regulations 1997.</p>

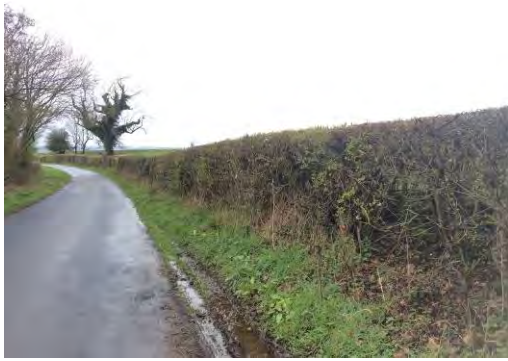
TR3.H10

<p>A roadside hedgerow 800 m in length, 1.5 in height and 1.5 wide. It has recently been flailed/trimmed and is a mature established hedgerow more than 30 years old. There are four gaps, totalling no more than 1% of the overall hedgerow length. There is one associated mature tree (sycamore), no ditches and no hedge bank. There is a connection to one other hedgerow (across a road gap).</p> <p>The canopy is extremely diverse with no clear dominant species with abundant holly and hawthorn and additional hazel, ash, blackthorn, rose species, willow (<i>Salix</i> sp.), elder and rowan (nine canopy species). Notable (Schedule 2) ground flora species are as follows: ramsons (<i>Allium ursinum</i>), broad buckler fern, male-fern, wood avens, barren strawberry, primrose and wood sage. Other climbers and ground flora species noted include greater stitchwort, lesser celandine, ground elder, bush vetch, common bird's-foot trefoil (<i>Lotus corniculatus</i>), snowdrop (<i>Galanthus nivalis</i>), common knapweed (<i>Centaurea nigra</i>), red campion, yarrow and hedge woundwort. No Wildlife & Countryside Act protected species have been identified to be present.</p> <p>This hedgerow classifies under ecological criteria as 'Important' under The Hedgerow Regulations 1997.</p>

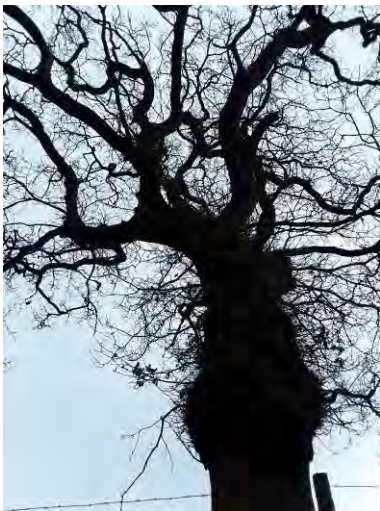
4 Survey Results	
Individual Trees	
TR3.HBT1

<p>NGR: SD 64436 68913</p> <p>Species: Oak species (<i>Quercus</i> sp.)</p> <p>Categorisation: Low potential</p>
TR3.HBT2

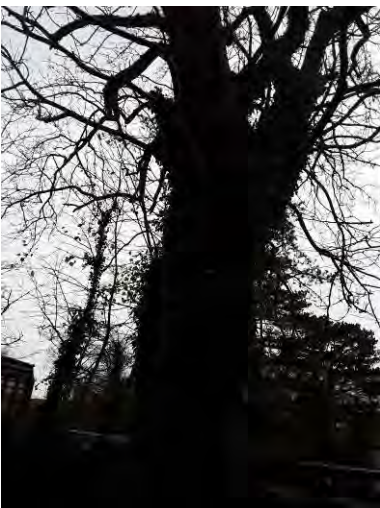
<p>NGR: SD 64562 69310</p> <p>Species: Ash (<i>Fraxinus excelsior</i>)</p> <p>Categorisation: High potential</p> <p>(Ancient/veteran ash tree with multiple features. Avoid impacts)</p>

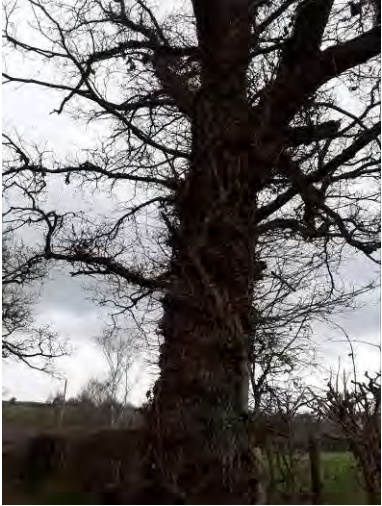
TR3.HBT3

<p>NGR: SD 64645 69246</p> <p>Species: Oak species</p> <p>Categorisation: Low potential</p>
TR3.HBT4

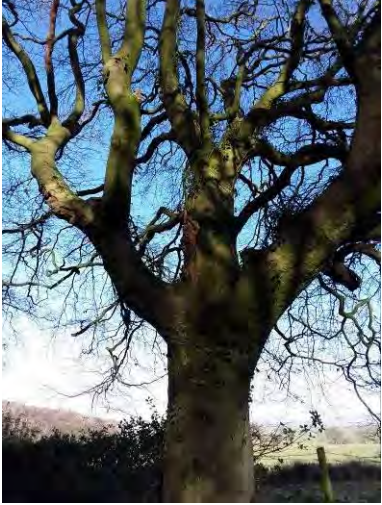
<p>NGR: SD 64096 68465</p> <p>Species: Common beech (<i>Fagus sylvatica</i>)</p> <p>Categorisation: Moderate potential</p>
TR3.HBT5

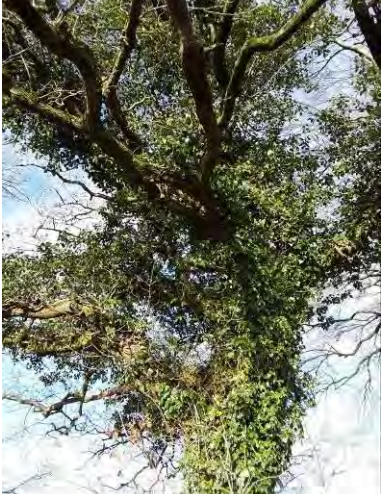
<p>NGR: SD 64126 68449</p> <p>Species: Oak species</p> <p>Categorisation: Low potential</p>

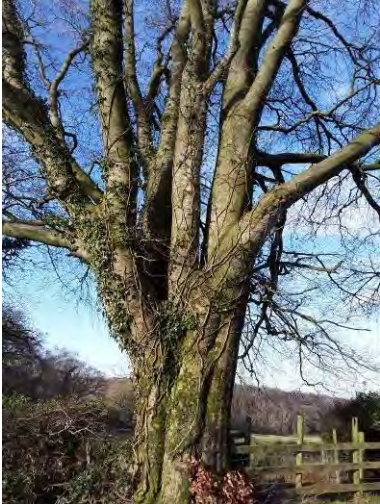
TR3.HBT6

<p>NGR: SD 64135 68452</p> <p>Species: Common beech</p> <p>Categorisation: Low potential</p>
TR3.HBT7

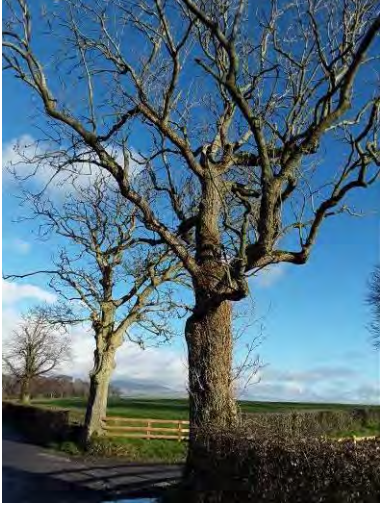
<p>NGR: SD 64275 68575</p> <p>Species: Ash</p> <p>Categorisation: Moderate potential</p>
TR3.HBT8

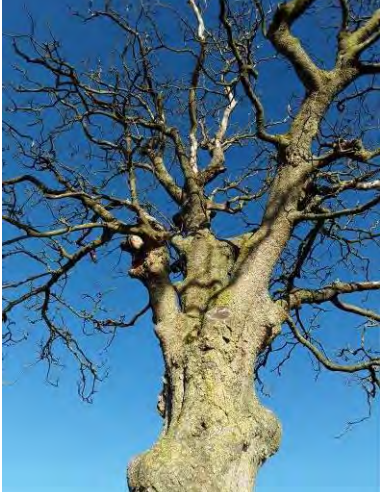
<p>NGR: SD 64276 68581</p> <p>Species: Common lime (<i>Tilia x europaea</i>)</p> <p>Categorisation: Low potential</p>

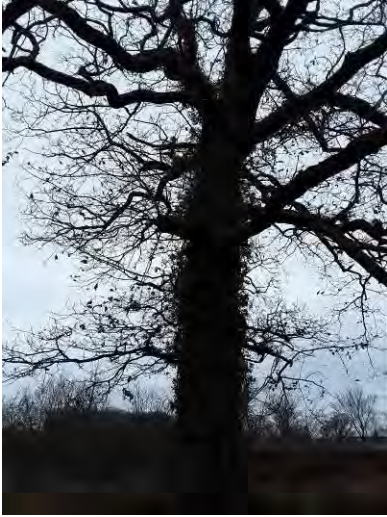
TR3.HBT9

<p>NGR: SD 63906 69582</p> <p>Species: Oak species</p> <p>Categorisation: High potential</p>
TR3.HBT10

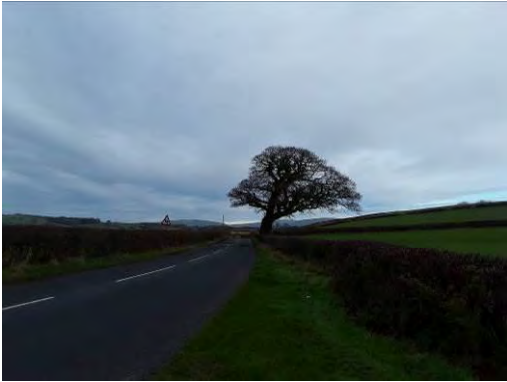
<p>NGR: SD 60576 68191</p> <p>Species: Oak species</p> <p>Categorisation: Low potential</p>
TR3.HBT11

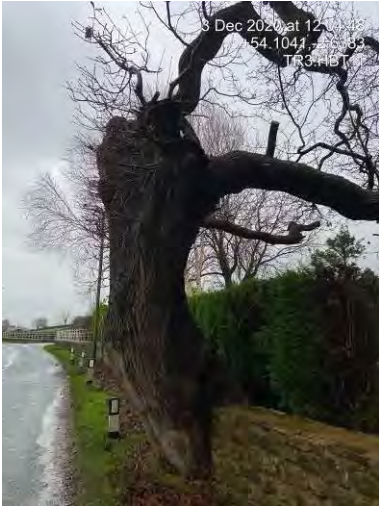
<p>NGR: SD 58361 67768</p> <p>Species: Oak species</p> <p>Categorisation: High potential</p>

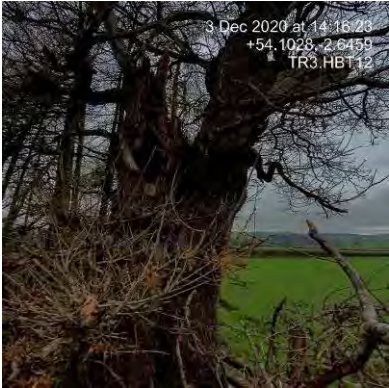
TR3.HBT12

<p>NGR: SD 57857 67622</p> <p>Species: Oak species</p> <p>Categorisation: Moderate potential</p>
TR3.HBT13

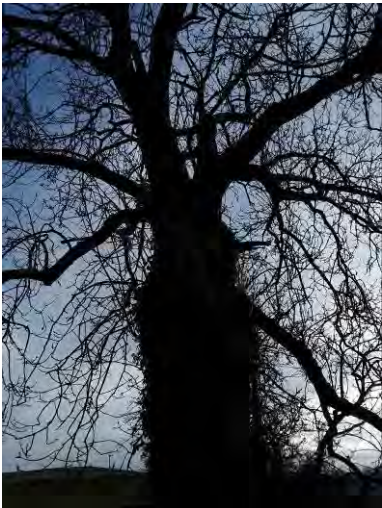
<p>NGR: SD 61148 69367</p> <p>Species: Ash</p> <p>Categorisation: Low potential</p>

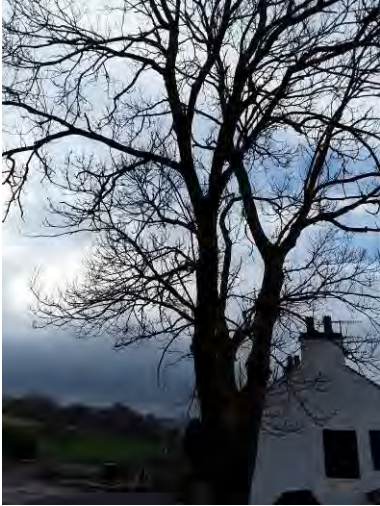
TR3.HBT15

<p>NGR: SD 61255 69525</p> <p>Species: Ash</p> <p>Categorisation: Low potential</p>
TR3.HBT16	
No photo.	<p>NGR: SD 62254 70293</p> <p>Species: Oak species</p> <p>Categorisation: Low potential</p>
<p><i>The following bat tree descriptions are from "TR3 Ecology Survey Data Report: Bat Tree Report V2" (Bowland Ecology, 2020).</i></p>	
TR3.BT1

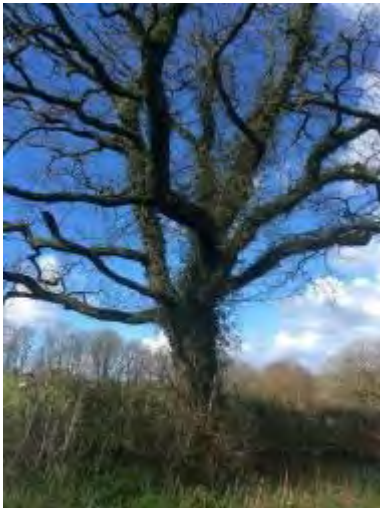
<p>NGR: SD 60664 67299</p> <p>Species: Oak species</p> <p>Categorisation: Low potential</p>

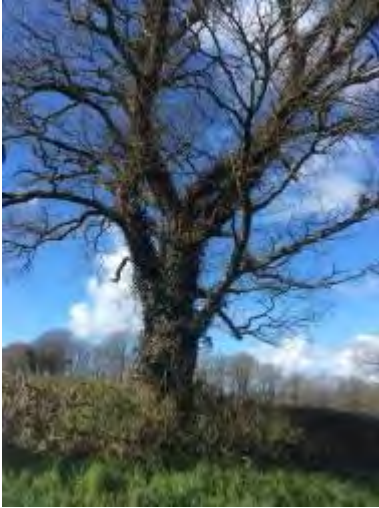
TR3.BT2

<p>NGR: SD 60671 67282</p> <p>Species: Oak species</p> <p>Categorisation: Low potential</p>
TR3.BT3	
 	<p>NGR: SD 60693 67268</p> <p>Species: Oak species</p> <p>Categorisation: High potential</p>
TR3.BT4	
 	<p>NGR: SD 60877 67098</p> <p>Species: Ash</p> <p>Categorisation: Moderate potential</p>

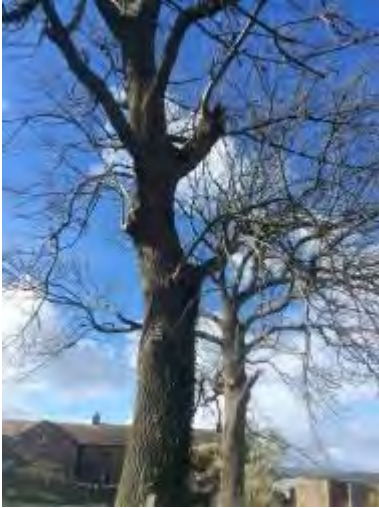
TR3.BT5

<p>NGR: SD 60884 67096</p> <p>Species: Ash</p> <p>Categorisation: Low potential</p>
TR3.BT6

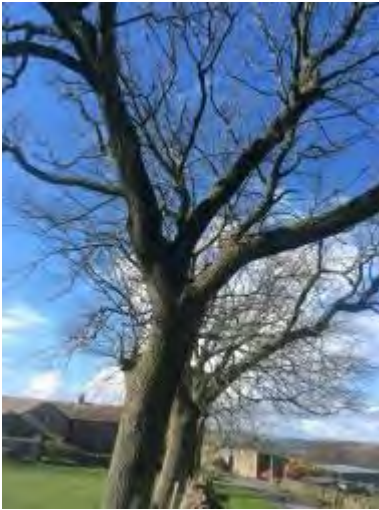
<p>NGR: SD 60909 67078</p> <p>Species: Ash</p> <p>Categorisation: Low potential</p>
TR3.BT7

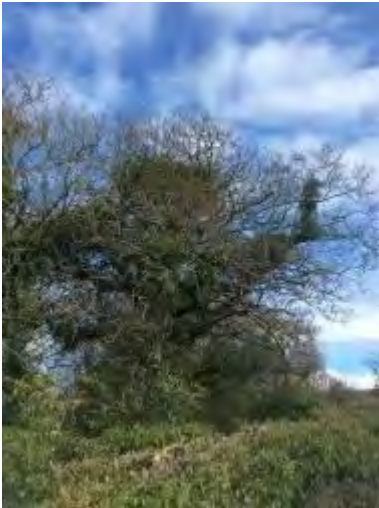
<p>NGR: SD 60735 67187</p> <p>Species: Oak species</p> <p>Categorisation: Low potential</p>

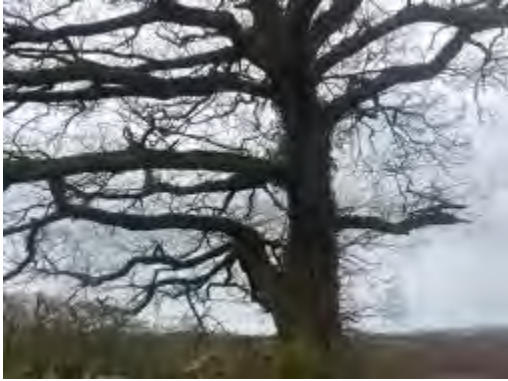
TR3.BT8

<p>NGR: SD 61080 66901</p> <p>Species: Oak species</p> <p>Categorisation: Low potential</p>
TR3.BT9

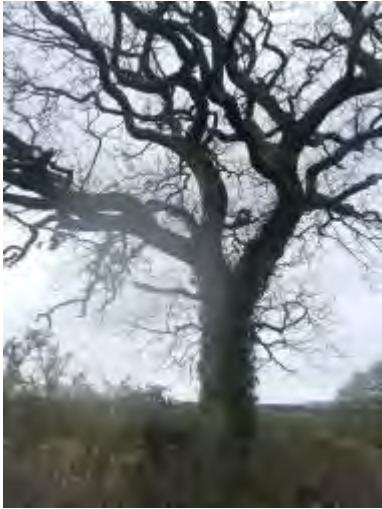
<p>NGR: SD 61137 66875</p> <p>Species: Oak species</p> <p>Categorisation: Moderate potential</p>
TR3.BT10

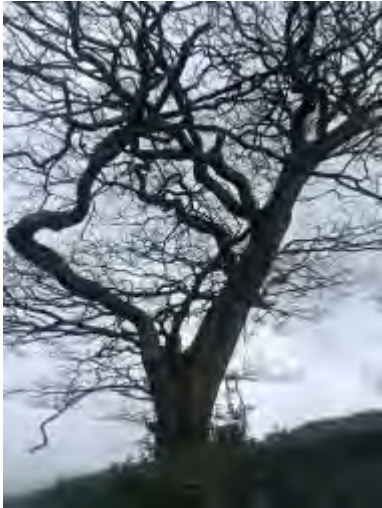
<p>NGR: SD 61176 66879</p> <p>Species: Oak species</p> <p>Categorisation: Moderate potential</p>

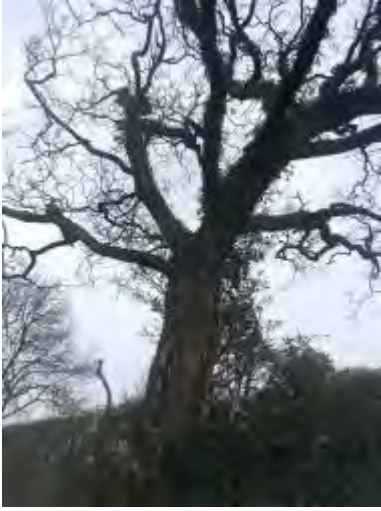
TR3.BT11

<p>NGR: SD 61204 66868</p> <p>Species: Oak species</p> <p>Categorisation: Low potential</p>
TR3.BT12

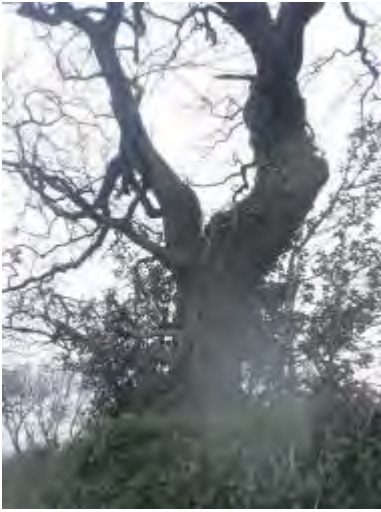
<p>NGR: SD 61221 66861</p> <p>Species: Oak species</p> <p>Categorisation: Low potential</p>
TR3.BT13

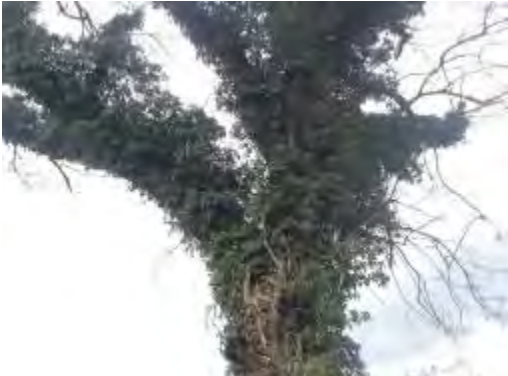
<p>NGR: SD 61933 66571</p> <p>Species: Ash</p> <p>Categorisation: Low potential</p>

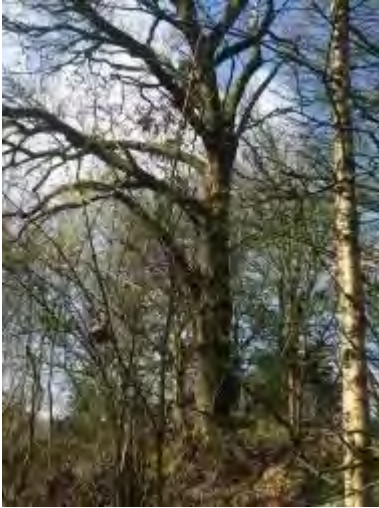
TR3.BT17

<p>NGR: SD 62113 66417</p> <p>Species: Oak species</p> <p>Categorisation: Moderate potential</p>
TR3.BT18

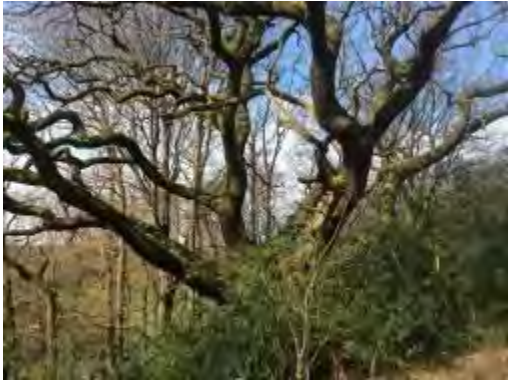
<p>NGR: SD 36214 66359</p> <p>Species: Oak species</p> <p>Categorisation: High potential</p>

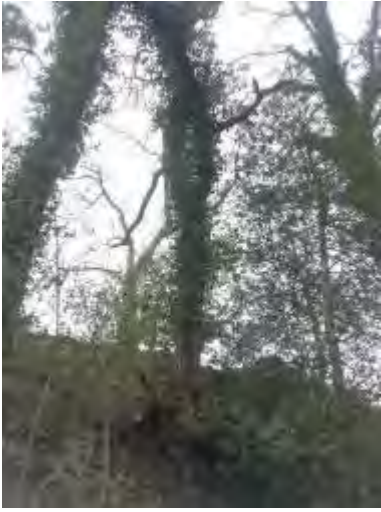
TR3.BT23

<p>NGR: SD 62117 66431</p> <p>Species: Sycamore (<i>Acer pseudoplatanus</i>)</p> <p>Categorisation: Low potential</p>
GROUPS	
TR3.HBG1

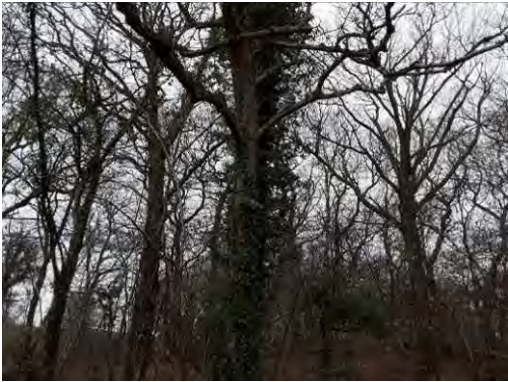
<p>NGR: SD 64474 69026</p> <p>Species: Oak species, beech, alder (<i>Alnus glutinosa</i>), silver birch (<i>Betula pendula</i>), sycamore</p> <p>Number of trees: 100+</p> <p>Categorisation: Moderate potential</p>
TR3.HBG2

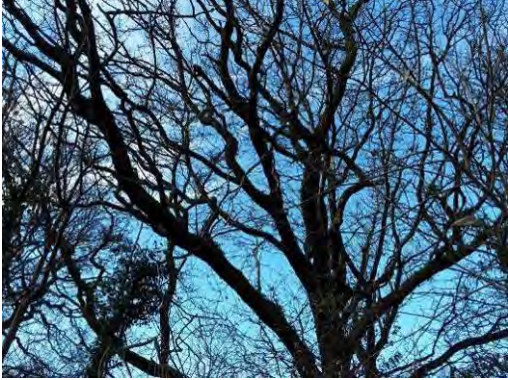
<p>NGR: SD 64077 68391</p> <p>Species: Oak, ash, sycamore</p> <p>Number of trees: 100+</p> <p>Categorisation: Low potential</p>

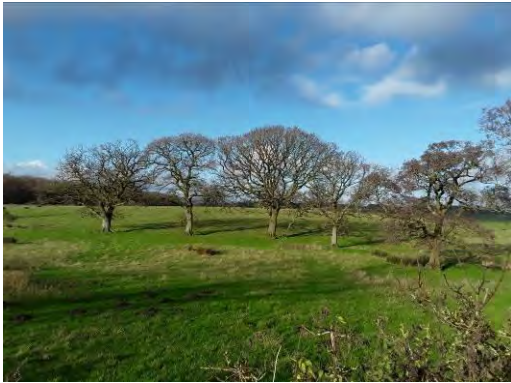
TR3.HBG3

<p>NGR: SD 64268 68659</p> <p>Species: Oak species, alder</p> <p>Number of trees: 7</p> <p>Categorisation: Moderate potential</p>
TR3.HBG4	
<p>No photo.</p>	<p>NGR: SD 64300 68562</p> <p>Species: Ash, sycamore</p> <p>Number of trees: 5</p> <p>Categorisation: Moderate potential</p>
TR3.HBG5

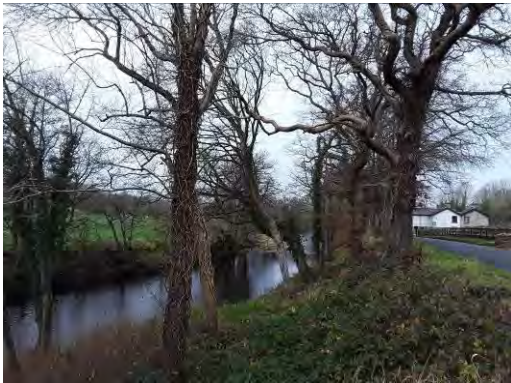
<p>NGR: SD 64008 69523</p> <p>Species: Sycamore, ash, alder, oak species</p> <p>Number of trees: 15</p> <p>Categorisation: High potential</p>
TR3.HBG6

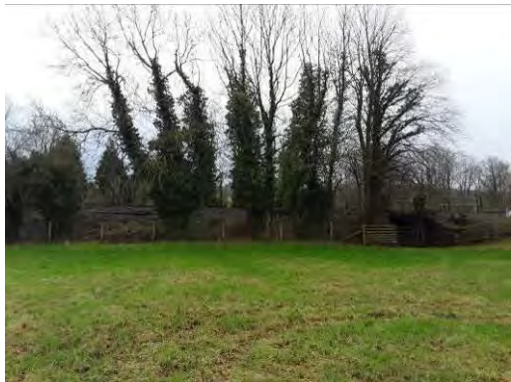
<p>NGR: SD 64049 69566</p> <p>Species: Ash, lime</p> <p>Number of trees: 20</p> <p>Categorisation: Low potential</p>

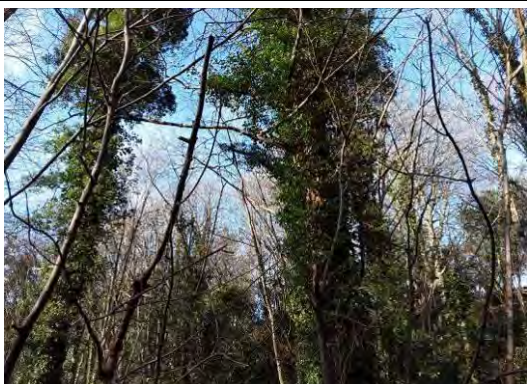
TR3.HBG7

<p>NGR: SD 62111 70092</p> <p>Species: Sycamore, oak species, beech, ash, holly</p> <p>Number of trees: 100+</p> <p>Categorisation: Moderate potential</p>
TR3.HBG8

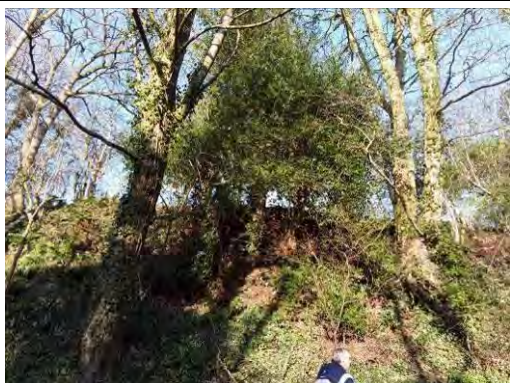
<p>NGR: SD 62113 70124</p> <p>Species: Oak species, beech, ash, lime</p> <p>Number of trees: 50</p> <p>Categorisation: High potential</p>
TR3.HBG9

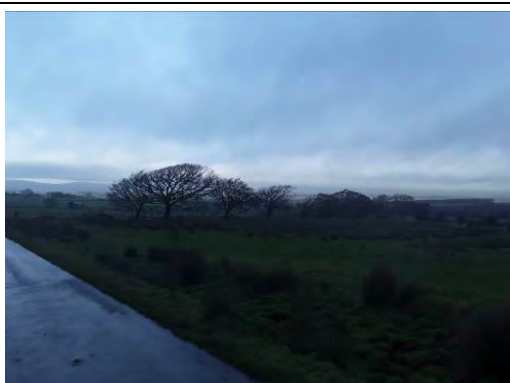
<p>NGR: SD 63182 66025</p> <p>Species: Alder, oak species, holly</p> <p>Number of trees: 13</p> <p>Categorisation: Low potential</p>

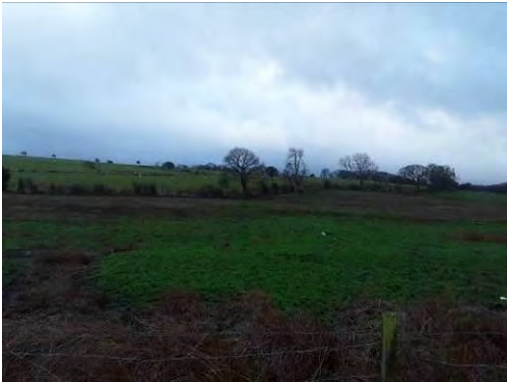
TR3.HBG11

<p>NGR: SD 62888 66086</p> <p>Species: Oak species, alder</p> <p>Number of trees: 4</p> <p>Categorisation: Low potential</p>
TR3.HBG12

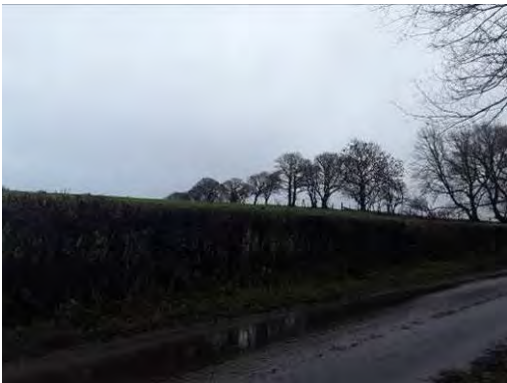
<p>NGR: SD 62029 66588</p> <p>Species: Oak species, alder</p> <p>Number of trees: 11</p> <p>Categorisation: Low potential</p>
TR3.HBG13

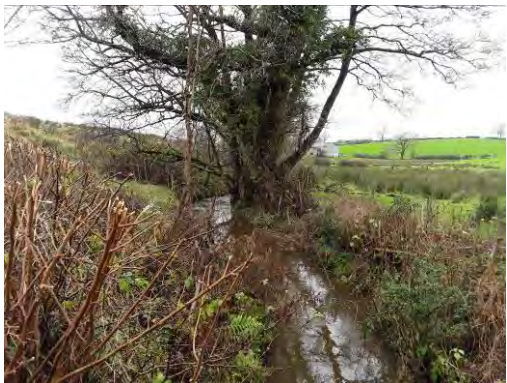
<p>NGR: SD 63822 68056</p> <p>Species: Alder</p> <p>Number of trees: 3</p> <p>Categorisation: Low potential</p>
TR3.HBG14

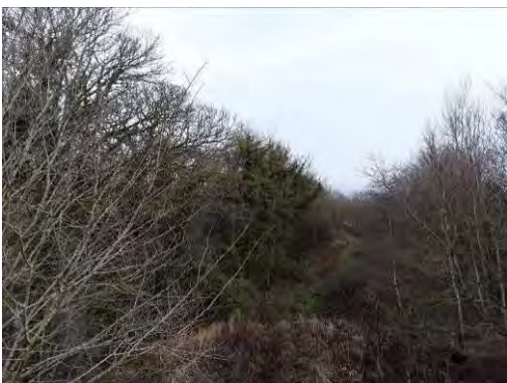
<p>NGR: SD 61095 69346</p> <p>Species: Sycamore, ash, beech</p> <p>Number of trees: 20</p> <p>Categorisation: Low potential</p>

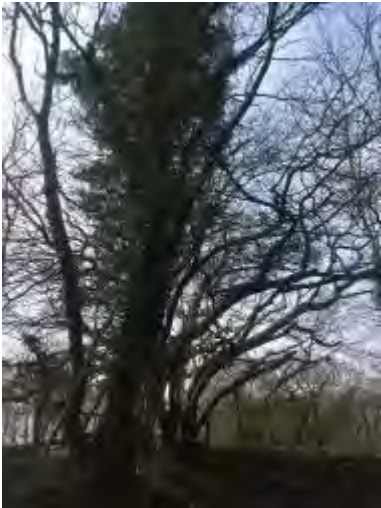
<p>NGR: SD 60626 67378</p> <p>Species: Beech, hazel, ash, sycamore</p> <p>Number of trees: 4</p> <p>Overall categorisation: Low potential</p>
TR3.BG2

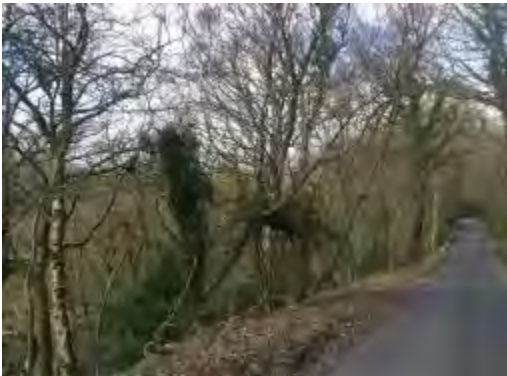
<p>NGR: SD 62160 66302</p> <p>Species: Oak species, sycamore, beech, holly, silver birch</p> <p>Number of trees: 10</p> <p>Overall categorisation: Moderate potential</p>

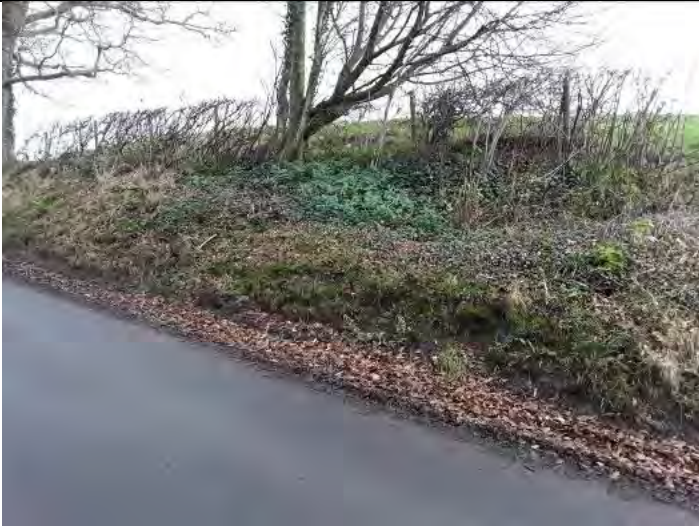
No ponds within 500m of the site		None			
Habitats Present within Site	Habitats Present adjacent to Site	Habitat Plan		Site Photos	
Species-rich intact hedgerow Semi-improved neutral grassland Poor semi-improved grassland Scattered broadleaved trees	Species-rich intact hedgerow Scrub Semi-improved neutral grassland Poor semi-improved grassland Semi-natural broad-leaved woodland Running water

Protected Species Assessment			Summary of Constraints		
<ul style="list-style-type: none">One tree within the works area has low potential to support roosting bats (TR3.HBT1). Removal of this tree may be required to facilitate works.The hedgerow has nesting bird potential.The adjacent SI grasslands have ground nesting bird potential.Watercourse within close proximity to the site (River Wenning <20 m) could have suitability to support commuting and foraging riverine species (otter/water vole).The adjacent woodland provides suitable habitat for small and large mammals (including badger (<i>Meles meles</i>)), nesting habitat for birds as well as roosting, foraging and commuting habitat for bats. Being adjacent to the river it may also provide lay-up sites for otter (<i>Lutra lutra</i>). No impacts to this habitat are anticipated.The mix of habitats on and adjacent to the site could support a range of foraging and commuting species (e.g. reptiles, bats, badger, brown hare, hedgehog, invertebrates).Amphibians are unlikely to be present due lack of connectivity with potential breeding ponds (none within 500 m).			<ul style="list-style-type: none">Habitats will not be reinstated on completion of the worksWorks lie adjacent to a SINC.Current proposals will require removal of approximately 70 m of species-rich intact hedgerow (TR3.HH1) and associated species-rich verge which has flora characteristic of woodland ground flora (TR3.HTN2)Hedgerow could be classed as important under the Hedgerow Regulations 1997.Mitigation for hedgerow loss will be required which needs agreeing with the LPA, either as part of the reinstatement proposals or improvement of adjacent areas of hedgerow.It appears the tree with low bat roost potential is likely to require removal to facilitate the works. Further surveys will be required in relation to roosting bats before works can commence.Works will result in the small loss of SI grassland associated with the roadside verge and adjoining fields. This loss is unlikely to have a significant adverse effect, but there could be disturbance to ground nesting species using the wider fields.Works should avoid the nesting bird season or be subject to nesting bird checks.A pre-commencement survey for badger and otter should be carried out within the site and within a suitable buffer of the surrounding areas prior to works commencing.

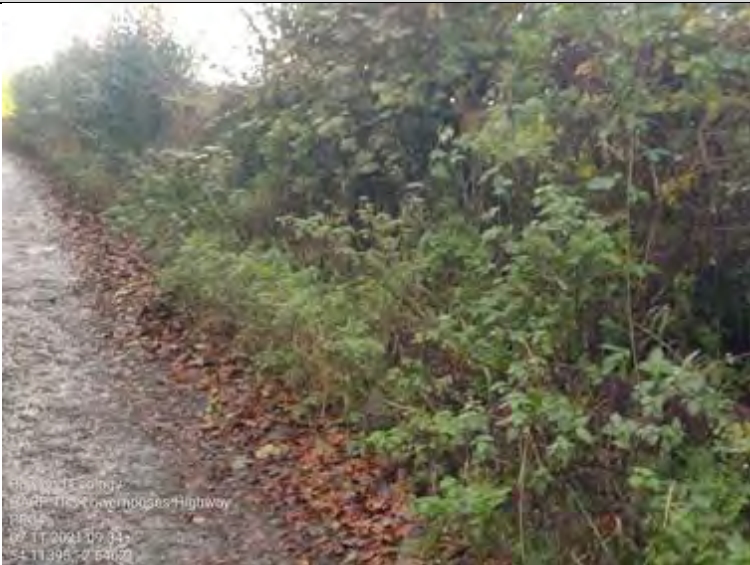
No ponds within 500m of the site		None			
Habitats Present within Site	Habitats Present adjacent to Site	Habitat Plan		Site Photos	
Species-rich intact hedgerow Poor semi-improved grassland	Species-rich intact hedgerow Poor semi-improved grassland Semi-natural broad-leaved woodland Wet ditch

Protected Species Assessment			Summary of Constraints		
<ul style="list-style-type: none">The hedgerow has nesting bird potential.Poor semi-improved grassland and semi-natural broad-leaved woodland adjacent to the site have potential to support ground nesting birds.Limited diversity in habitats on and adjacent to the site could support a limited range of foraging and commuting species (e.g. reptiles, bats, badger, brown hare, hedgehog, invertebrates).Amphibians are unlikely to be present due lack of connectivity with potential breeding ponds (none within 500 m).			<ul style="list-style-type: none">Habitats will not be reinstated on completion of the worksRW32 works lie adjacent to a BHS.Current proposals will require removal of approximately 100 m of species-rich intact hedgerow and associated bank habitat.Hedgerow could be classed as important under the Hedgerow Regulations 1997.Mitigation for hedgerow loss will be required which needs agreeing with the LPA, either as part of the reinstatement proposals or improvement of adjacent areas of hedgerow.Loss of a small area of adjacent species-poor semi-improved grassland is unlikely to have a significant adverse effect but there could be disturbance to ground nesting species using the wider field.Works should avoid the nesting bird season or be subject to nesting bird checks.

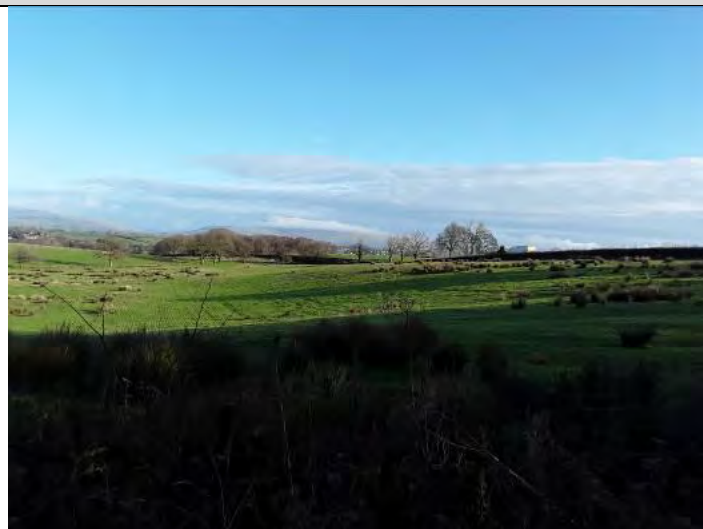
1 pond approx. 480m southeast of the site		None			
Habitats Present within Site	Habitats Present adjacent to Site	Habitat Plan		Site Photos	
Species-rich intact hedgerow Poor semi-improved grassland	Species-rich intact hedgerow Poor semi-improved grassland Scattered broad-leaved trees Semi-improved neutral grassland

Protected Species Assessment			Summary of Constraints		
<ul style="list-style-type: none">Two trees in close proximity to the works have low potential to support roosting bats (TR3.HBT5 and HBT6). These tree will not be removed to facilitate works but there is a risk overhanging branches may require removal.The hedgerow has nesting bird potential.The SI grassland has ground nesting bird potentialThe mix of habitats on and adjacent to the site could support a range of foraging and commuting species (e.g. reptiles, bats, badger, brown hare, hedgehog, invertebrates).Amphibians are unlikely to be present due to distance of nearest potential breeding pond (> 480m).			<ul style="list-style-type: none">Habitats will not be reinstated on completion of the worksCurrent proposals will require removal of approximately 50 m of species-rich intact hedgerow (TR3.HH10) and associated bank habitat.Hedgerow could be classed as important under the Hedgerow Regulations 1997.Mitigation for hedgerow loss will be required which needs agreeing with the LPA, either as part of the reinstatement proposals or improvement of adjacent areas of hedgerow.Loss of a small area of adjacent species-poor semi-improved grassland is unlikely to have a significant adverse effect but there could be disturbance to ground nesting species using the wider field.Works should avoid the nesting bird season or be subject to nesting bird checks.Works should avoid any impacts to trees with bat potential in proximity of the site. If any branches require removal to facilitate works, further surveys will be required in relation to roosting bats before works can commence.

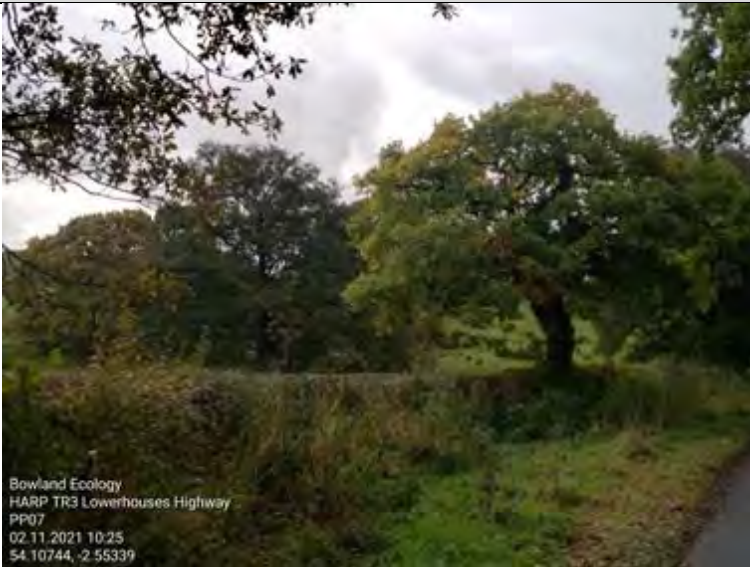
66NW19 BHS		1.8km north west of site					
Ponds present within 500m (mapping review only)				Desktop constraints							
2 ponds 170m and 240m southeast of the site				None							
Habitats Present within Site		Habitats Present adjacent to Site		Habitat Plan				Site Photos			
Species-rich intact hedgerow Semi-improved neutral grassland Poor semi-improved grassland		Species-rich intact hedgerow Semi-improved neutral grassland Poor semi-improved grassland Semi-natural broad-leaved woodland Running water (Clear Beck) Marshy grassland

Protected Species Assessment						Summary of Constraints					
<ul style="list-style-type: none">• The hedgerows have nesting bird potential.• The SI grasslands have ground nesting bird potential• The mix of habitats on and adjacent to the site could support a range of foraging and commuting species (e.g. reptiles, bats, badger, brown hare, hedgehog, invertebrates and amphibians).						<ul style="list-style-type: none">• Habitats will not be reinstated on completion of the works• Both sides of the road contain mature, species-rich hedgerows (TR3.HH7 and TR3.HH52).• Current proposals will require removal of approximately 120 m of species-rich intact hedgerow and associated bank habitat.• Hedgerow could be classed as important under the Hedgerow Regulations 1997.• Mitigation for hedgerow loss will be required which needs agreeing with the LPA, either as part of the reinstatement proposals or improvement of adjacent areas of hedgerow.• Loss of a small area of adjacent species-poor semi-improved grassland is unlikely to have a significant adverse effect but there could be disturbance to ground nesting species using the wider field.• Works should avoid the nesting bird season or be subject to nesting bird checks.• Works are located in close proximity to a watercourse (Clear Beck). Assumed impacts could be avoided.

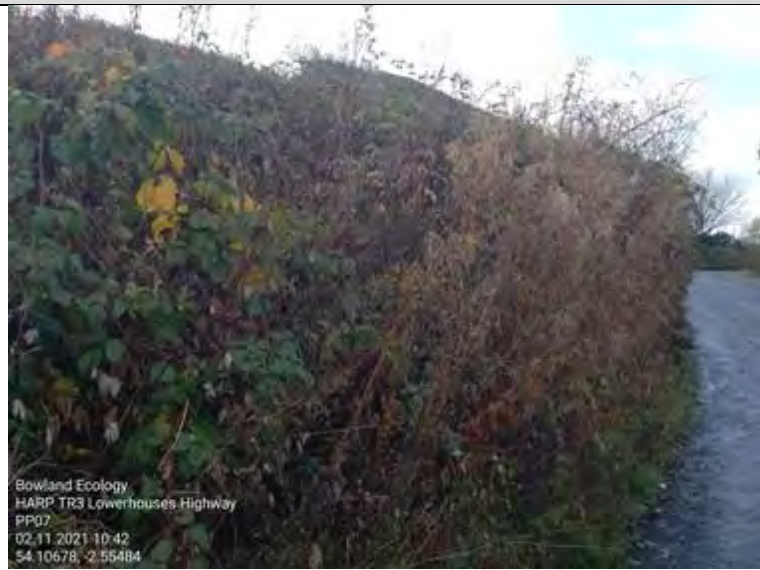
Ponds present within 500m (mapping review only)		Desktop constraints			
2 ponds 200m and 250m east of the site		None			
Habitats Present within Site	Habitats Present adjacent to Site	Habitat Plan		Site Photos	
Species-rich intact hedgerow Semi-improved neutral grassland Poor semi-improved grassland Scrub	Species-rich intact hedgerow Semi-improved neutral grassland Poor semi-improved grassland Running water (Clear Beck) Marshy grassland

<div>Bowland Ecology HARP TR3 Lowerhouses Highway PP07 02.11.2021 10:42 54 10678, 2 55484</div>	
Protected Species Assessment			Summary of Constraints		
<ul style="list-style-type: none">The hedgerow has nesting bird potential.The SI grassland has ground nesting bird potentialThe mix of habitats on and adjacent to the site could support a range of foraging and commuting species (e.g. reptiles, bats, badger, brown hare, hedgehog, invertebrates).Amphibians are unlikely to be present due to distance of nearest potential breeding pond (> 200m).			<ul style="list-style-type: none">Habitats will not be reinstated on completion of the worksCurrent proposals will require removal of approximately 70 m of species-rich intact hedgerow (TR3.HH7) and associated bank habitat.Hedgerow could be classed as important under the Hedgerow Regulations 1997.Mitigation for hedgerow loss will be required which needs agreeing with the LPA, either as part of the reinstatement proposals or improvement of adjacent areas of hedgerow.Loss of a small area of adjacent species-poor semi-improved grassland is unlikely to have a significant adverse effect but there could be disturbance to ground nesting species using the wider field.Works should avoid the nesting bird season or be subject to nesting bird checks.

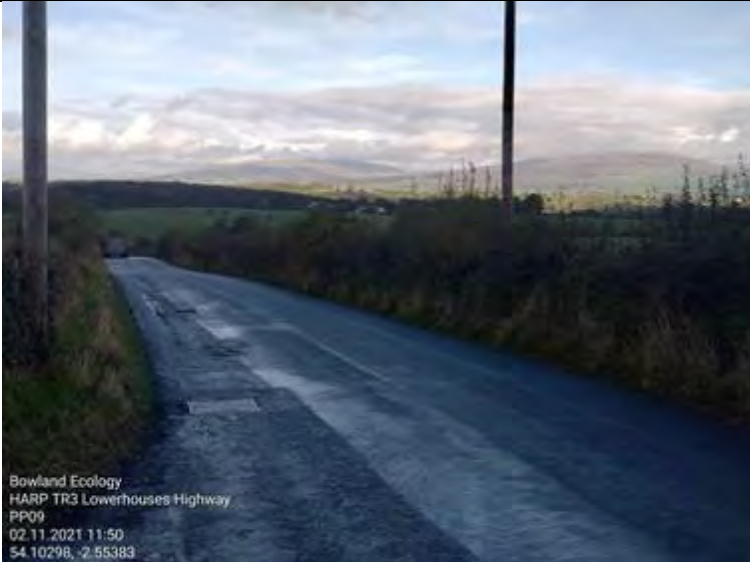
66NW11 BHS	1.8km south west of site		
Ponds present within 500m (mapping review only)		Desktop constraints			
2 ponds 230m and 250m northeast of the site		None			
Habitats Present within Site	Habitats Present adjacent to Site	Habitat Plan		Site Photos	
Species-rich intact hedgerow Semi-improved neutral grassland Poor semi-improved grassland	Species-rich intact hedgerow Semi-improved neutral grassland Poor semi-improved grassland Semi-natural broad-leaved woodland

Protected Species Assessment			Summary of Constraints		
<ul style="list-style-type: none">The hedgerows have nesting bird potential.The SI grassland has ground nesting bird potentialThe mix of habitats on and adjacent to the site could support a range of foraging and commuting species (e.g. reptiles, bats, badger, brown hare, hedgehog, invertebrates).Amphibians are unlikely to be present due to distance of nearest potential breeding pond (>230m).			<ul style="list-style-type: none">Habitats will be reinstated on completion of the worksCurrent proposals will require removal of approximately 200 m of species-rich intact hedgerow and associated bank habitat.Hedgerow could be classed as important under the Hedgerow Regulations 1997.Mitigation for hedgerow loss will be required which needs agreeing with the LPA, either as part of the reinstatement proposals or improvement of adjacent areas of hedgerow.Loss of a small area of adjacent species-poor semi-improved grassland is unlikely to have a significant adverse effect but there could be disturbance to ground nesting species using the wider field.Works should avoid the nesting bird season or be subject to nesting bird checks.

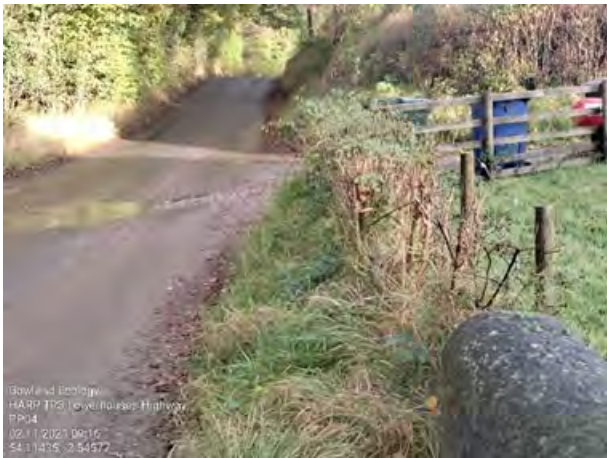
TR3.HTN38

<p>Bowland Ecology HARP TR3 Lower Houses Highway PP04 02.11.2021 09:16 S411425 -2.54572</p>
	<p>A small section of species poor defunct hedgerow consisting of hawthorn (<i>Crataegus monogyna</i>), ash (<i>Fraxinus excelsior</i>) and hazel (<i>Corylus avellana</i>) is present on the eastern side of Eskew lane bounding a grazed field to the east. It does not qualify as a hedgerow due to the short length (less than 20 m), however, it has been replanted and cut into the shape of a hedgerow.</p> <p>Habitat condition (provisional): Poor (Score 1)</p>
TR3.HTN39

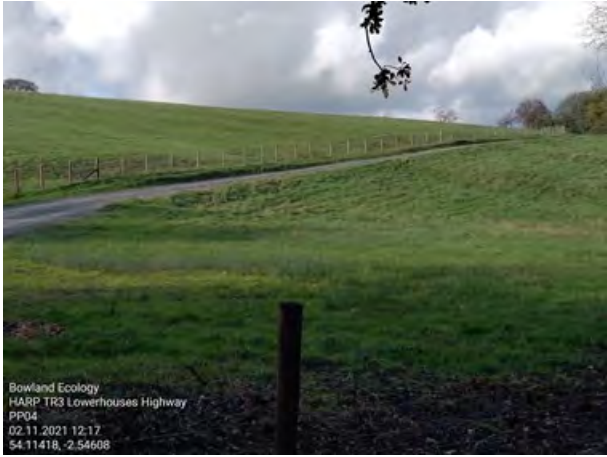
<p>Bowland Ecology HARP TR3 Lower Houses Highway PP04 02.11.2021 12:17 S411418 -2.54608</p>
	<p>A patch of marshy grassland is present to the west of Eskew beck immediately north of a gravel track. The area is dominated by soft rush (<i>Juncus effusus</i>) and appears quite waterlogged. Sitting in a natural depression, the area is likely fed by run off from the surrounding fields.</p> <p>Habitat condition (provisional): Poor (Score 1)</p>

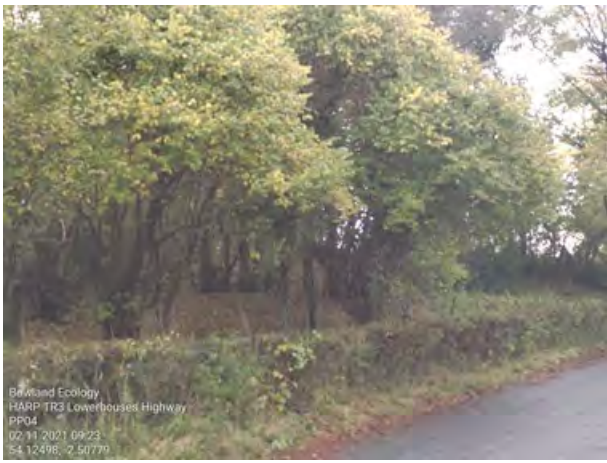
TR3.HTN41

<p>Released Ecology HARP TR3 Lower Houses Highway PP04 02/11/2021 09:23 54.12496, -2.50779</p>
<p>Semi-natural deciduous woodland bordering Long Lane to the east. The trees are semi-mature to mature with smaller saplings present as well. The canopy species primarily consists of oak (<i>Quercus robur</i>), alder, beech (<i>Fagus sylvatica</i>) and silver birch (<i>Betula pendula</i>). The understory is generally sparse but is occasionally dense towards the road edge and includes the species; hazel, holly and hawthorn. Between the road and woodland sits a hedgerow consisting of hawthorn and hazel. The hedgerow is heavily overgrown with ivy. The hedgerow ground flora includes; dog's mercury, male fern, common polypody (<i>Polypodium vulgare</i>), garlic mustard, Yorkshire fog (<i>Holcus lanatus</i>), colt's foot (<i>Tussilago farfara</i>), common nettle (<i>Urtica dioica</i>), broadleaved dock (<i>Rumex obtusifolius</i>) and herb Robert. Extending from the south of the woodland a line of trees (primarily beech) closely follows the road for around 12-15 m merging with the hedgerow for its length. The line of trees terminates with a large oak tree.</p> <p>Habitat condition (provisional): Poor (Score 1)</p>
