**Haweswater Aqueduct Resilience Programme -
Proposed Bowland Section
Supplementary Environmental Information**

Off-Site Highways Works – TR3 Hedgerows Report

January 2022

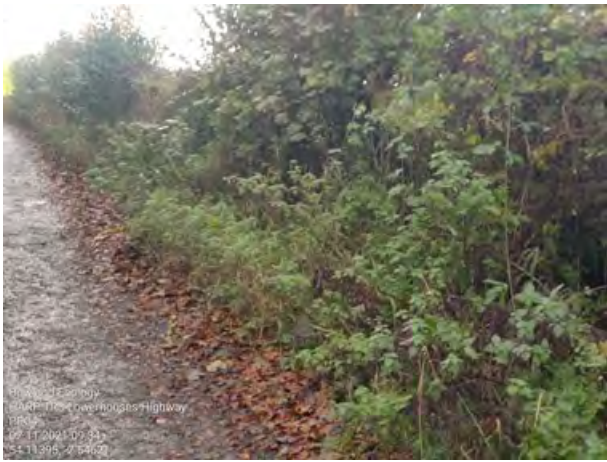
TR3.HTN42

<p>Released Ecology HARP TR3 Lower Houses Highway PP04 02/11/2021 09:31 54.11396, -2.51609</p>
<p>The hedgerow on the western side of Long Lane is made up of sycamore, hazel and holly with additional dog rose (<i>Rosa canina</i>). The associated verge, approximately 0.6 m wide, includes abundant nettle, dog's mercury, bedstraw sp., male fern, cow parsley (<i>Anthriscus sylvestris</i>), common polypody and hogweed (<i>Heracleum sphondylium</i>). Additional more infrequent species include garlic mustard, dandelion (<i>Taraxicum</i> agg.), sow thistle (<i>Sonchus</i> sp.), creeping thistle (<i>Cirsium arvense</i>), herb Robert and colt's foot.</p> <p>Habitat condition (provisional): Moderate (Score 1)</p>

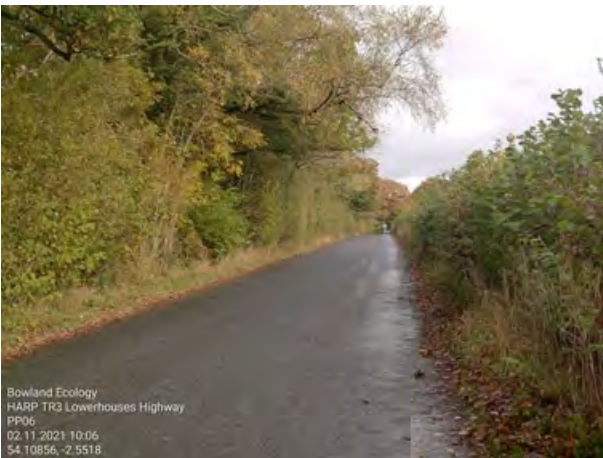
TR3.HTN43

<p>Bowland Ecology HARP TR3 Lowerhouses Highway PP06 02.11.2021 10:06 S4 10856, -2.5518</p>
<p>Broadleaf semi-natural woodland bordering Long lane to the west. The woodland is linear in nature, extending back approximately 25-30 m from the road which it follows closely. The woodland has a mixed age structure with relatively large and mature canopy species include ash, oak and sycamore. The shrub layer comprises hazel, blackthorn (<i>Prunus spinosa</i>), hawthorn and holly and is reasonable dense along the edge of the road but does not form a continuous barrier. Habitat condition (provisional): Poor (Score 1)</p>	
TR3.HTN44

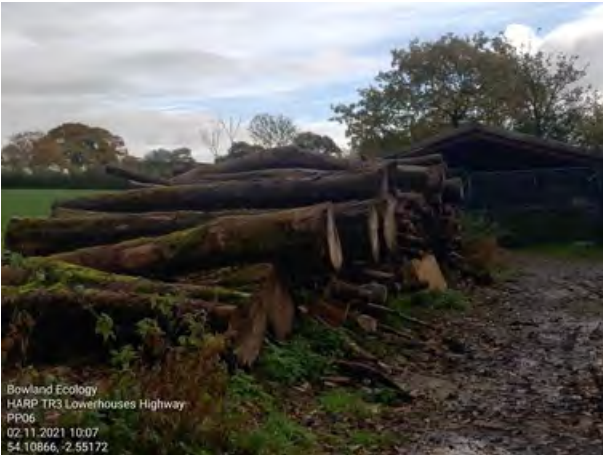
<p>Bowland Ecology HARP TR3 Lowerhouses Highway PP06 02.11.2021 10:07 S4 10866, -2.55172</p>

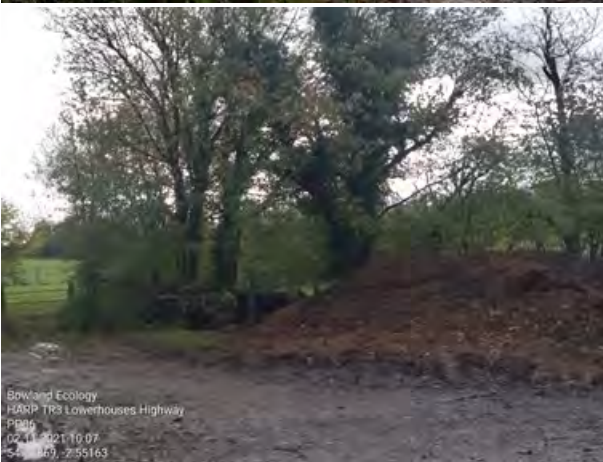
<p>Bowland Ecology HARP TR3 Lowerhouses Highway PP06 02.11.2021 10:07 S4 10867, -2.55163</p>
<p>An agricultural yard area is present to the east of Long lane, accessible through a field gate. The yard is covered by a layer of hard-standing gravel with limited terrestrial ground cover. Towards the east of the yard (further back from the road) there is a storage shed constructed from steel girders and corrugated metal. The shed is completely open to the west and appears to be wet inside. Additionally, several large stacks of logs are being stored in the yard with diameters ranging from 0.3-0.6 m. Common nettle, bramble and rosebay willowherb sp (<i>Epilobium angustifolium</i>) have grown up</p>

around the logs. As well as the logs a large pile of what appear to be wood chips is also present. The yard is bordered by a tree line of alder and oak to the east and west.

Habitat condition (provisional): Poor (Score 1)

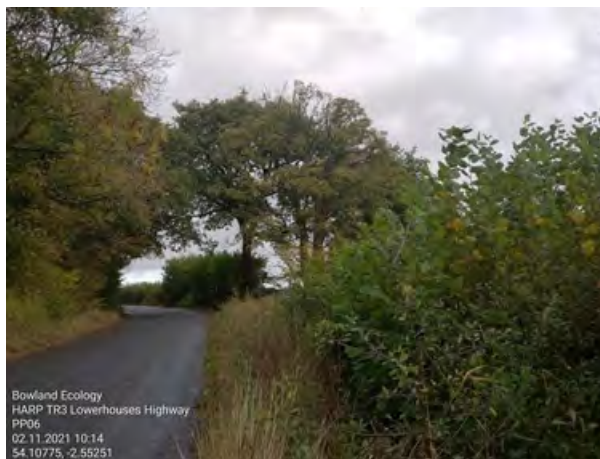
A particularly wide section of roadside verge is present on the eastern side of Long lane with tall ruderal and semi-improved neutral grassland vegetation. Bordered to the east by a hazel dominated hedgerow, the verge extends back from the road by around 5 m at its widest. Species present in the verge include Yorkshire fog, cock's foot, burdock (*Arctium lappa*), creeping thistle, spear thistle (*Cirsium vulgare*), cow parsley, common sow thistle, common nettle, broadleaved dock, hogweed, knapweed sp. (*Centurea nigra*), willow herb sp.

Habitat condition (provisional): Moderate (Score 2)

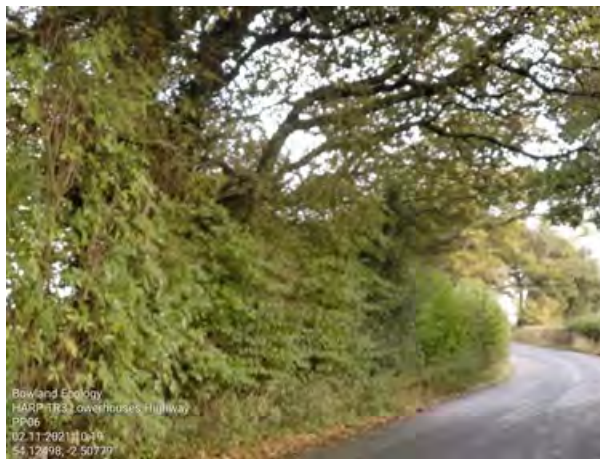
A small group/copse of deciduous trees comprising semi-mature alder bordering Long lane to the west. Beneath the canopy trees, the understory consisting of wych elm (*Ulmis glabra*), hazel, holly, blackthorn and hawthorn. The ground flora includes the species male fern, dog's mercury, dandelion, common sow thistle, willow herb sp., creeping buttercup (*Ranunculus repens*).

Habitat condition (provisional): Poor (Score 1)

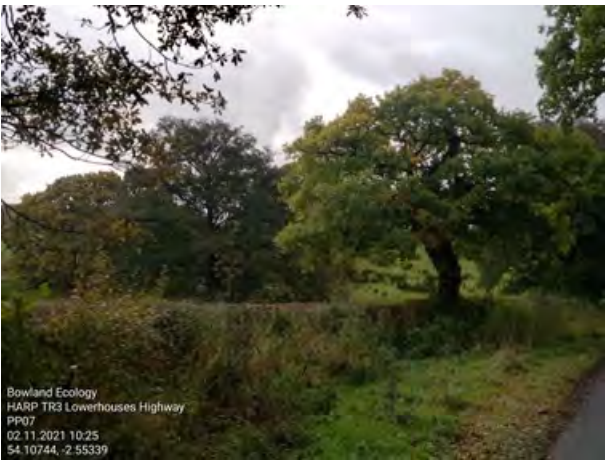
TR3.HTN47

<p>Another section of wide road side verge, somewhat continuous with TR3.HTN45 with similar dimensions (approximately 5 m wide). The verge has semi-improved neutral grassland vegetation transitioning to tall ruderal vegetation further away from the road. The verge is bordered by a hazel and hawthorn hedge. Two mature oak and two mature alder trees are present along the course of the hedgerow. Species present in the verge include: creeping buttercup, herb Robert, dandelion, dock, greater plantain (<i>Plantago major</i>), Yorkshire fog, bush vetch (<i>Vicia sepium</i>), nettle, creeping buttercup, common hogweed, male fern, bramble, and willowherb sp.</p> <p>Habitat condition (provisional): Moderate (Score 2)</p>
TR3.HTN48

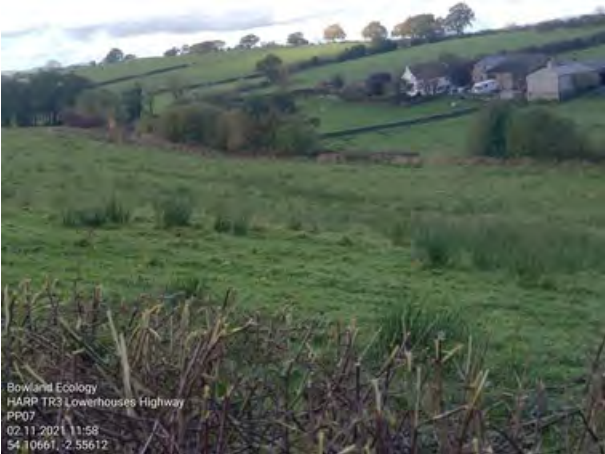
<p>An area of marshy grassland situated in the fields on the north-western side of Long lane bordering a small stream (clear beck). The area has abundant soft rush growth with more scattered and infrequent growth extending out particularly to the east. Species composition could not be assessed from the road side; if impacted recommend further assessment.</p> <p>Habitat condition (provisional): Poor (Score 1)</p>

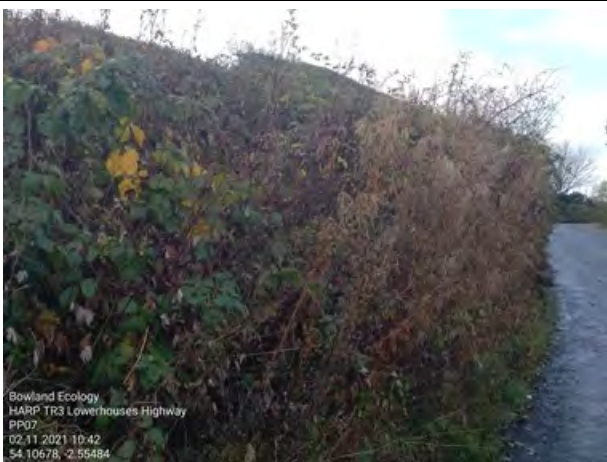
TR3.HTN49

<p>Bowland Ecology HARP TR3 Lowerhouses Highway PP07 02.11.2021 10:42 54.10678, -2.55484</p>
	<p>The road is bordered on both sides by hedgerow comprising hazel and hawthorn with addition sections of holly. The associated road side verge on the south-eastern side is reasonable wide - around 2 m - and has extensive tall ruderal growth. Species present include: bush vetch, dandelion, nettle, bramble, nipple wort (<i>Lapsana communis</i>), black knapweed, willowherb sp., male fern, garlic mustard, and horse tail (<i>Equisetum</i> sp.). The bordering hedgerow on the south-eastern side of the road ends with a patch of dense gorse scrub.</p> <p>Habitat condition (provisional): Moderate (Score 2)</p>
TR3.HTN50

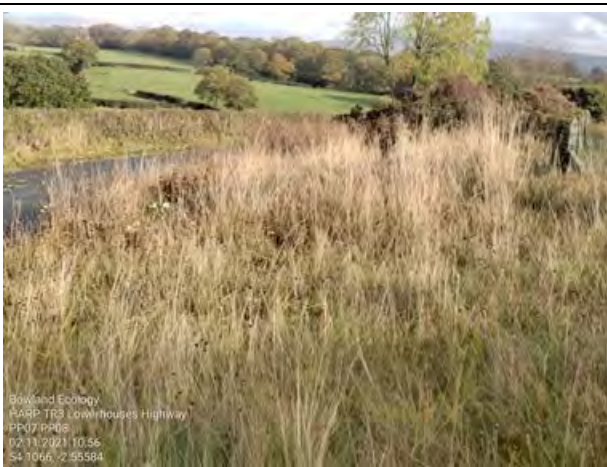
<p>Bowland Ecology HARP TR3 Lowerhouses Highway PP07/PP08 02.11.2021 10:55 54.1066, -2.55584</p>
	<p>At the junction of Long lane and Fairheath road there is an especially large area of roadside verge – approximately 10 m wide. The section is fenced off from the field to the east and bordered by Long lane to the north-west and Fairheath road to the south. The area is indicative of species rich semi-improved neutral grassland and is dominated by meadow grass sp. and bush vetch with additional species including greater plantain, horse tail sp. (<i>Equisetum</i> sp.), creeping thistle, black knapweed, meadow sweet (<i>Filipendula ulmaria</i>) and cow parsley.</p> <p>Habitat condition (provisional): Moderate (Score 2)</p>

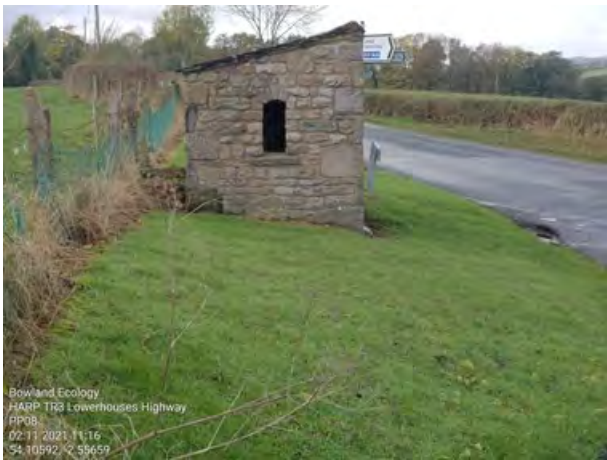
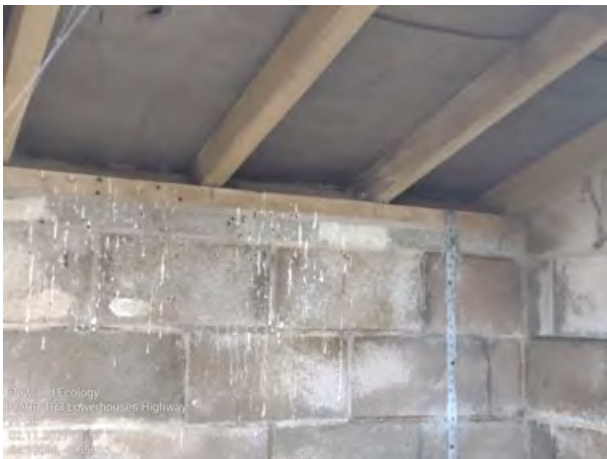
TR3.HTN51

<p>To the south of the junction between Long land and Fairheath road a small section of amenity grassland is present with a bus shelter. The shelter is irregular cemented stone on the outside with breeze block interior, an unglazed window opening is present on the eastern aspect. The roof comprises cement tiles supported by a timber frame. The interior has substantial amounts of bird droppings, likely from pigeons. It is considered to offer low/negligible bat roosting potential.</p> <p>Habitat condition (provisional): Poor (Score 1)</p>
TR3.HTN52

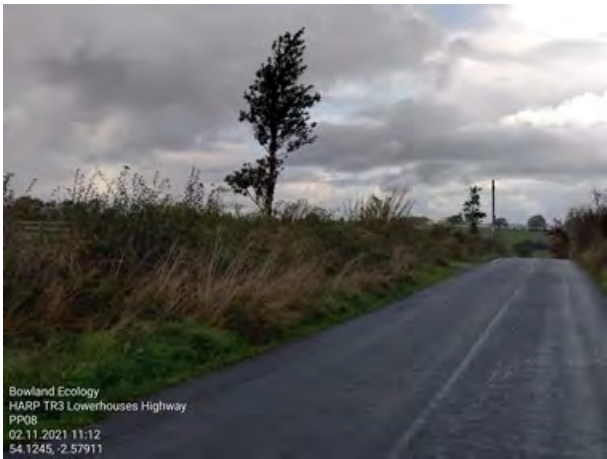
<p>The hedgerows running along Fairheath road primarily consists hawthorn and holly with additional sycamore and dog rose. The two immature trees growing within the hedgerow, are holly and rowan. The associated road side verge on the south-western road side is relatively wide at roughly 3 m, with species including: meadow grass sp. (<i>Poa</i> sp.), black</p>

<p>knapweed, bush vetch, creeping buttercup, wood avens (<i>Geum urbanum</i>), dog's mercury, greater plantain, ribwort plantain, herb Robert and colt's foot.</p> <p>Habitat condition (provisional): Poor (Score 1)</p>	
<p>TR3.HTN53</p>

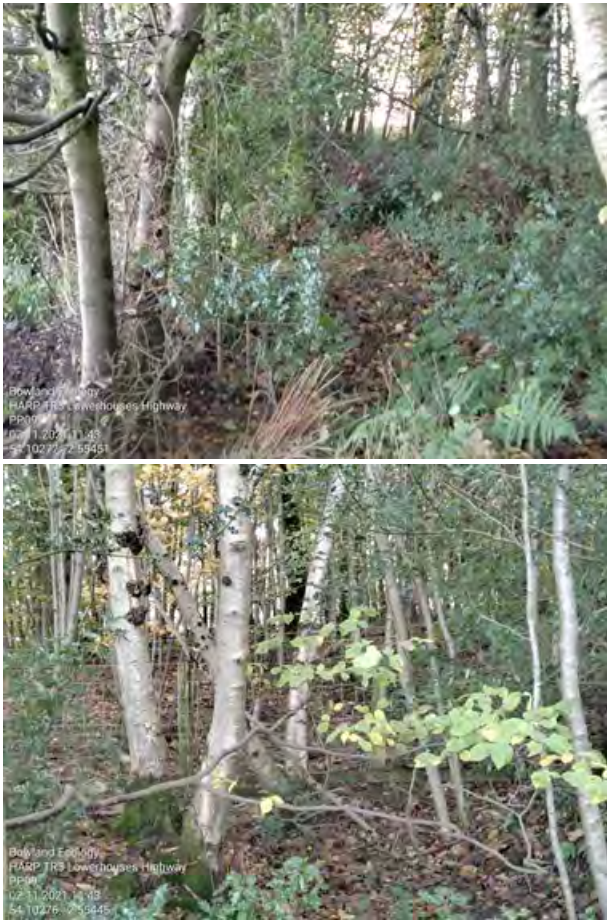
<p>A section of deciduous woodland which is bounded by Furnessford road to the east and Spen brow to the west. The woodland has a mixed age structure with mature canopy trees comprising primarily of oak and silver birch with additional beech and hazel. The understory is relatively sparse internally but is occasionally dense towards the road side, species include hawthorn and holly. The ground flora beneath the canopy consists of almost exclusive of male fern with additional broad buckler fern (<i>Dryopteris dilatata</i>) and bramble. Towards the road verge side additional species are present including black knapweed, Yorkshire fog, nettle, creeping buttercup and ribwort plantain.</p> <p>Habitat condition (provisional): Moderate (Score 2)</p>

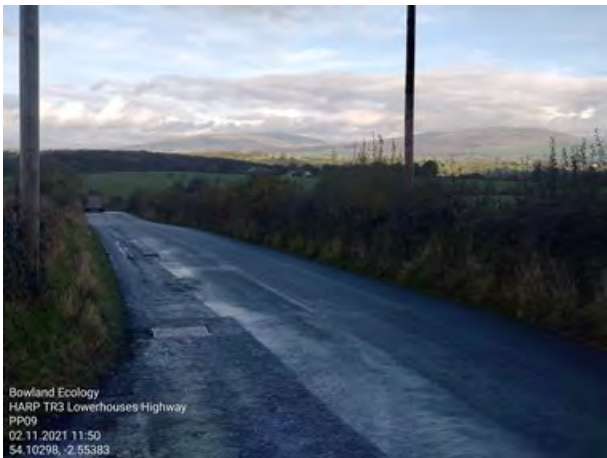
TR3.HTN54

<p>Bowland Ecology HARP TR3 Lowerhouses Highway PP09 02.11.2021 11:50 54.10298, -2.55383</p>
<p>The hedgerow on the western side of the road comprises oak, hawthorn and bramble with infrequent patches of honey suckle and holly. A small willow tree is present growing out of the hedgerow on the western road side. On the opposite side of the road the hedgerow comprises hawthorn and sycamore with no oak present. The associated verges on Spennings Brow include meadow grass sp., cow parsley, garlic mustard, bedstraw sp., hedge wound wort (<i>Stachys sylvatica</i>) and an abundance of cleavers (<i>Galium aparine</i>).</p> <p>Habitat condition (provisional): Poor (Score 1)</p>	
Watercourses	
TR3.HWC1

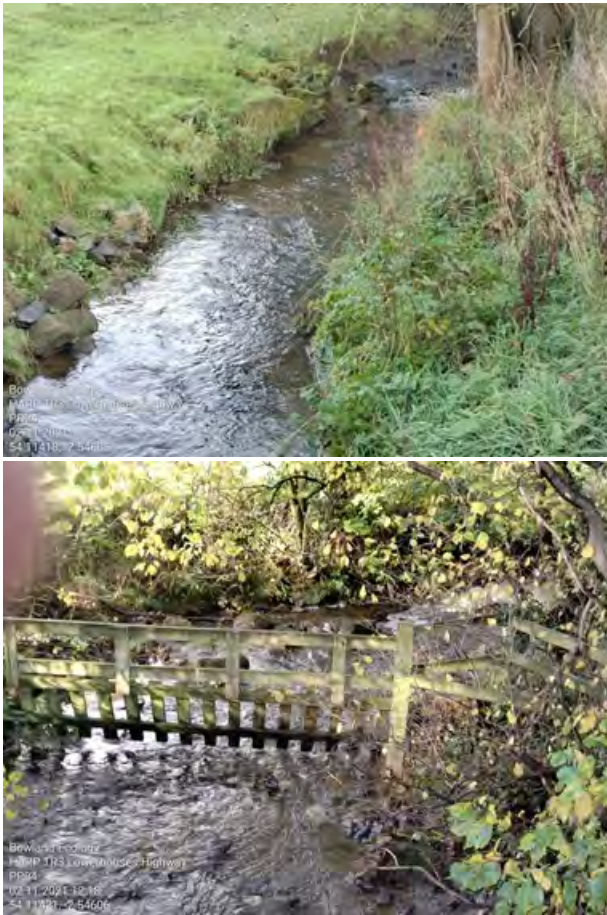
<p>Bowland Ecology HARP TR3 Lowerhouses Highway PP09 02.11.2021 12:16 54.11318, -2.54609</p>
<p>Moderate flowing stream approximately 1.5 to 5 m wide. 0.1-0.5 m deep with some pools and riffles. Flowing over cobbles, stones, gravels and silt. Shallow banks are earth and stone, with some larger rocks. Downstream the watercourse has some</p>

sections of much steeper embankments, which are bare rock with some vertical and undercut areas. Bordered by broadleaved woodland on the eastern bank and species-poor semi-improved grassland, with some small areas of marshy grassland and possible semi-improved neutral grassland to the west. The stream is channelised under the bridge with a concrete culvert structure. On the western side of the road the stream is surrounded by deciduous woodland on both banks. The watercourse flows in a northerly direction. Potential for salmonids, otter (*Lutra lutra*), and white-clawed crayfish (*Austropotamobius pallipes*) but is low risk for water vole (*Arvicola amphibius*).

Habitat condition (provisional): Poor (Score 1)

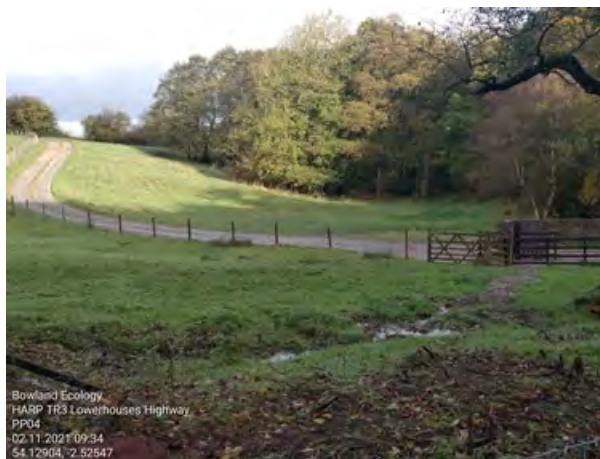
A small wet ditch on the western side of the road with running water flowing in a northerly direction into Eskew beck. The stream is very small around 0.6 m wide and the banks are poorly defined, especially towards the northern end immediately before joining the larger Eskew beck. Towards the southern end the watercourse is surrounded by semi-mature hawthorn and alder (*Alnus glutinosa*).

Habitat condition (provisional): Poor (Score 1)

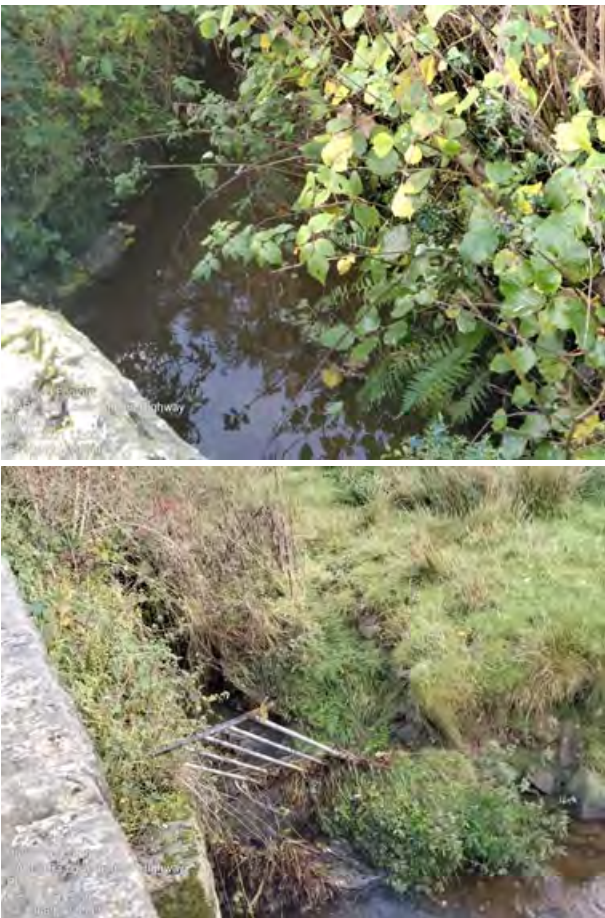
<p>A small stream (Clear Beck) flowing under Long lane from east to west. The stream follows parallel to the road for around 20 m on the eastern road side before crossing under a stone culvert. The channel ranges in width from around 0.6 m on the south-eastern side of the road to 1.5 m on the north western side. The banks of the stream on the south-eastern side of the road are heavily overgrown with tall ruderal vegetation including willowherb sp., creeping thistle, nettle and bramble which completely covers the water channel itself. Meanwhile on the north-western side the banks are colonised by taller scrub vegetation comprising hazel, holly and bramble. The bed of the stream is of a silty substrate with large irregular stone blocks reinforcing the banks, upon which ferns and bryophytes are growing at the water level.</p> <p>habitat condition (provisional): Poor (Score 1)</p>

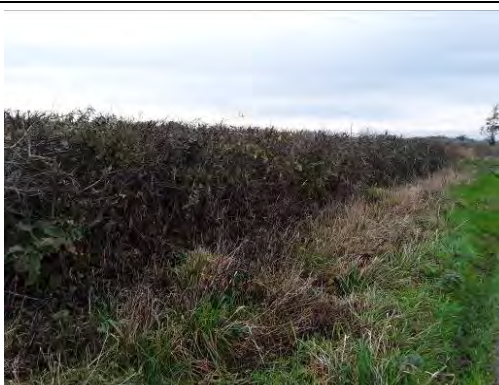
TR3.HH5

The hedgerow is 106 m long and 1.5 m in height and 1.5 m wide. There is one gap within the hedgerow which forms approximately 5% of the hedgerow length and there are two associated mature trees. A parallel hedge lies within 15 m of the hedgerow (TR3.HH4). Connections with other hedgerows or woodlands do not score four or more points. The canopy is species rich, with abundant hawthorn. Hazel, holly, blackthorn, whitebeam and rose sp. are also present (six woody species). The ground flora has notable species of lady fern, broad buckler fern (*Dryopteris dilatata*) and herb Robert. Noted within the ground flora were additional species including; foxglove (*Digitalis purpurea*), meadow sweet, bush vetch, common nettle, creeping bent, bramble, black knapweed (*Centaurea nigra*), cleavers (*alium aparine*), bracken (*Pteridium aquilinum*), stitchwort sp., cow parsley and nipplewort (*Lapsana communis*). The hedgerow appears to be more than 30 years in age.

No Wildlife & Countryside Act protected species have been identified to be present. **This hedgerow is classified under ecological criteria as 'Important' under The Hedgerow Regulations 1997.**

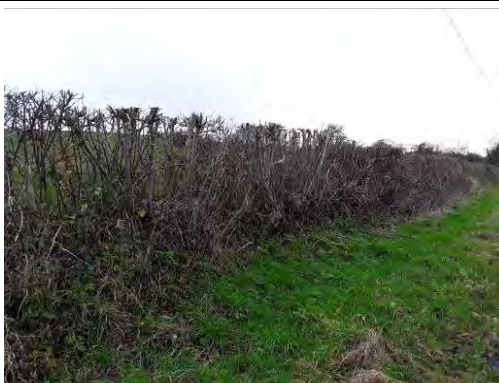
TR3.HH6

The hedgerow is 75 m long and 1.5 m in height and 1.5 m wide. It does not have an associated bank, wall or ditch. There are no gaps within the hedgerow and there are no associated mature trees. Connections with other hedgerows or woodlands do not score four or more points. The canopy is species rich, with dominant hawthorn. Hazel, ash, holly and rose sp. are also present (five woody species). The ground flora has notable species of herb Robert. Also noted within the ground flora were additional species including; bramble, cow parsley, common nettle, common hogweed, cleavers, bracken, stitchwort sp. and crosswort (*Cruciata laevipes*). A parallel hedgerow is present within 15 m (TR3.HH7). The hedgerow appears to be more than 30 years in age.

No Wildlife & Countryside Act protected species have been identified to be present. **This hedgerow is classified under ecological criteria as 'Important' under The Hedgerow Regulations 1997.**

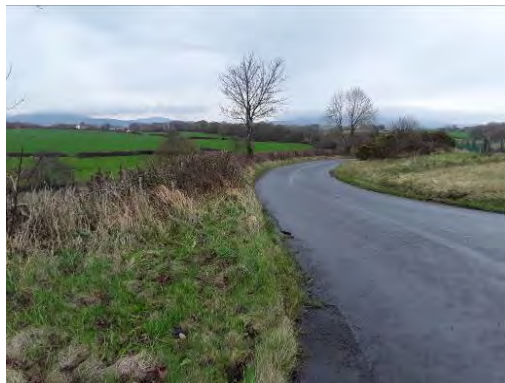
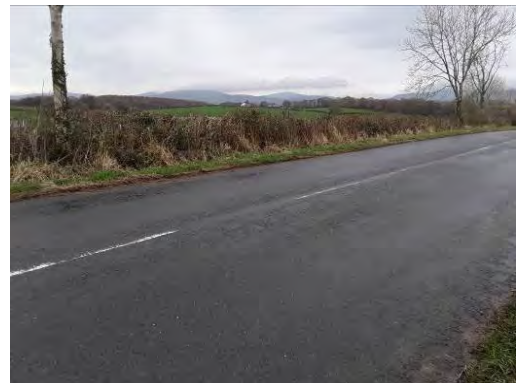
TR3.HH7

The hedgerow is 271 m long and 1 m in height and 1 m wide. There is one gap within the hedgerow which is less than 10% of the hedgerow length and there is one associated mature tree (there are 11 immature trees <20 cm diameter) within the hedgerow). Connections with other hedgerows or woodlands do not score four or more points. Two parallel hedgerows are present within 15 m (TR3.HH6 and TR3.HH8) and there is one connecting hedgerow (TR3.HH41). There is no associated ditch or bank. The canopy is species rich and dominated by hawthorn. Hazel, ash, holly, blackthorn and rose sp. are also present (six woody species). The ground flora has one notable species; herb Robert and other species present include; cow parsley, common hogweed, common nettle, bramble, cleavers, crosswort, ribwort plantain, yarrow (*Achillea millefolium*), meadow vetchling (*Lathyrus pratensis*), bush vetch and red fescue. The hedgerow appears to be more than 30 years in age.

No Wildlife & Countryside Act protected species have been identified to be present. **This hedgerow is classified under ecological criteria as 'Important' under The Hedgerow Regulations 1997.**

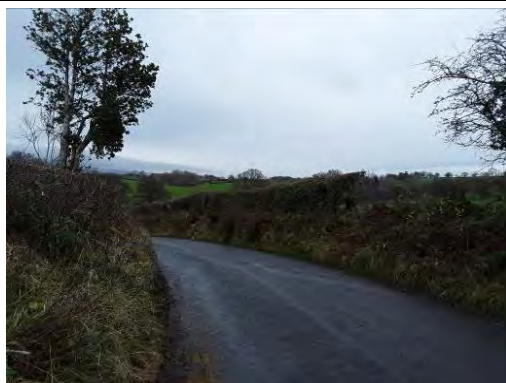
TR3.HH8

This hedgerow is 91 m in length, approximately 1.5 m in height and 2 m wide. There are no gaps or ditches along the length. There are no associated supporting banks or walls and there are no mature trees. The canopy is dominated by blackthorn, with hazel and holly also present (three woody species). Schedule 2 ground flora species recorded include male fern, lady fern, pignut (*Conopodium majus*), herb Robert, wood avens and dog's mercury. Additional ground flora species recorded include opposite leaved golden saxifrage (*Chrysosplenium oppositifolium*), cow parsley, bracken, meadow sweet, ivy, coltsfoot (*Tussilago farfara*), common hogweed, black knapweed and cleavers. Connections with other hedgerows or woodlands do not score four or more points, however there is a parallel hedgerow within 15 m (TR3.HH7). The hedgerow does not appear to be less than 30 years old.

No Wildlife & Countryside Act protected species have been identified to be present. This hedgerow does not classify under ecological criteria as 'Important' under The Hedgerow Regulations 1997.

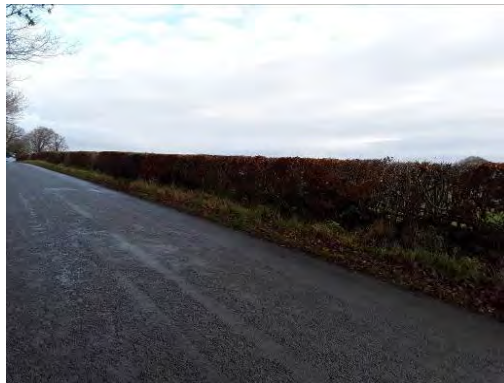
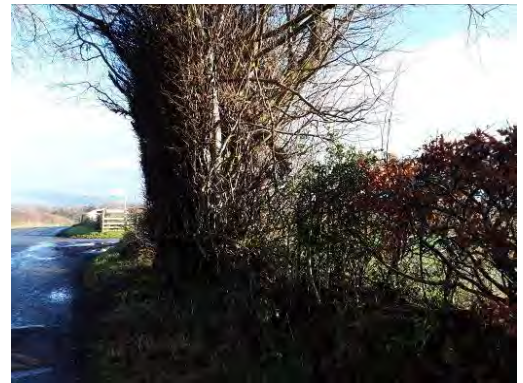
TR3.HH9

This hedgerow is 333 m in length, approximately 1.5 m in height and 2 m wide. There are no gaps in the hedgerow. There is no dry ditch associated with the hedgerow. The hedgerow is supported by a bank/wall. There is one mature tree associated with the hedgerow. The canopy is dominated by beech and with hazel, hawthorn, ash and holly also present (five woody species). Schedule 2 ground flora species present include male fern, lady fern, herb Robert, wood avens, dog's mercury, common polypody fern (*Polypodium vulgare*) and barren strawberry. Additional ground flora species recorded include; bramble, nipplewort, garlic mustard, ivy, cleavers, common nettle, common hogweed, reed canary grass (*Phalaris arundinacea*), meadow grass sp. (*Poa* sp.), meadowsweet, creeping buttercup, foxglove, cow parsley, dandelion (*Taraxacum officinale* agg.), sow thistle (*Sonchus* sp.), broadleaved dock (*Rumex obtusifolius*), hedge woundwort and sneezewort (*Achillea ptarmica*). Connections with other hedgerows or woodlands do not score four or more points, however there is a parallel hedgerow within 15 m (TR3.HH12). There are at least three woodland species within one metre, in any direction, of the outermost edge of the hedgerow. The hedgerow appears to be more than 30 years old.

No Wildlife & Countryside Act protected species have been identified to be present. **This hedgerow classifies under ecological criteria as 'Important' under The Hedgerow Regulations 1997.**

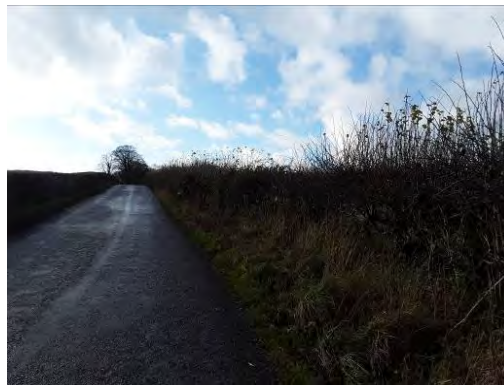
TR3.HH10

This hedgerow is 413 m in length, approximately 1.5 m in height and 1.5 m wide. There are no gaps in the hedgerow. There is no ditch associated with the hedgerow. The hedgerow is not supported by a bank/wall. There are four mature trees associated with the hedgerow. The canopy is dominated by hazel and blackthorn with hawthorn, ash, rose and holly also present (six woody species). Schedule 2 ground flora species present include; lady fern, herb Robert, wood avens, dog's mercury, broad-leaved helleborine (*Epipactis helleborine*) and barren strawberry. Additional ground flora species recorded include; bramble, garlic mustard, black knapweed, cleavers, common hogweed, false oat grass, sow thistle (*Sonchus* sp.), broadleaved dock, and stitchwort sp.. Connections with other hedgerows or woodlands do not score four or more points, however there are two parallel hedgerows within 15 m (TR3.HH11 and TR3.HH13). There are at least three woodland species within one metre, in any direction, of the outermost edge of the hedgerow. The hedgerow appears to be more than 30 years old.

No Wildlife & Countryside Act protected species have been identified to be present. **This hedgerow classifies under ecological criteria as 'Important' under The Hedgerow Regulations 1997.**

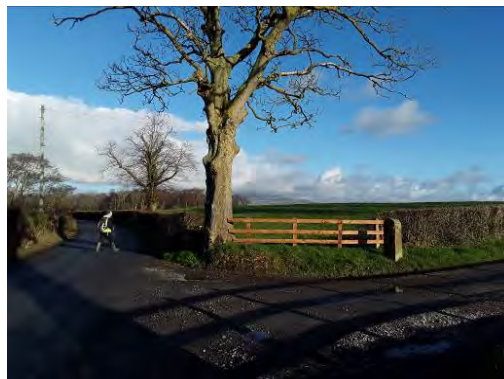
TR3.HH13

This hedgerow is 178 m in length, approximately 1.5 m in height and 3 m wide. There are no gaps in the hedgerow. There is no ditch associated with the hedgerow and it is not supported by a bank/wall. There are three mature trees associated with the hedgerow. The canopy comprises a mix of species with beech, blackthorn, hawthorn, ash, rose, large-leaved lime, elm sp. (*Ulmus* sp.), oak (*Quercus* sp.) and holly present with no species being dominant (nine woody species). Schedule 2 ground flora species present include lady fern, male fern, dog's mercury, common polypody and barren strawberry. Additional ground flora species recorded include; garlic mustard, cleavers, cow parsley, common nettle, common hogweed, creeping bent, dandelion, ivy, meadowsweet and coltsfoot. Signs of use by mammals, include paths through the hedgerow. Connections with other hedgerows or woodlands do not score four or more points, however there is a parallel hedgerow within 15 m (TR3.HH10). At least three Schedule 2 woodland ground flora species are present within one metre of the outermost edge of the hedgerow. The hedgerow appears to be more than 30 years old.

No Wildlife & Countryside Act protected species have been identified to be present. **This hedgerow classifies under ecological criteria as 'Important' under The Hedgerow Regulations 1997.**

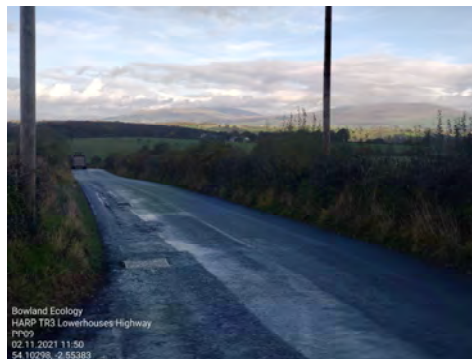
TR3.HH50

This hedgerow is 250 m in length, approximately 1.5 m in height and 1.5 m wide. There are no gaps in the hedgerow. There is no ditch associated with the hedgerow. The hedgerow is not supported by a bank/wall. There are no mature trees associated with the hedgerow. The canopy is dominated by hawthorn with holly, rose and willow also present (four woody species). Schedule 2 ground flora species present include; lady fern, and dog's mercury. Additional ground flora species recorded include; bramble, bush vetch, ivy, cleavers, common nettle, male fern, and stitchwort sp.. Connections with other hedgerows or woodlands do not score four or more points, however there is one parallel hedgerows within 15 m (TR3.HH11 and TR3.HH13). The hedgerow does not appear to be more than 30 years old.

No Wildlife & Countryside Act protected species have been identified as present. This hedgerow does not classify under ecological criteria as 'Important' under The Hedgerow Regulations 1997.

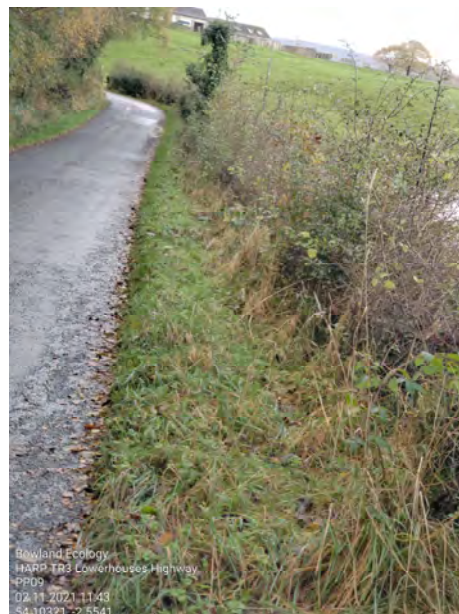
TR3.HH51

This hedgerow is 50 m in length, approximately 2 m in height and 1.5 m wide. There are no gaps in the hedgerow. There is no ditch associated with the hedgerow. The hedgerow is not supported by a bank/wall. There is one mature tree associated with the hedgerow. The canopy is dominated by hawthorn with holly, rose and sycamore also present (four woody species). No schedule 2 ground flora species are present. Additional ground flora species recorded include; bramble, bush vetch, common nettle, cow parsley, creeping buttercup, ivy and raspberry. Connections with other hedgerows or woodlands do not score four or more points. There is a parallel woodland but no parallel hedgerow. There are at least three woodland species within one metre, in any direction, of the outermost edge of the hedgerow. The hedgerow appears to be more than 30 years old.

No Wildlife & Countryside Act protected species have been identified to be present. This hedgerow does not classify under ecological criteria as 'Important' under The Hedgerow Regulations 1997.

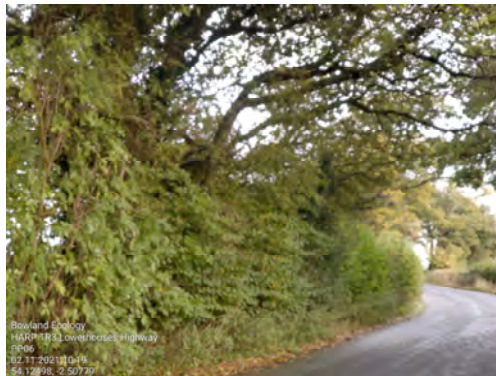
TR3.HH52

This hedgerow is 200 m in length, approximately 2 m in height and 2 m wide. There are no gaps in the hedgerow. There is no ditch associated with the hedgerow. The hedgerow is not supported by a bank/wall. There are six mature trees associated with the hedgerow. The most abundant canopy species are hazel and hawthorn with holly, blackthorn, rose, willow and elder also present (seven woody species). Schedule 2 ground flora species present include dog's mercury. Additional ground flora species recorded include; bramble, common nettle, common hog weed, cleavers, creeping thistle, ivy, male fern and meadow sweet. Connections with other hedgerows or woodlands do not score four or more points, however there is one parallel hedgerows within 15 m (TR3.HH53). The hedgerow appears to be more than 30 years old.

No Wildlife & Countryside Act protected species have been identified to be present. **This hedgerow classifies under ecological criteria as 'Important' under The Hedgerow Regulations 1997.**

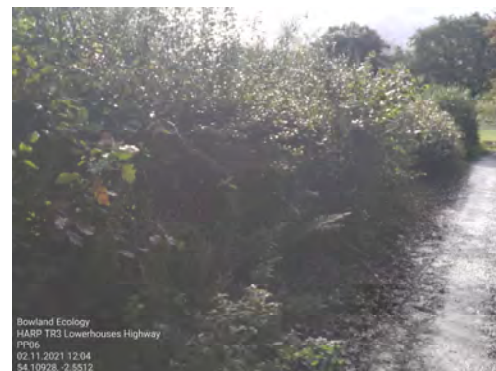
TR3.HH53

This hedgerow is 80 m in length, approximately 2 m in height and 1.5 m wide. There are no gaps in the hedgerow. There is no ditch associated with the hedgerow. The hedgerow is not supported by a bank/wall. There are five mature trees associated with the hedgerow. The canopy is dominated by holly with hawthorn, hazel, blackthorn rose and elder also present (six woody species). Schedule 2 ground flora species present include; wood avens and dog's mercury. Additional ground flora species recorded include; bramble, garlic mustard, common vetch, male fern and sow thistle. Connections with other hedgerows or woodlands scores four points, and there is one parallel hedgerows within 15 m (TR3.HH52). The hedgerow appears to be more than 30 years old.

No Wildlife & Countryside Act protected species have been identified to be present. **This hedgerow classifies under ecological criteria as 'Important' under The Hedgerow Regulations 1997.**

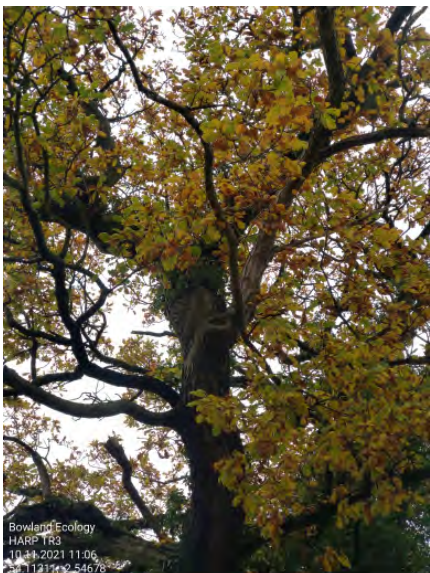
establish the presence of bat roosts.
4 Survey Results	
Individual Trees	
TR3.HBT17

<p>Bowland Ecology HARP TR3 10.11.2023 11:06 54.11348, -2.54678</p>	<p>NGR: SD 64344 98710</p> <p>Species: Oak species (<i>Quercus</i> sp.)</p> <p>Categorisation: Moderate potential</p>
TR3.HBT18

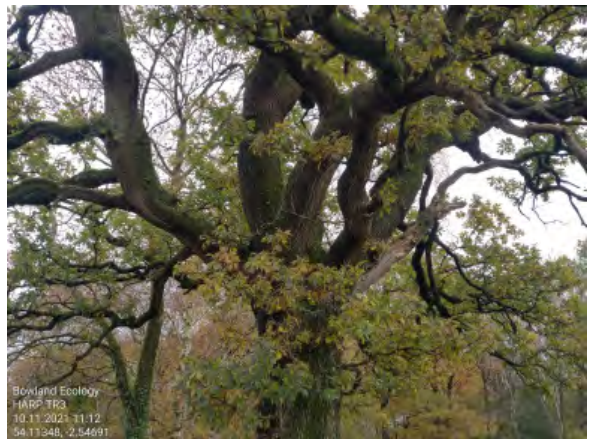
<p>Bowland Ecology HARP TR3 10.11.2023 11:12 54.11348, -2.54691</p>	<p>NGR: SD 64562 69310</p> <p>Species: Ash (<i>Fraxinus excelsior</i>)</p> <p>Categorisation: Low potential</p>
TR3.HBT19	
No picture	<p>NGR: SD 64340 68680</p> <p>Species: lime</p> <p>Categorization: low</p>
TR3.HBT20

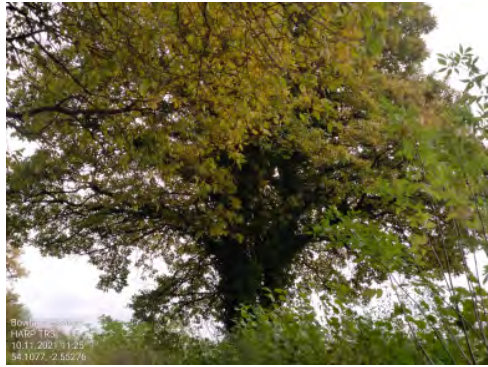
<p>NGR: SD 63904 68060</p> <p>Species: oak species (<i>Quercus</i> sp.)</p> <p>Categorization: low</p>
TR3.HBT21

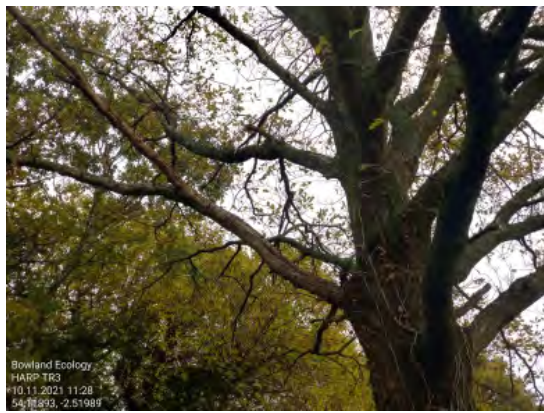
<p>NGR: SD 63901 68071</p> <p>Species: oak species (<i>Quercus</i> sp.)</p> <p>Categorization: moderate</p>
TR3.HBT22

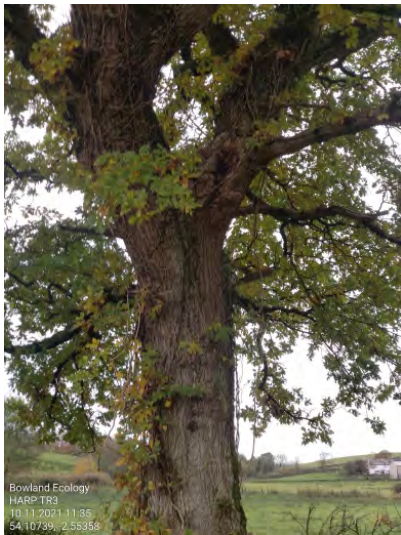
<p>NGR: SD 63921 68071</p> <p>Species: oak (<i>Quercus</i> sp.)</p> <p>Categorization: moderate</p>
TR3.HBT23

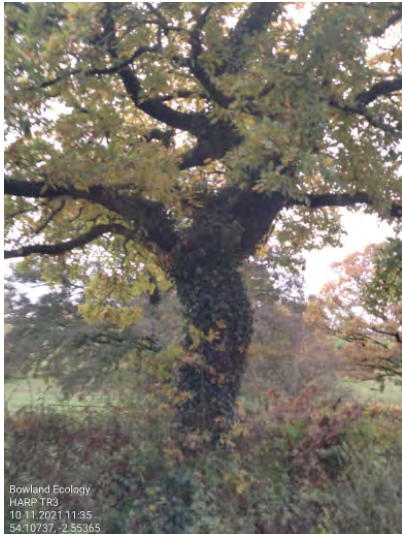
<p>Bowland Ecology HARP TR3 10.11.2021 11:35 54.10737, -2.55365</p>	<p>NGR: SD 63915 98085</p> <p>Species: oak (<i>Quercus</i> sp.)</p> <p>Categorization: moderate</p>
TR3.HBT24

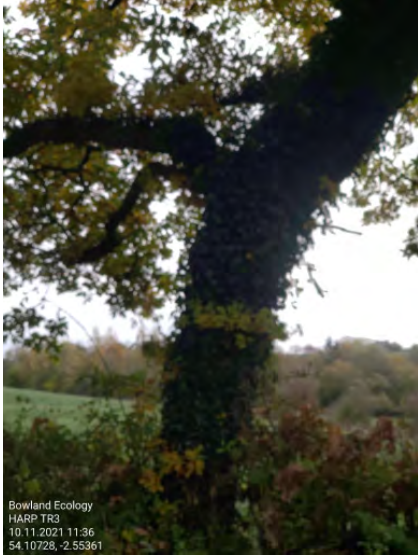
<p>Bowland Ecology HARP TR3 10.11.2021 11:36 54.10728, -2.55361</p>	<p>NGR: SD 63972 68128</p> <p>Species: oak (<i>Quercus</i> sp.)</p> <p>Categorization: low</p>
Tree groups	
TR3.HBG17

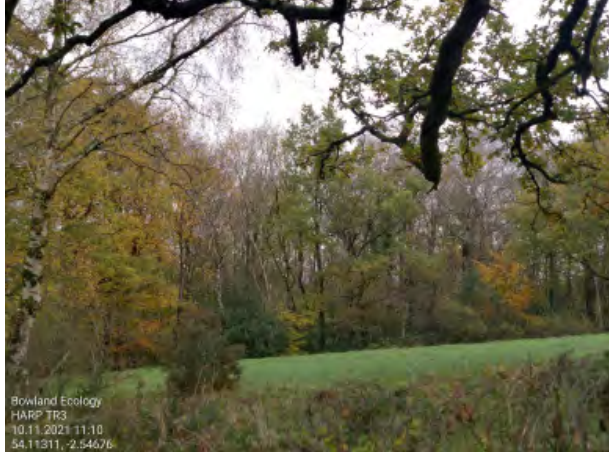
<p>Bowland Ecology HARP TR3 10.11.2021 11:10 54.11311, -2.54676</p>	<p>NGR: SD 64440 68763</p> <p>Species: oak, alder, beech, silver birch</p> <p>Number of trees: >100</p> <p>Categorization: moderate</p>
TR3.HBG18

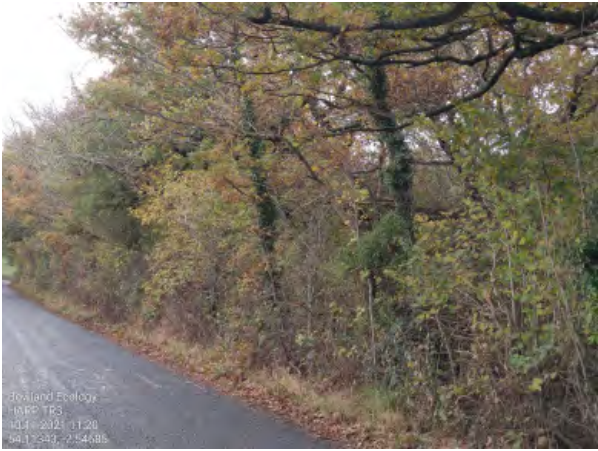
<p>NGR: SD 64047 68310</p> <p>Species: oak, sycamore, ash</p> <p>Number of trees: >100</p> <p>Categorization: high</p>
TR3.HBG19

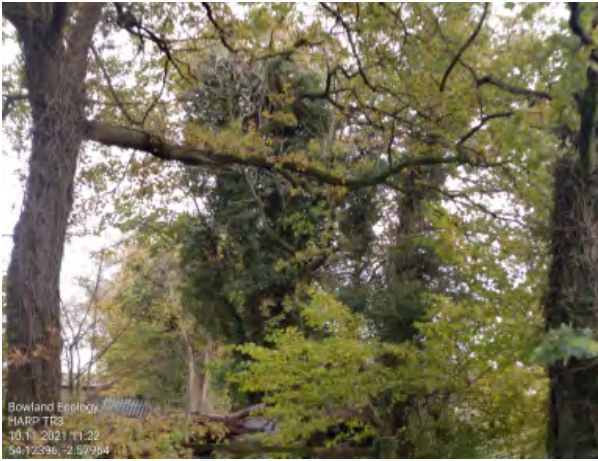
<p>NGR: SD 64050 68207</p> <p>Species: oak, sycamore, alder</p> <p>Number of trees: 10</p> <p>Categorization: moderate</p>
TR3.HBG20

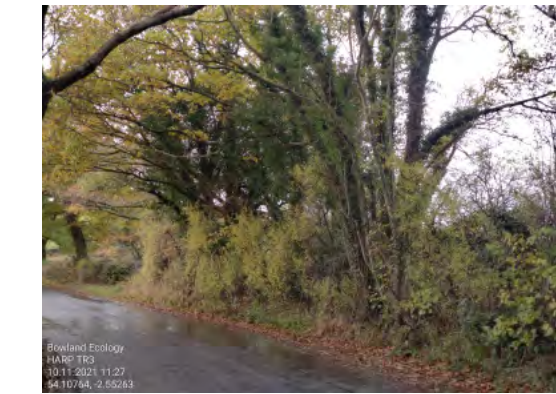
<p>NGR: SD 63941 98119</p> <p>Species: oak, hazel</p> <p>Number of trees: approximately 15</p> <p>Categorization: moderate</p>
TR3.HBG21

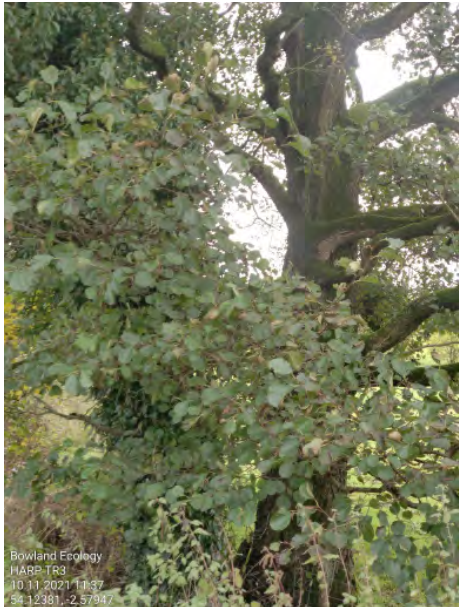
<p>Bowland Ecology HABP-TR3 10.11.2021 11:37 54.12381, -2.57947</p>	<p>NGR:SD 63883 68044</p> <p>Species: alder (<i>Alnus glutinosa</i>)</p> <p>Number of trees: 2</p> <p>Categorization: low</p>
<p>TR3.HBG22</p>

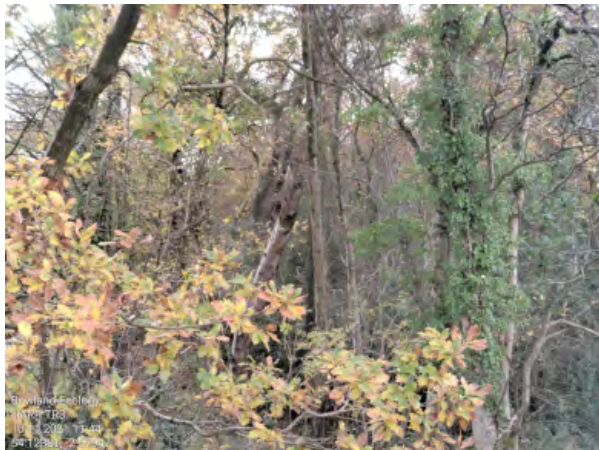
<p>Bowland Ecology HABP-TR3 10.11.2021 11:40 54.12381, -2.57947</p>	<p>NGR:SD 63837 67525</p> <p>Species: oak, silverbirch, beech</p> <p>Number of trees: >100</p> <p>Categorization: moderate</p>
