**Haweswater Aqueduct Resilience Programme - Proposed Marl Hill
Section**

Environmental Statement

Appendix 6.6: Arboricultural Impact Assessment

June 2021

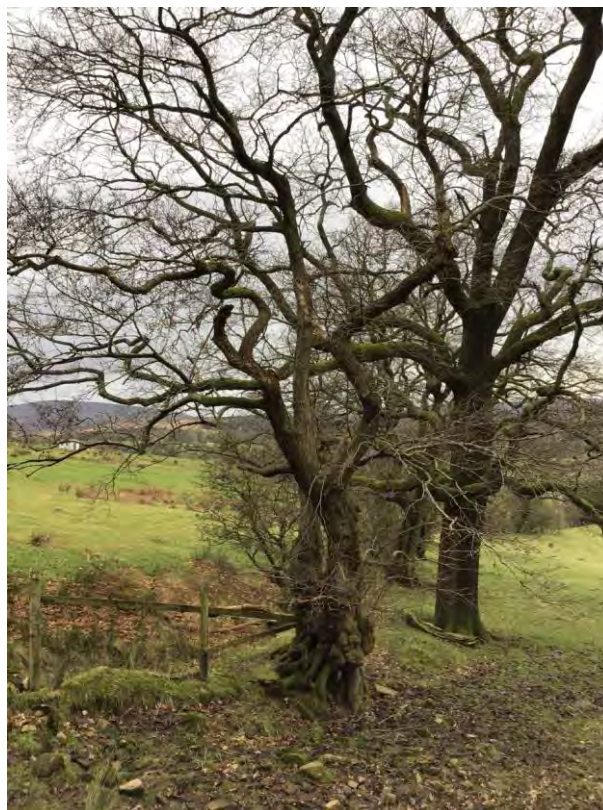
Illustration 1: Potential veteran alder tree located on field boundary

- 29) The proposed location of the Bonstone Compound is within open sloping landscape comprising agricultural fields and grassland. An existing access track, approximately 2.5 m wide, approaches Bonstone Compound from the east from Slaidburn Road. The assessment area is intermittently covered with scattered individual trees and mixed species woodland with land boundaries regularly margined by field boundary vegetation.
- 30) Approximately 45 % of the Proposed Marl Hill Section's surveyed trees are located at this compound location with the majority of surveyed trees assessed to be of at least mature age class. Surveyed tree stock is predominantly of moderate quality but contains five high quality trees including four potential veteran trees. These potential veteran trees are all situated at trackside or existing field boundaries including Illustrations 1 and 2.

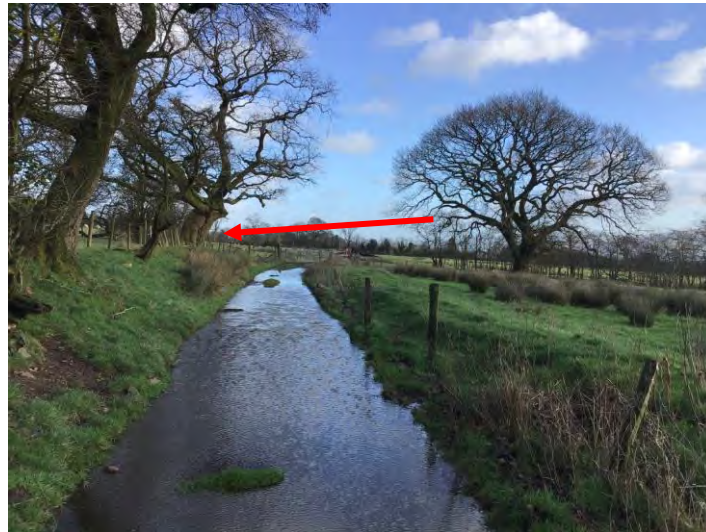
Illustration 3: Section of existing access track contiguously flanked either side by trees including three potential veteran trees. The largest tree stem at Braddup, a potential veteran oak, is red arrowed below

- 33) An existing access track, approximately 2.5 m wide, approaches Braddup Compound from the east from Slaidburn Road. This track, as shown in Illustration 3, is intermittently flanked by verge-side trees of predominantly high quality including three potential veteran trees.

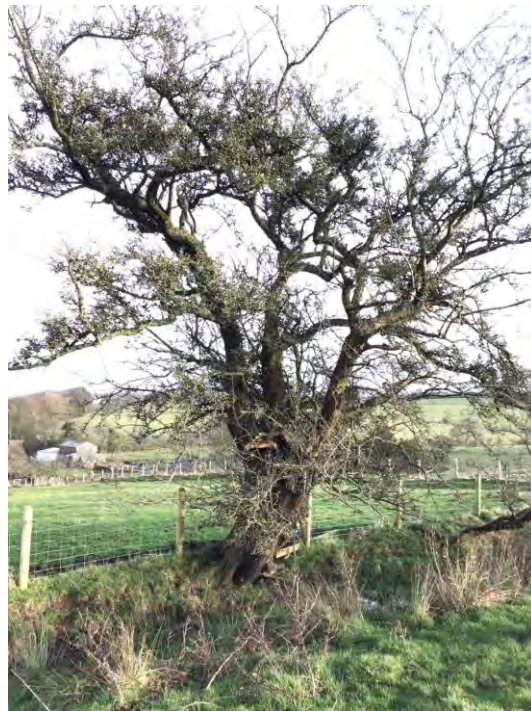
Illustration 4: Potential veteran hawthorn tree to be removed at the proposed Bonstone Compound

- 46) 29 % of trees surveyed at the proposed Bonstone Compound location are subject to varying extents of removal or assessed to be at risk of removal including one notable tree further discussed in Paragraph 47.
- 47) One potential veteran tree (Illustration 4) is to be removed due to its location within the indicative open cut section of the proposed core working area. This open cut section is required for new pipeline installation and connection work into the existing HA. It should be noted that the tree is located outside the proposed pipeline alignment but is fully encroached within the pipeline’s indicative external works area approximately 20 m wide each side.

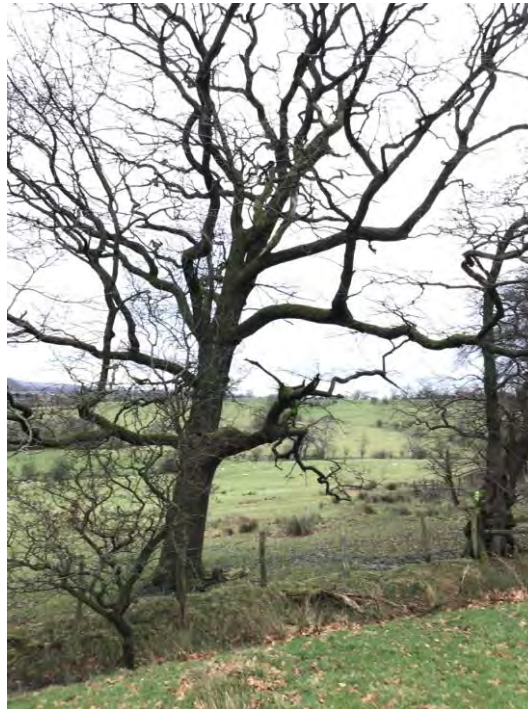
Illustration 5: Encroached A grade oak tree at the proposed Bonstone Compound. Two encroached potential veteran trees are located either side of this feature

- 48) Approximately 33 % of trees surveyed at the proposed Bonstone Compound are considered encroached but RwPM including four trees assessed as notable. Encroached features are reported as retainable (Green within the RAG assessment) subject to pre-construction tree protection measures as detailed within a SS-AMS.

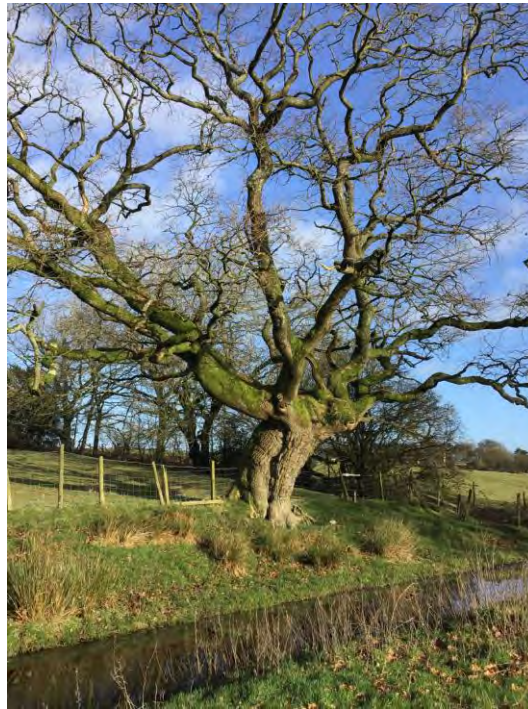
Illustration 6: Potential veteran oak tree located on northern verge side of existing access track

- 53) The majority of trees at risk of removal are located on the grass verge located immediately north of the existing access track. Impacts resulting from proposed track improvements include the potential loss of three potential veteran trees (Illustrations 6 to 8) and four A grade features (examples in Illustrations 9 and 10).

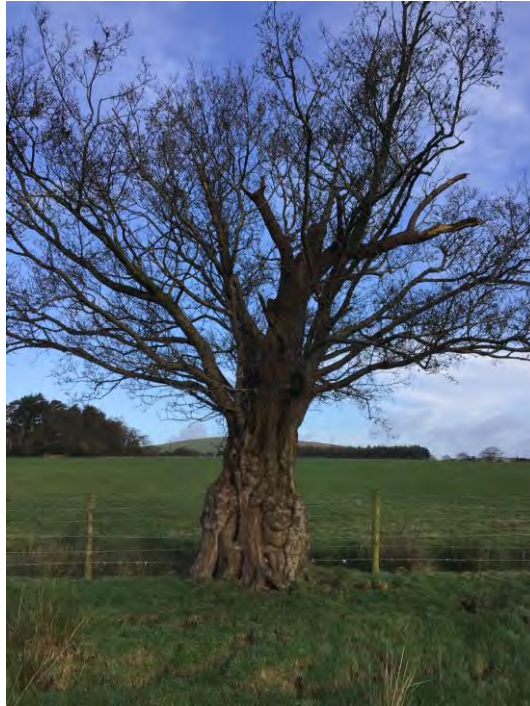
Illustration 7: Potential veteran alder tree located on northern verge side of existing access track

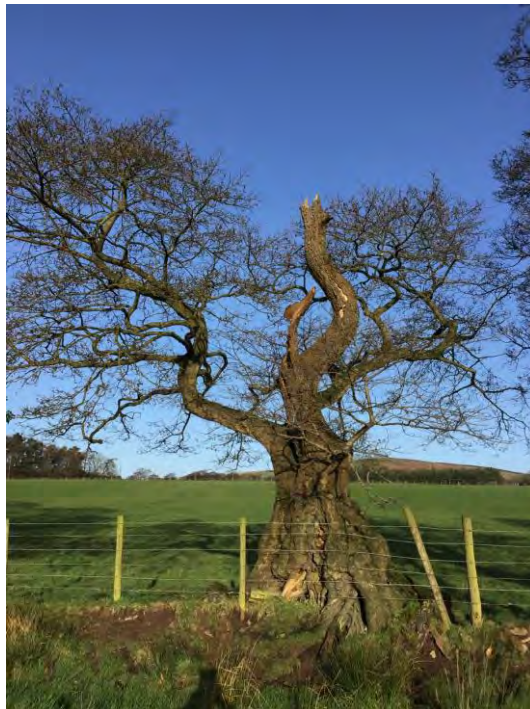
Illustration 8: Potential veteran alder tree located on northern verge side of existing access track

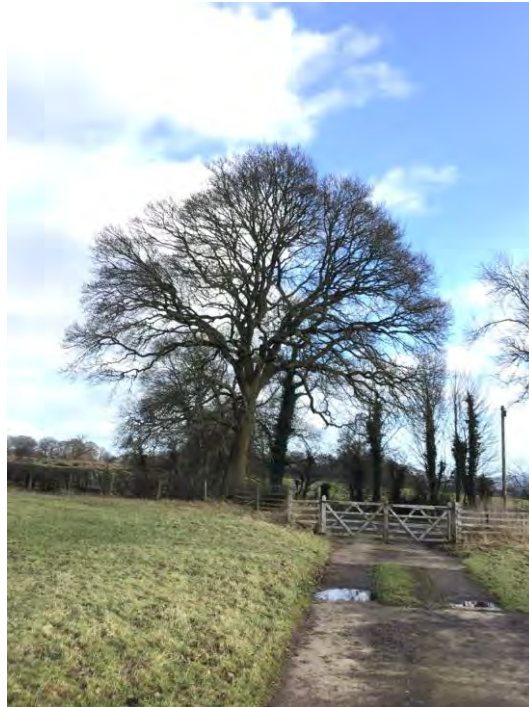
Illustration 9: At risk A grade oak tree located by track entrance to Slaidburn Road

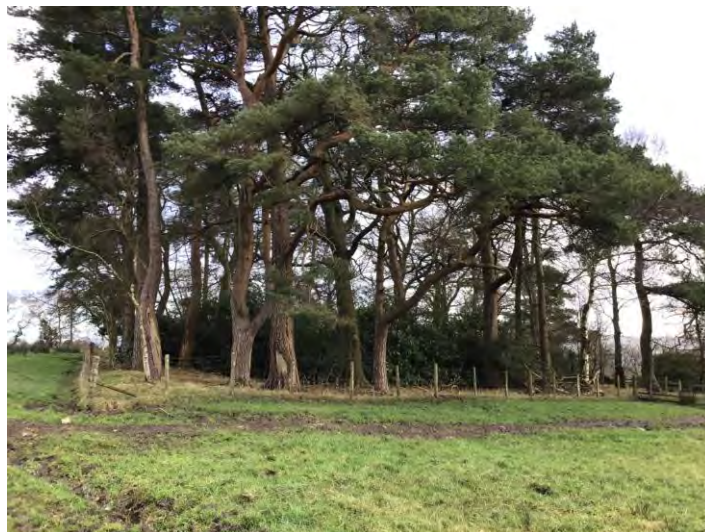
Illustration 10: At risk A grade woodland located on southern verge side of existing access track

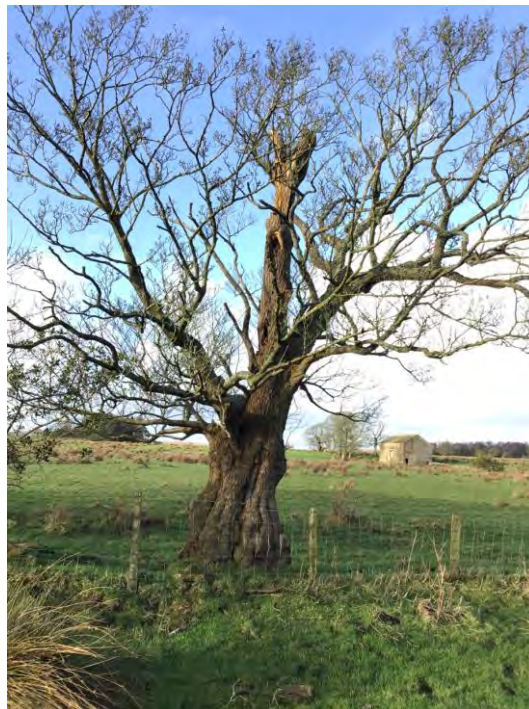
Illustration 11: At risk potential veteran alder tree located on a field boundary.

- 54) An additional potential veteran tree (Illustration 11) is at risk due to its location within the proposed alignment of a new section of tarmac road within the indicative 15 m wide working corridor.

70) Two potential veteran trees (Paragraphs 54 and 55 of Section 5.3.1) are at risk due to their full encroachment by the new road's associated works corridor and indicative layout of the packaged water treatment plant. In the first instance, it is recommended that these design elements are micro-sited to avoid any RPA encroachment. Similar recommendations as outlined in Paragraphs 64 and 65 would also be considered.

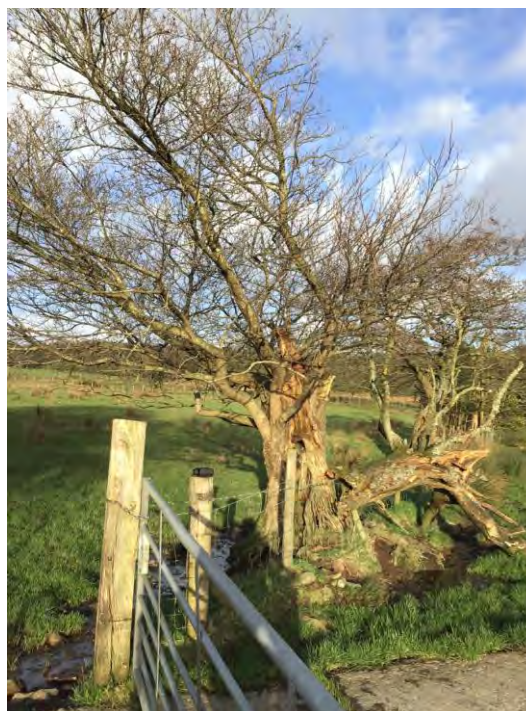
Illustration 12: At risk potential veteran alder tree located on a field boundary adjacent to gate entrance.

- 55) An additional potential veteran tree (Illustration 12) is at risk due to its location within the associated works area for the proposed new tarmac road and proximity to the indicative site layout of the packaged water treatment plant.

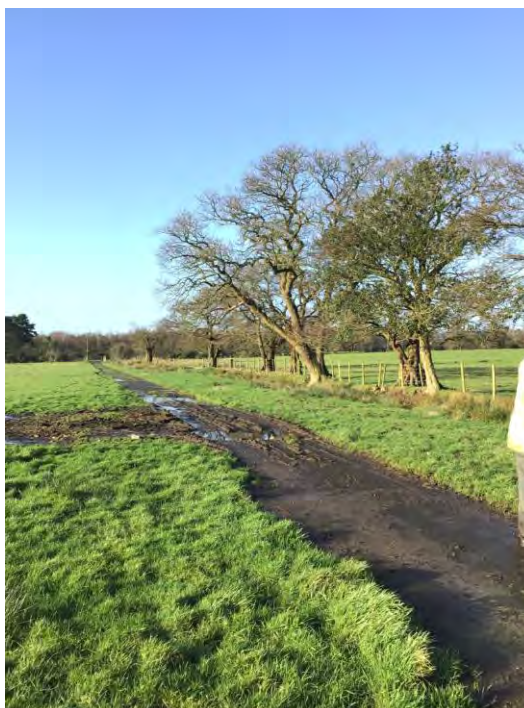
Illustration 13: section of access track flanked on single side by limited tree cover

- 67) In the first instance, it is recommended that the new road alignment (approximately 1.5 km long) and associated works corridor (approximately 15 m wide) are micro-sited to avoid RPA encroachment upon verge-side trees including three potential veteran trees. As illustrated in Illustration 13, around 90 % of the existing verge length to the south of the access track is devoid of tree cover.
