Haweswater Aqueduct Resilience Programme - Proposed Marl Hill Section

**Proposed Ribble Crossing**

Appendix 11.1 Geotechnical and Geo-environmental Site Briefing (Desk Study) Report

**Initial Conceptual Model Report**

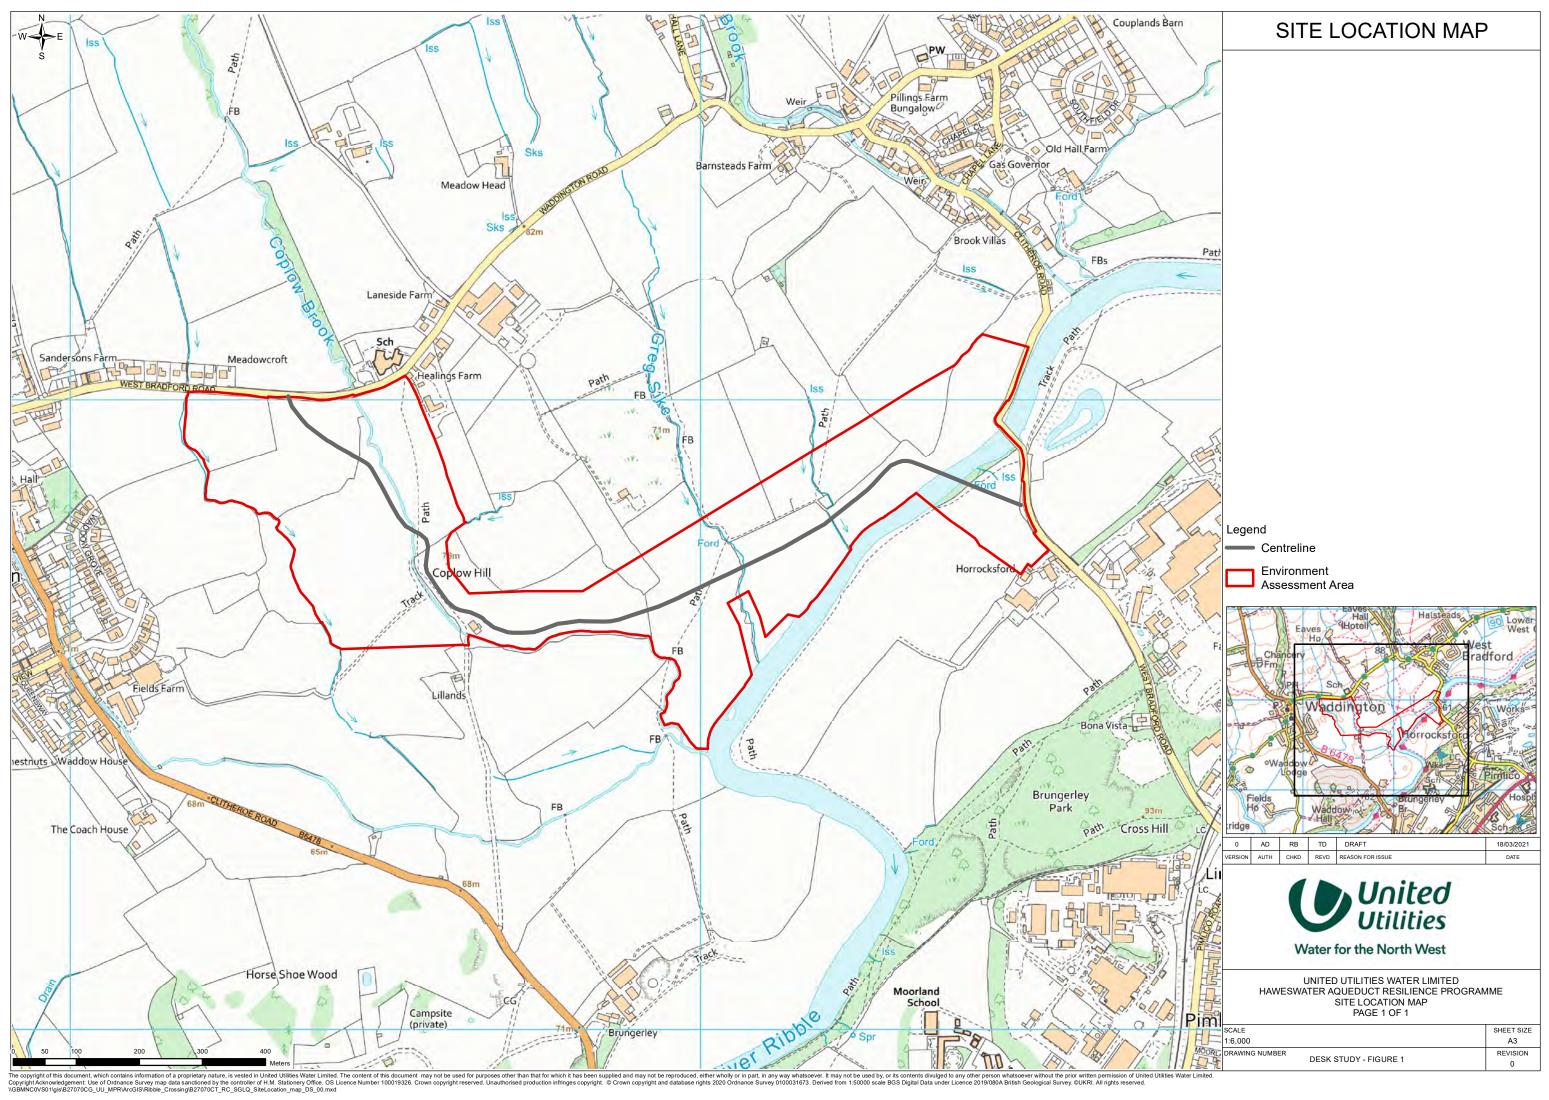
Within this report, the study area comprises a 250 m buffer around the red line planning boundary as shown on Figure 1. However, it should be noted that the development of the Proposed Ribble Crossing haul road and bridge across the River Ribble is smaller in extent (approximately 5 Ha.) than the planning boundary (approximately 30 Ha.).

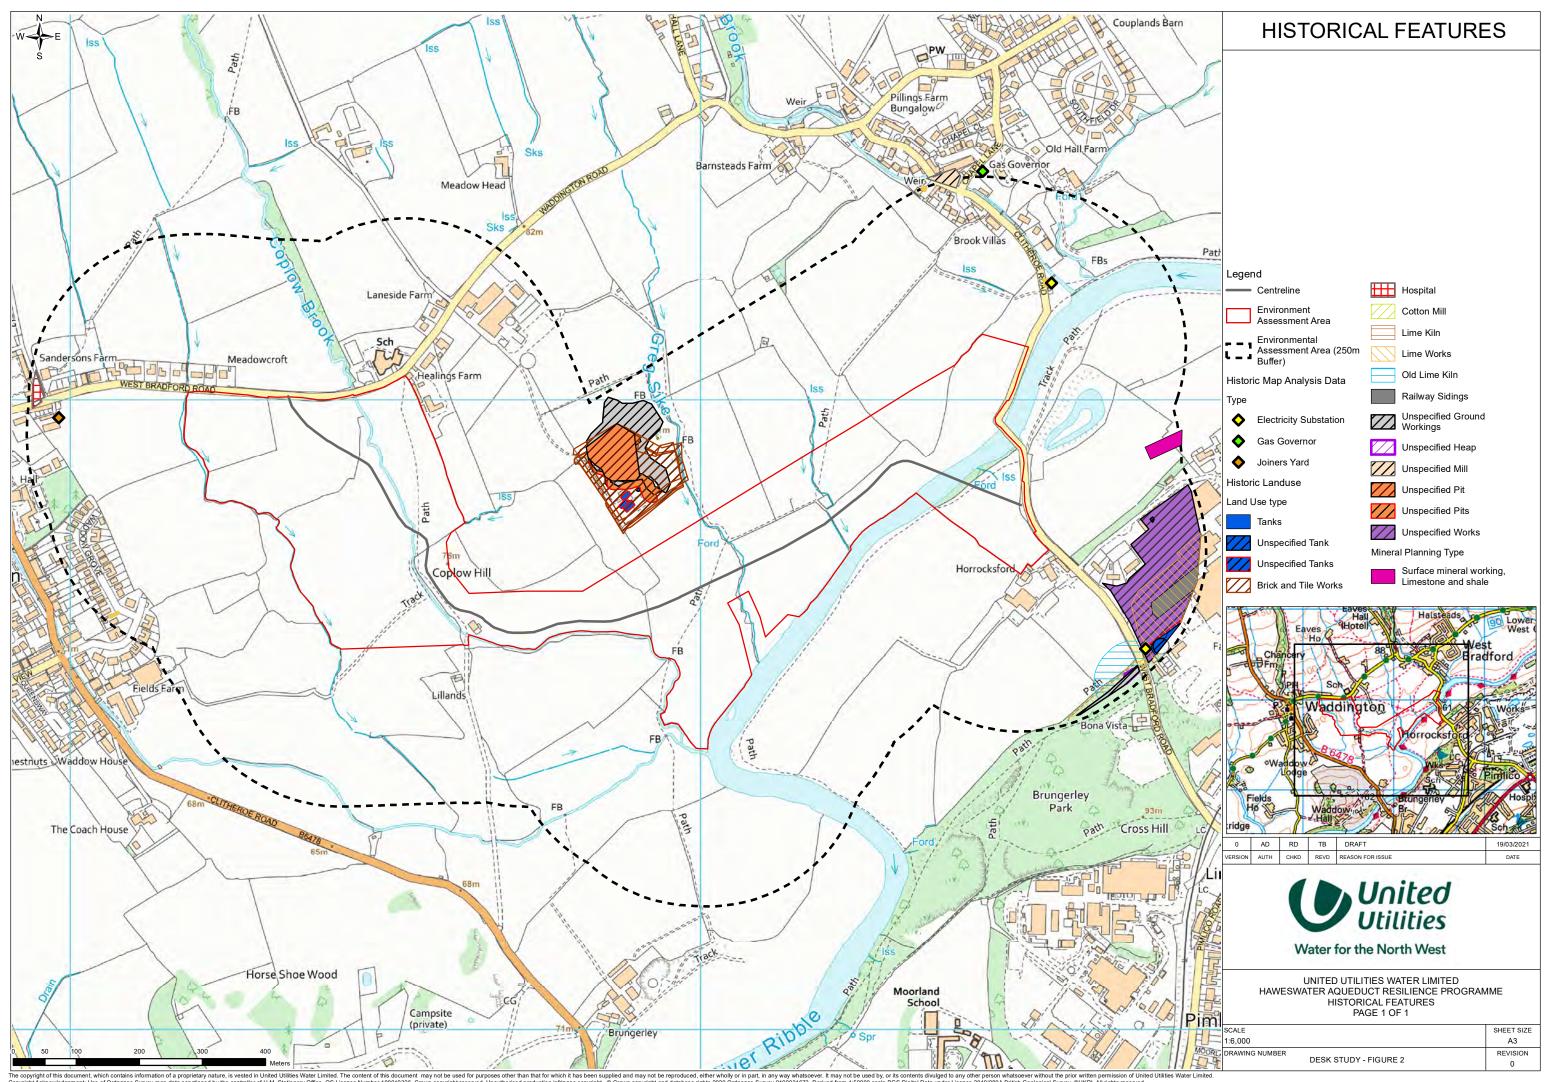
The following information relating to waste and minerals is shown across Figure 2 and Figure 3.

There is one recorded historical landfill located within the study area, namely Waddington Brickworks, located approximately 60 m north of the site. It is understood that this landfill accepted household waste, however no further details relating to the site were available at the time of reporting.

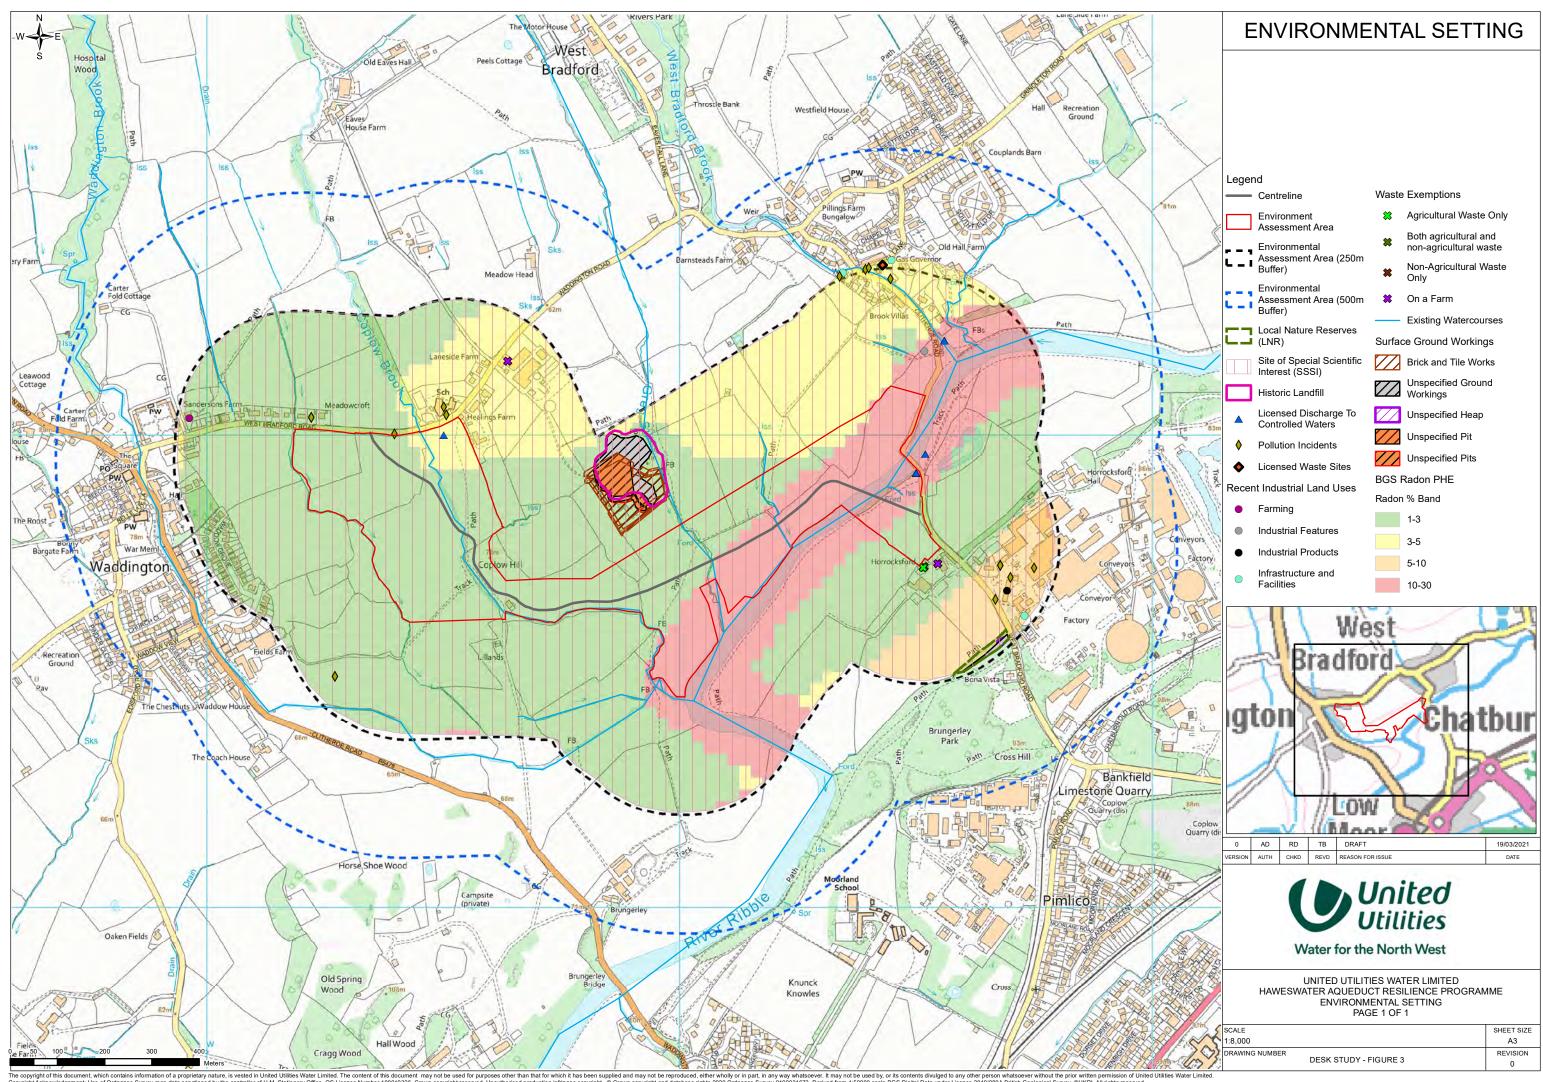
The following surface water features have been identified within the study area and are shown on Figure 3:

- Coplow Brook running approximately north-south towards the River Ribble and crossed by the Proposed Ribble Crossing;
- Greg Sike running approximately north-south towards the River Ribble and crossed by the Proposed Ribble Crossing;

- Moor Roads Sike running approximately northeast-southwest towards the River Ribble, located in the east of the study area, but not crossed by the Proposed Ribble Crossing;
- River Ribble runs along the southern boundary of the Proposed Ribble Crossing and crossed by the development in the southeast;
- Waddington Brook running approximately north-south towards the River Ribble in the west of the study area; and
- West Bradford Brook/Porters Brook running approximately north-south towards the River Ribble in the east of the study area.

Recent industrial land uses have been identified within the study area and outlined in Table 6.1. The recent industrial land uses are shown on Figure 3.

Four discharge consents have been identified within the study area. Table 6.2 provides a summary of these consents and their locations are shown on Figure 3.

Four recorded pollution incidents to controlled waters and land have been identified within the study area. Table 6.3 details the incidents which are shown on Figure 3.

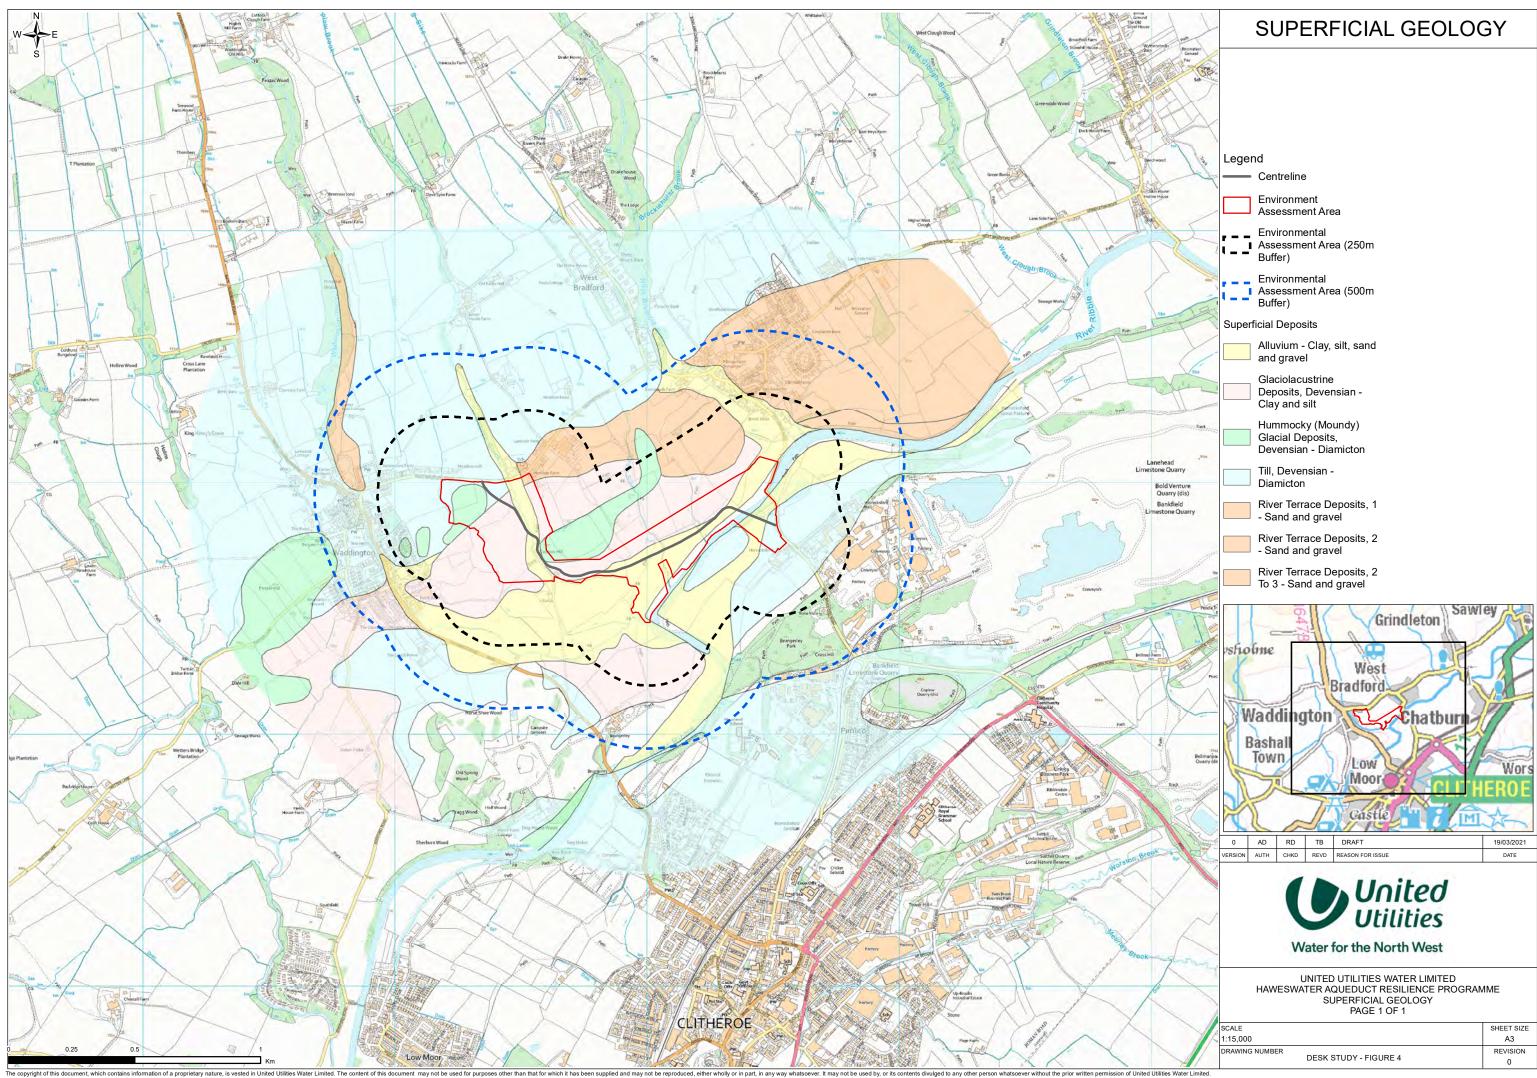
The following section presents the geological setting of the study area based on available published information. The superficial geology is presented in Figure 4 and the bedrock geology is presented in Figure 5.

BGS 1:50 000 mapping records the superficial geology within the study area as:

- Alluvium;
- River Terrace Deposits;
- Hummocky (moundy) glacial deposits
- Glacial Till; and
- · Glaciolacustrine deposits.

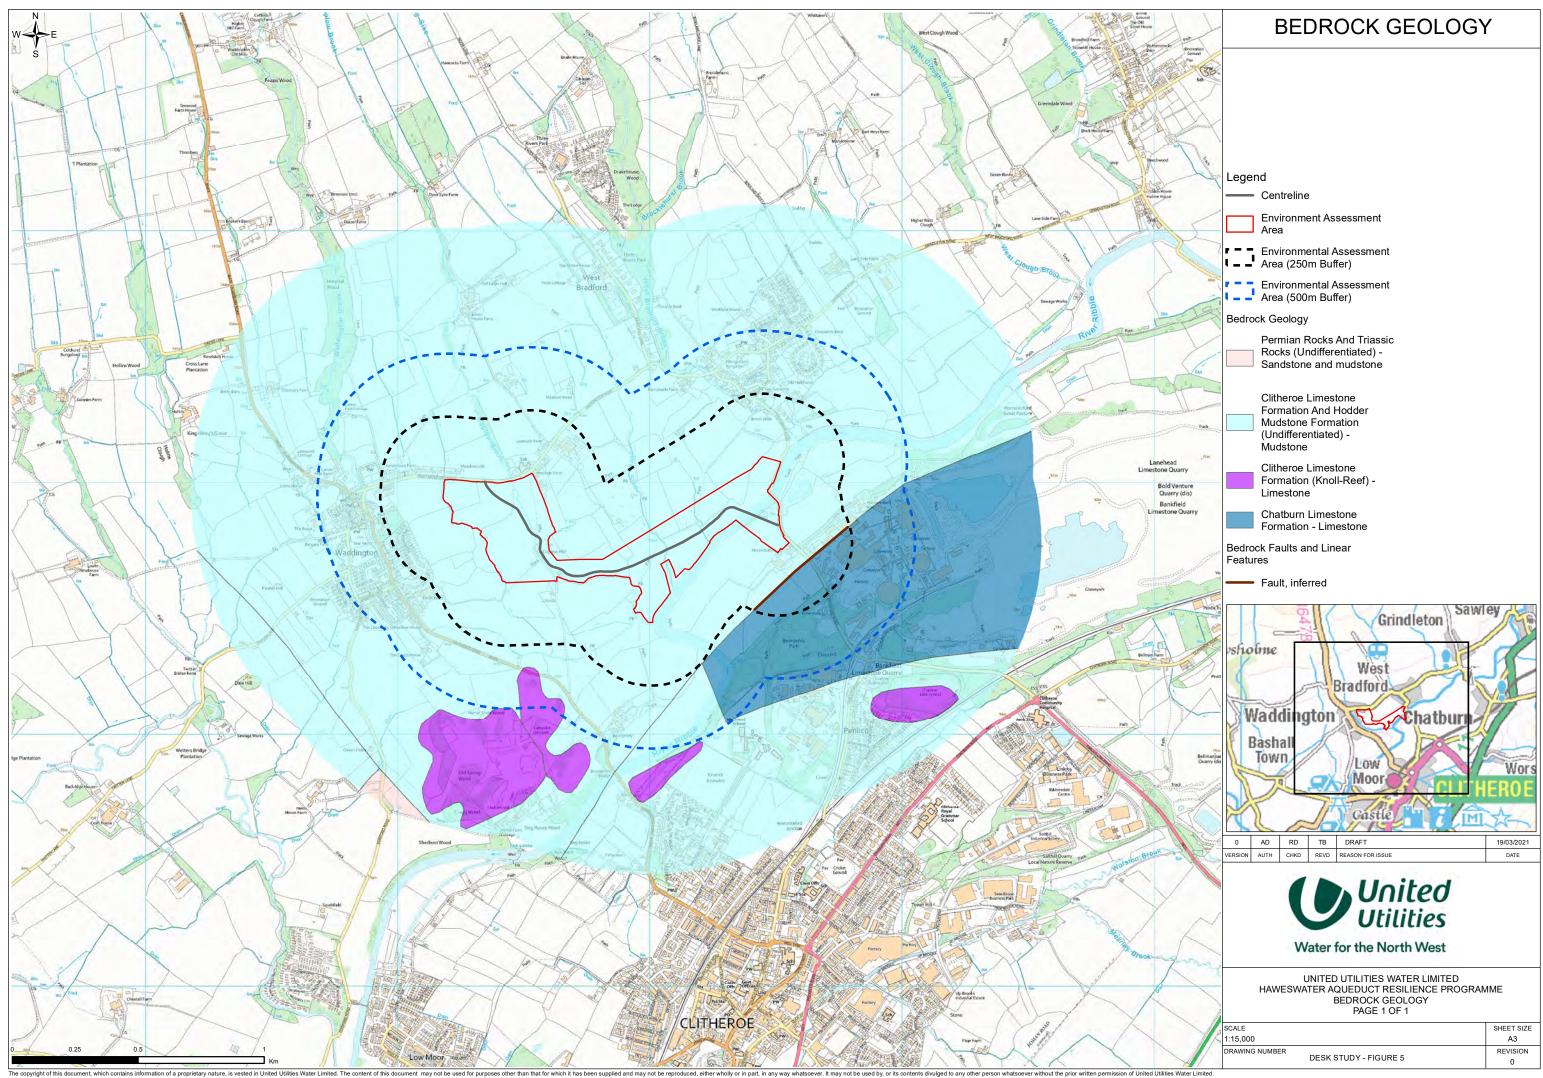
The bedrock underlying the majority of the study area comprises carboniferous limestone and mudstone of the Clitheroe Limestone Formation and Hodder Mudstone Formation. A small area in the southeast of the study area is underlain by carboniferous limestone bedrock of the Chatburn Limestone Formation. The bedrock within the study area is shown in Figure 5.
