Document reference: RVBC-MH-TA-006-B1

Haweswater Aqueduct Resilience Programme - Proposed Marl Hill Section

Supplementary Environmental Information

Appendix B1: Landscape and Visual Addendum

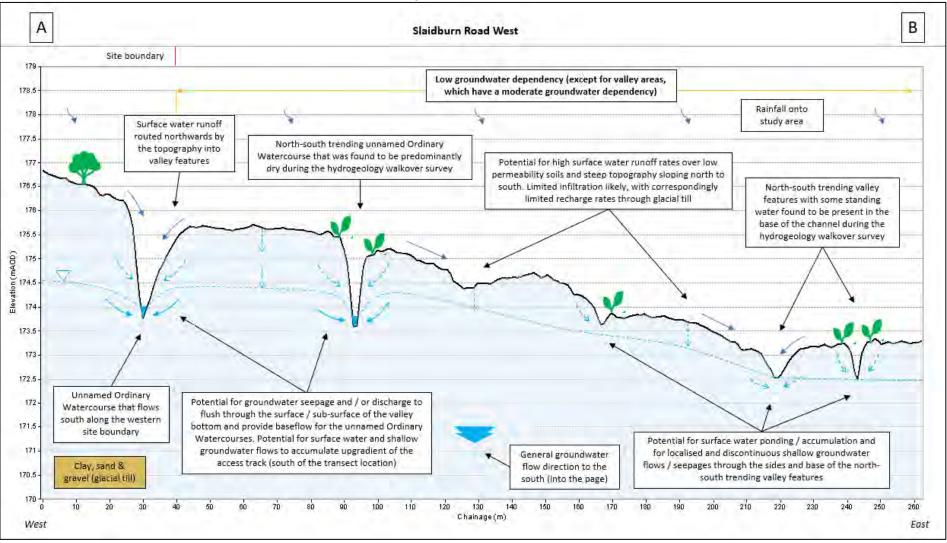
Illustration 2.1: Conceptual Site Model for Slaidburn Road West

15) Illustration 2.1 shows a conceptualised cross-section running west to east through the centre of the site (Section A-B). The CSM highlights the indicative movement of groundwater and surface water through the site, and guideline groundwater dependencies supporting vegetation and habitats present.

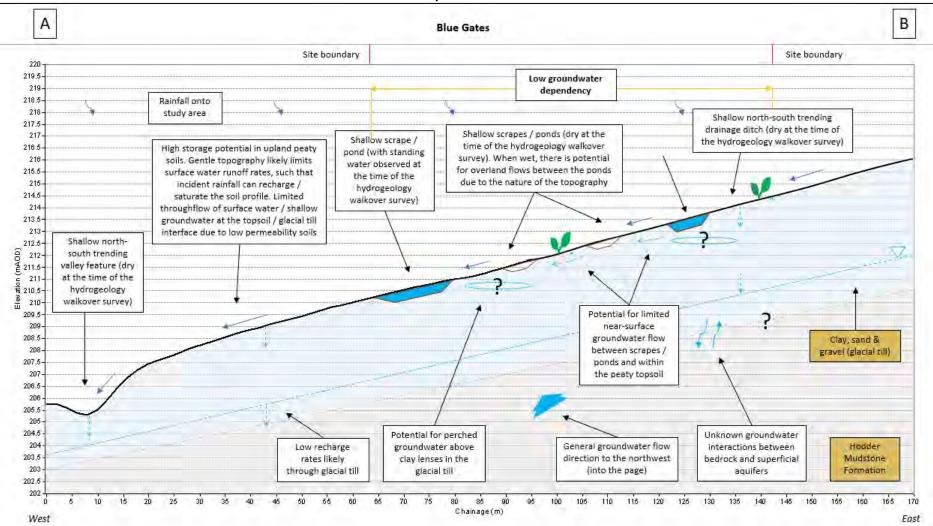
Illustration 2.2: Conceptual Site Model for Blue Gates

16) Illustration 2.2 shows a conceptualised cross-section running west to east through the site (Section A-B). The CSM highlights the indicative movement of groundwater and surface water through the site, and guideline groundwater dependencies supporting vegetation and habitats.

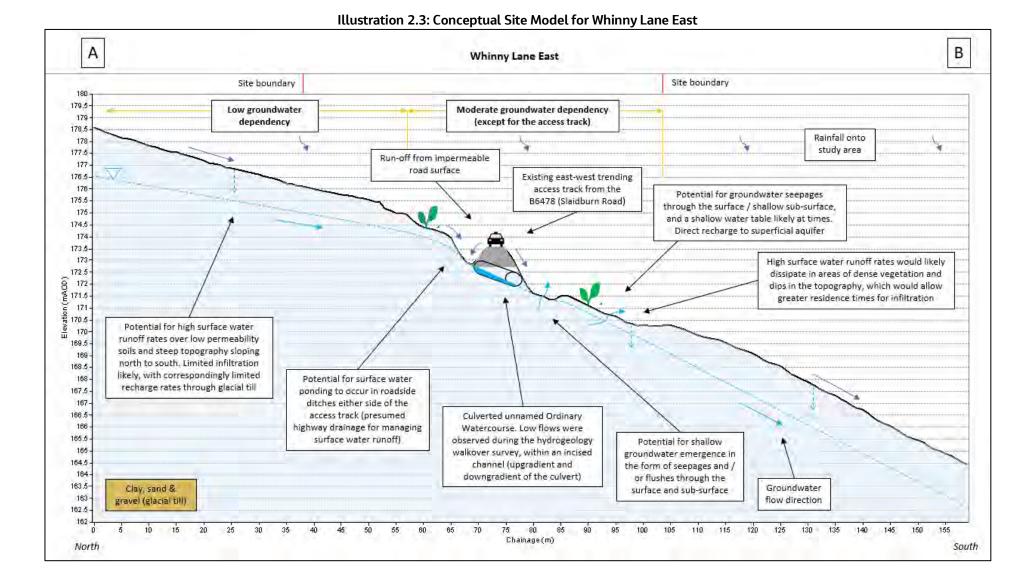
17) Illustration 2.3 shows a conceptualised cross-section running north to south through the centre of the site (Section A-B). The CSM highlights the indicative movement of groundwater and surface water through the site, and guideline groundwater dependencies supporting vegetation and habitats.
