**Haweswater Aqueduct Resilience Programme -
Proposed Marl Hill Section**

Appendix B5: Ecology Assessment - Marl Hill

January 2022

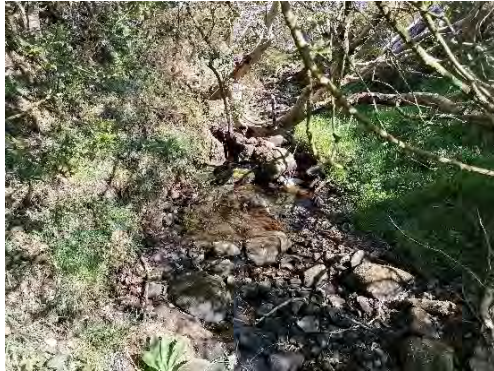
T04: W520 Unnamed Watercourse 430 (Upstream reach)

No evidence of otter was observed.

Despite the burrows being found, in the absence of definitive evidence i.e. latrines, it is considered unlikely that water vole are present at the site.

The channel substrate was a mix of boulder, cobble, sand and gravel. The stream was bordered by sheep-grazed pasture. The width of the channel was c. 0.5 m and the water depth was c. 2 cm.

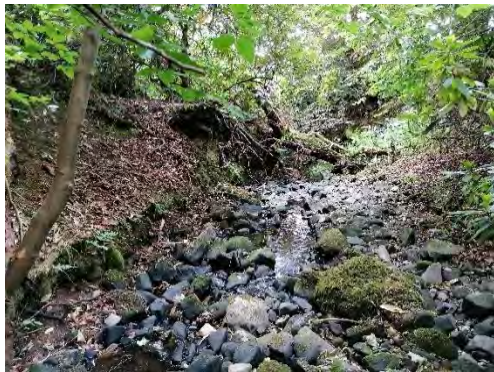
T04: W520 Unnamed Watercourse 430 (Downstream reach)

No evidence of water vole was found during surveys. Due to heavy shading throughout and lack of available foraging resources, the reach was considered unsuitable for water vole.

<p>No evidence of otter was recorded on W520, however, the watercourse possessed suitable resting sites (exposed tree roots and cavities below large boulders) and commuting potential for otters.</p> <p>The watercourse was a steep sided, shallow flowing stream, shaded throughout with both native deciduous and non-native ever green canopy (<i>rhododendron</i> sp.). The in-channel substrate was comprised of boulder, cobble, and gravel with occasional coarse woody debris.</p> <p>A small section of W520 had artificially reinforced banks, stone walls, and a weir was present in the upstream section.</p> <p>The width of the channel was c. 2.5 m and the water depth was c. 10 cm.</p>
--	--

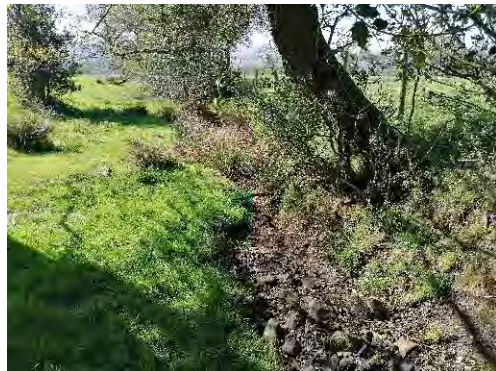
T04: W521 Unnamed Watercourse 431

The shallow sloping banks were vegetated with grasses and trees with occasional *Juncus* sp., herbs and scrub. The ditch was bordered by sheep-grazed pasture. The in-channel substrate was comprised of boulder, cobble and gravel.

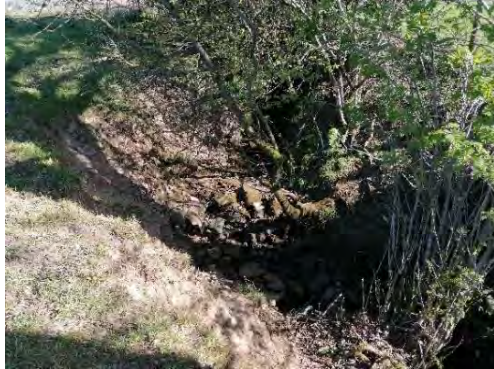
T04: W523 Unnamed Watercourse 433

The channel substrate was a mix of boulder, cobble, and gravel with occasional mud. The banks were steep and principally bare earth or grass. The bordering vegetation was comprised of grass, *Juncus* sp., scrub and trees.

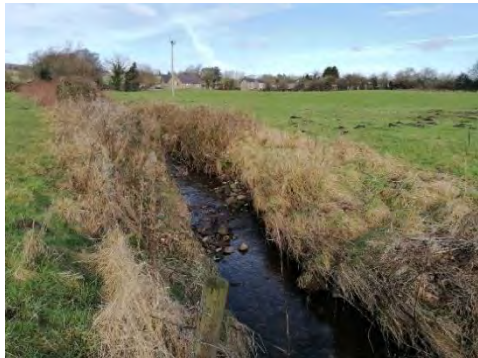
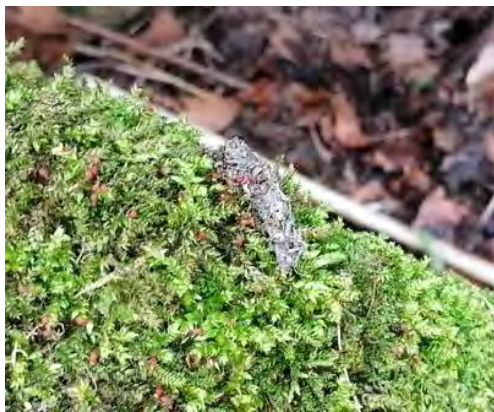
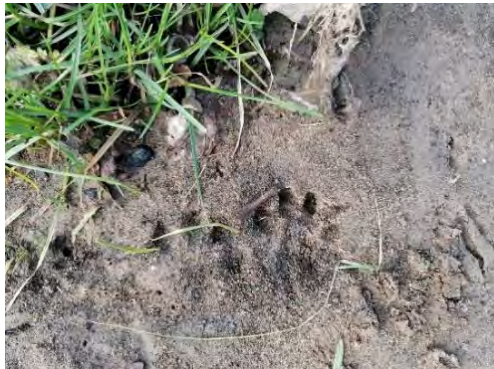
T04: W506 Coplow Brook

No evidence of water vole was recorded during the survey and habitat was largely unsuitable at W506.

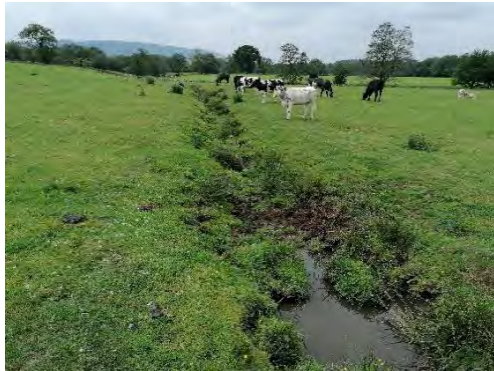
T04: W538 Unnamed Watercourse 446

W538 passed under another road and entered another cattle-grazed, semi-improved / improved pasture. The bank was poached through trampling.

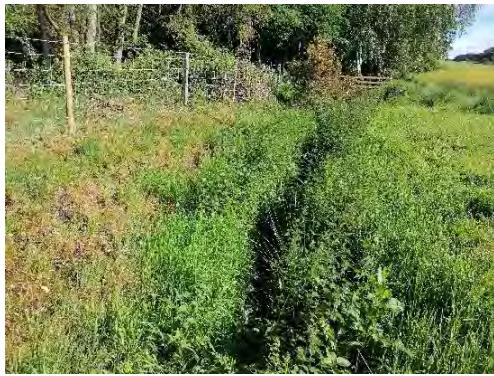
The channel width was c. 1.0 m, and, at the time of survey, the channel was predominantly dry with some ponded areas with no flow.

No evidence of water vole was found during surveys. Due to heavy shading throughout and a lack of suitable foraging resources, the reach is considered largely unsuitable for water vole. A small section of channel is unshaded providing suitable bankside habitat for water vole (pictured). This is located towards the downstream extent of the survey reach and was dry at the time of the survey.

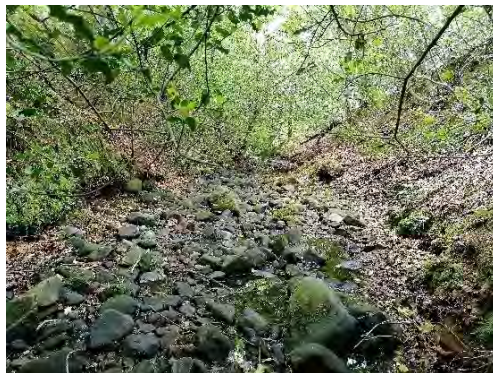
T04: W530 Sandy Ford Brook

No evidence of otter was found at W530. The habitat was generally unsuitable for otter because, although suitable resting areas were identified (cavities under bankside trees), low flows currently limit aquatic foraging opportunities.

The upper section of W530 was potentially suitable for water vole with lush bankside vegetation present and bankside substrate for burrowing. Small mammal activity was observed in the form of burrows and feeding evidence (pictured) but this was characteristic of bank voles (*Myodes glareolus*).

The upper reaches of the stream bisect pasture and at this point there was little, or no flow observed.

As the watercourse flows downstream, the gently sloping banks are replaced by steep forested banks which have minimal herbaceous vegetation. The substrate was boulder, cobble, and gravel, with frequent coarse woody debris.

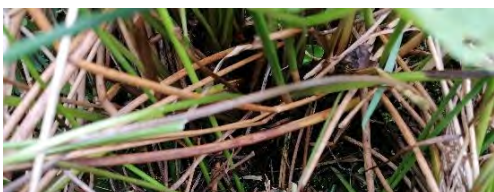
- **No evidence of otter or water vole at W530.**
- **Habitat generally unsuitable for both species.**

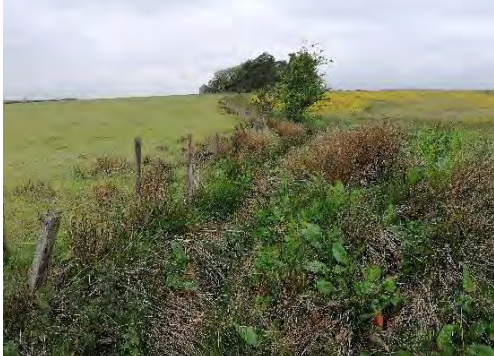
The channel width ranged from 2 - 5 m and the water depth remained shallow throughout at c. 3 cm.

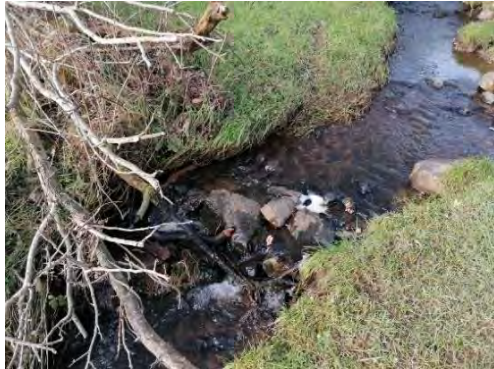
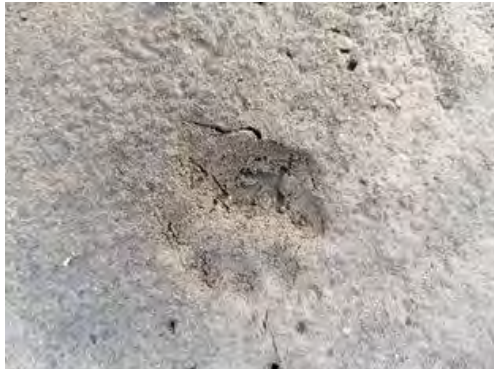
T04: W2321 Greg Sike

As the banks of the watercourse were mostly shallow, heavily shaded and lacking herbaceous vegetation the habitat was assessed to be largely unsuitable for water vole.

No crayfish captured or observed. Habitat of moderate suitability at W2321.

Although suitable refuges were recorded (boulders and undercut banks) they were infrequent. More than 25 refuges were searched during the survey but no evidence of crayfish was found on W104. Food sources such as macroinvertebrates however were readily available providing suitable foraging for crayfish.

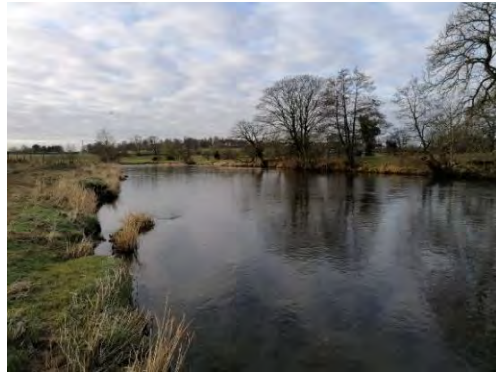
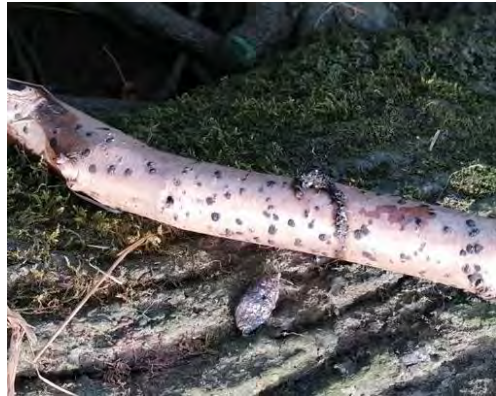
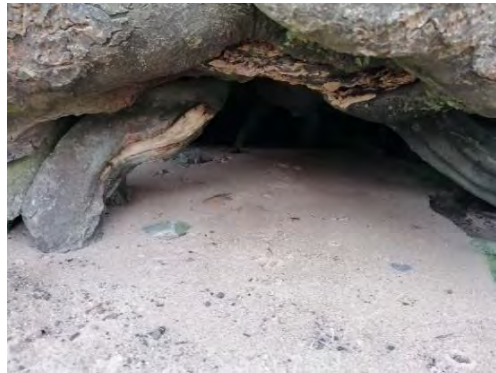
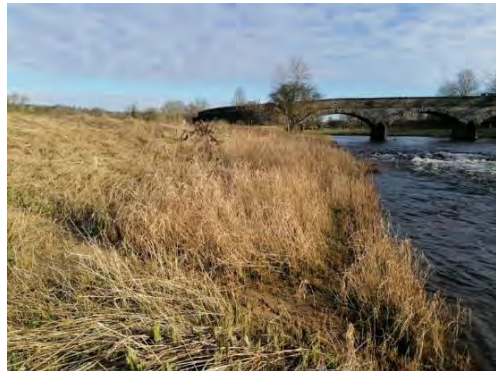
T04: W2325 River Ribble

On the left-hand bank of the watercourse a well-used public footpath was present that encompassed the entire survey reach. During the survey several members of the public, including dog walkers, were observed using this right of way.

Evidence of otter was present in the form of spraint (5 separate locations), two suspected couches and 3 potential holts (*Figure 2 – W2325*). Otter footprints were observed that lead from beneath one of the potential holts (cavity beneath tree roots – pictured left), heading towards the watercourse (*Figure 2 – W2325*).

There were several marginal sections where the substrate was comprised of sand and silt and provided either optimal or sub-optimal habitat for lamprey.

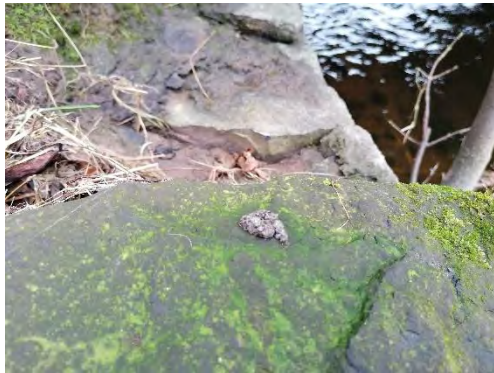
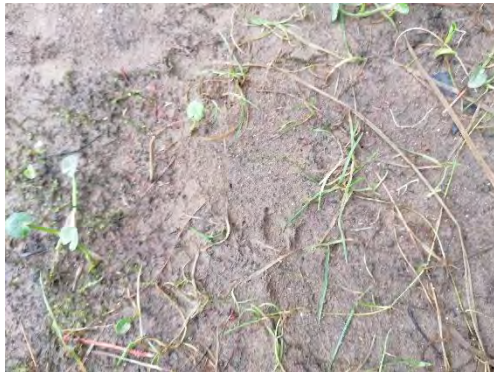
T04: RW03-RW05

Evidence of otter was observed on the river Ribble at RW03-RW05 in the form of spraint and footprints (both pictured). No otter holts or resting areas (couches) were recorded (*Figure 2 – RW03-RW05*). A cavity was present beneath some tree roots at the upstream extent of the reach (left bank) but there was no evidence to suggest it was being used by otters as refuge.

At the time of survey, the bankside and emergent vegetation was sparse (partly owing to the timings of the survey). A small area of emergent reeds was present downstream of the road bridge (right bank), which could provide foraging habitat for water vole.

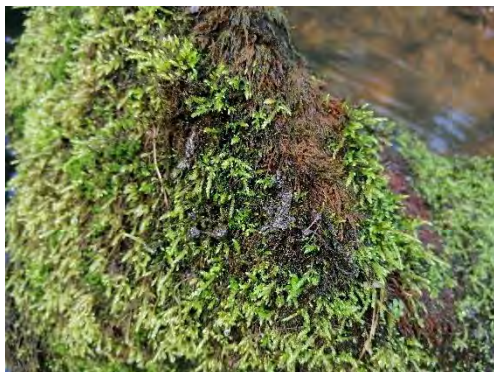
T04: RW17

Three otter spraints were observed during the survey and one potential couch was recorded at the base of a tree trunk (*Figure 2 – RW17*). Habitat within the survey extent is suitable for otter but due to the size of the watercourse foraging opportunities could be limited.

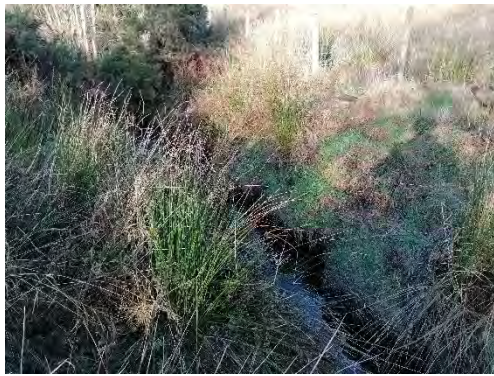
Habitat was largely unsuitable for water vole as large sections of the channel were shaded by tree cover, inhibiting the growth of low-lying herbaceous plants. Bank substrate was also primarily large boulders and therefore often unsuitable for burrowing.

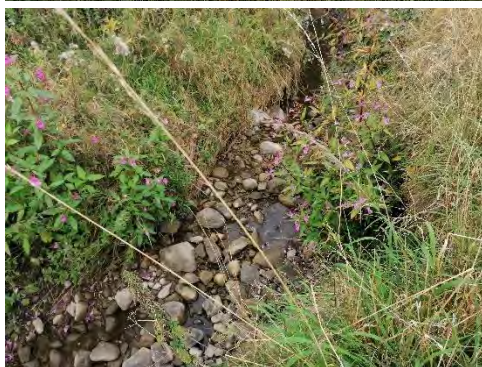
T04: W2349 Coplow Brook

- **No evidence of otter at W2349, some suitable habitat present.**

The channel width was c. 1.25 m, and, at the time of survey, the water depth was c. 0.05 cm. The substrate comprised mostly of boulder, cobble, gravel, and sand, with some silt at the downstream end. The survey reach at W2349 is situated immediately upstream of reach W506.

No evidence of otter was recorded during the surveys. Habitat was not considered to be of high suitability for otter, but there were sections of woody and anthropogenic debris on the bank which otters may choose to use for refuge. Minnows were abundant throughout the survey extent providing a potential source of food for otters.

The invasive species Himalayan Balsam (*Impatiens glandulifera*) and Japanese Knotweed (*Fallopia japonica*) were both recorded within the survey extent.

<p>Upstream: 373624 443620 Downstream: 373466 444014</p> <p>No crayfish captured or observed. Habitat of moderate suitability at W2349.</p> <p>Suitable refuges which could provide habitat for crayfish (e.g. boulders) were observed in low abundance. No crayfish were recorded during the surveys at W2349.</p> <p>Within the survey extent the width of the channel is c. 1.5 m and at the time of the survey the depth was c. 0.05 m. The survey extent is bordered on both banks by grazed pasture.</p> <p>Cattle have direct access to the channel at multiple locations within the survey extent and during the</p>

survey cattle faeces was observed in the channel at two locations. This is likely to reduce the sites suitability to support white-clawed crayfish which prefer to inhabit streams with good water quality.

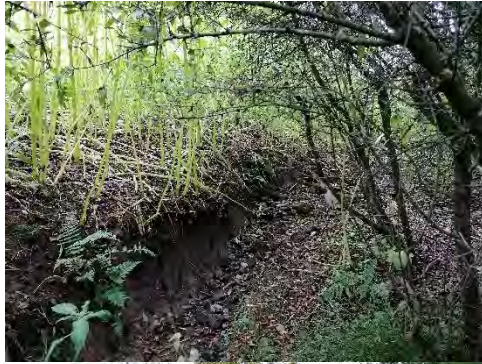
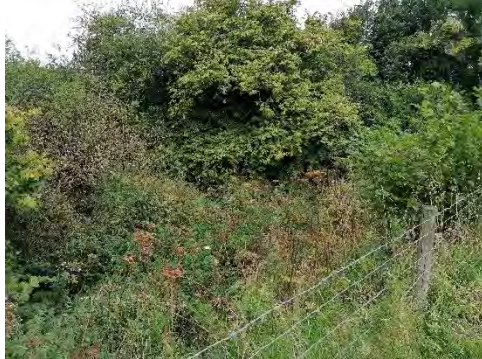
T04: W2348 Unnamed watercourse 2097

An area of dense scrub is present at the upstream extent of the watercourse which could provide refuge for otters. A public footpath does however bisect this area which could cause disturbance to otters.

<p>Upstream: 374169 443996 Downstream: 374236 443779</p> <p>No crayfish captured or observed. Habitat unsuitable at W2348.</p> <p>At the time of the survey W2348 was dry with no evidence of recent or sustained flow. The site is therefore considered unsuitable for white-clawed crayfish.</p>

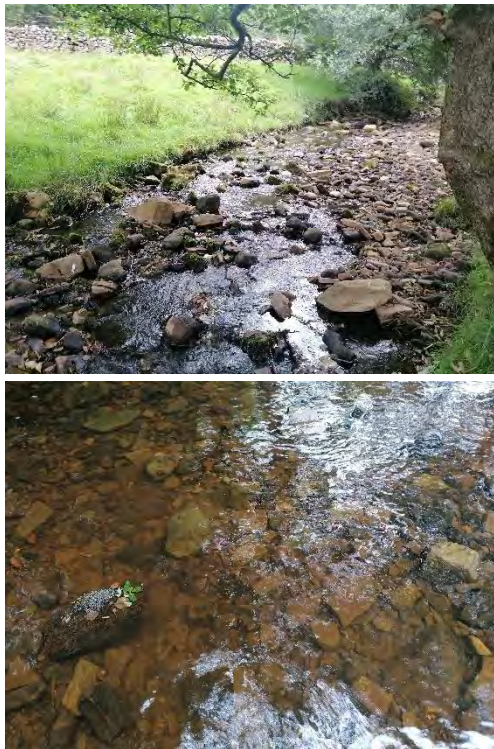
T04: W498 Bonstone Brook

<p>Upstream: 369186 448740 Downstream: 369719 448561</p> <p>No crayfish captured or observed. Suitable habitat present.</p> <p>Suitable refuges were observed throughout the survey extent including boulders, undercut banks and coarse woody debris. During the surveys more than 250 refuges were searched but no crayfish were recorded at W498. Several otter spraints were also observed during the survey of which none contained remains of crayfish.</p> <p>Within the survey extent the width of the channel is c. 4 m and at the time of the survey the depth was c. 0.2 m. Instream habitats included run, riffle, cascade, pool and glide. Dominant substrate types included boulder, cobble, gravel and bedrock,</p> <p>The survey extent is bordered by grazed pasture and woodland.</p>
T04: W2349 Coplow Brook

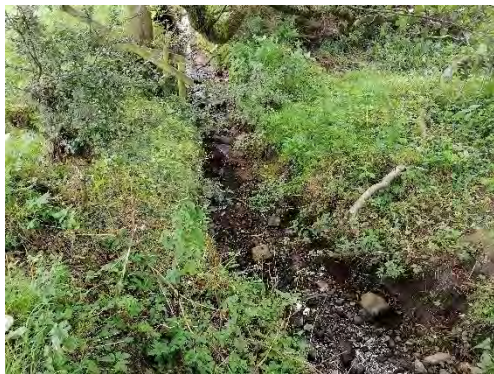
T04: W2321 Greg Sike

Upstream: 373964 443939
 Downstream: 374095 443580

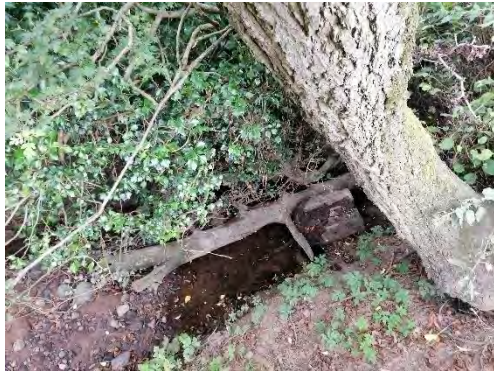
Within the survey extent the width of the channel is c. 1.0 m and at the time of the survey the depth was c. 0.1 m. The survey extent is bordered on both banks by grazed pasture. A narrow strip of riparian vegetation comprising trees, bushes and low-lying herbaceous plants is however retained on both banks.

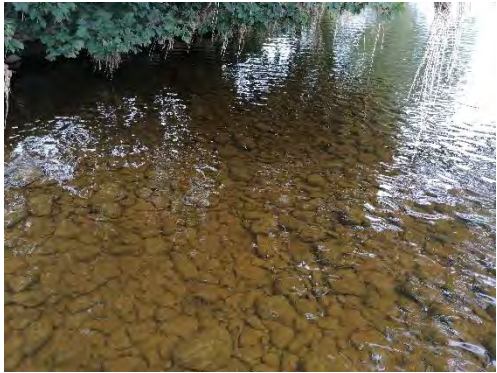
No crayfish captured or observed. Suitable habitat present at W2321.

Suitable refuges were observed, predominantly boulders but no crayfish were recorded at W498. Otter spraint also was observed during the survey, none of which contained crayfish remains.

<p>It was not possible to survey certain sections of channel (using manual searching) as water depths frequently exceeded 0.5 m. As suitable refuges were also present in shallower marginal areas this is not considered to have impacted the survey.</p> <p>Within the survey extent the channel is c. 30 m in width and the depth is c. 0.75 m. The channel substrate comprises a mixture of boulder, cobble, gravel and bedrock. Instream habitats included run, riffle, glide and pool.</p>
<p>T04: W2348 Unnamed watercourse 2097</p>
