Appendix B6: Ecology Assessment – Ribble Crossing

Document reference: RVBC-MH_SEI-Appendix B6

**Haweswater Aqueduct Resilience Programme -
Proposed Marl Hill Section
Supplementary Environmental Information**

January 2022

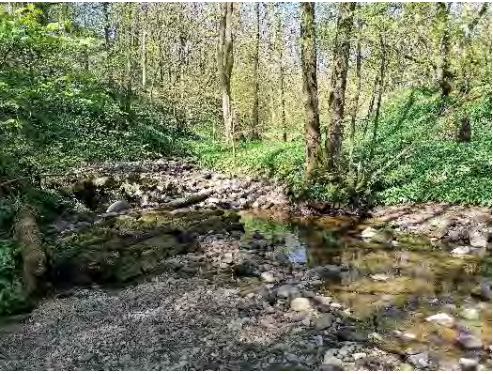
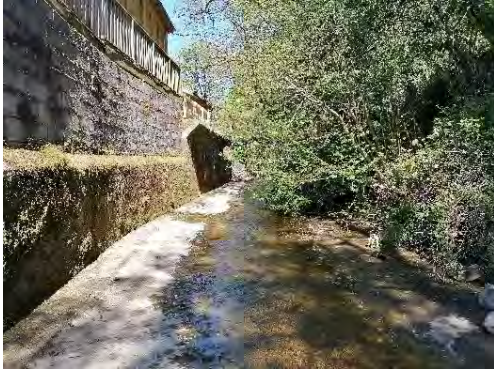
T04: W512 Bashall Brook

<p>Eastings and Northings Upstream: X: 369928 Y: 444567 Downstream: X: 370018 Y: 444057</p> <ul style="list-style-type: none"> Evidence of otter, suitable habitat at W512. <p>Evidence of otter was recorded at W512; four spraints were recorded (<i>Figure 2 – W512</i>). W512 is considered suitable habitat for otter.</p> <p>W512 was a moderately flowing stream with varying flow types and pools. The channel substrate was predominantly comprised of bedrock, boulder, cobble, and gravel. Filamentous algae was occasionally present throughout the surveyed reach. The width of the channel was variable ranging from c. 2.4 - 4.5 m. Similarly, the depth was also variable ranging from c. 0.03 - 0.45 m. Large woody debris and side bars were present throughout the watercourse providing heterogeneous flow and aquatic habitat.</p> <p>The majority of W512 was comprised of steep, wooded, channel sides with bankside herbs.</p> <p>W512 had a section of artificial substrate and vertical embankment with a culvert present immediately upstream of the bridge. Downstream of the bridge a large man-made cascade was present. A fish ladder was adjacent to this obstruction but was blocked by boulders and cobbles at the time of the survey.</p>

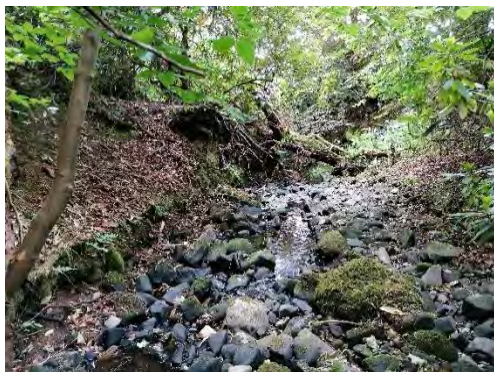
T04: W520 Unnamed Watercourse 430 (Downstream reach)

No evidence of water vole was found during surveys. Due to heavy shading throughout and lack of available foraging resources, the reach was considered unsuitable for water vole.

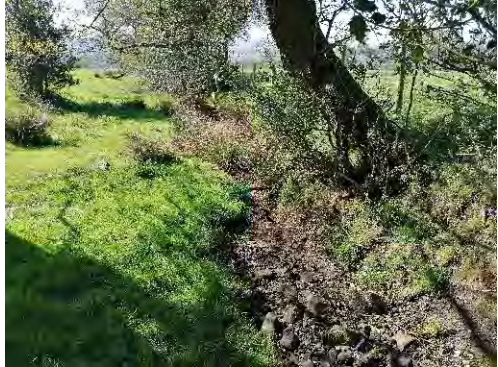
<p>Eastings and Northings Upstream: X: 371727 Y: 445030 Downstream: X: 371737 Y: 444952</p> <ul style="list-style-type: none"> No otter evidence, low habitat suitability at W521. <p>No evidence of otter was recorded at W521 during the surveys (<i>Figure 2 – W521</i>).</p> <p>W521 was predominantly dry with areas of shallow standing water. The width of the channel was c. 0.3 m and the water depth was c. 1 cm, where water was present.</p> <p>The shallow sloping banks were vegetated with grasses and trees with occasional <i>Juncus</i> sp., herbs and scrub. The ditch was bordered by sheep-grazed pasture. The in-channel substrate was comprised of boulder, cobble and gravel.</p>

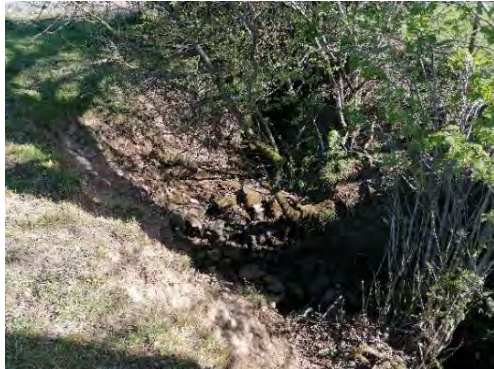
T04: W523 Unnamed Watercourse 433

The channel substrate was a mix of boulder, cobble, and gravel with occasional mud. The banks were steep and principally bare earth or grass. The bordering vegetation was comprised of grass, *Juncus* sp., scrub and trees.

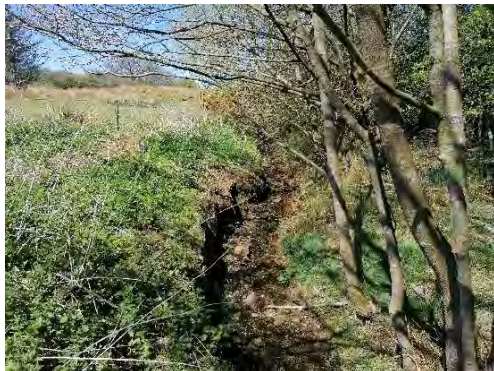
T04: W533 Unnamed Watercourse 442

The channel cuts through grazed pasture and follows a line of trees. Bank growth mainly consists of trees, grass and *Juncus* sp. with occasional scrub and herbs (dominated by nettles).

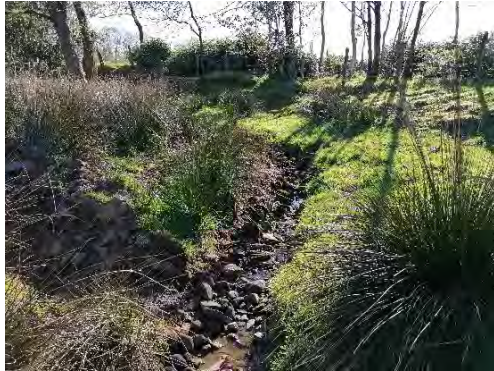
T04: W557 Unnamed Watercourse 463

Bankside vegetation was comprised mostly of grasses and *Juncus* sp. with areas of bare ground and occasional scrub or tree cover. The stream was bordered by sheep grazed pasture. No in-channel vegetation was observed and there was evidence of trampling and poaching on the banks.

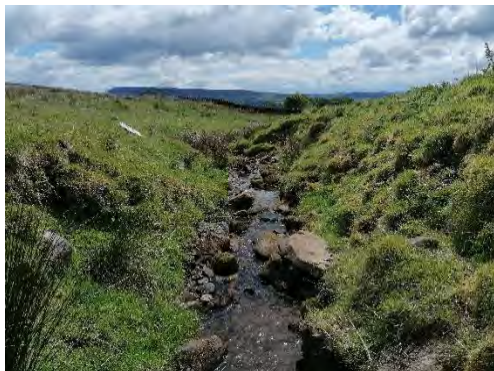
T04: W506 Waddington Brook

The watercourse was generally, a moderately flowing, shallow brook with a substrate comprised predominantly from boulders, cobble, gravel, silt, and bedrock. Bedrock cascades and pools were

<p>also frequent. Although variable, the width of the channel was 1 – 3.5 m and the water depth was c. 20 cm.</p> <p>Vegetation on the steep, sheep-grazed banks was comprised of herbs, <i>Juncus</i> sp. and ferns. No in-channel vegetation was recorded.</p>
T04: W506 Coplow Brook

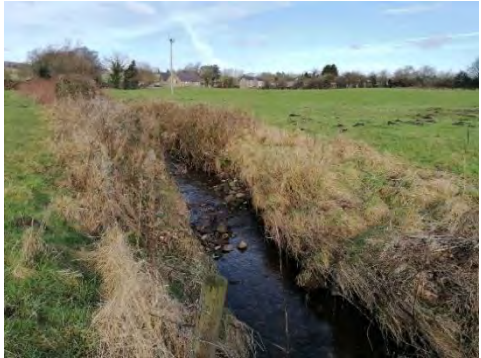
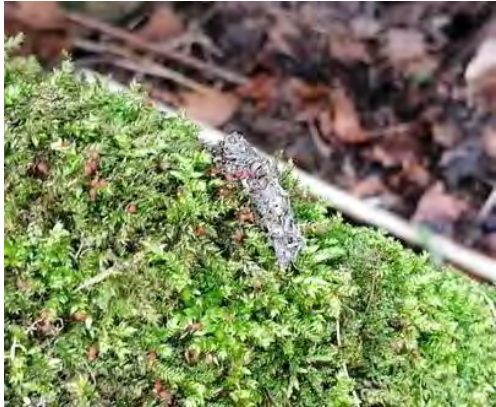
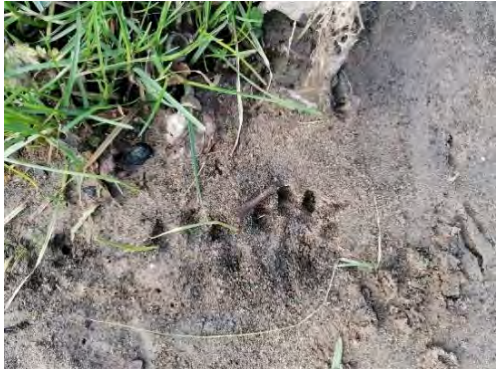
<p>Eastings and Northings Upstream: X: 373521 Y: 443840 Downstream: X: 373924 Y: 443617</p> <ul style="list-style-type: none"> • Evidence of otter at W506, some suitable habitat present. • No evidence of water vole, habitat of low suitability. <p>The channel width was c. 1.25 m, and, at the time of survey, the water depth was c. 10 cm, although both of these were variable. The substrate comprised mostly of boulder, cobble, gravel, and sand, with some silt at the downstream end.</p> <p>Sewage fungus was recorded over a large stretch of the reach indicating a water quality issues may be a problem within the watercourse.</p> <p>Evidence of otter was recorded in the form of spraint and footprints (<i>Figure 2 – W506</i>). Habitat was not considered to be of high suitability for otter, but there were sections of woody and anthropogenic debris on the bank which otters may choose to use for refuge.</p> <p>No evidence of water vole was recorded during the survey and habitat was largely unsuitable at W506.</p>

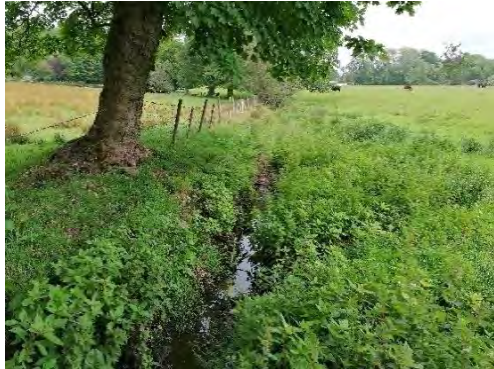
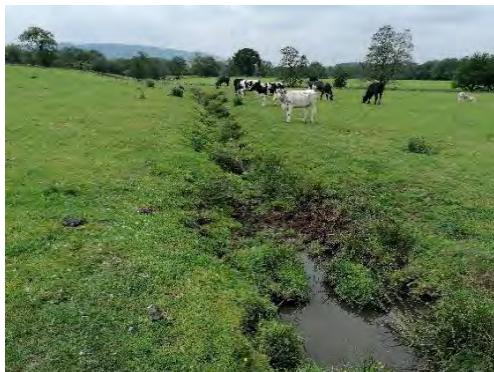
T04: W538 Unnamed Watercourse 446

W538 passed under another road and entered another cattle-grazed, semi-improved / improved pasture. The bank was poached through trampling.

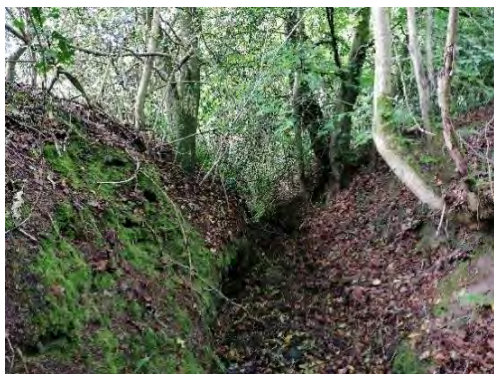
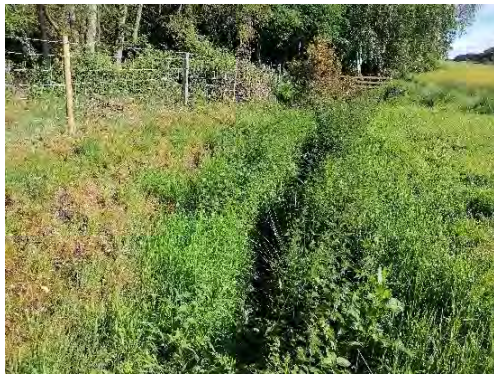
T04: W537 Unnamed Watercourse 445

- **No evidence of otter or water vole on W537.**
- **Habitat largely unsuitable for both species.**

The channel width was c. 1.0 m, and, at the time of survey, the channel was predominantly dry with some ponded areas with no flow.

No evidence of water vole was found during surveys. Due to heavy shading throughout and a lack of suitable foraging resources, the reach is considered largely unsuitable for water vole. A small section of channel is unshaded providing suitable bankside habitat for water vole (pictured). This is located towards the downstream extent of the survey reach and was dry at the time of the survey.

No evidence of otter was recorded on W537. Due to the lack of available foraging and resting opportunities, the habitat was regarded as being unsuitable for otter.

W537 was a predominantly shaded channel with trees growing along both banks. A short section of the channel entered a meadow where herbs, grass and *Juncus* sp. dominate the banks. The channel was dry with a few sections of ponded water. The substrate was boulder, cobble, and gravel.

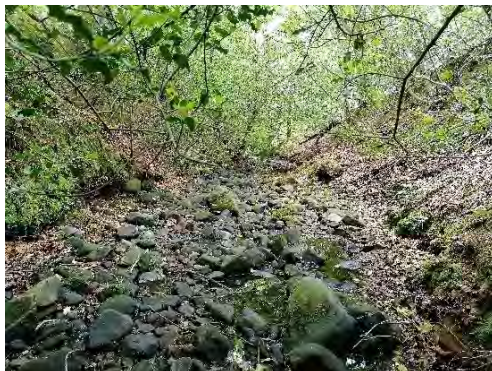
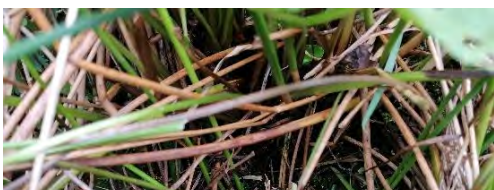
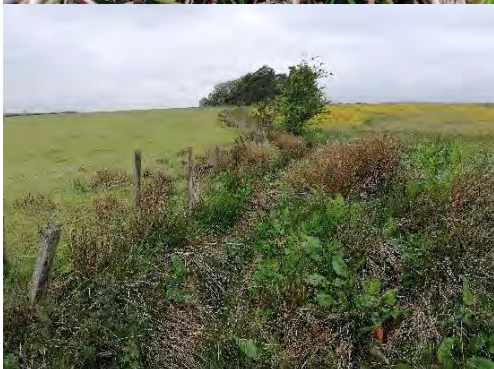
T04: W530 Sandy Ford Brook

No evidence of otter was found at W530. The habitat was generally unsuitable for otter because, although suitable resting areas were identified (cavities under bankside trees), low flows currently limit aquatic foraging opportunities.

The upper section of W530 was potentially suitable for water vole with lush bankside vegetation present and bankside substrate for burrowing. Small mammal activity was observed in the form of burrows and feeding evidence (pictured) but this was characteristic of bank voles (*Myodes glareolus*).

The upper reaches of the stream bisect pasture and at this point there was little, or no flow observed.

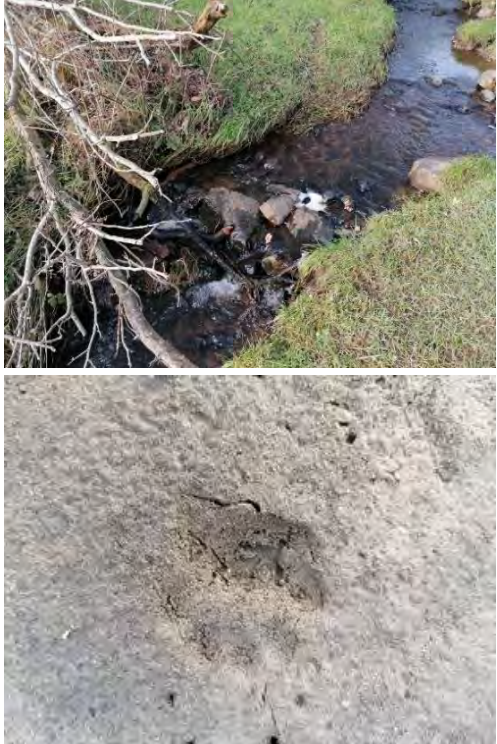
<p>Eastings and Northings</p> <p>Upstream: X: 373964 Y: 443939 Downstream: X: 374095 Y: 443580</p> <ul style="list-style-type: none"> • Evidence of otter present at W2321. • No evidence of water vole and habitat largely unsuitable. <p>The channel width was c. 1 m, and, at the time of survey, the water depth was c. 10 cm, although both of these were variable. The substrate comprised mostly of cobble, gravel, and sand with boulders in some sections. The downstream reach comprised of finer sediment and was composed mostly of sand and silt.</p> <p>No holts, couches or spraint were recorded at W2321. A single otter footprint (pictured) was however recorded in an area of sand adjacent to the watercourse (<i>Figure 2 – W2321</i>). Although the watercourse provides limited opportunities for refuge this evidence suggests that otter could use the watercourse for foraging.</p> <p>As the banks of the watercourse were mostly shallow, heavily shaded and lacking herbaceous vegetation the habitat was assessed to be largely unsuitable for water vole.</p>

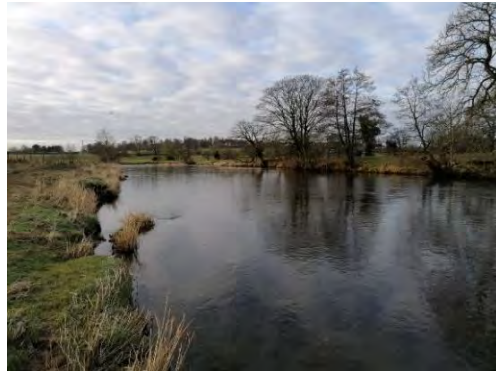
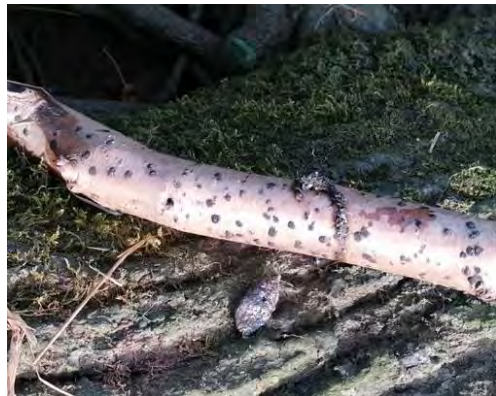
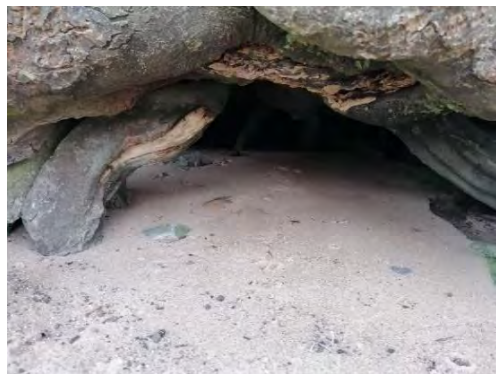
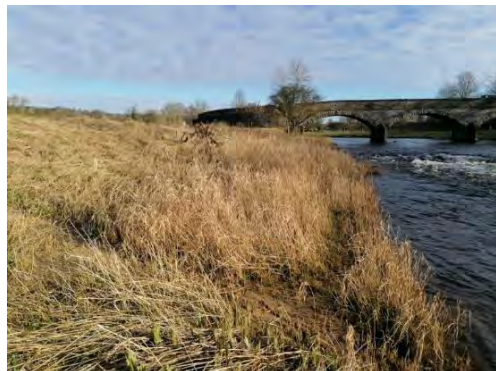
T04: W2325 River Ribble

Evidence of otter was present in the form of spraint (5 separate locations), two suspected couches and 3 potential holts (*Figure 2 – W2325*). Otter footprints were observed that lead from beneath one of the potential holts (cavity beneath tree roots – pictured left), heading towards the watercourse (*Figure 2 – W2325*).

There were several marginal sections where the substrate was comprised of sand and silt and provided either optimal or sub-optimal habitat for lamprey.

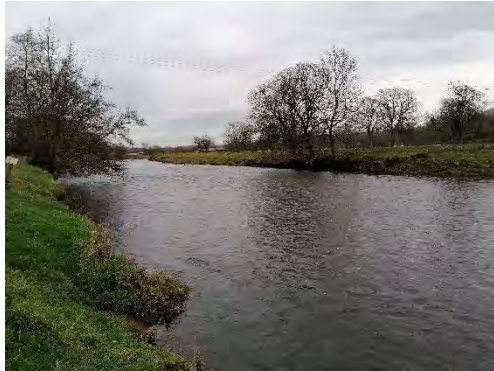
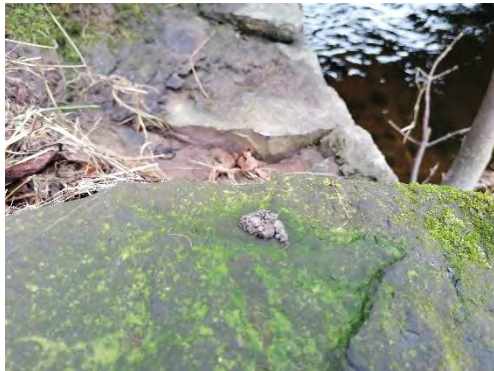
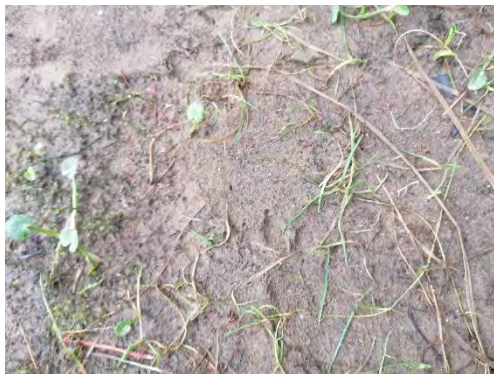
T04: RW03-RW05

Evidence of otter was observed on the river Ribble at RW03-RW05 in the form of spraint and footprints (both pictured). No otter holts or resting areas (couches) were recorded (*Figure 2 – RW03-RW05*). A cavity was present beneath some tree roots at the upstream extent of the reach (left bank) but there was no evidence to suggest it was being used by otters as refuge.

At the time of survey, the bankside and emergent vegetation was sparse (partly owing to the timings of the survey). A small area of emergent reeds was present downstream of the road bridge (right bank), which could provide foraging habitat for water vole.

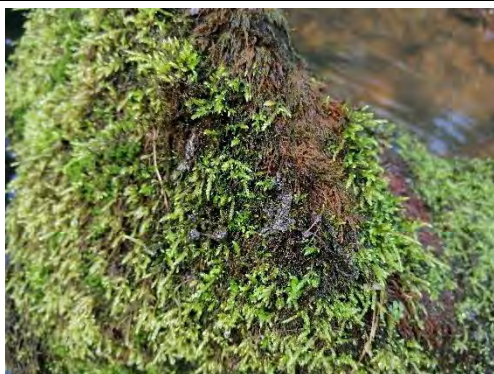
T04: RW17

- **Evidence of otter, suitable habitat present at RW17.**
- **No evidence of water vole, habitat of moderate suitability.**

Three otter spraints were observed during the survey and one potential couch was recorded at the base of a tree trunk (*Figure 2 – RW17*). Habitat within the survey extent is suitable for otter but due to the size of the watercourse foraging opportunities could be limited.

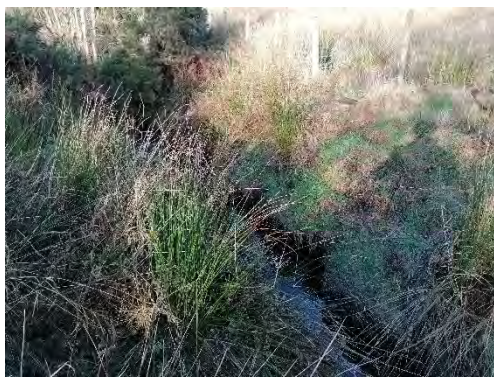
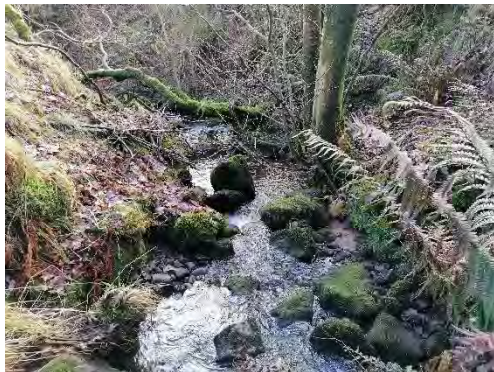
Habitat was largely unsuitable for water vole as large sections of the channel were shaded by tree cover, inhibiting the growth of low-lying herbaceous plants. Bank substrate was also primarily large boulders and therefore often unsuitable for burrowing.

Upstream of the main confluence on the reach the watercourse flows adjacent to an area of open grassland for approximately 100 m (pictured). The left-hand bank is reasonably steep at this point and is comprised of earth making it suitable for burrowing. *Juncus* sp. is abundant in this location, which does provide potential foraging habitat.

At this location with the watercourse averages just 0.4 m in width and 0.15 m in water depth. No areas of deep open water (which water vole could use to evade predation) were recorded adjacent to the suitable burrowing habitat.

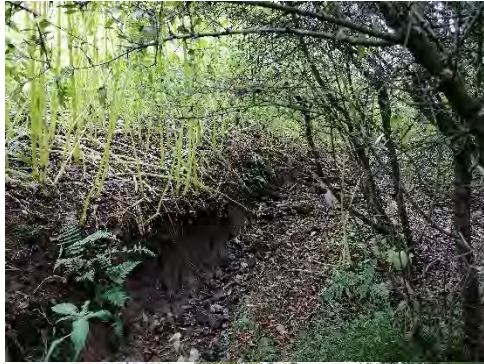
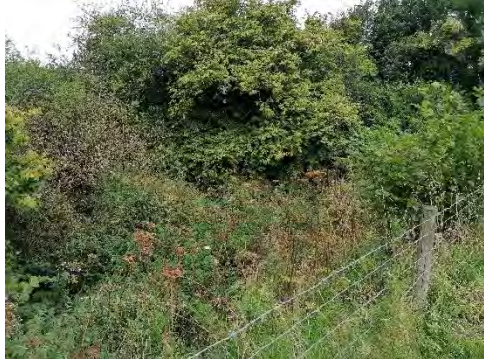
T04: W2348 Unnamed watercourse 2097

An area of dense scrub is present at the upstream extent of the watercourse which could provide refuge for otters. A public footpath does however bisect this area which could cause disturbance to otters.

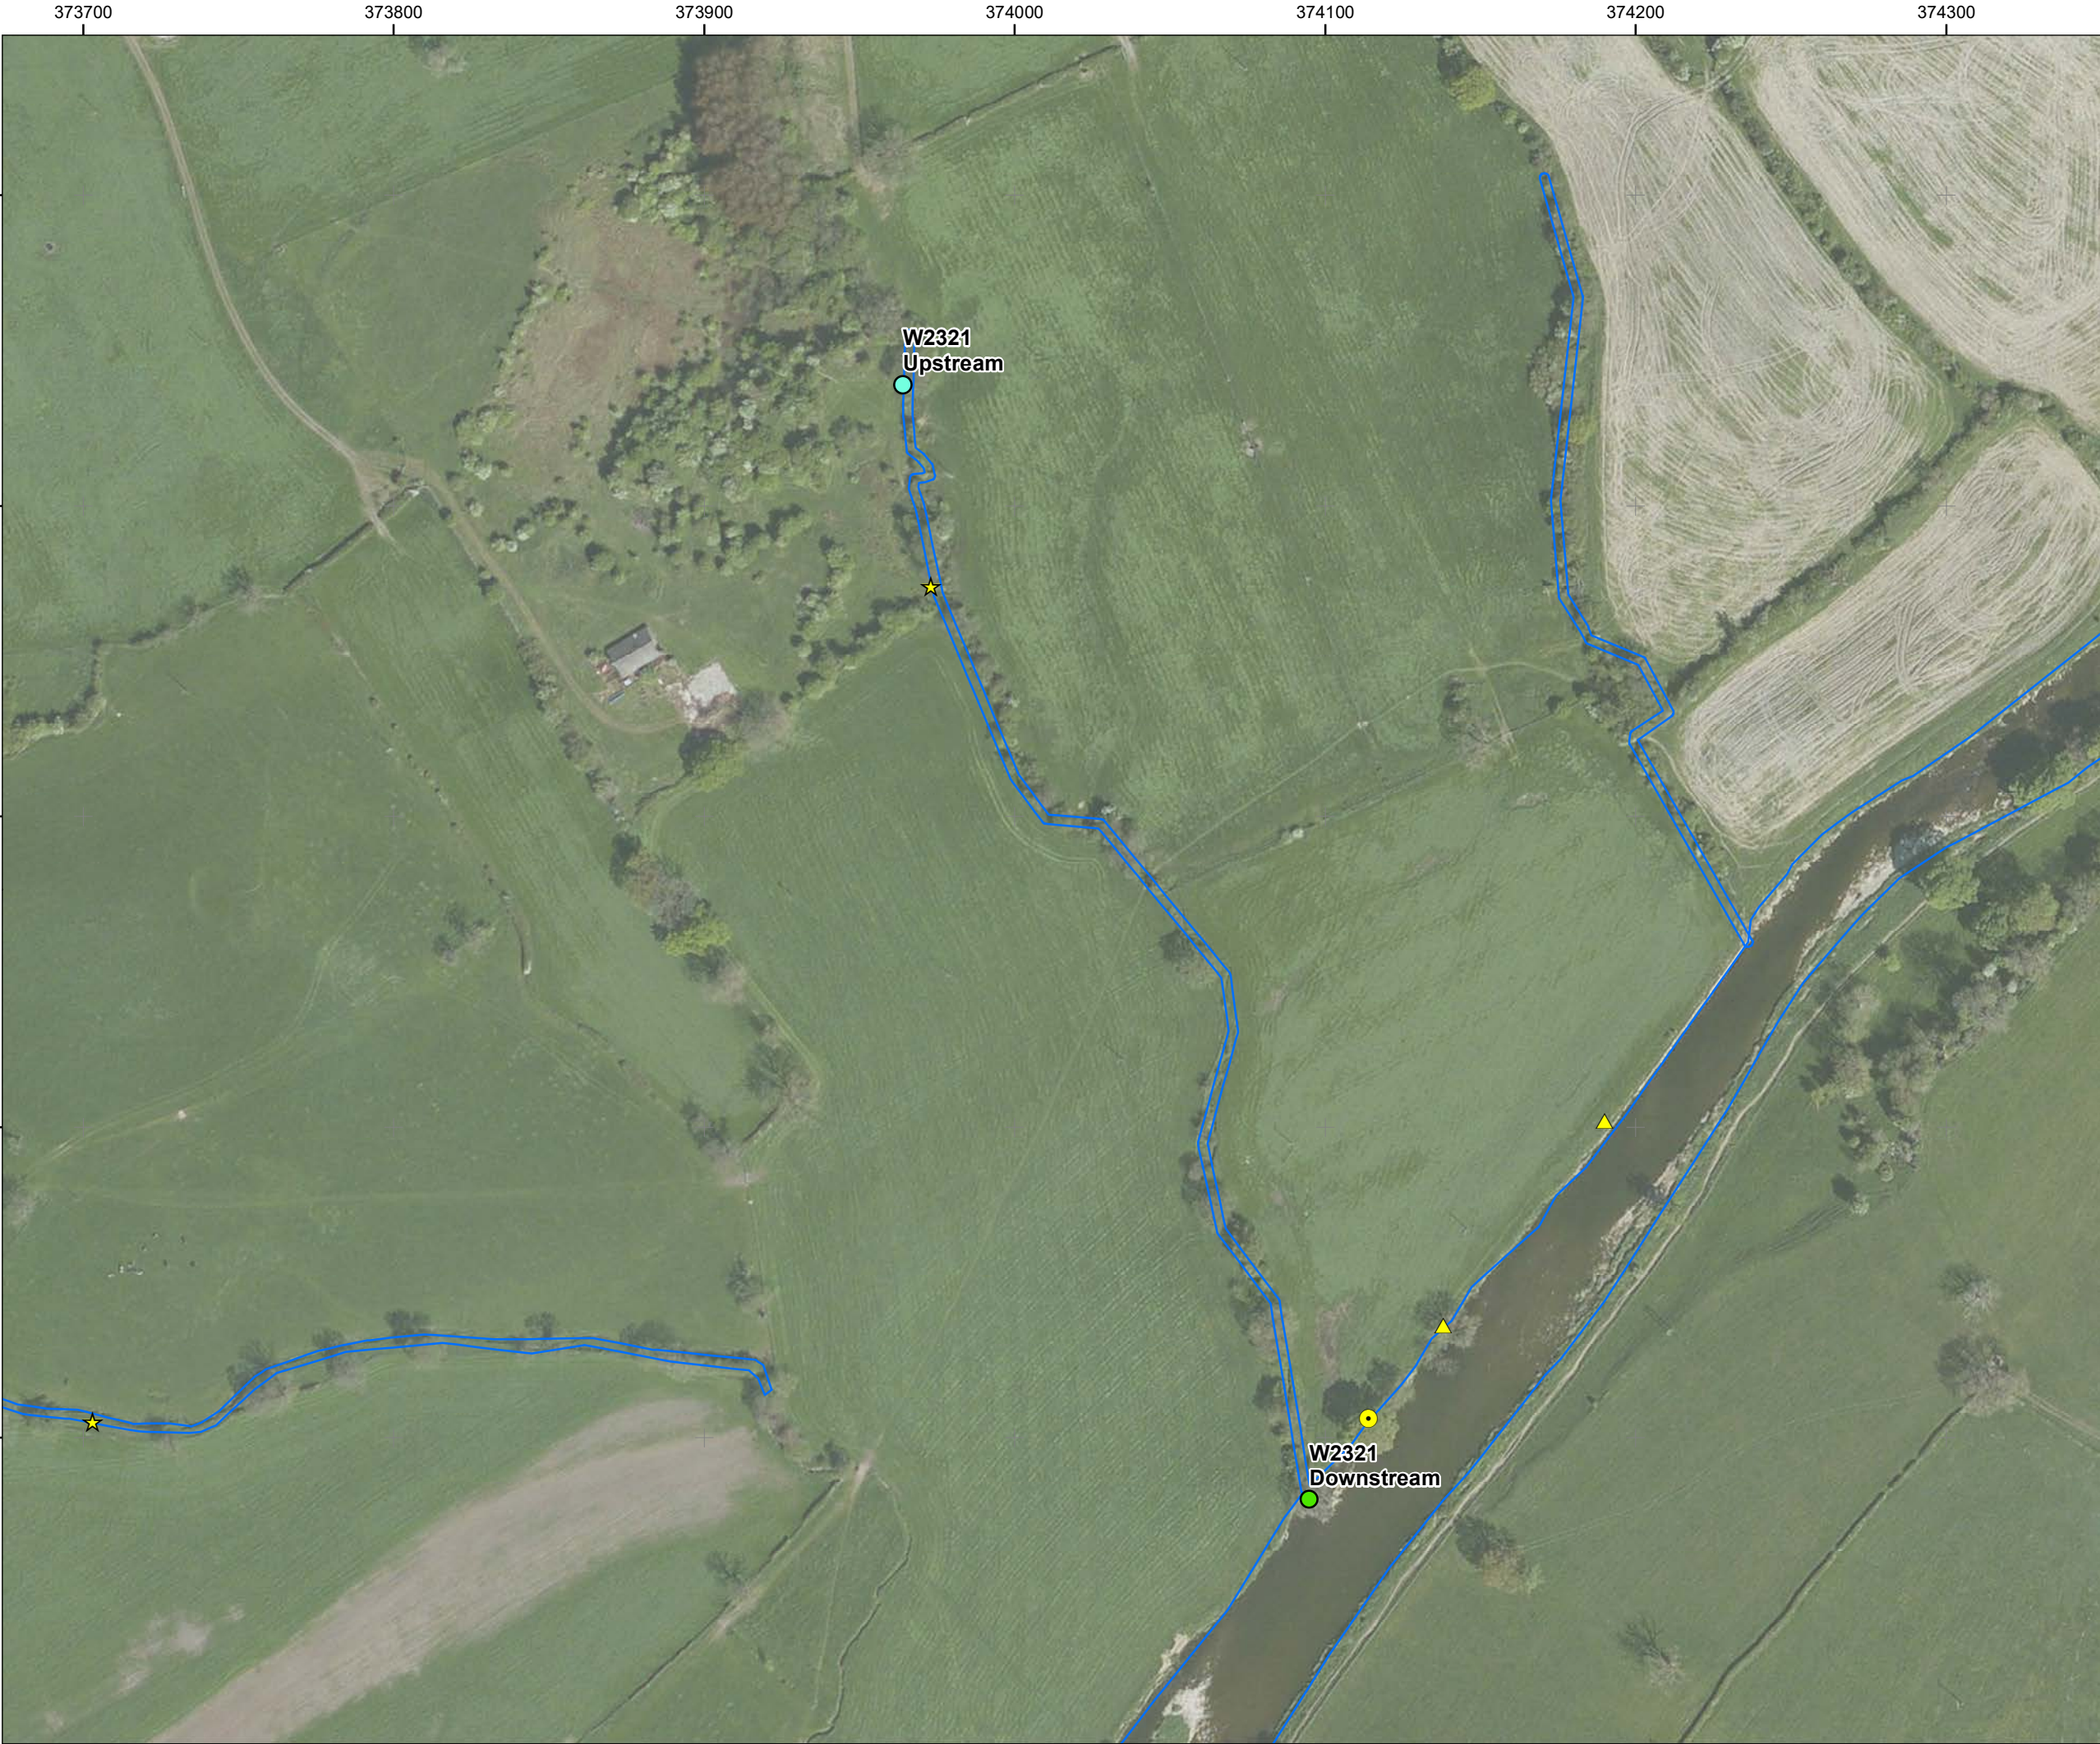
- Legend:**
- Waterbody
 - Upstream Survey Extent
 - Downstream Survey Extent
- Otter Evidence**
- Potential Otter Holt
 - Otter Spraint
 - Otter Footprint

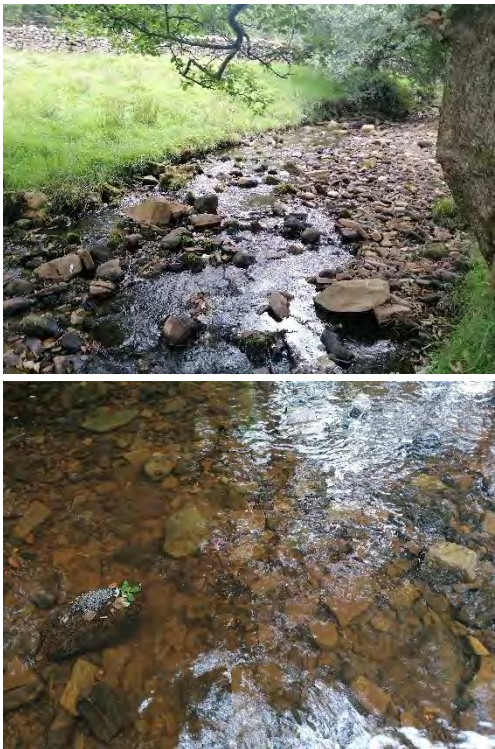
T04: W498 Bonstone Brook

<p>Upstream: 369186 448740 Downstream: 369719 448561</p> <p>No crayfish captured or observed. Suitable habitat present.</p> <p>Suitable refuges were observed throughout the survey extent including boulders, undercut banks and coarse woody debris. During the surveys more than 250 refuges were searched but no crayfish were recorded at W498. Several otter spraints were also observed during the survey of which none contained remains of crayfish.</p> <p>Within the survey extent the width of the channel is c. 4 m and at the time of the survey the depth was c. 0.2 m. Instream habitats included run, riffle, cascade, pool and glide. Dominant substrate types included boulder, cobble, gravel and bedrock,</p> <p>The survey extent is bordered by grazed pasture and woodland.</p>
T04: W2349 Coplow Brook

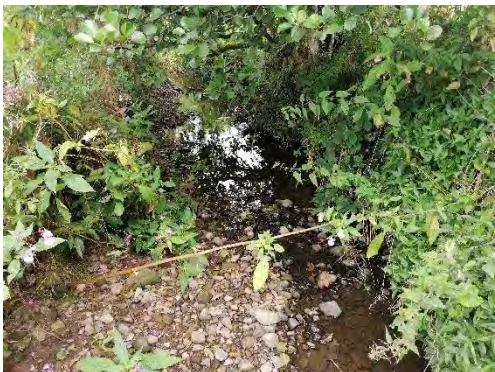
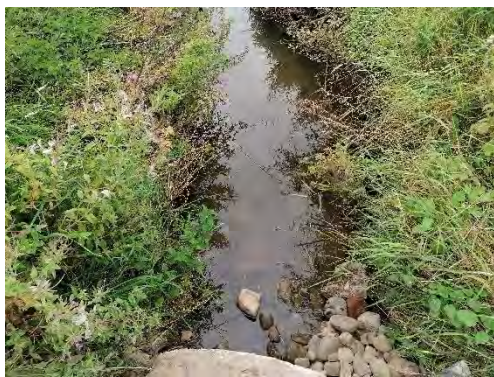
<p>Upstream: 373624 443620 Downstream: 373466 444014</p> <p>No crayfish captured or observed. Habitat of moderate suitability at W2349.</p> <p>Suitable refuges which could provide habitat for crayfish (e.g. boulders) were observed in low abundance. No crayfish were recorded during the surveys at W2349.</p> <p>Within the survey extent the width of the channel is c. 1.5 m and at the time of the survey the depth was c. 0.05 m. The survey extent is bordered on both banks by grazed pasture.</p> <p>Cattle have direct access to the channel at multiple locations within the survey extent and during the</p>

survey cattle faeces was observed in the channel at two locations. This is likely to reduce the sites suitability to support white-clawed crayfish which prefer to inhabit streams with good water quality.

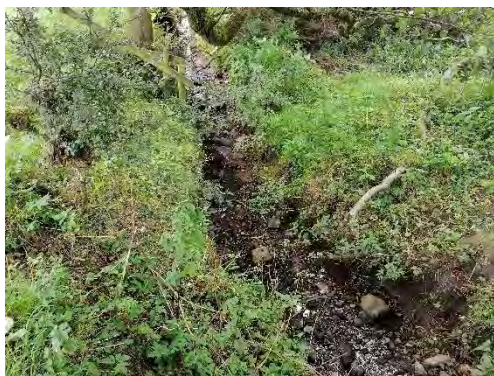
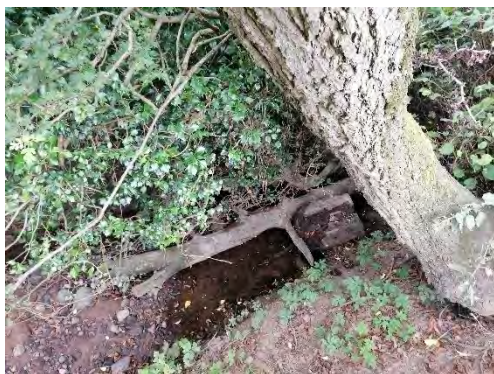
T04: W2321 Greg Sike

Upstream: 373964 443939
 Downstream: 374095 443580

No crayfish captured or observed. Habitat of moderate suitability at W2321.

Although suitable refuges were recorded (boulders and undercut banks) they were infrequent. More than 25 refuges were searched during the survey but no evidence of crayfish was found on W104. Food sources such as macroinvertebrates however were readily available providing suitable foraging for crayfish.

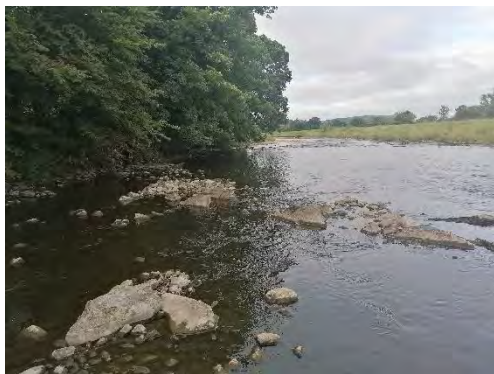
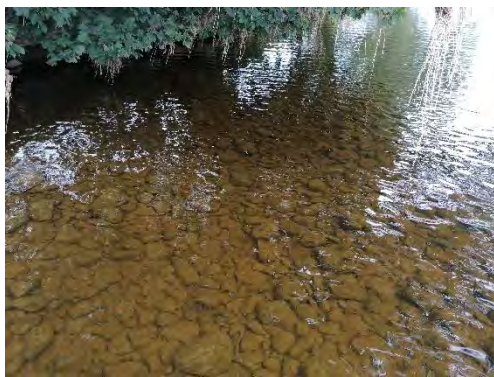
T04: W2325 River Ribble

Upstream: 374488 443947
 Downstream: 374020 443440

No crayfish captured or observed. Suitable habitat present at W2321.

Suitable refuges were observed, predominantly boulders but no crayfish were recorded at W498. Otter spraint also was observed during the survey, none of which contained crayfish remains.

It was not possible to survey certain sections of channel (using manual searching) as water depths frequently exceeded 0.5 m. As suitable refuges were also present in shallower marginal areas this is not considered to have impacted the survey.

Within the survey extent the channel is c. 30 m in width and the depth is c. 0.75 m. The channel substrate comprises a mixture of boulder, cobble, gravel and bedrock. Instream habitats included run, riffle, glide and pool.

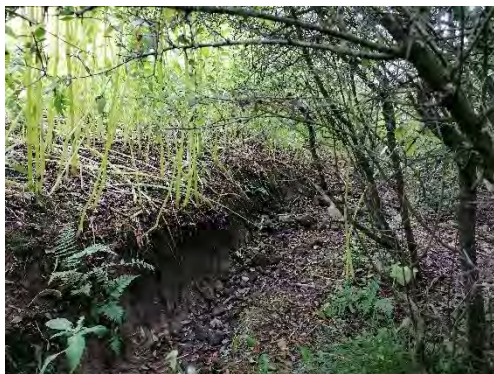
T04: W2348 Unnamed watercourse 2097

Upstream: 374169 443996
 Downstream: 374236 443779

No crayfish captured or observed. Habitat unsuitable at W2348.

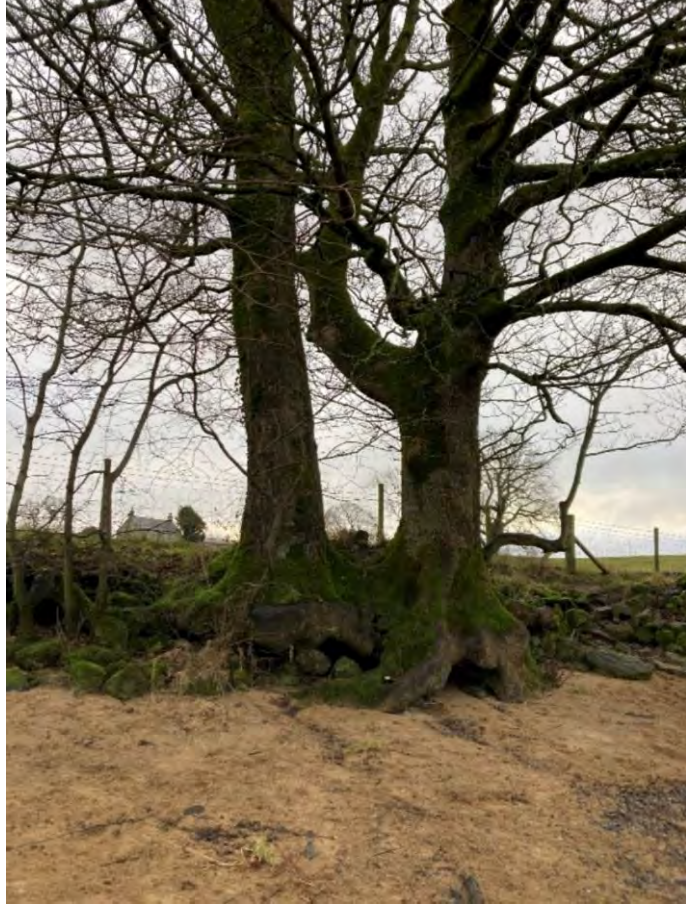
<p>Photo 2.</p> <p>Joined sycamore (<i>Acer pseudoplatanus</i>) trees with confirmed otter holt in cavities below roots immediately upstream of Ribble crossing location.</p>

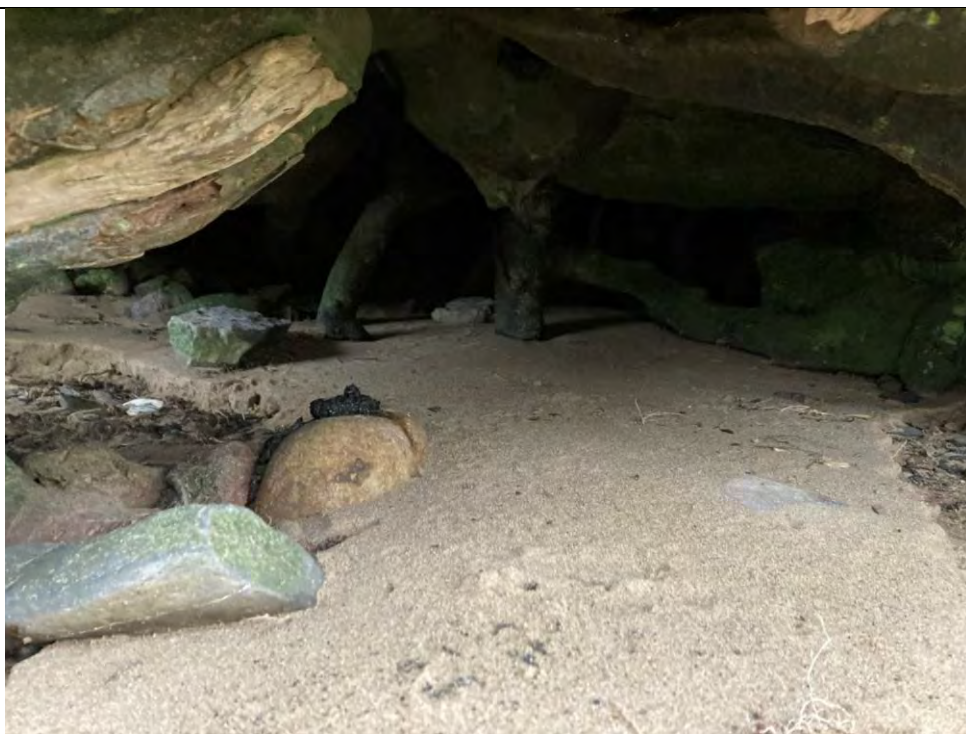
Photo 3.

Ribble crossing
– otter holt -
spraint and print
in entrance to
cavity under
tree.

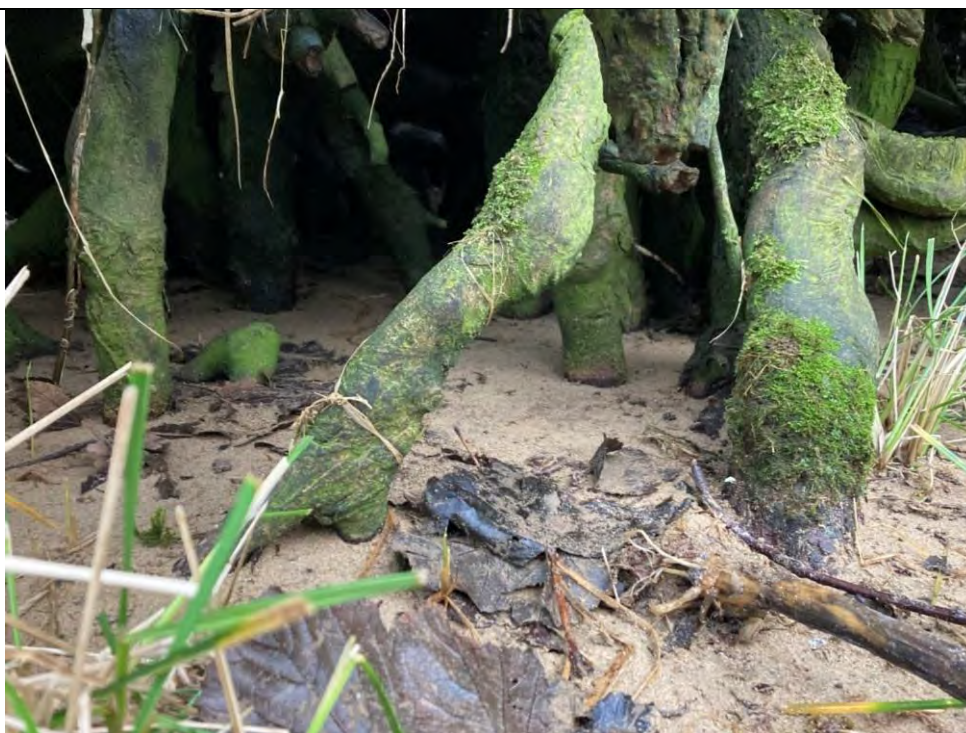
Photo 4.

Potential holt
location under
tree stump at
crossing
location

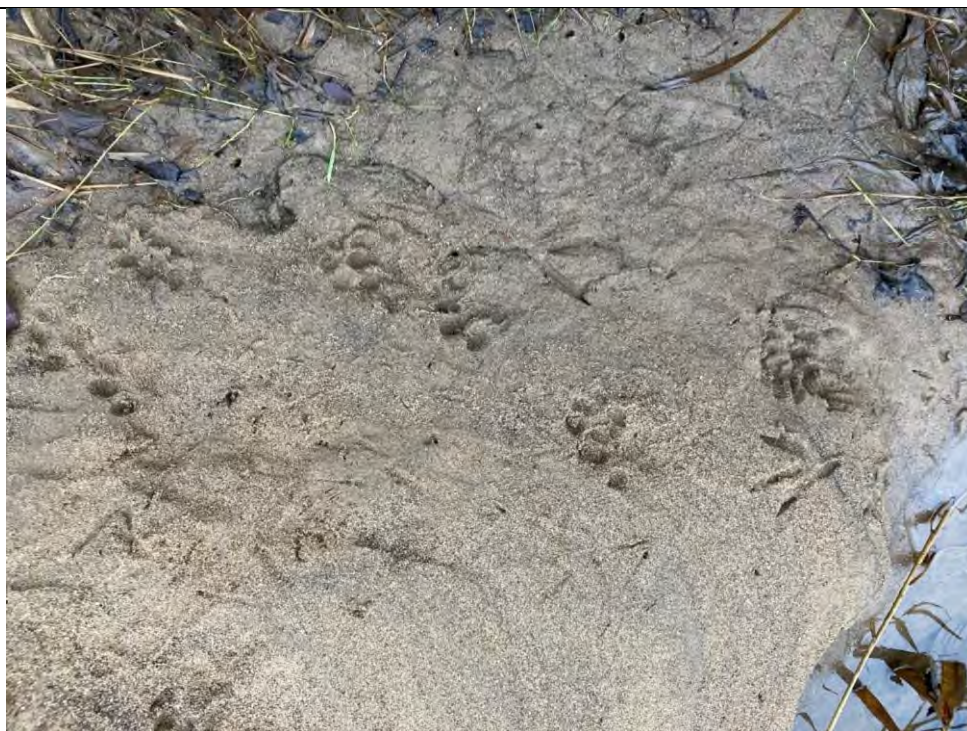
Photo 5.

Otter prints in sand on south bank of the River Ribble at the Crossing location

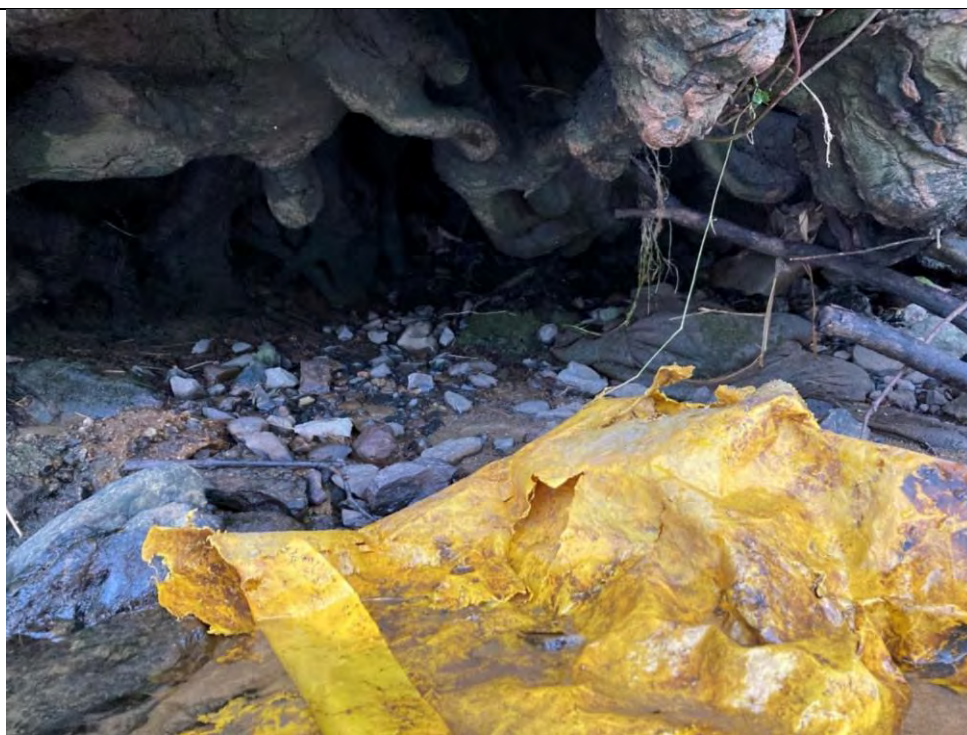
Photo 6.

Undercut banks and exposed tree roots with otter spraint downstream of proposed crossing location
