HAWESWATER AQUEDUCT RESILIENCE PROGRAMME

Marl Hill Section - Biodiversity Net Gain
Assessment, Habitat Compensation: Ribble
Valley Borough Council

OUR REF. NO. RVBC-MH-APP-008_02

DATE: JANUARY 2022

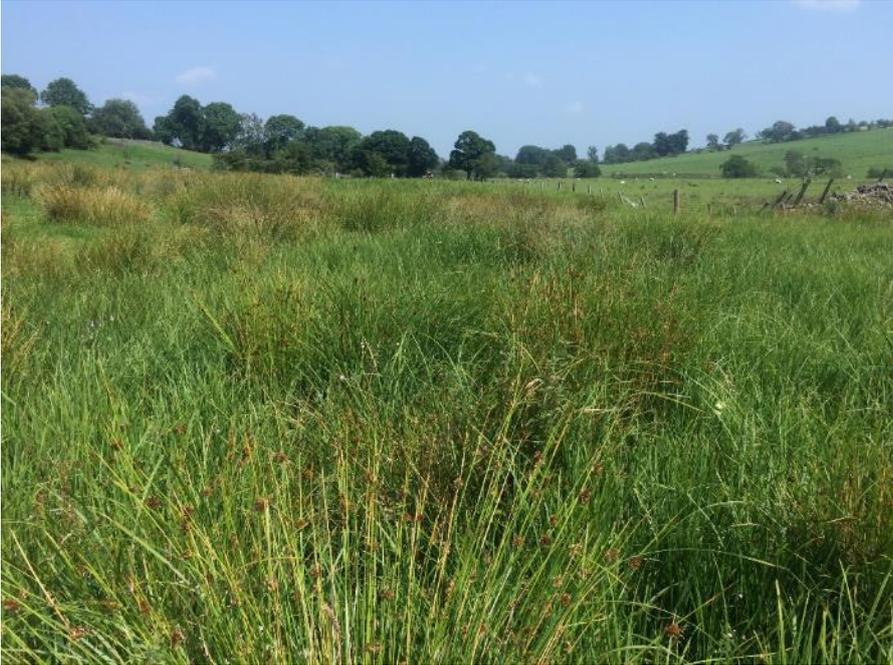
RUSH PASTURE – WETLAND RP3

Description	Wetland situated north of Grassland G7 and Hedgerow H10. Evidence of livestock being able to access in some places. Soft rush dominated with stinging nettle frequent <i>Urtica dioica</i> . Large sedge (unidentified; but swamp community found nearby suggests this could be lesser pond sedge <i>Carex acutiformis</i>) and water mint occasional.
NVC classification	M23b <i>Juncus effusus/acutiflorus-Galium palustre</i> rush-pasture, <i>Juncus effusus</i> sub-community
UKHab classification	f2a Lowland fens
Photograph

Condition	Good

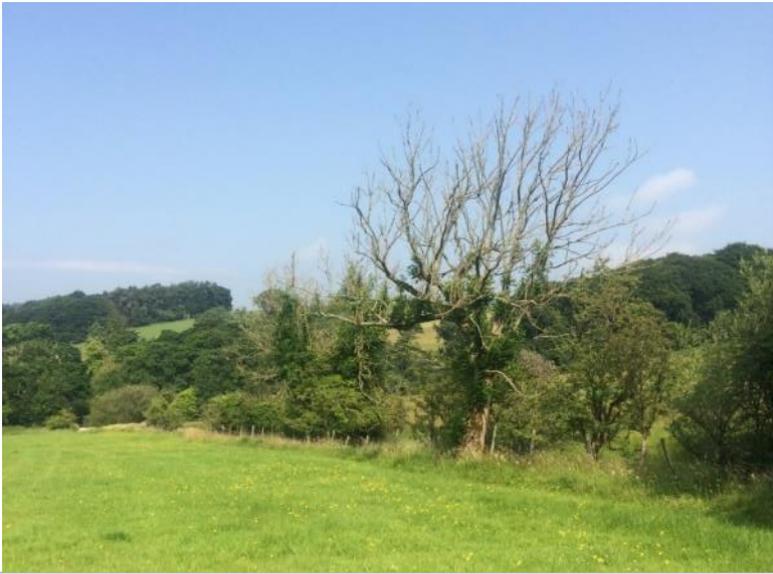
LINE OF TREES L2

Description	Line of trees forming the field boundary between Grassland G3 and Grassland G1. Alder <i>Alnus glutinosa</i> was the dominant tree species with sycamore, ash, willow <i>Salix</i> sp., holly <i>Ilex aquifolium</i> , and oak also present. The understorey was dominated by meadowsweet <i>Filipendula ulmaria</i> with soft rush <i>Juncus effusus</i> also frequently present. Meadow foxtail <i>Alopecurus pratensis</i> , field horsetail <i>Equisetum arvense</i> , jointed rush <i>Juncus articulatus</i> , meadow vetchling <i>Lathyrus pratensis</i> , common bird's-foot-trefoil, <i>Lotus corniculatus</i> and rough meadow-grass <i>Poa trivialis</i> appeared throughout but not as frequently as soft rush. No evidence of significant grazing within the feature.
NVC classification	n/a
UKHab classification	w1g6 Line of trees
Photograph

Condition	Poor

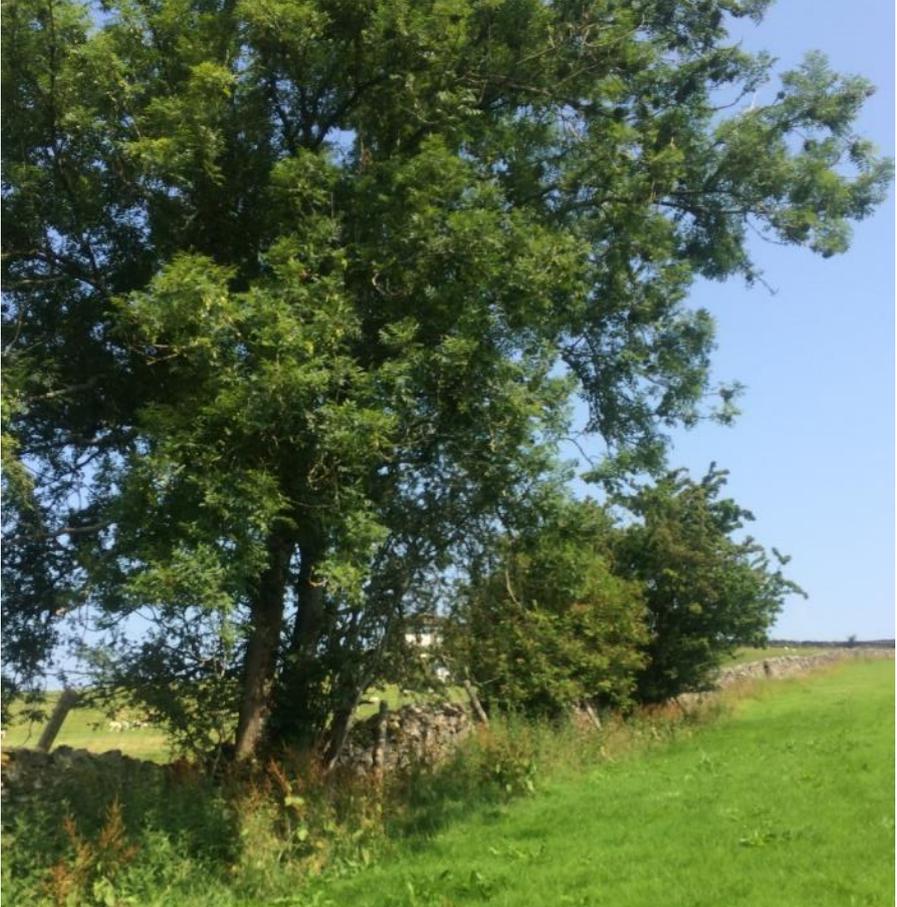
LINE OF TREES L3

Description	Line of trees along the boundary between Grassland G4 and Grassland G2. Historically likely a hedge but long since defunct. Some mature hawthorn, elder <i>Sambucus nigra</i> and semi-mature ash trees were present. Yorkshire fog, perennial rye-grass <i>Lolium perenne</i> and rough meadow-grass dominated the understorey along with stinging nettles. Creeping thistle <i>Cirsium arvense</i> and broad-leaved dock <i>Rumex obtusifolius</i> were occasional.
NVC classification	n/a
UKHab classification	w1g6 Line of trees
Photograph

Condition	Moderate

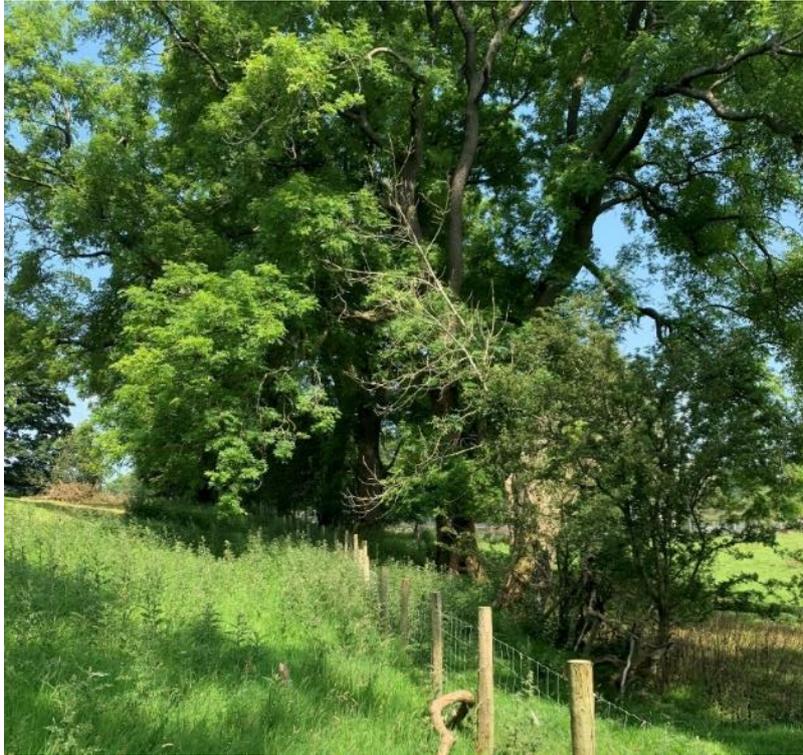
LINE OF TREES L5

Description	Line of trees along north-western field boundary of Grassland G7. Composed of mature ash and sycamore trees with occasional hawthorn and rare bird cherry <i>Prunus padus</i> . Understorey was dominated by Yorkshire fog, stinging nettle and perennial rye-grass. Impacts of livestock presence was in effect here with exposed roots and evidence of grazing.
NVC classification	n/a
UKHab classification	w1g6 Line of trees
Photograph

Condition	Moderate

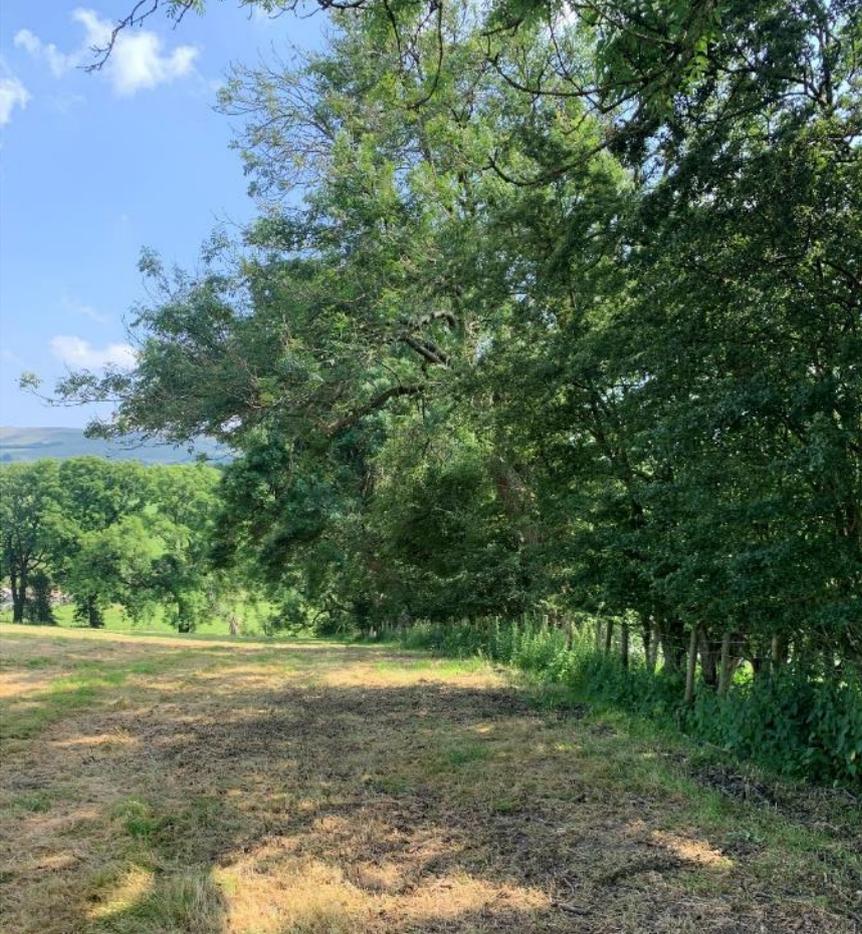
LINE OF TREES L6

Description	Line of trees along the field boundaries of Grassland G8 and Grassland G9. Composed of mature ash trees with hawthorn and blackthorn <i>Prunus spinosa</i> interspersed throughout. The understorey was dominated by stinging nettle with Yorkshire fog less frequent. Creeping thistle and cock's-foot were occasional.
NVC classification	n/a
UKHab classification	w1g6 Line of trees
Photograph

Condition	Moderate

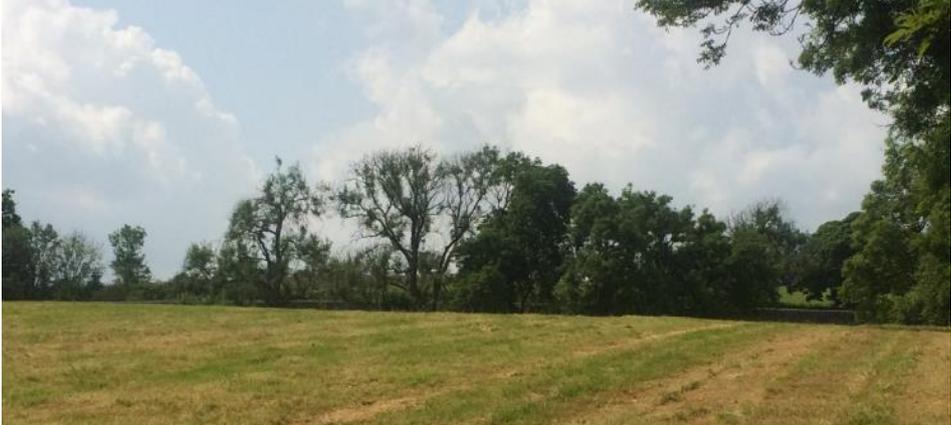
LINE OF TREES L7

Description	Line of trees along the north-west field boundary of Grassland G9. Several mature ash trees formed the dominant woody species cover with hawthorn occasional and hazel <i>Corylus avellana</i> infrequent. The understorey was dominated by stinging nettles with Yorkshire fog appearing frequently. Cock's-foot was also frequent throughout with creeping thistle and smooth meadow-grass occasional.
NVC classification	n/a
UKHab classification	w1g6 Line of trees
Photograph

Condition	Poor

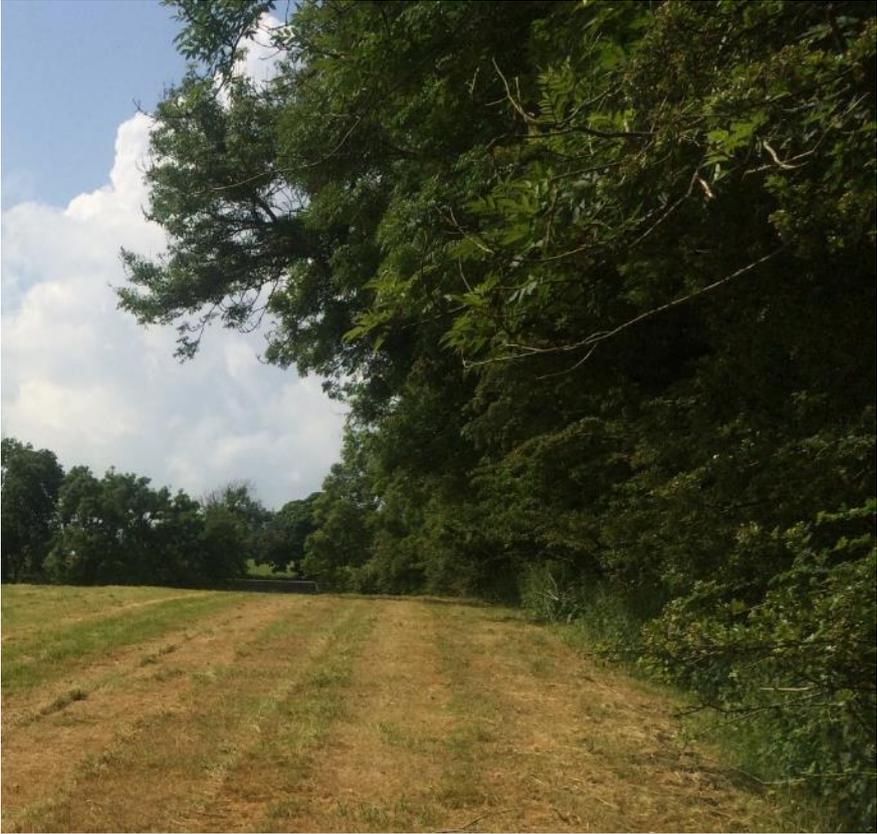
LINE OF TREES L8

Description	Line of trees on the north-eastern field boundary of Grassland G9. Several mature ash trees and hawthorn form the dominant woody species cover with sycamore and wild cherry <i>Prunus avium</i> rare. The understorey was dominated by stinging nettles with Yorkshire fog featuring occasionally. Cock's-foot, perennial rye-grass, rough meadow-grass and creeping buttercup all featured infrequently.
NVC classification	n/a
UKHab classification	w1g6 Line of trees
Photograph

Condition	Moderate

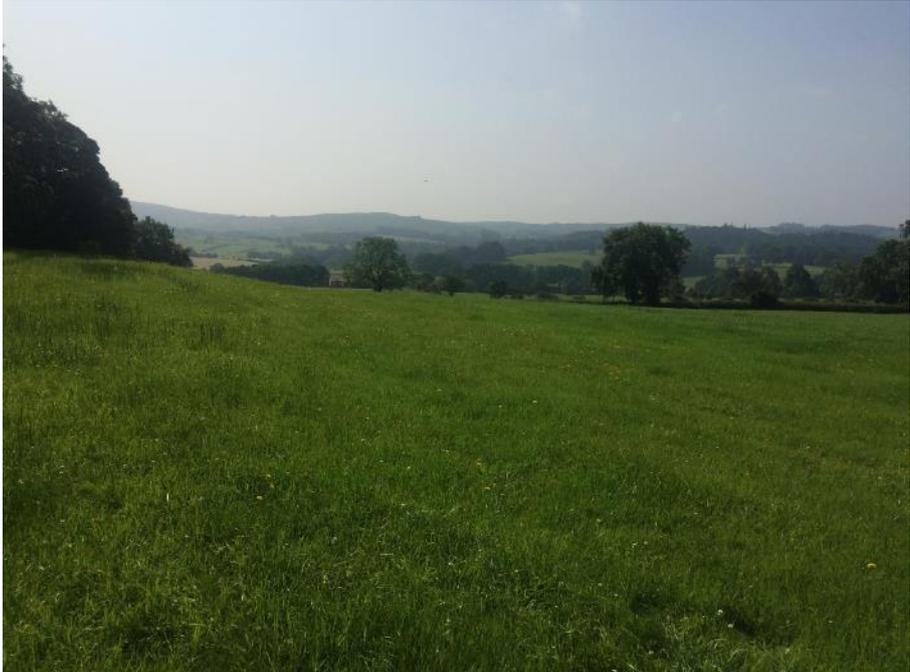
GRASSLAND G3

Description	Area of neutral grassland with no recent evidence of livestock but appeared mown within the last month. Yorkshire fog was by far the most dominant species with creeping buttercup and broad-leaved dock appearing frequently within the grassland.
NVC classification	MG6a <i>Lolium perenne</i> - <i>Cynosurus cristatus</i> grassland, typical sub-community
UKHab classification	g3c Other neutral grassland
Photograph

Condition	Poor

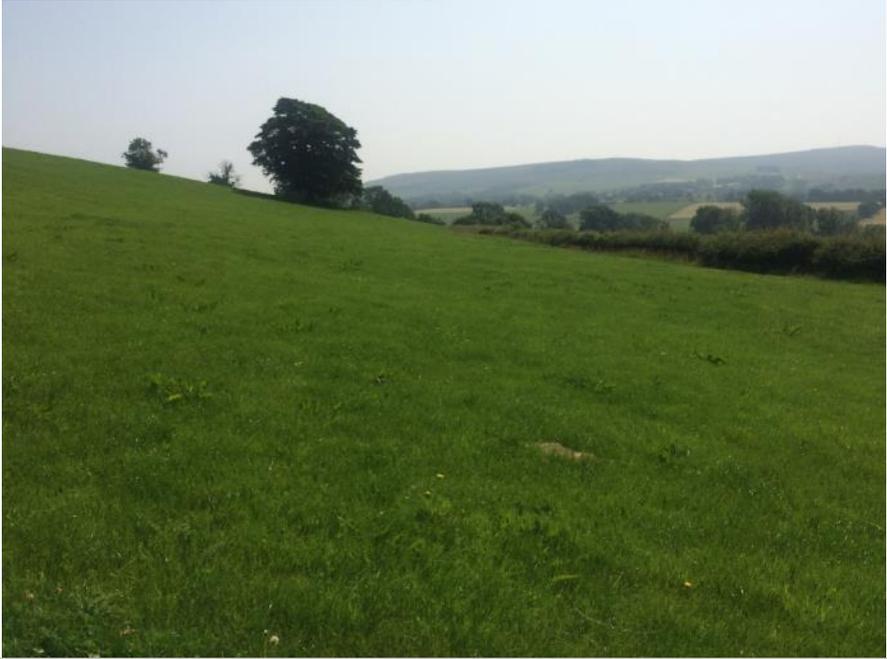
GRASSLAND G4

Description	Area of neutral grassland with evidence of recent mowing. No livestock present. Gradient from north to south of feature. Perennial rye-grass and Yorkshire fog were the two dominant species within the grassland. Sweet vernal-grass, meadow buttercup and broad-leaved dock were the next most prevalent species occurring within the grassland.
NVC classification	MG6a <i>Lolium perenne</i> - <i>Cynosurus cristatus</i> grassland, typical sub-community
UKHab classification	g3c Other neutral grassland
Photograph

Condition	Poor

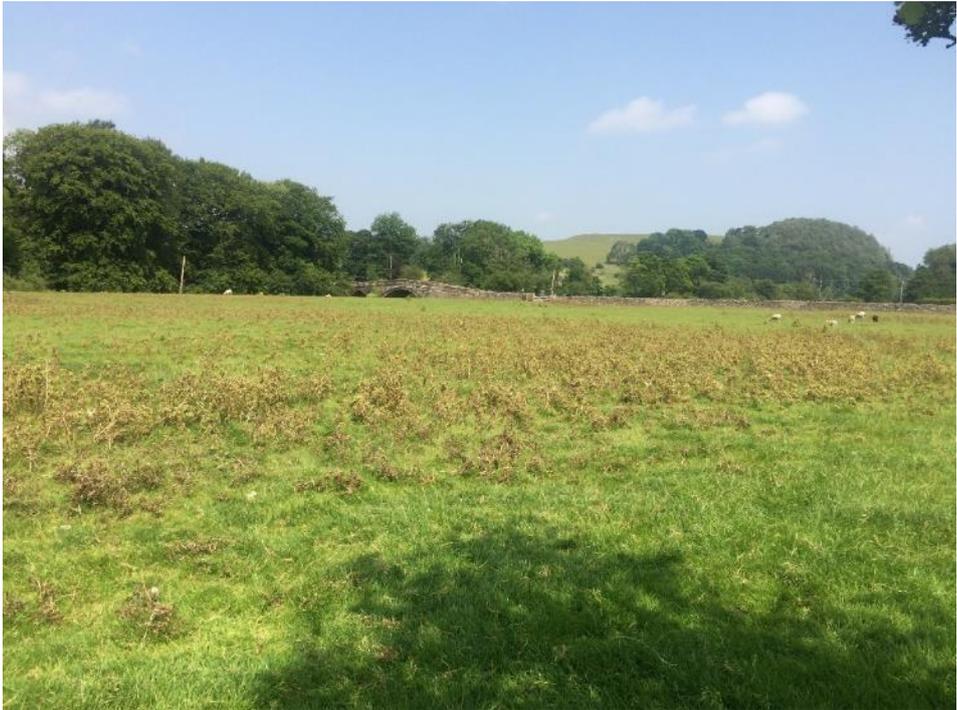
GRASSLAND G5

Description	Modified grassland field in western extent of the Site boundary. Intensively grazed by sheep. Perennial rye-grass was the dominant species in the grassland with sweet vernal-grass also featuring throughout. Creeping thistle, cock's-foot and annual meadow-grass <i>Poa annua</i> were noticeably present throughout but not as frequently as the sweet vernal-grass. Red fescue <i>Festuca rubra</i> and white clover occasionally occurred. There was a steep gradient on the Site parallel to Hedgerow H5 and Hedgerow H6 going from south-east to north-west where it plateaued out.
NVC classification	MG7 <i>Lolium perenne</i> leys and related grasslands
UKHab classification	g4 Modified grassland
Photograph

Condition	Moderate

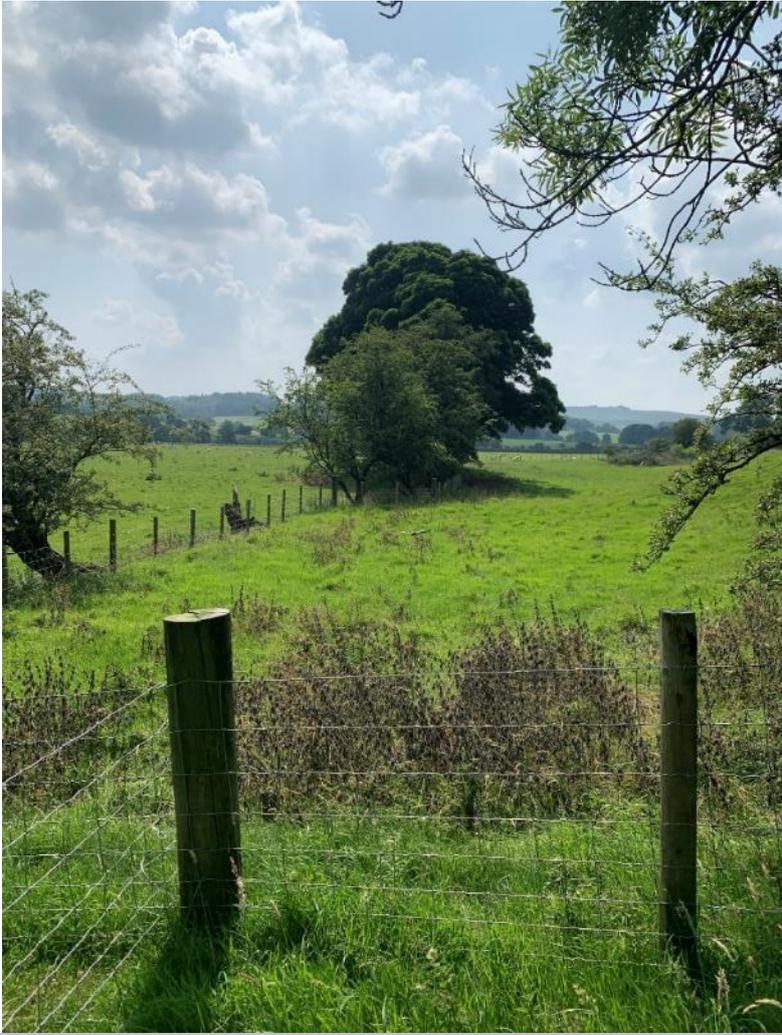
GRASSLAND G8

Description	Modified grassland north-west of Line of trees L5. Dominated by Yorkshire fog and perennial rye-grass. Common bent, sweet vernal-grass and soft rush were also frequent.
NVC classification	MG10a <i>Holcus lanatus</i> - <i>Juncus effusus</i> rush-pasture, typical sub-community
UKHab classification	g3c8 <i>Holcus</i> - <i>Juncus</i> neutral grassland
Photograph

Condition	Moderate

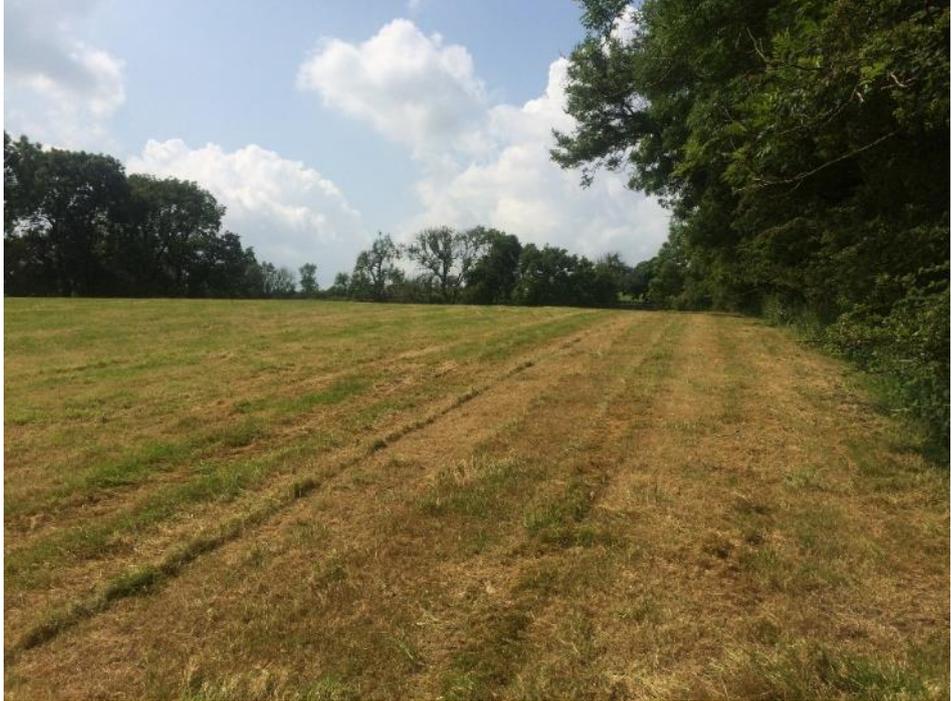
GRASSLAND G9

Description	Neutral grassland field had evidence of recent mowing though there was no evidence of recent livestock presence. Almost exclusively composed of Yorkshire fog. Rare creeping thistle, meadow buttercup, creeping buttercup, common sorrel <i>Rumex acetosa</i> , broad-leaved dock and stinging nettle.
NVC classification	MG10a <i>Holcus lanatus</i> - <i>Juncus effusus</i> rush-pasture, typical sub-community
UKHab classification	g3c8 <i>Holcus</i> - <i>Juncus</i> neutral grassland
Photograph

Condition	Poor

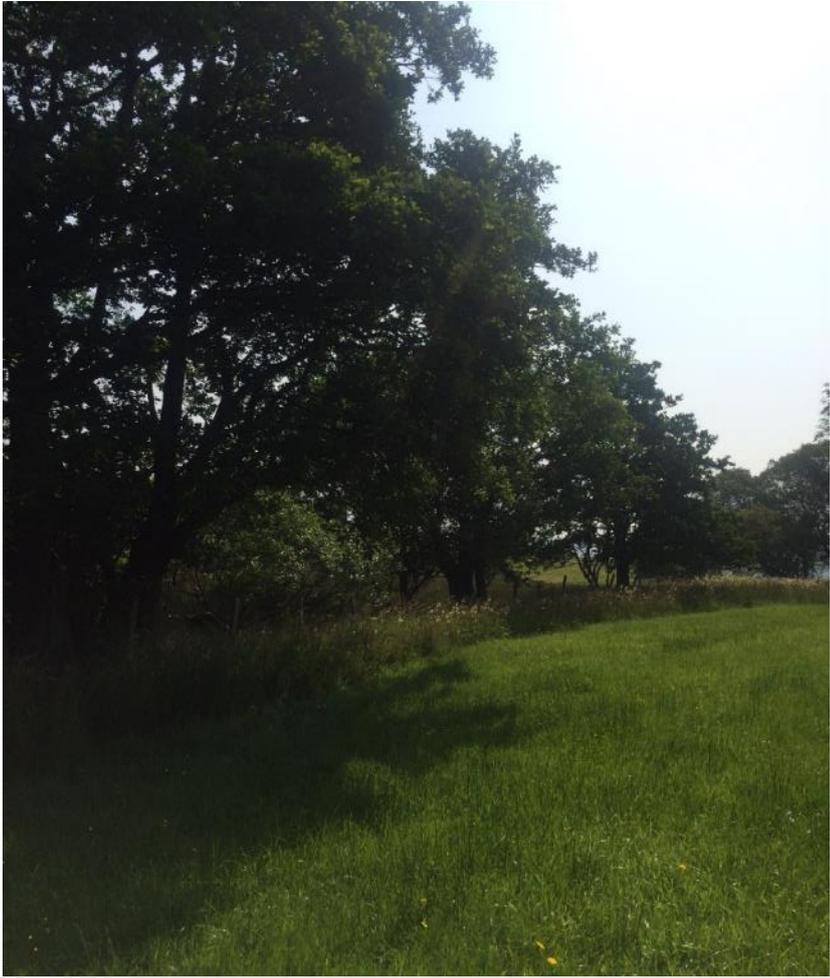
HEDGEROW H2

Description	<p>Hedgerow with trees that form the boundary between Grassland G2 and Grassland G3. Post and wire-mesh fence on south-west aspect of hedge that prevented access of livestock to south-west aspect. North-east aspect displayed damage from livestock around the base of the hedgerow with exposed roots from soil erosion and grazing suppression of leafy growth to about a 1.5m height. The hedge was predominantly hawthorn with hazel, dog rose <i>Rosa canina</i> and ash also present. Ash trees were present, mainly along the north-west stretch of hedge. The understorey did not appear subject to grazing. Yorkshire fog was dominant; perennial rye-grass; common bent, sweet vernal-grass, false oat-grass, creeping thistle, stinging nettle were regularly featuring.</p>
NVC classification	W21 <i>Crataegus monogyna-Hedera helix</i> scrub
UKHab classification	h2a Hedgerow (priority habitat)
Photograph

Condition	Moderate

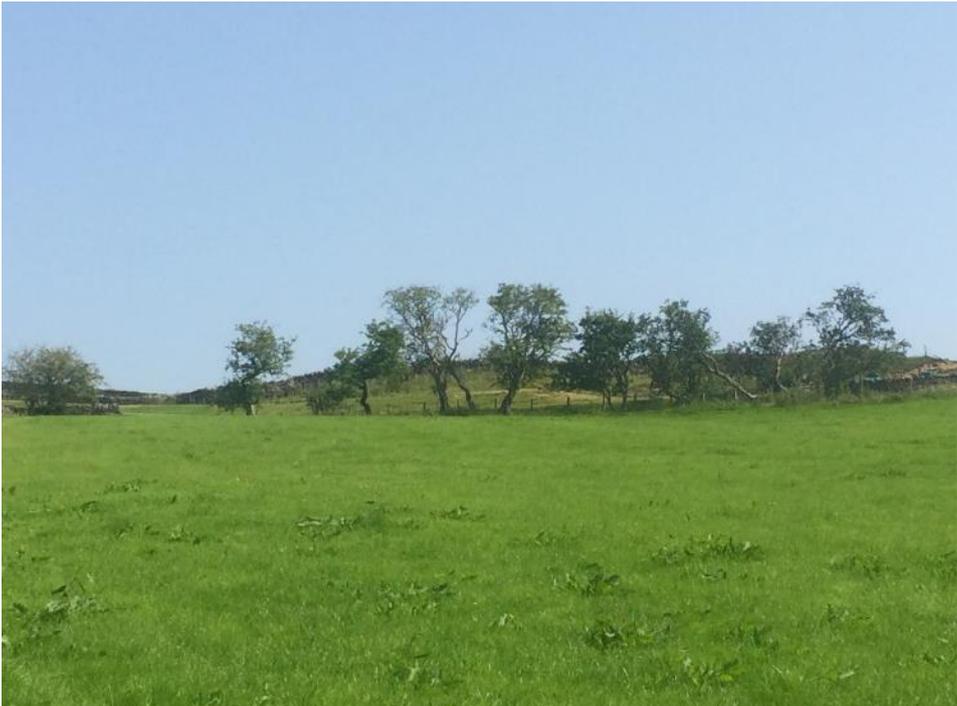
HEDGEROW H3

Description	Defunct hedgerow along northern boundary of Grassland G4. No evidence of any management for a while. Hedge composed of hawthorn with an understorey dominated by Yorkshire fog. Rough meadow-grass was also frequent within the understorey with bent <i>Capillaris</i> sp. and perennial rye-grass featuring less frequently.
NVC classification	W21 <i>Crataegus monogyna-Hedera helix</i> scrub
UKHab classification	h2a Hedgerow (priority habitat)
Photograph

Condition	Poor

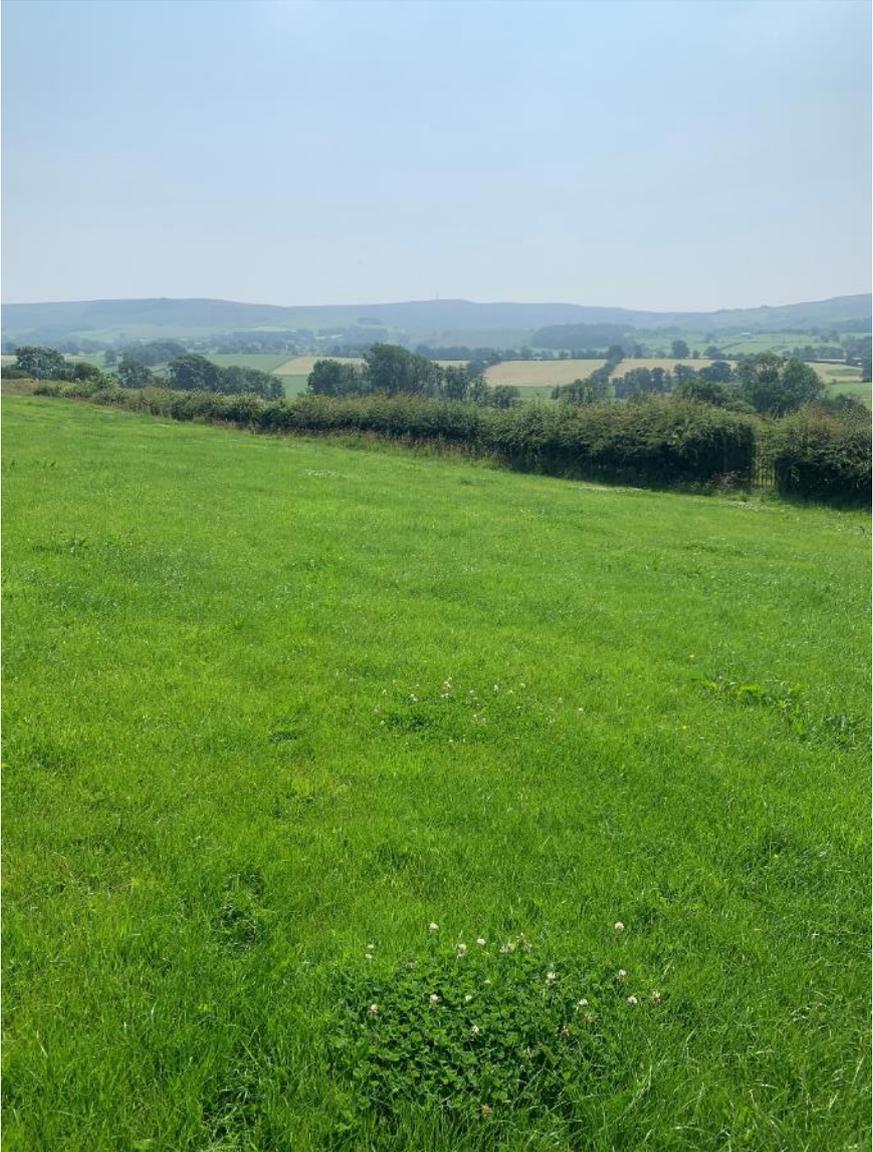
HEDGEROW H4

Description	Intact hedgerow along southern field boundary of Grassland G4 and the road. Hawthorn was dominant with bird cherry, ash and hazel the other woody species present. The understorey and margin were dominated by Yorkshire fog with creeping thistle, stinging nettle and cleavers <i>Galium aparine</i> all frequent. Well managed hedge.
NVC classification	W21 <i>Crataegus monogyna-Hedera helix</i> scrub
UKHab classification	h2a Hedgerow (priority habitat)
Photograph

Condition	Moderate

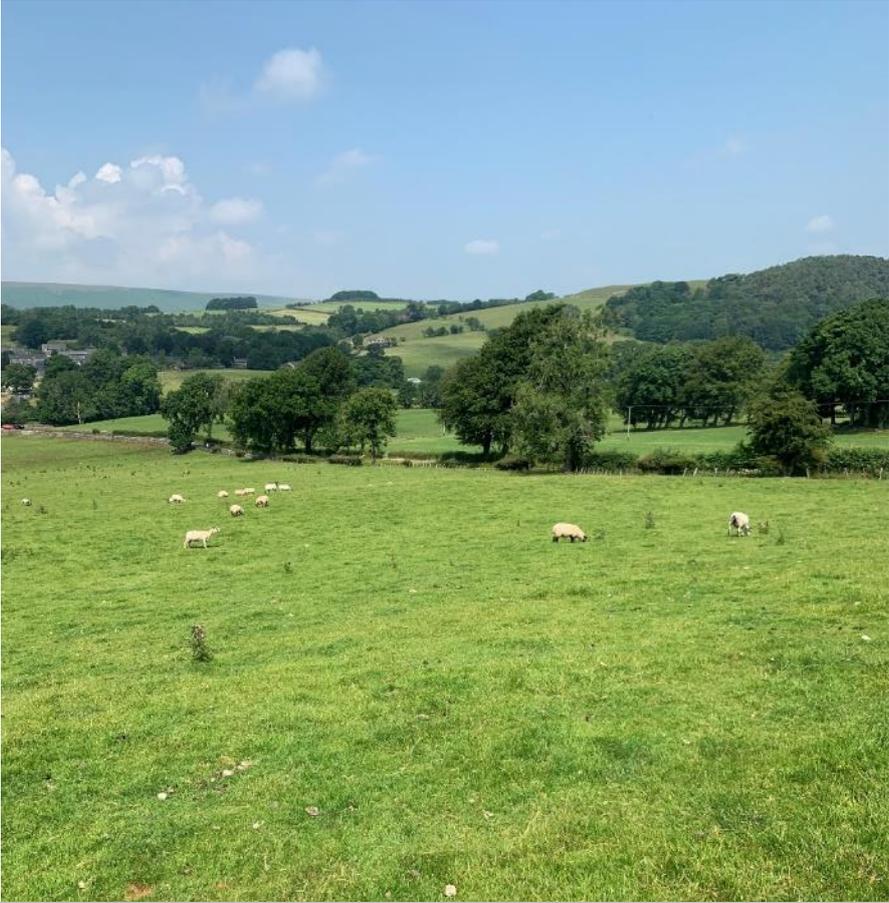
HEDGEROW H5

Description	Hedgerow with trees along field boundary of Grassland G5 with road on north-east aspect. Sheep were grazing in field and present in and around the hedgerow with intense grazing and soil erosion around the base of the hedgerow and associated trees. The hedgerow was composed of dominant hawthorn with ash and elm <i>Ulmus minor</i> the other woody species in the hedgerow. Mature ash trees appeared throughout. Stinging nettles dominated the understorey with creeping thistle and meadowsweet also prominent. Perennial rye-grass also featured throughout albeit less frequent than the aforementioned species.
NVC classification	W21 <i>Crataegus monogyna-Hedera helix</i> scrub
UKHab classification	h2a Hedgerow (priority habitat)
Photograph

Condition	Moderate

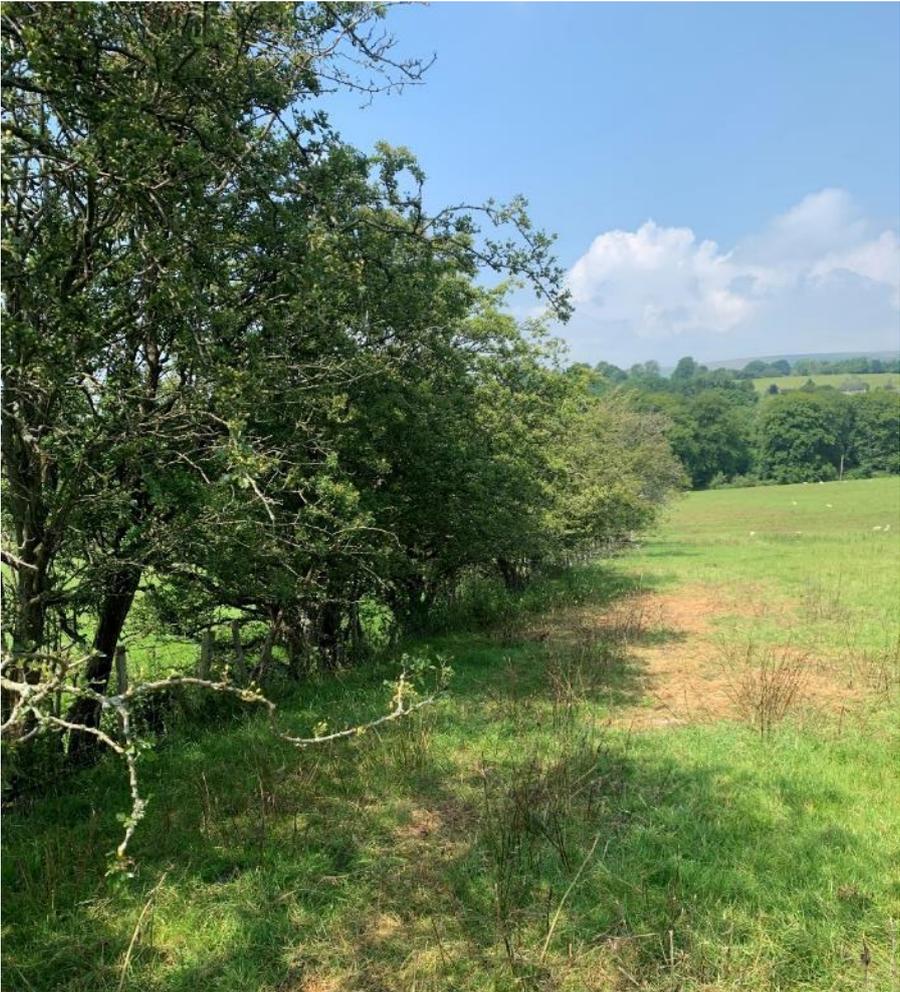
HEDGEROW H6

Description	Hedgerow on the south-west boundary of Grassland G5. No signs of recent management and clear signs of the prolonged impacts of livestock. No leafy growth around the base and soil erosion around roots from livestock. The hedge was dominated by hawthorn as the only woody species. The understorey was composed of dominant stinging nettle with perennial rye-grass and Yorkshire fog also prominent. Creeping thistle and spear thistle <i>Cirsium vulgare</i> were less frequent but featured sporadically throughout.
NVC classification	W21 <i>Crataegus monogyna-Hedera helix</i> scrub
UKHab classification	h2a Hedgerow (priority habitat)
Photograph

Condition	Poor

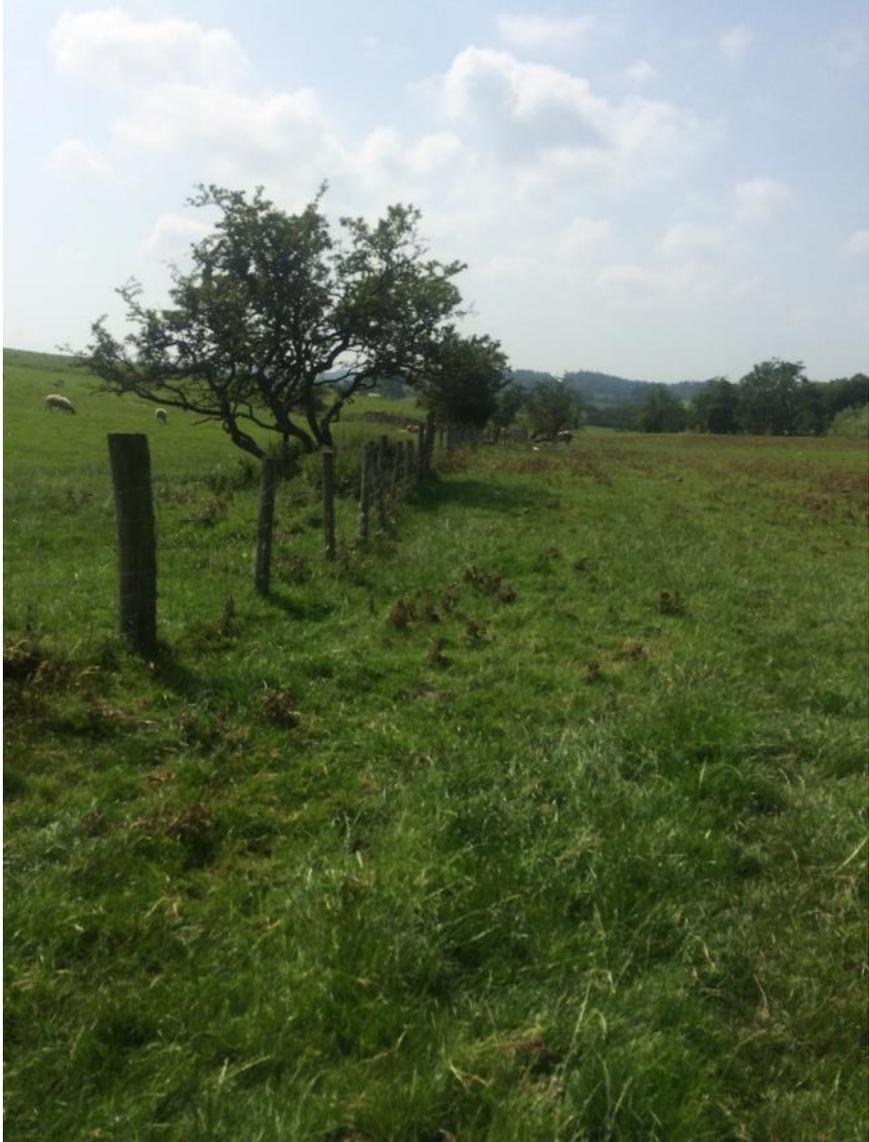
HEDGEROW H7

Description	Defunct hedgerow running perpendicular to Hedgerow H6 and formed a part of the field boundary for Grassland G5 in collaboration with a post and wire-mesh fence. Livestock pressures were in effect from both sides of the hedgerow and coupled with a lack of management had resulted in a poor condition. The remaining hedge was comprised of dominant hawthorn. The understorey was just an extension of the species present in Grassland G5.
NVC classification	W21 <i>Crataegus monogyna-Hedera helix</i> scrub
UKHab classification	h2a Hedgerow (priority habitat)
Photograph

Condition	Poor

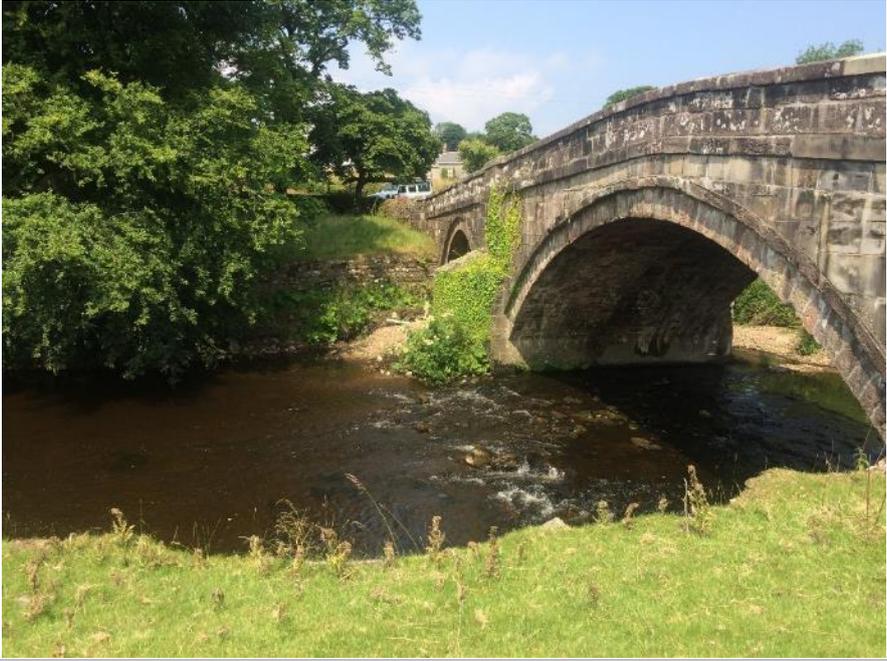
RIVER R1

Description	No condition assessment undertaken for aquatic features. River Hodder running through agricultural landscape, with modified grassland adjacent to the southern bank and woodland outside of the Site bordering the northern bank.
NVC classification	n/a
UKHab classification	r2a Rivers (priority habitat)
Photograph

Condition	n/a
