HAWESWATER AQUEDUCT RESILIENCE PROGRAMME MARL HILL- RIBBLE VALLEY BOROUGH COUNCIL

BIODIVERSITY NET GAIN ASSESSMENT REF: RVBC-MH-APP-008_01

Document Title	Biodiversity Net Gain Assessment	Ref: RVBC-MH-APP-008_01
Prepared for	United Utilities	
Prepared by	TEP - Warrington	
Document Ref	7478.04.007

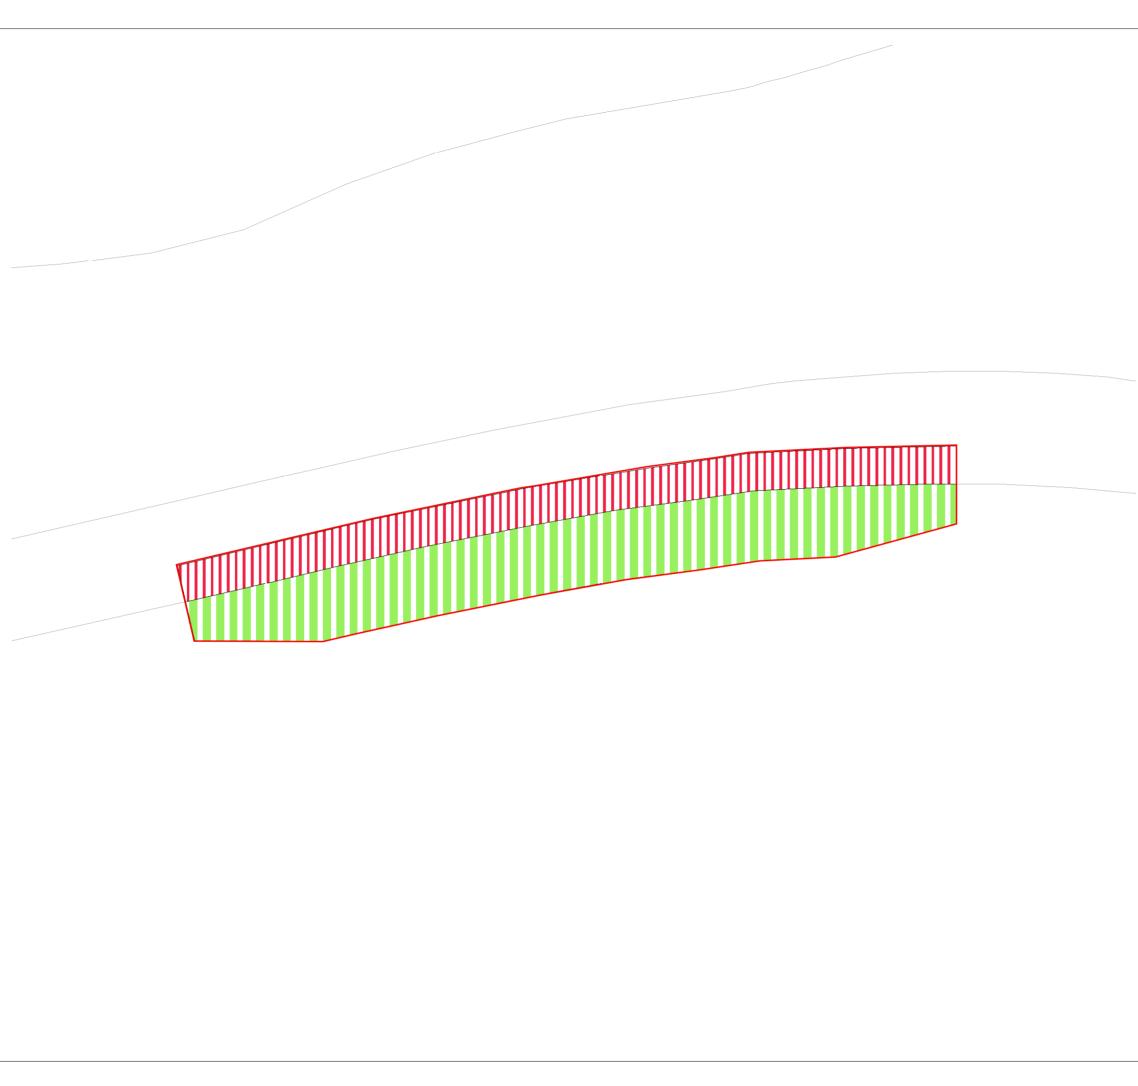
G747	Number 8.04.017I	B.3		Sheet 3 of 23
Drawn	Checked	Approved	Scale	Date

- 3.2 The baseline habitats drawing (TEP Ref: G7478.004.017) illustrates the habitats present across the site. Tables 1-3 list the habitats present, their Phase 1 habitat code and reclassified UK Habitat classification (UK Hab) code with their associated conditions and also provides a summary of how this assessment was derived.

- 3.4 Drawing TEP Ref: G7478.004.017 also illustrates the location of the hedgerows. Table 4 lists the hedgerows present within the application area, their Phase 1 habitat code and reclassified UK Habitat classification code with their associated conditions and provides a summary of how this assessment was derived.

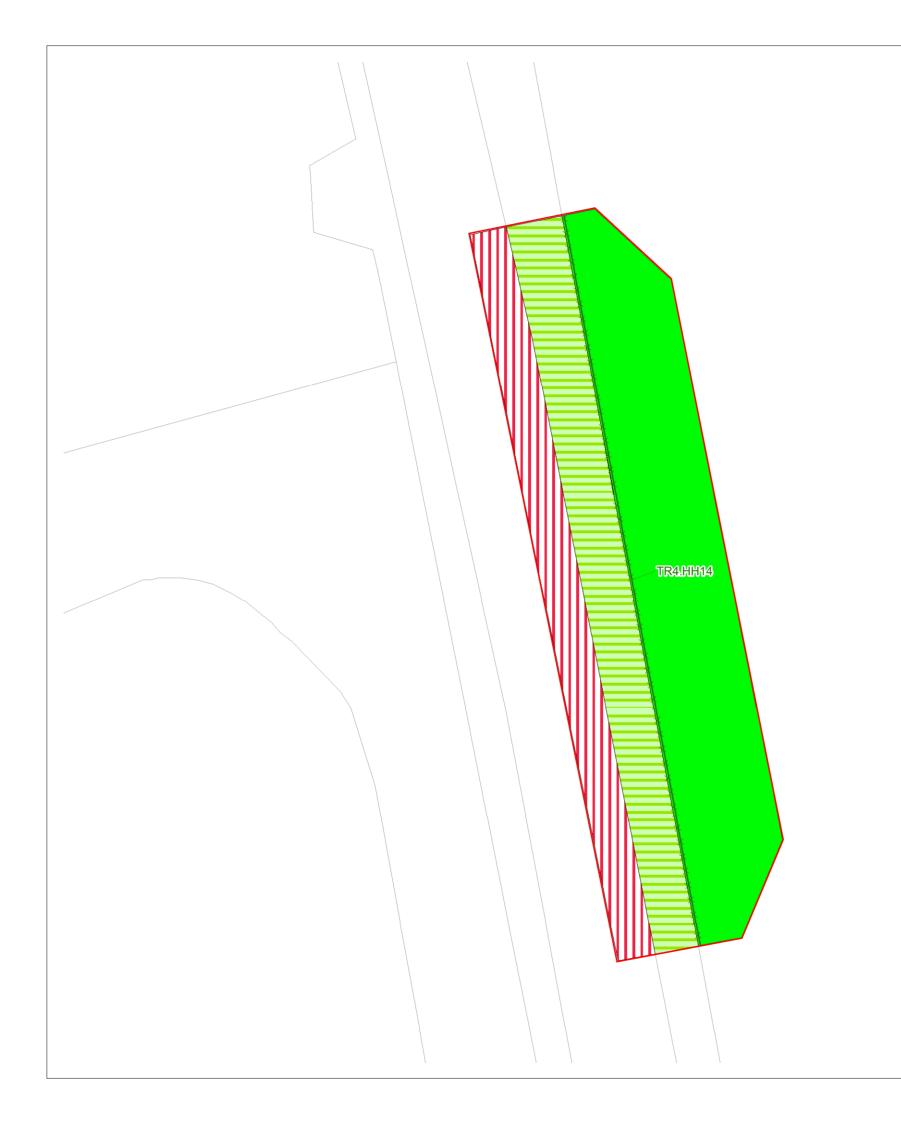
G7478.04.017B.12 Sheet 12 of 23 Drawn Checked Approved Scale
JO AH IH 1:200 @ A3 18/01/2022

Ribble Valley District Baseline Habitats - Marl Hill Section, Highways

The locations of habitats and habitat features are indicative.

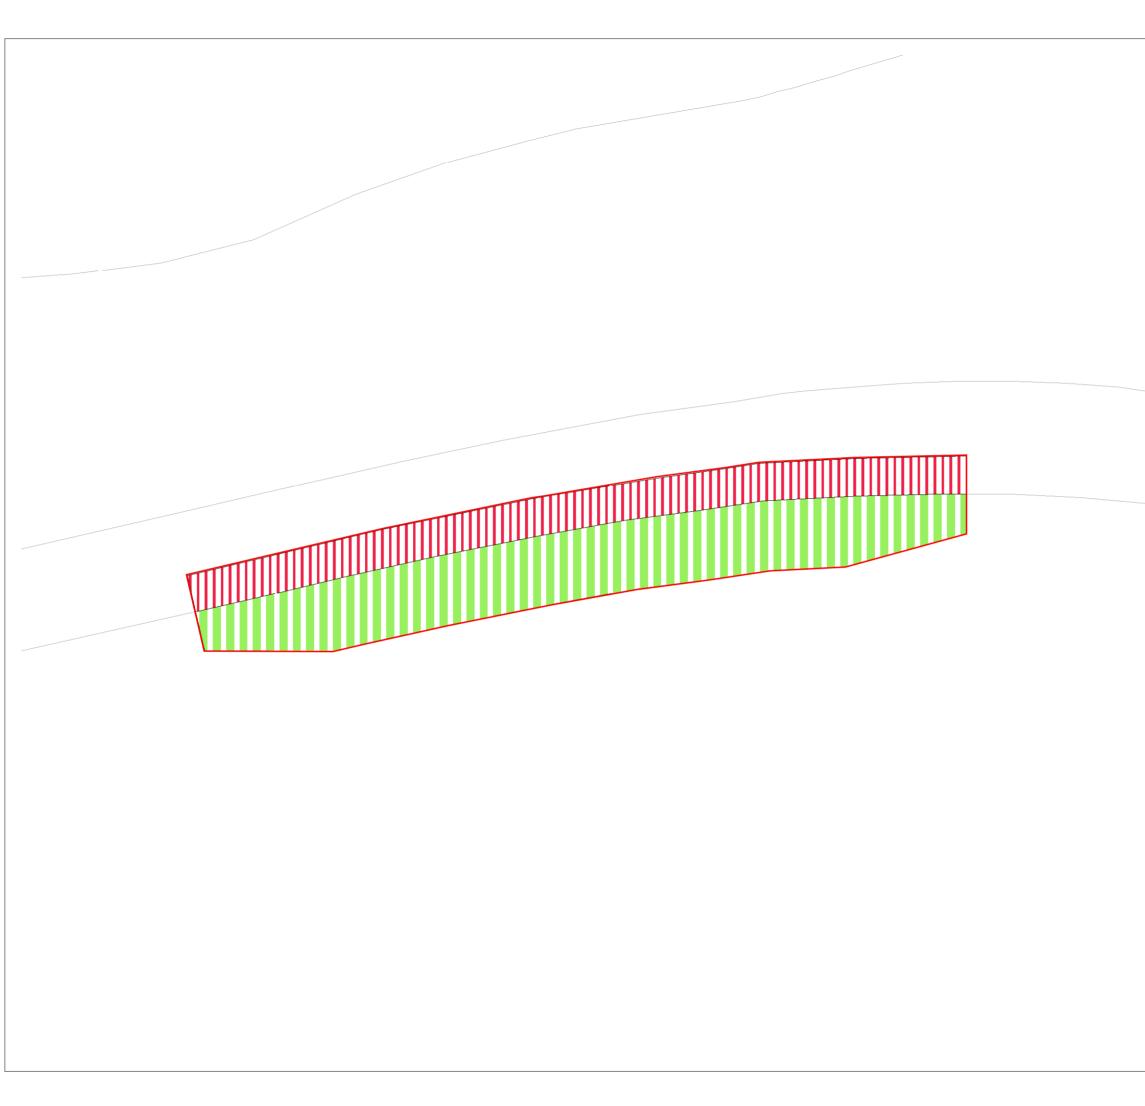
G747	Number 8.04.018I	B.3		Sheet 3 of 23
Drawn	Checked	Approved	Scale	Date

- 3.7 As shown in the BNG metric all other habitats to be lost will be reinstated to the same condition they achieved during the baseline assessment. The exceptions to this are any retained trees and some small areas of permanent loss which will form new permanent access roads, hard standing and buildings essential to the continued maintenance of the proposed aqueduct.
