Haweswater Aqueduct Resilience Programme

Proposed Marl Hill Section Environmental Statement

Technical Appendix 9B.3

Water Vole Baseline

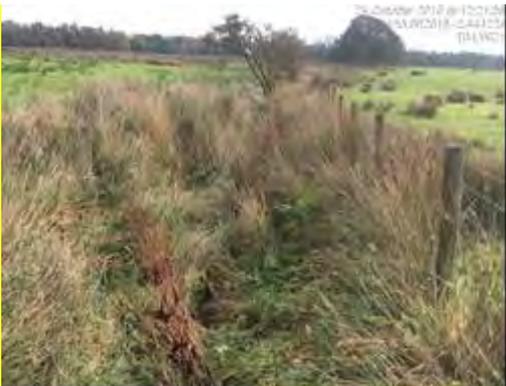
<p>WC1 Upstream: SD70854521</p> <p>WC1 Downstream: SD71184486</p> <p>WC2 Upstream: SD71234499</p> <p>WC2 Downstream: SD71144496</p> <p>No evidence of water vole. Considered to be low suitability. Evidence of recent flooding.</p> <p>A ditch with running water and sections of steep and shallow earth banks. The water depth is less than 0.5 m. It becomes wider and more steep-sided in the downstream sections.</p>

<p>The bordering vegetation is grazed grassland. The ditch is approximately 1 m with some sections of slow flowing water and some faster flowing sections.</p> <p>The bankside vegetation comprises dominant rush, with occasional bankside trees, and more rarely bushes and herbs. There is no evidence of human disturbance. There is also a locally dominant stand of bankside Himalayan balsam.</p>
--	--
