# Preliminary Bat Roost Assessment Report

**Stables at Lower Edge Farm,  
Tinklers Lane,  
Slaidburn,  
BB7 4TP**

**15.07.2021**

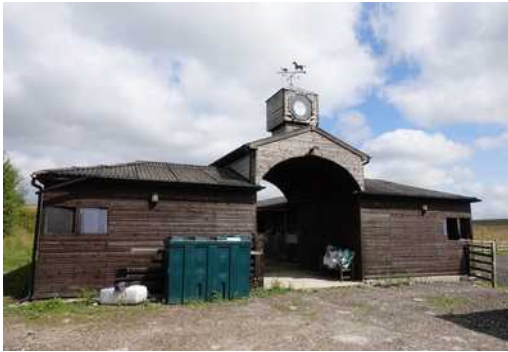
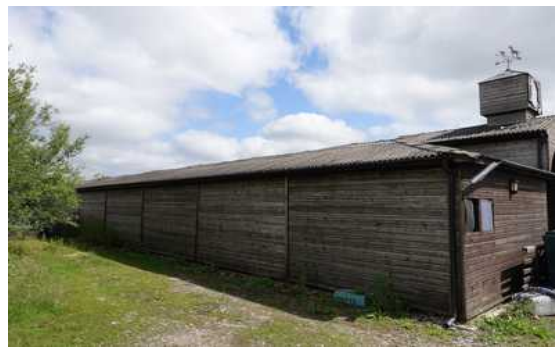
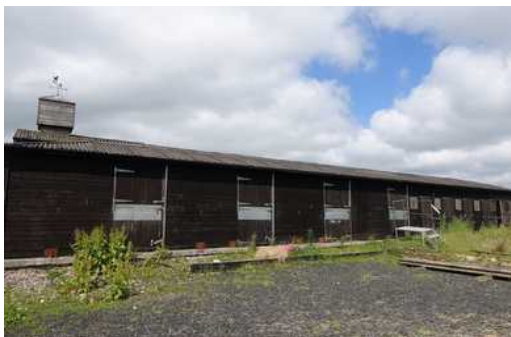
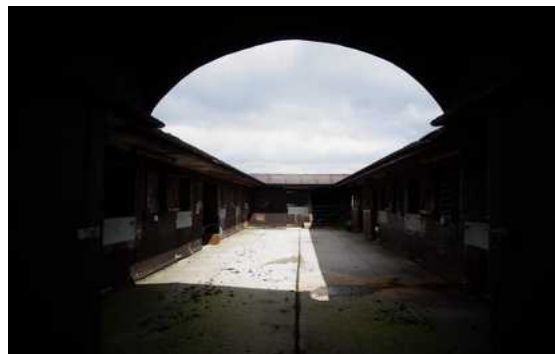
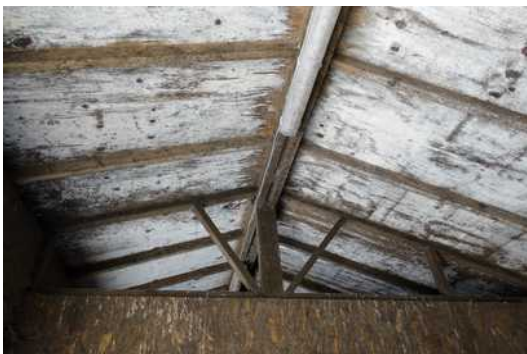
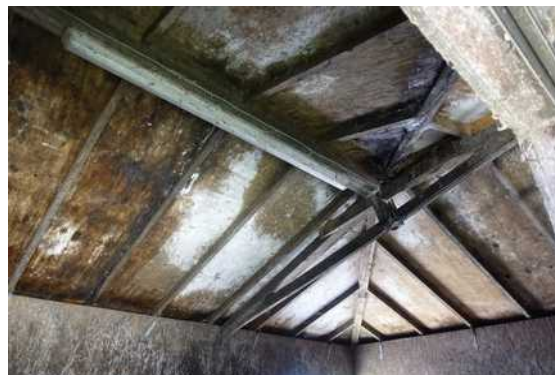
The property consists of a detached single skin timber stable block with a double pitched corrugated fibreboard roofs.

External walls have no obvious cavities, cracks, gaps or crevices present. Timber boards are close fitting with no obvious gaps present.

Roof panels are close fitting with no cavities, gaps or crevices. Roof panels are unlined and the ridge is exposed to the interior.

The building can be considered to offer negligible roosting bat potential.

The property was assessed as offering negligible roosting potential with no obvious gaps or crevices suitable for roosting bats. The building is generally well sealed and well maintained.

No physical evidence of bats grease marks or urine splashing was recorded on or around the buildings despite suitable horizontal surfaces being present and undisturbed.

11 swallow nests were recorded, however nesting birds were absent.
