Preliminary Bat Roost Assessment Report

**24 Bosburn Drive
Mellor Brook
Blackburn
Lancashire BB2 7PA**

26.07.2021

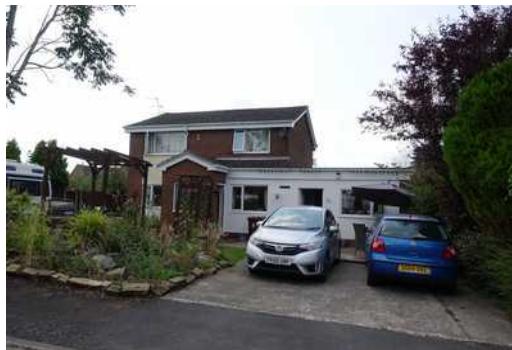
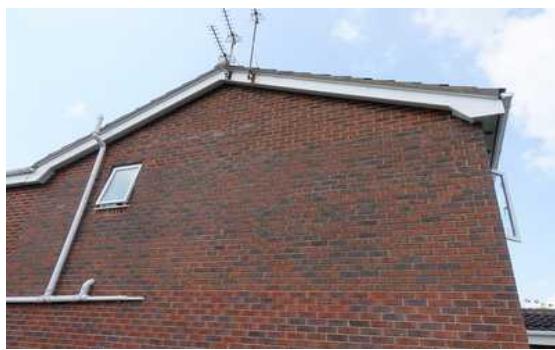
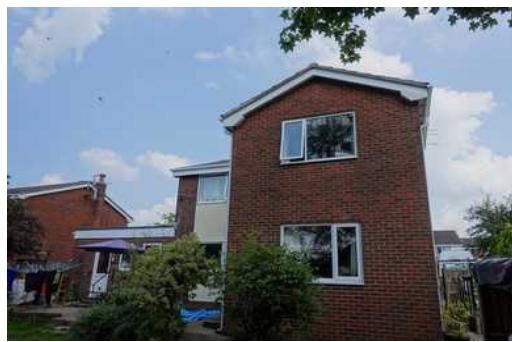
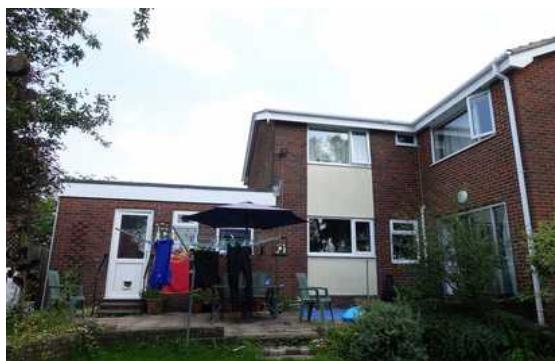
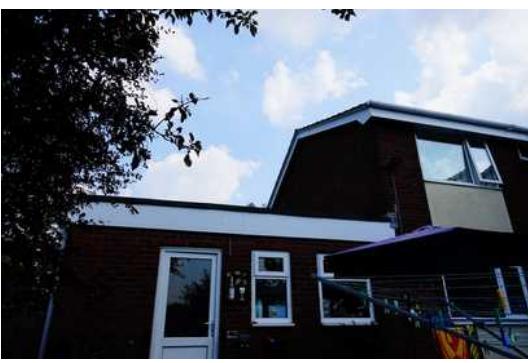
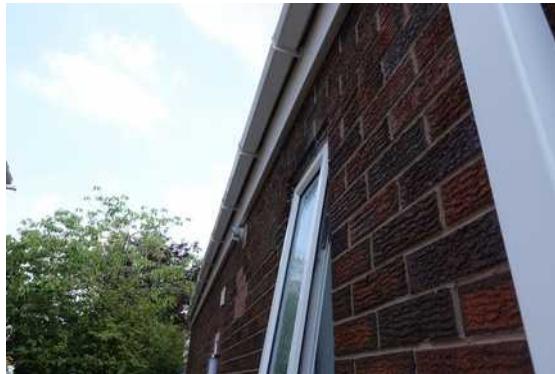
The property consists of a two storey detached brick built house with a double pitched tiled roof. A single storey flat roofed garage is present on the northern gable of the building.

External walls are well pointed no obvious cavities, cracks, gaps or crevices present. The gables are well sealed. Lead flashing where present is close fitting. Upvc soffits and fascia boards are close fitting with no obvious gaps present.

Roof tiles are close fitting with no lifted, slipped or missing tiles present. The ridge is well sealed.

The building can be considered to offer negligible roosting bat potential.
