St James Primary School, Clitheroe

Ecological Impact Assessment

Document:	BOW17_1446 St James School, Clitheroe			
Version	Date	Prepared by	Technical Reviewer	Approved by
V1	July 2021	Jodie Marks	Jeremy James	Jeremy James
V2	July 2023 – change in development plans	Jodie Marks	Jeremy James	Jeremy James
V2	Aug 2023 – input of architect development plans	Jodie Marks	N/A	N/A

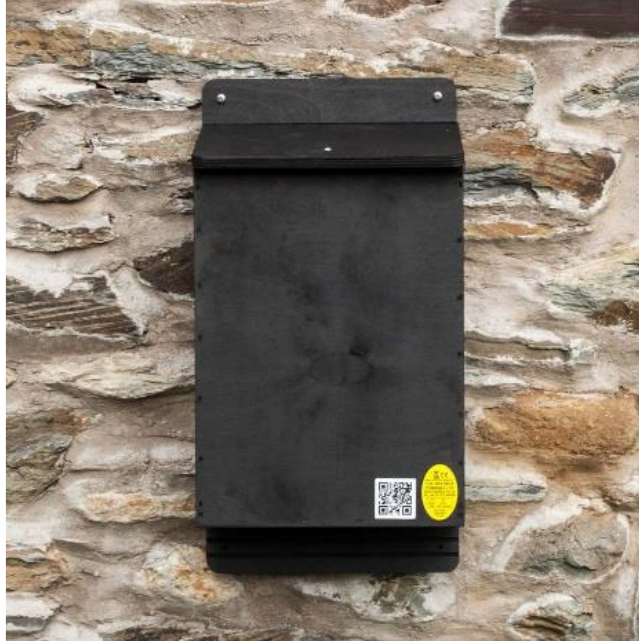
Figure 1. Roost maternity bat box

- **Prior to the commencement of works**, a single Roost Maternity Bat Box (See Figure 1 below) with multiple internal crevices will be installed on a mature tree under the supervision of an experienced ecologist, along the perimeter of the school grounds. The bat box will be used to receive any bats found during the works and be retained for long term enhancement of bat roosting habitat within the surrounding area;

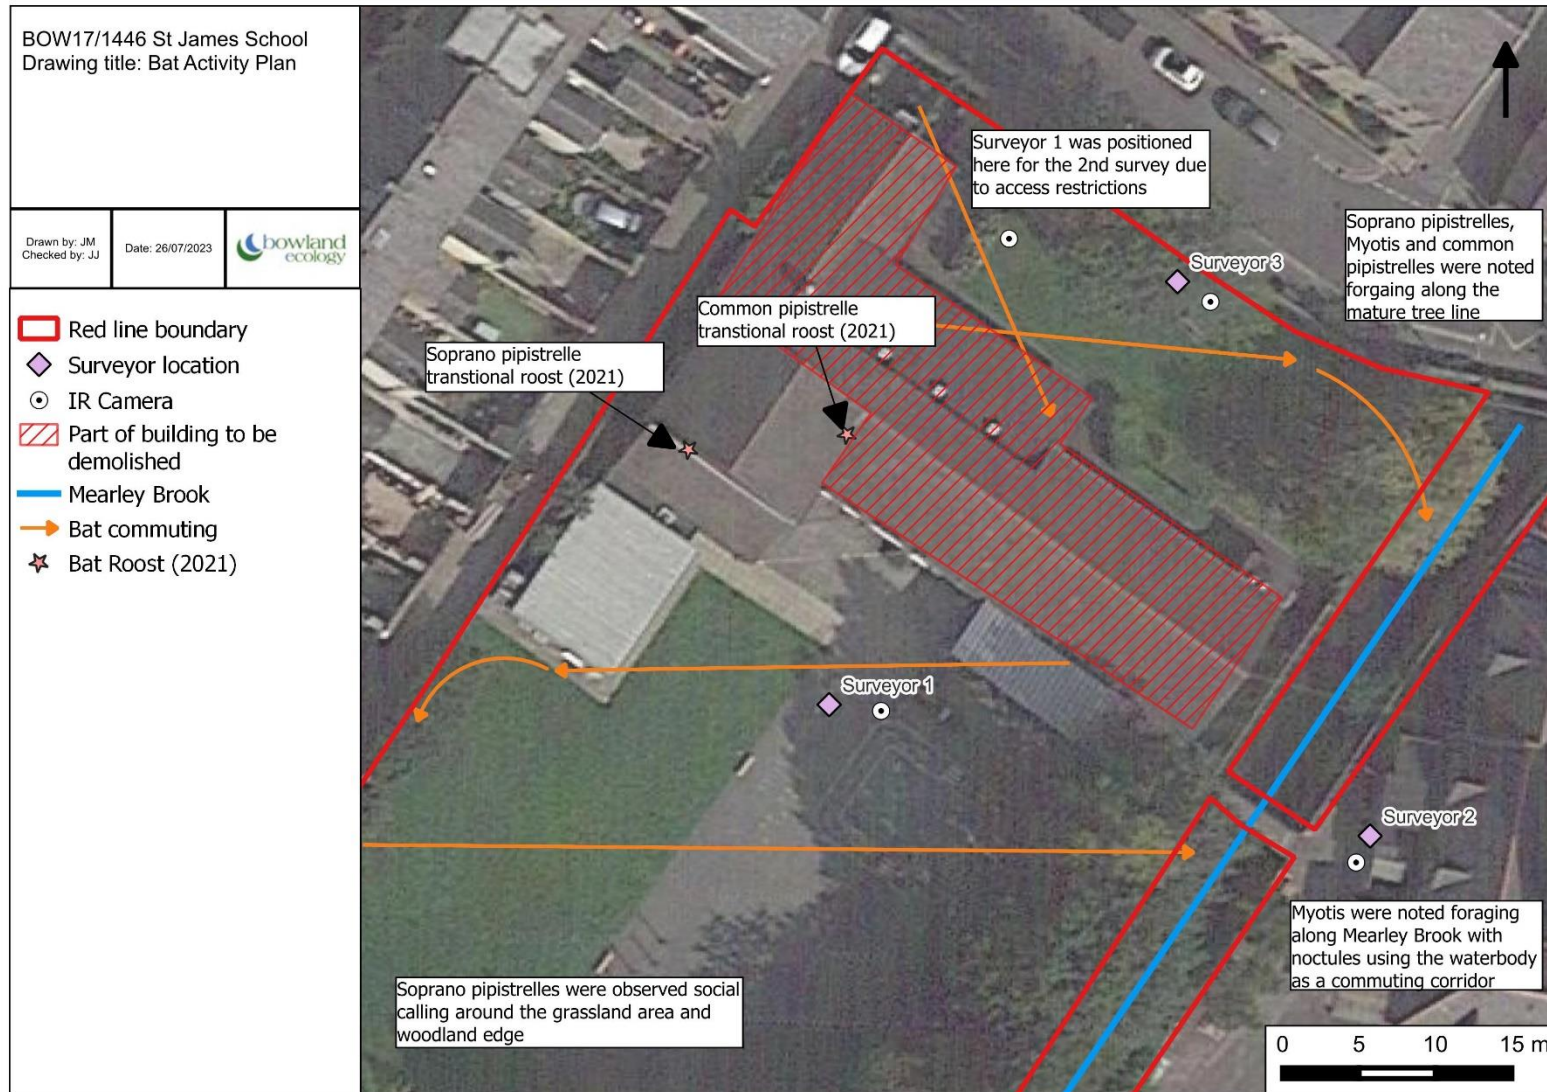
Appendix C – UK Habitat Plan and Bat Activity Plan

- 3.5 The location of habitats recorded during the Extended UK Habitat Survey is mapped in Appendix C. The Target Notes (TNs) describing each habitat and key interest features for wildlife are set out in Appendix D. Each habitat type is described below. Plant species nomenclature follows Stace (2010). The condition and subsequent descriptions of the habitats have not changed since the previous survey.

See the UK Habitat Plan for location of each Target Note.

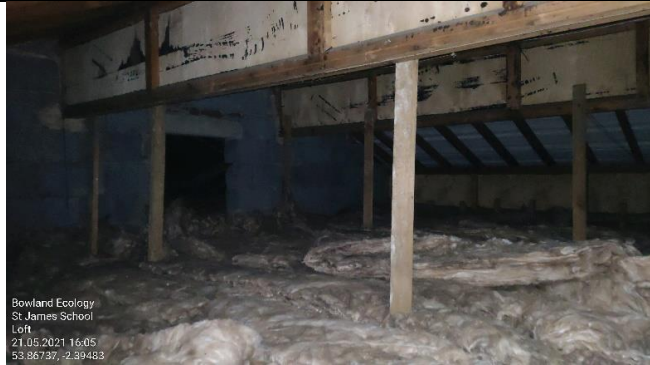
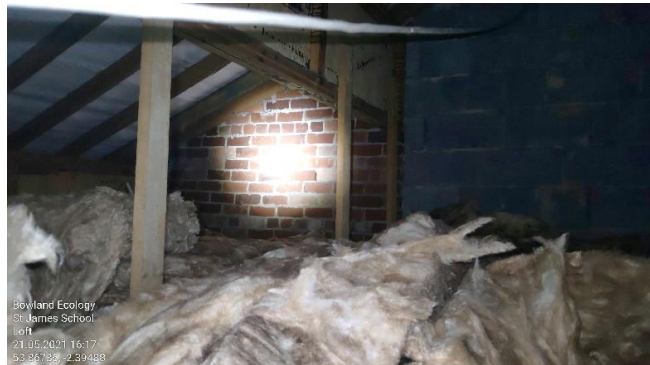
B1's internal loft space was accessed via three loft hatches throughout the school with only the eastern end able to be physically entered. The loft space consists of one continuous space which is sectioned by breeze block walls which have small crawl-space entryways between. The roof is lined with breathable roofing membrane and has wooden rafters, purlins and vertical struts. The vertical struts are partially boarded between with plywood. The space is well-insulated on the floor and is rarely used, seemingly only for access

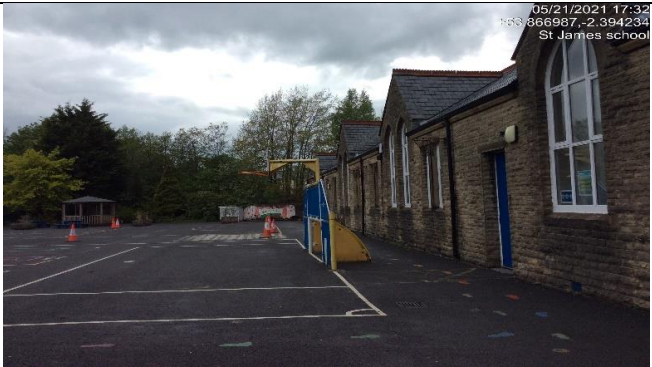
<p>to any wiring or pipework which are present in the loft. Light ingress is visible at the south western end of the loft space (roughly where the two pipistrelle roosts were located in 2021). No signs of bats were identified. Several undisturbed cobwebs were noted, and a single mouse dropping was discovered. B1 is considered to have low potential to support roosting bats.</p>	
<p>B2</p>	<p>Building 2 is situated to the east of the site and is constructed of stone walls with a slate tiled roof. The roof structure is complex and includes gable roof sections, hipped roof sections, flat roofed sections, along with window dormer sections. Negligible bat roosting features were identified - the building is in good condition and well-sealed.</p>

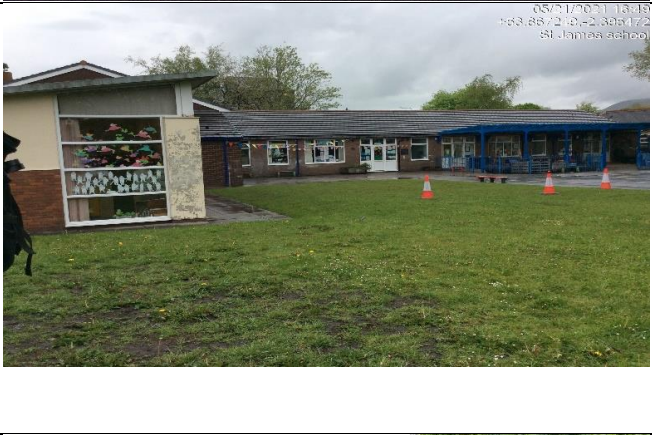
<p>05/21/2021 17:32 +53.866987,-2.394234 St James school</p>
<p>T1</p>	<p>Amenity grassland comprising the school playground occupies half the northeast and southwest areas of the western half of the site. The grass is managed resulting in a short sward height. Species present include perennial rye grass meadow grass species and red fescue along with herbs including red clover, daisy and dandelion. The grassland is generally flat although there is a mound towards the south</p>

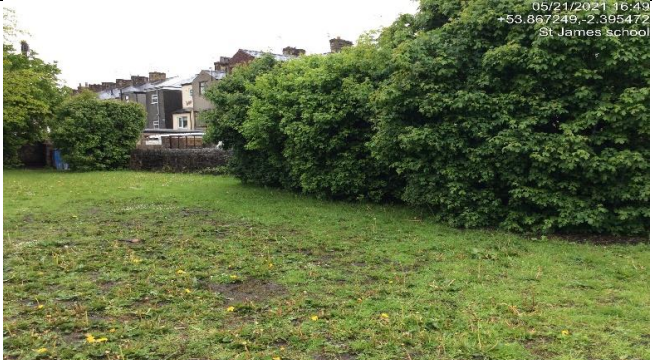
<p>T2</p>	<p>A short (approximately 10 m in length) hedgerow is present at the edge of the amenity grassland playground. The hedge is approximately 3 m tall and 2 m wide with a species composition of field maple and privet.</p>

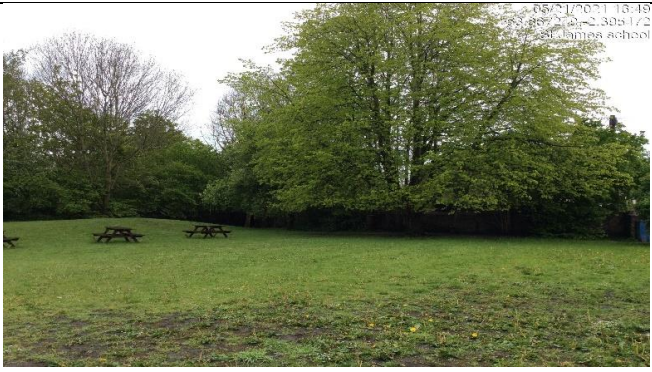
<p>T3</p>	<p>Mature trees surround the southern boundary of the amenity grassland and hard standing playground forming a woodland strip. Canopy species include lime, alder, ash, beech, hazel, willow, sycamore, poplar, rowan, field maple and silver birch with an understory of holly, hawthorn and hazel. The ground flora is predominantly amenity grassland with scattered perennial plants at the perimeter including wood avens, broadleaved willowherb, creeping buttercup, herb Robert, lesser celandine, common nettle, ivy, common hogweed and holly. There are some areas of leaf litter and patches of bare ground.</p>

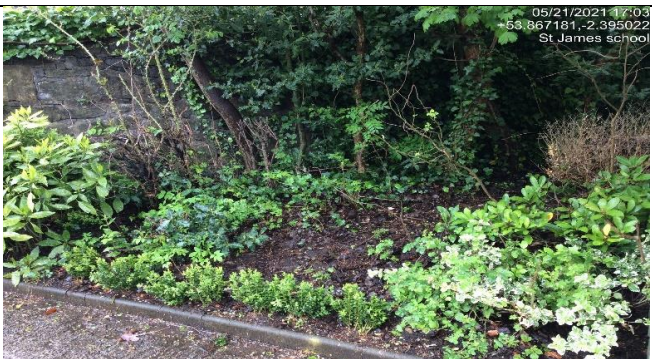
<p>T4</p>	<p>A small area of ornamental planting is present to the north of the woodland strip. Species present include ornamental non-native shrubs along with privet, rose and holly.</p>

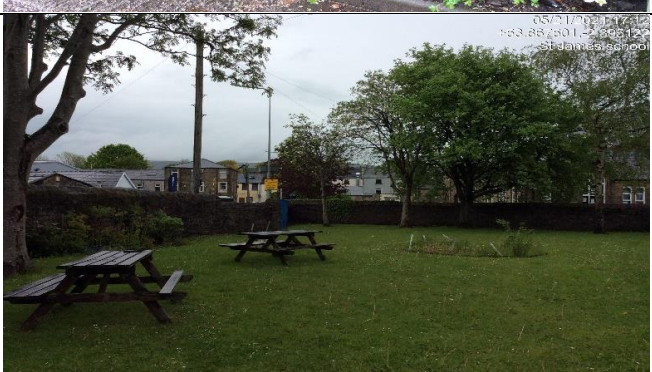
<p>T5</p>	<p>Amenity grassland at the front of the school which is surrounded by short sections of managed hedges (beech and ornamental species) along with scattered mature trees including rowan, silver birch and white beam. There is a small un-mown central area with greater species diversity and taller sward including Yorkshire fog, rose, daisy, dandelion, creeping buttercup, fescue grass, ornamental herb species, cleavers, and oxeye daisy. There are small sections of introduced shrubs planted at the grassland edge which include some rose, grey poplar, forget-me-not, dandelion, willowherb.</p>

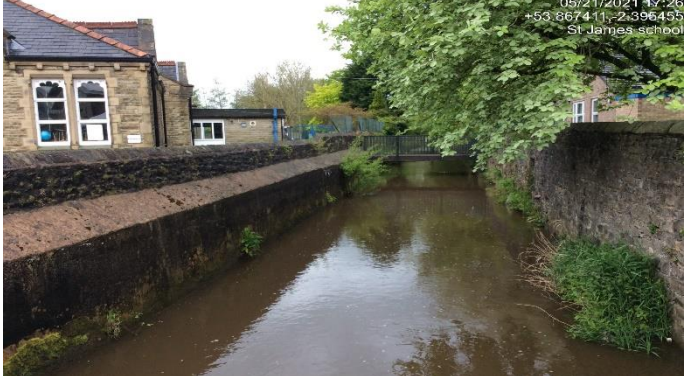
T6	<p>Mearley Brook approximately 6 m wide, intercepts the school campus and is out of the footprint of works. The brook is a channelised watercourse, roughly flowing north to south, with vertical stone embankments. The watercourse has an absence of emergent vegetation with ivy growth on the stone walls.</p>

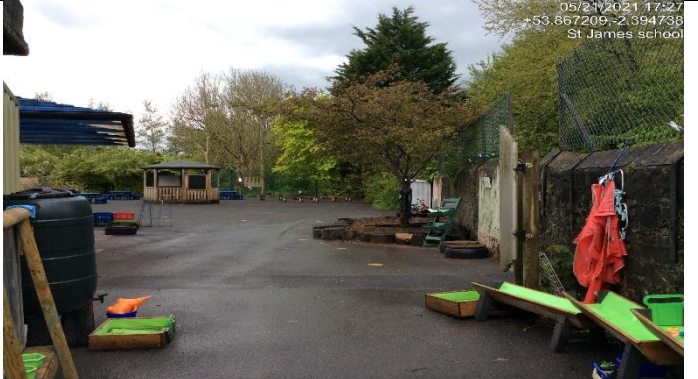
T7	<p>Playground is present at the rear of Building 2. This area comprises hard standing with scattered borders of introduced ornamental shrubs, scattered scrub and immature trees with the species identified as being the same as those listed in TN3, 4 and 5.</p>

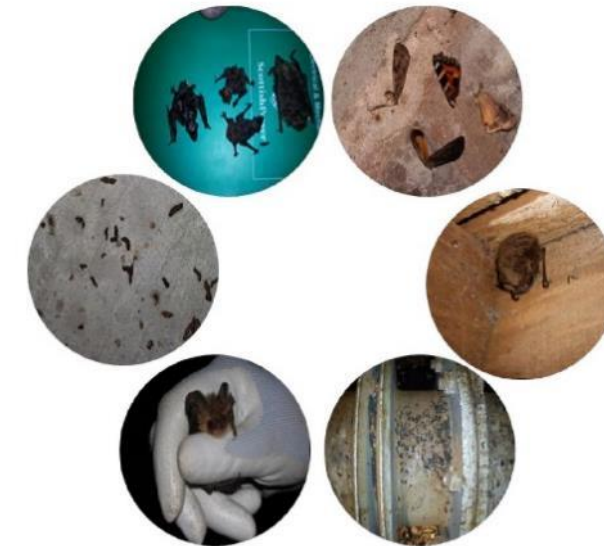
Places that bats may use in buildings

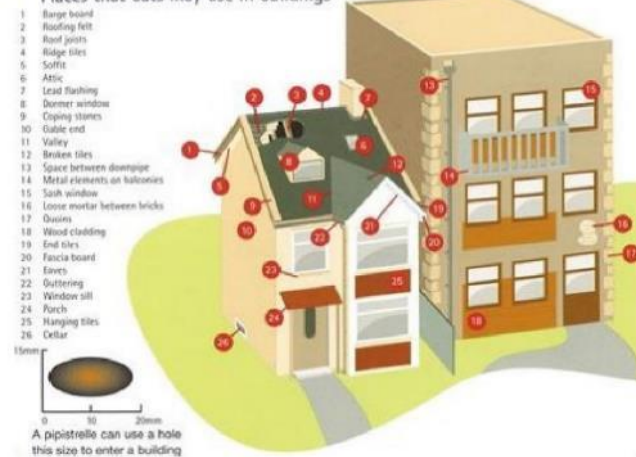
Schematic from www.bats.org.uk

Bats can roost in the following places:

- The top of gable end or dividing wall;
- The top of chimney breasts;
- Ridge and hip beams and other roof beams;
- Mortise and tension joints;
- All beams/ceilings/pipework (free hanging bats);
- The junction of roof timbers, especially where ridge and hip beams meet;
- Behind purlins;
- Between tiles and the roof lining;
- Under flat felt roofs;
- Under barge boards;
- In cavity walls;
- In cracks in stone or concrete;
- Behind peeling paint/wall coverings;
- Gaps behind window and door frames;
- Between window panes and timber boarding.
- In trees (cracks/holes/ivy cladding).
