**St James Primary School, Clitheroe**

***Preliminary Ecological Appraisal***

July 2021

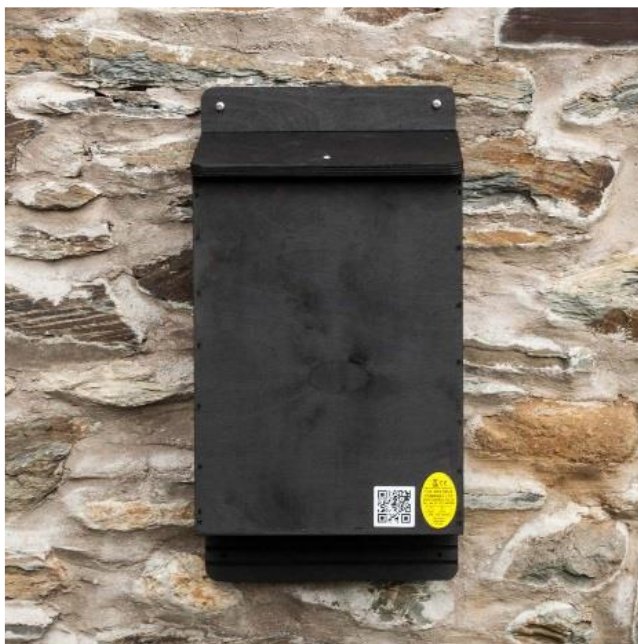
Figure 2. Roost maternity bat box

- **Prior to the commencement of works**, a single Roost Maternity Bat Box (See Figure 2 below) with multiple internal crevices will be installed on a mature tree under the supervision of an experienced ecologist, along the perimeter of the school grounds. The bat box will be used to receive any bats found during the works and be retained for long term enhancement of bat roosting habitat within the surrounding area.

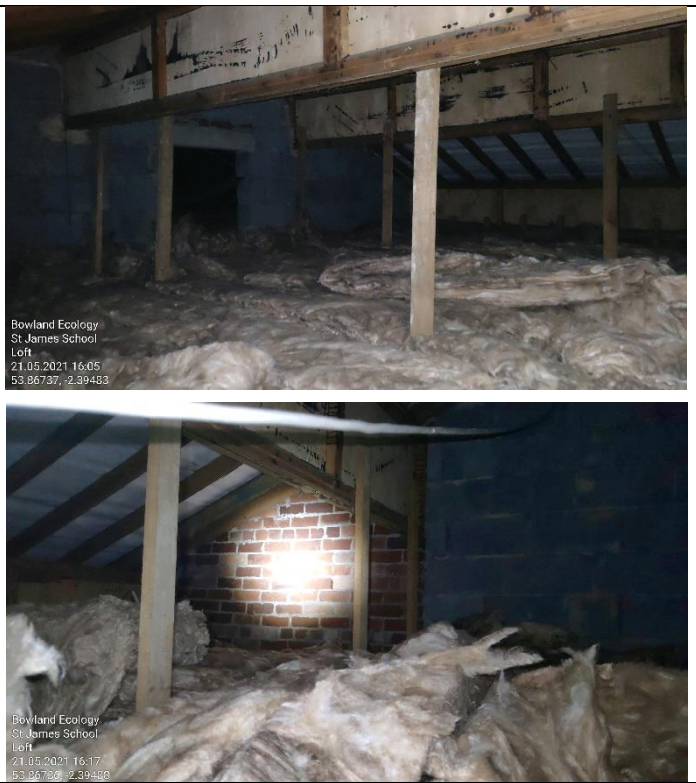
Ref	Description	Photograph
B1	<p>B1 is situated to the west of the site and is an Irregular T-shaped, single storey school building. The walls are constructed of brick with small areas of external concrete render and wooden cladding. There are several areas of extensions to the main school building as evidenced by several different roof structures and compositions. The majority of the roof is pitched with gable ends at the south-eastern and north-western elevations. The main hall section of the school towards the north-west is much taller than the rest of the school and has a pitched roof with gable ends at the north-east and south-west elevations. A small extension joins onto the main hall on the south-west elevation, this has a mono pitch roof which is constructed of corrugated metal. There is a small single storey-flat roof extension at the front of the building (north-eastern elevation) which houses the entrance. The fascia boards and soffit boards are a combination of plastic and wood construction.</p> <p>The south-east elevation comprises a gable end and single storey flat roof extension which faces towards Mearley Brook. There are three identified gaps suitable for roosting bats: 1) a gap at the southern corner where the roof edge meets the wall plate and the soffit, measuring 10 cm by 10 cm and of an undetermined depth which may lead into the roof space; 2) a gap at the peak of the gable end beneath the end ridge tile with undetermined dimensions that may lead into the roof space or into the ridge tile void; and 3) an identical gap to gap 1) on the opposite eastern corner of the building.</p> <p>The south-western elevation is at the rear of the school and faces towards the playground, a combination of hard standing, amenity grassland and broadleaved woodland. There is a permanent awning structure which extends outwards from approximately half of the building on the eastern side. The roof tiles and ridge tiles on this elevation appear to be well sealed. There are three visible gaps suitable for roosting bats: 1) a small gap measuring approximately 5 cm by 8 cm at the corner of the tall main hall windows where the soffit meets the wall plate and adjacent to an exterior light; 2) a long gap between the soffit and wall plate which is approximately 2 cm by 3 cm and extends along the edge of the main hall building at the roof valley; and 3) gap beneath the white fascia along the entire gable end of the main school hall building.</p> <p>The north-eastern elevation is at the front of the school and faces a small area of amenity grassland, scattered trees and shrubs which are situated in front of Greenacre street. This elevation is well sealed for bats apart from a</p>	<p>Bowland Ecology St James School South west 21.05.2021 16:36 53.86731, -2.39502</p> <p>Bowland Ecology St James School North east 21.05.2021 16:36 53.86758, -2.3947</p> <p>Bowland Ecology St James School South east 21.05.2021 16:32 53.86727, -2.39477</p> <p>05/01/2021 17:18 +53.867730, -2.395220 St James school</p>

<p>single small gap beneath the gable end peak ridge tile of the northern extension area. The gap measures approximately 5 cm square with possible interior access to the loft. The north-western elevation faces the alley and is well sealed with negligible potential for roosting bats.</p> <p>B1's internal loft space was accessed via three loft hatches throughout the school. The loft space consists of one continuous space which is sectioned by breeze block walls which have small crawl-space entryways between. The roof is lined with breathable roofing membrane and has wooden rafters, purlins and vertical struts. The vertical struts are partially boarded between with plywood. The space is well-insulated on the floor and is rarely used, seemingly only for access to any wiring or pipework which are present in the loft. There are no obvious areas of exterior light spill viewed from the loft hatches which suggests no large gaps to the exterior. No signs of bats were identified from the loft hatch vantage points. Several undisturbed cobwebs were noted and a single mouse dropping was discovered. B1 is considered to have <b>low potential</b> to support roosting bats.</p>

<p>Bowland Ecology St James School Loft 21.05.2021 16:05 53.86737, -2.39483</p> <p>Bowland Ecology St James School Loft 21.05.2021 16:17 53.86737, -2.39483</p>

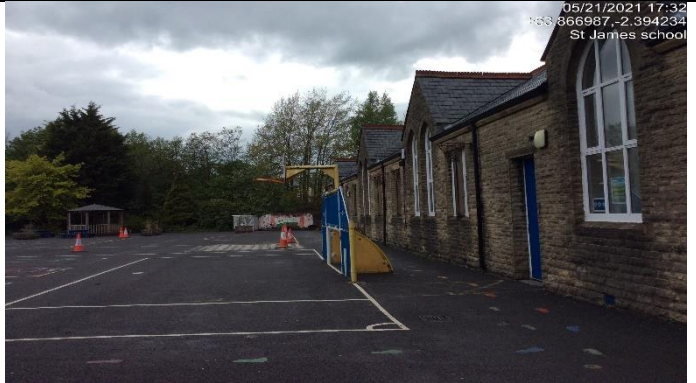
<p>B2 A small extension will be constructed on the western elevation after the demolition of the toilet block. Building 2 is situated to the east of the site and is constructed of stone walls with a slate tiled roof. The roof structure is complex and includes gable roof sections, hipped roof sections, flat roofed sections, along with window dormer sections. Negligible bat roosting features were identified - the building is in good condition and well-sealed.</p>

As Building 2 had negligible bat roost potential, no further survey or mitigation measures with respect to bats are required.

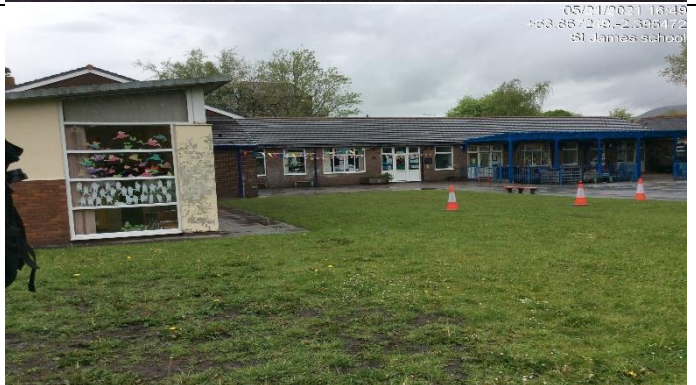
<p>05/21/2021 17:32 53.866987, -2.394234 St James school</p>
<p>T1 Amenity grassland comprising the school playground occupies half the northeast and southwest areas of the western half of the site. The grass is managed resulting in a short sward height. Species present include perennial rye grass meadow grass species and red fescue along with herbs including red clover, daisy and dandelion. The grassland is generally flat although there is a mound towards the south</p>

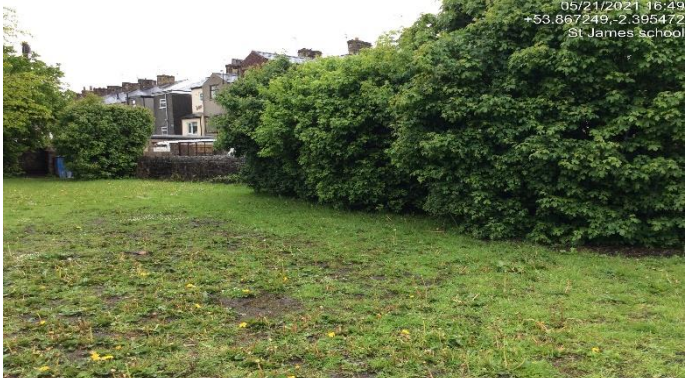
<p>T2</p>	<p>A short (approximately 10 m in length) hedgerow is present at the edge of the amenity grassland playground. The hedge is approximately 3 m tall and 2 m wide with a species composition of field maple and privet.</p>

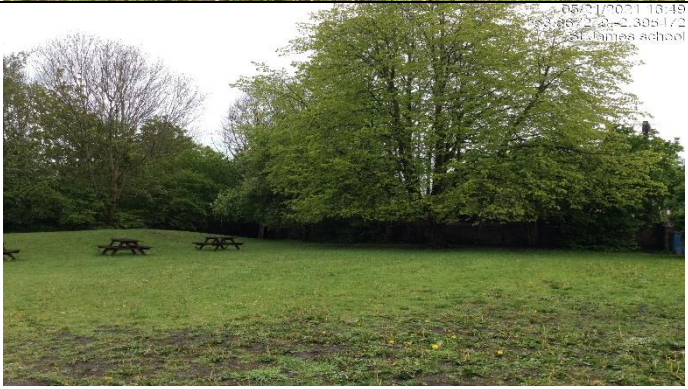
<p>T3</p>	<p>Mature trees surround the southern boundary of the amenity grassland and hard standing playground forming a woodland strip. Canopy species include lime, alder, ash, beech, hazel, willow, sycamore, poplar, rowan, field maple and silver birch with an understory of holly, hawthorn and hazel. The ground flora is predominantly amenity grassland with scattered perennial plants at the perimeter including wood avens, broadleaved willowherb, creeping buttercup, herb Robert, lesser celandine, common nettle, ivy, common hogweed and holly. There are some areas of leaf litter and patches of bare ground.</p>

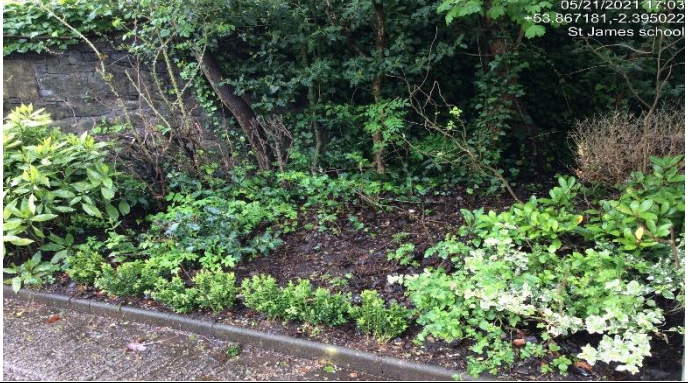
<p>T4</p>	<p>A small area of ornamental planting is present to the north of the woodland strip. Species present include ornamental non-native shrubs along with privet, rose and holly.</p>

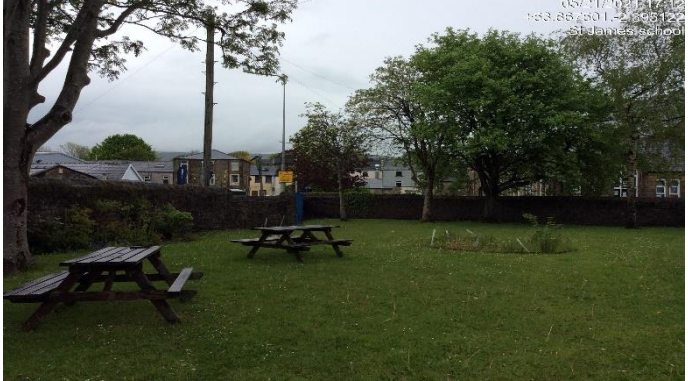
<p>T5</p>	<p>Amenity grassland at the front of the school which is surrounded by short sections of managed hedges (beech and ornamental species) along with scattered mature trees including rowan, silver birch and white beam. There is a small un-mown central area with greater species diversity and taller sward including Yorkshire fog, rose, daisy, dandelion, creeping buttercup, fescue grass, ornamental herb species, cleavers, and oxeye daisy. There are small sections of introduced shrubs planted at the grassland edge which include some rose, grey poplar, forget-me-not, dandelion, willowherb.</p>

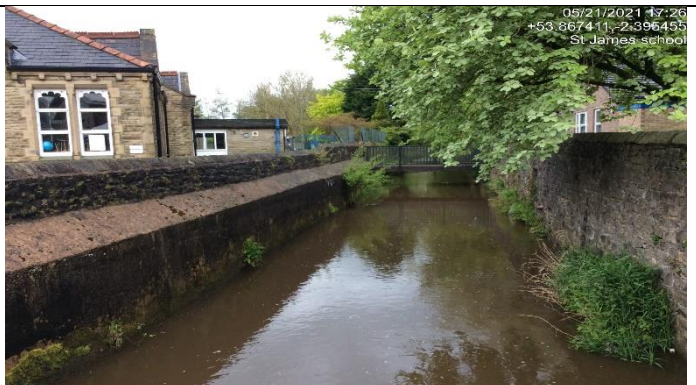
<p>T6</p>	<p>Mearley Brook approximately 6 m wide, intercepts the school campus in the centre and is out of the footprint of works. The brook is a channelised watercourse, roughly flowing north to south, with vertical stone embankments. The watercourse has an absence of emergent vegetation with ivy growth on the stone walls. At the time of the survey the brook had a moderate flow rate and was slightly discoloured brown, possibly due to recent heavy rain.</p>

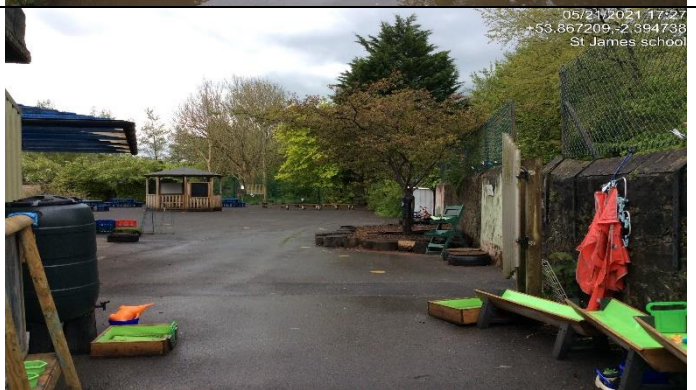
<p>05/21/2021 17:26 +53.867411,-2.396455 St James school</p>
<p>T7</p>	<p>Playground is present at the rear of Building 2. This area comprises hard standing with scattered borders of introduced ornamental shrubs, scattered scrub and immature trees with the species identified as being the same as those listed in TN3, 4 and 5.</p>

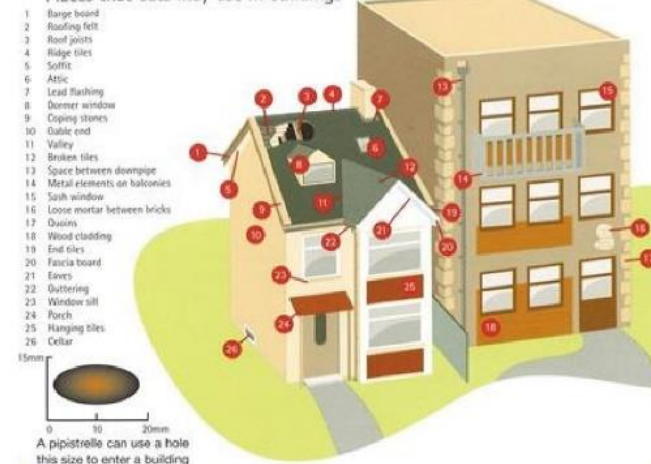
#### Places that bats may use in buildings

Schematic from [www.bats.org.uk](http://www.bats.org.uk)

- The top of gable end or dividing wall;
- The top of chimney breasts;
- Ridge and hip beams and other roof beams;
- Mortise and tension joints;
- All beams/ceilings/pipework (free hanging bats);
- The junction of roof timbers, especially where ridge and hip beams meet;
- Behind purlins;
- Between tiles and the roof lining;
- Under flat felt roofs;
- Under barge boards;
- In cavity walls;
- In cracks in stone or concrete;
- Behind peeling paint/wall coverings;
- Gaps behind window and door frames;
- Between window panes and timber boarding.
- In trees (cracks/holes/ivy cladding).
