DAYTIME BAT SURVEY & ECOLOGICAL SCOPING SURVEY

THE BARN BY THE RIVER, KENYON
LANE, DINCKLEY, LANCASHIRE

JULY 2021

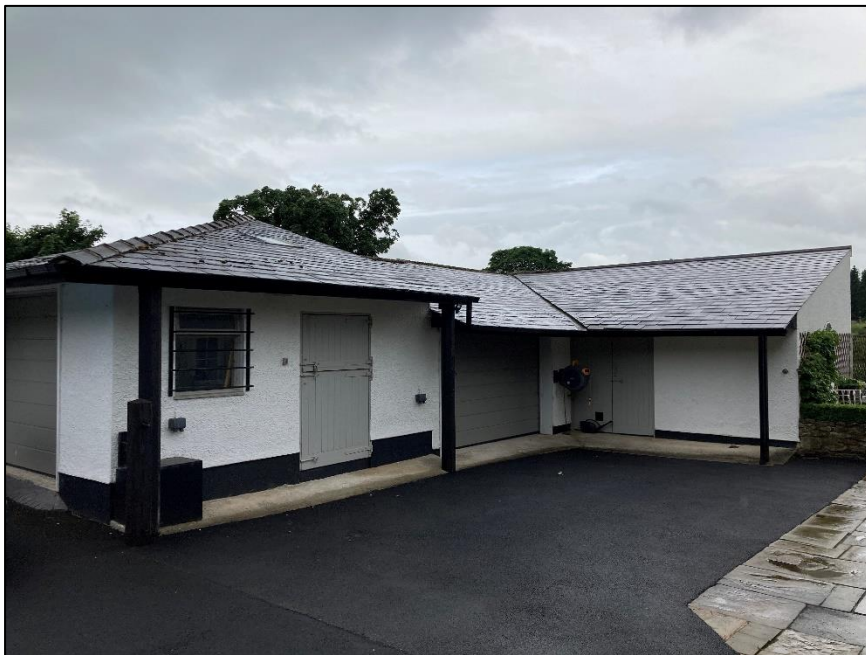
- 3.2 The garage and store is a well-maintained structure (see Photograph 1). The render is intact throughout with no missing masonry on the exterior. All windows and doors are intact and the frames are well-sealed to the surrounding walls. The majority of the structure is painted white with one wall painted blue.

Photograph 1 showing the front exterior of the garage/store

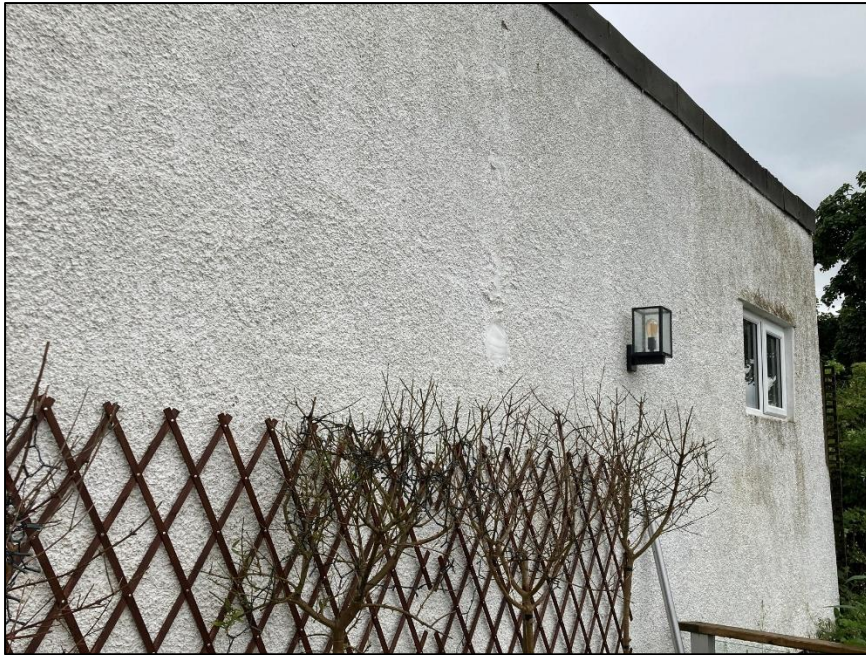
Photograph 2 showing the rear exterior of the garage/store

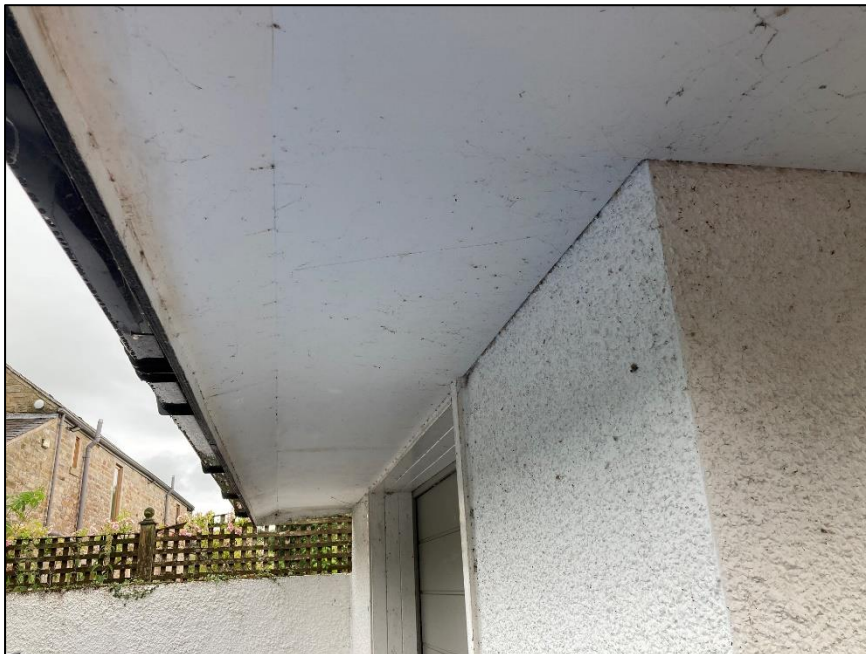
- 3.3 An overhang exists at the front of the structure (see Photograph 3). This is intact and the boards are flush to the walls. The walls and overhang support cobwebs. A gap exists between wooden timbers above the garage (see Photograph 4). This is heavily cobwebbed and was investigated with an endoscope with no evidence of bat usage found.

Photograph 3 showing the overhang

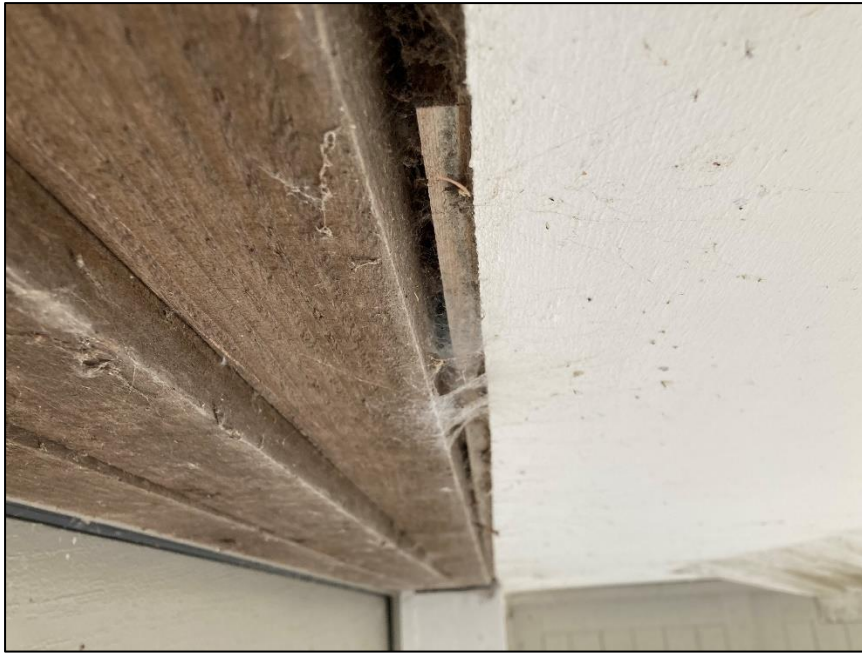
Photograph 4 showing the cobwebbed gap

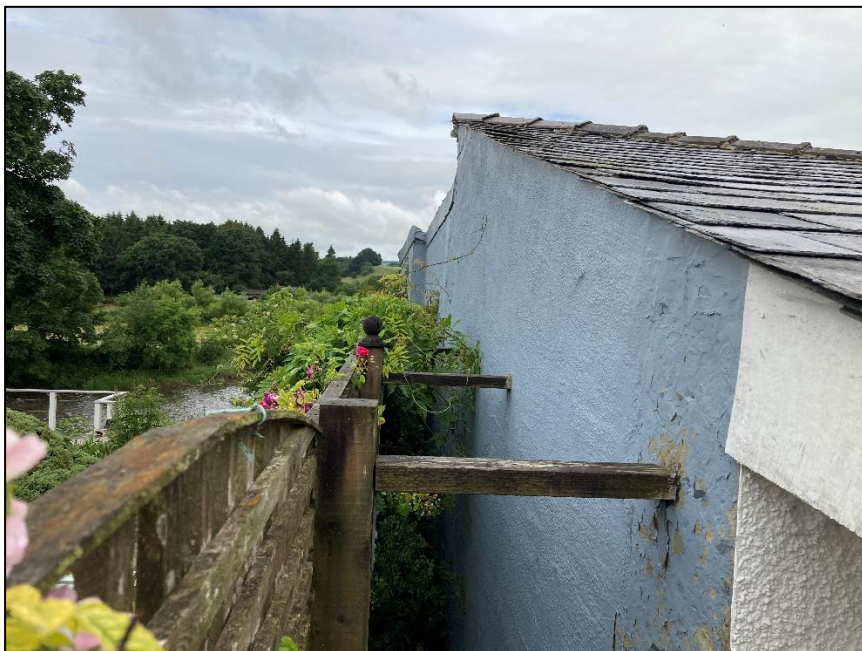
- 3.4 The roof is pitched and tiled, with all roof tiles in situ and flush to one another (see Photograph 1 above and 5 below). Skylights exist which are intact. The ridge tiles are all intact. Where the roof edges meet the walls, these are sealed with mortar, with no gaps. Where roofs meet, and lead flashing occurs (see Photograph 6), this is flush to the walls and tiles. Wooden bargeboards and plastic guttering exist in places and these are well-maintained and flush to the walls. No potential bat entry/exit points were found across the exterior of the structure.

Photograph 5 showing the roof and west-facing edge

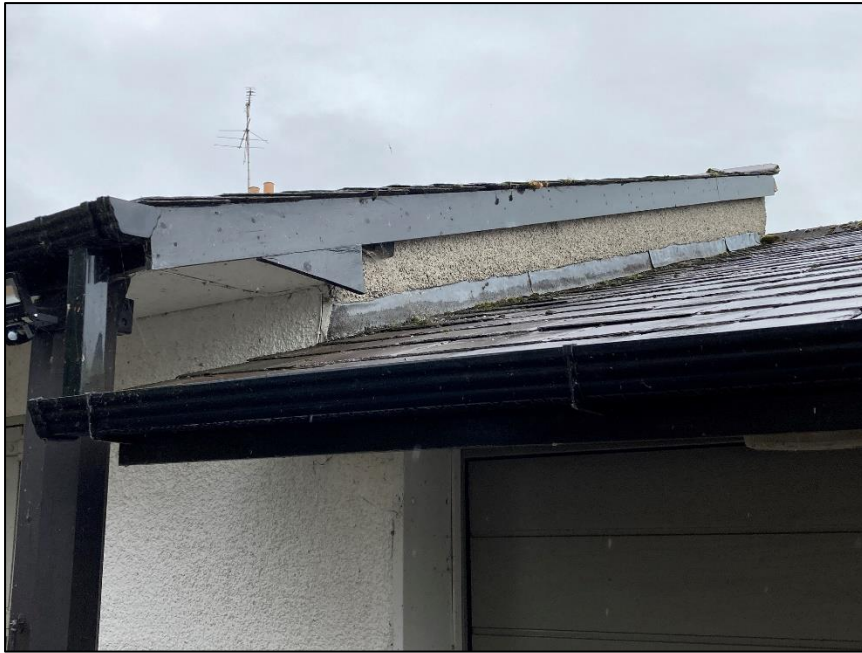
Photograph 6 showing the roof edges and flashing

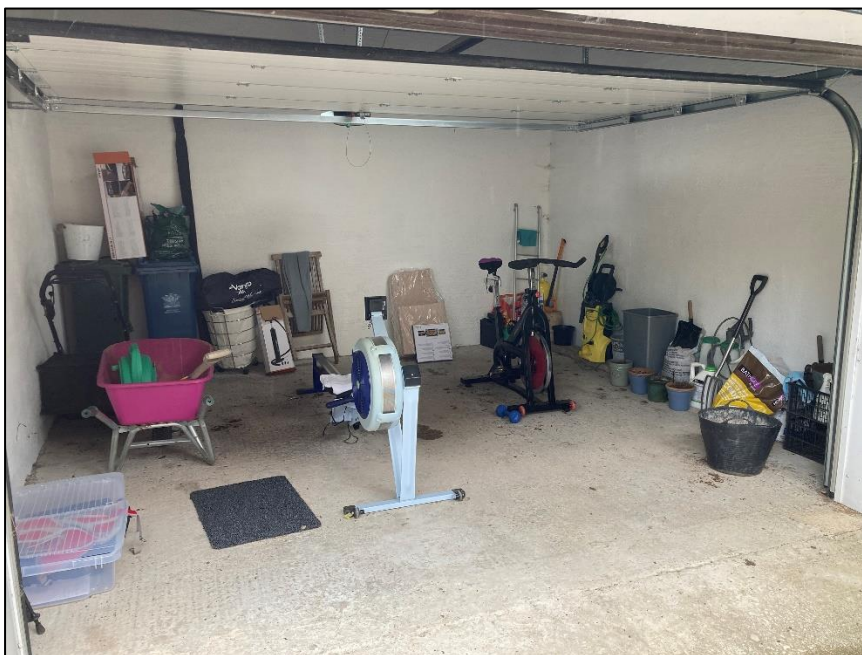
- 3.5 Internally, the garage and store are well-lit spaces and both are in use (see Photographs 7 and 8). The interior walls are whitewashed and intact. The flooring is concrete.

Photograph 7 showing the interior of the garage

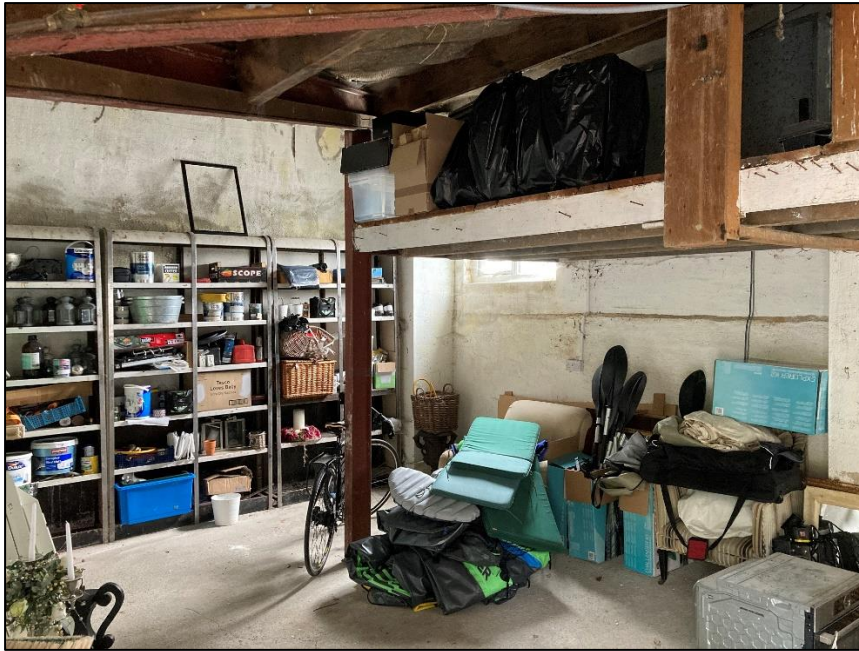
Photograph 8 showing the interior of the store

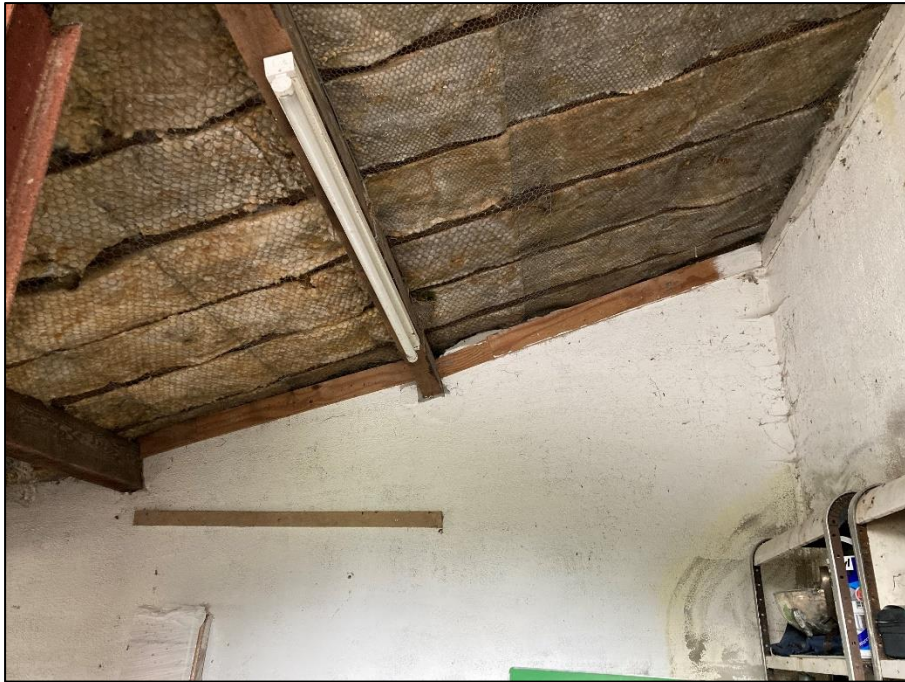
- 3.6 No roof voids exist throughout the garage and store. The roof structure throughout is in excellent condition (see Photographs 9 and 10). Felt roof lining is in place across parts of the roof and this is intact with no tears or gaps. The roof timbers are also intact with no cavities. Above the store, the roof is insulated and sealed with chicken wire. No daylight could be seen at any part of the roof. Heavy cobwebs occur throughout and the skylights and windows cause the roof and spaces to be well-lit.

Photograph 9 showing the interior roof of the store

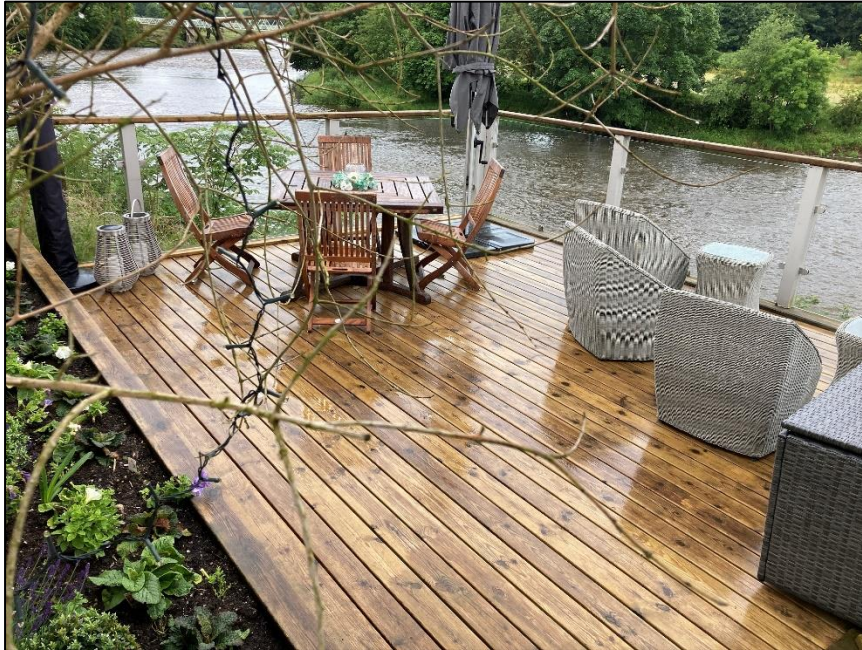
- 4.1 The building is immediately surrounded by hardstanding, which comprises tarmac and paved areas, used for access and parking. To the rear of the structure lies an area of decking (see Photograph 11). A flowerbed separates the decking from the wall of the structure.

Photograph 11 showing the decking

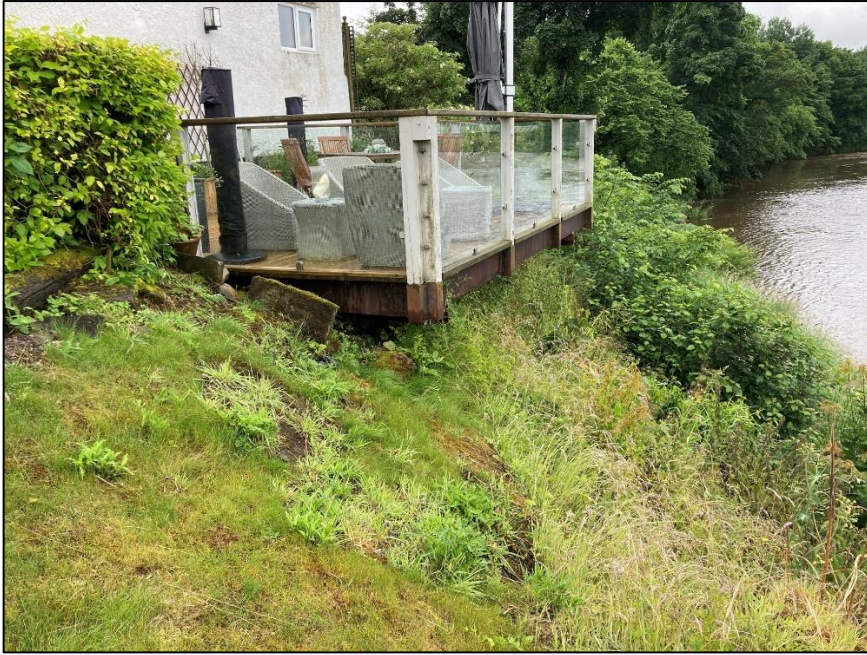
- 4.2 The decking lies within a slope leading down to the river (see Photograph 12). To the west of the decking lies scrub and grassland. To the south and east lies rank grassland and ruderal species including Common Nettle *Urtica dioica* and Creeping Thistle *Cirsium arvense*. To the east of the site (off-site) lie lawns, flowerbeds, shrub beds and patio areas, which form part of the gardens of the main dwelling.

Photograph 12 showing the decking and riverbank

- 5.3 The decking will be slightly extended to the west and this will involve the loss a small amount of scattered scrub and rank grassland. Given the construction zone is more or less the footprint of the building, with a small extension to the decking, then there is expected to be no deleterious impact on the riverbank habitats.

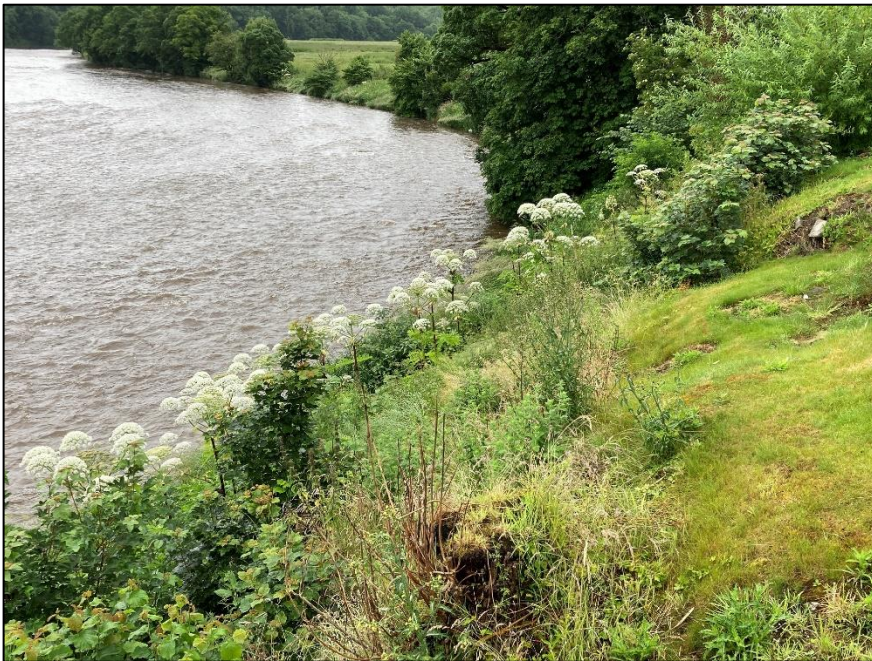
- 4.3 No invasive, non-native species exist on the proposed development site. Giant Hogweed *Heracleum mantegazzianum* lies 15 metres from the site close to the water. This is an invasive, non-native species and is listed on Schedule 9 Part II (plants) of The Wildlife and Countryside Act 1981 (as amended), making it an offence to allow this species to spread into the wild.

Photograph 13 showing the Giant Hogweed

- 5.4 Giant Hogweed, an invasive, non-native species, was found approximately 15 metres from the development site. This should remain undisturbed throughout the construction phase or, if it lies on land within the developers control, it should be eradicated using a suitable herbicide (approved for use near water).
