**BAT SURVEY AT -
RAKEFOOT BARN
CHAIGLEY
CLITHEROE**

**DATE AND TIME OF VISIT
26th July 2021 6.00pm**

REFERENCE. Mr Milligan

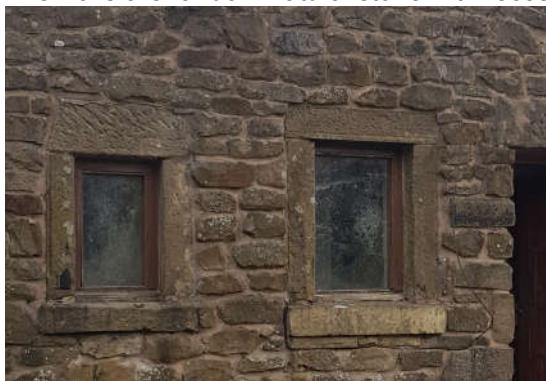
WALL CONSTRUCTION

The walls are random natural stone with recessed pointing.

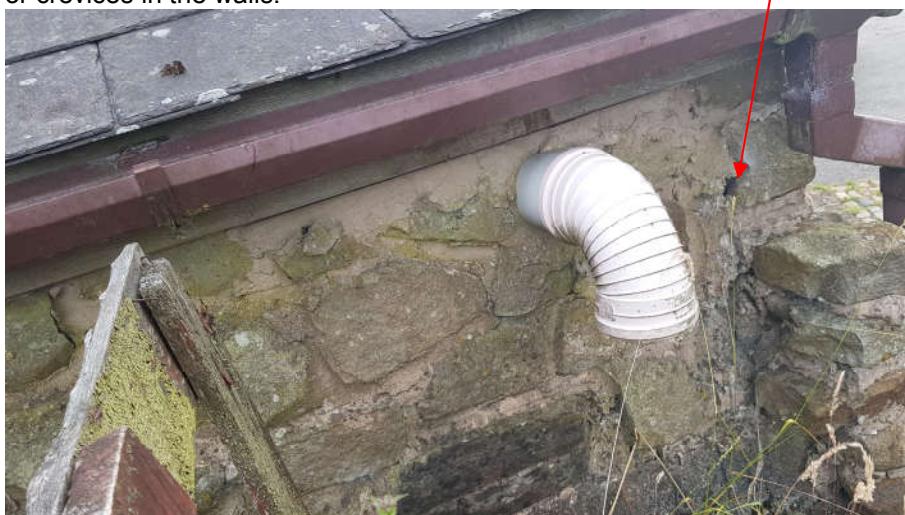
BAT ACCESS POINTS IN WALLS

All the visible sections of wall were closely examined, a small crevice in the north east side elevation near to the front was inspected. No evidence of bat presence was found. There were no other cracks or crevices in the walls.

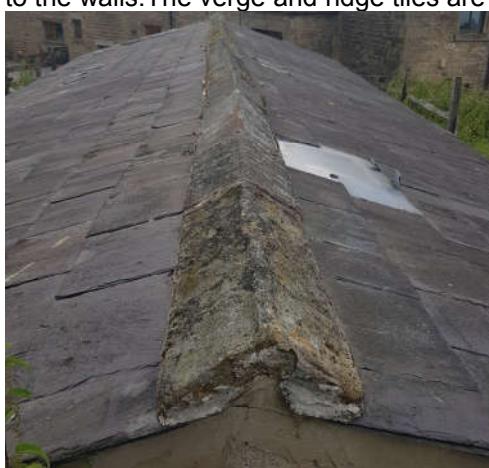
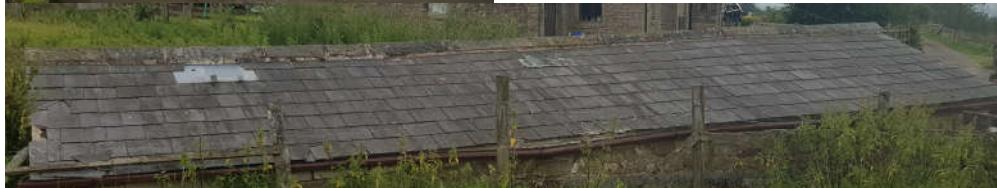
ROOF CONSTRUCTION

The roof is pitched with a blue slate finish with a small glazed rooflight. Timber fascias are fixed flush to the walls. The verge and ridge tiles are pointed.

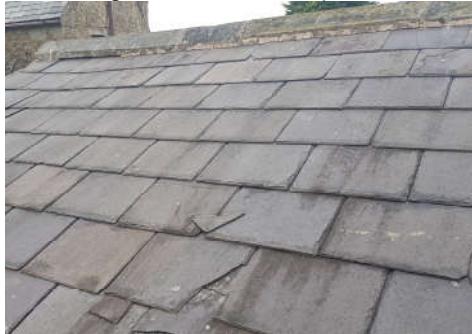
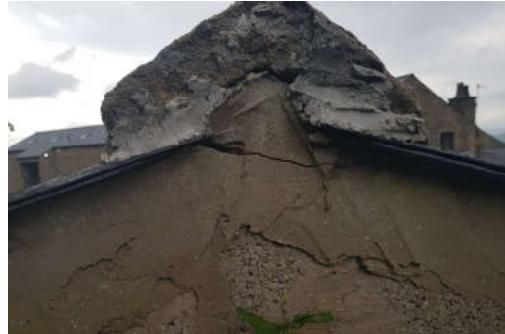
BAT ACCESS POINTS IN ROOF

The roof could be examined very closely, the slates are very tight fitting and in reasonable condition with the exception of a missing slate on the rear verge north west pitch and some broken slates on the south west pitch. however there was no potential for bat access or crevices to provide roost potential. The verges and ridge tiles were well pointed and did not provide cracks or crevices suitable for bat ingress. No access points, cracks or crevices were found.

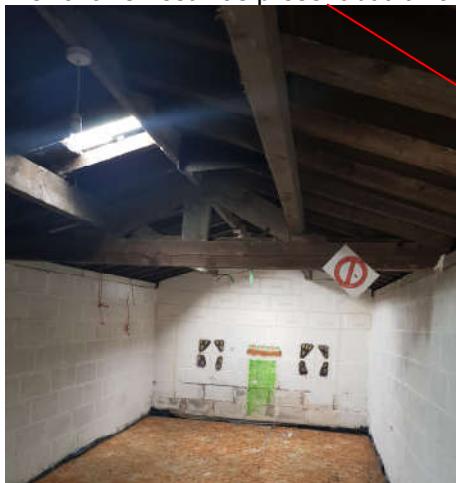
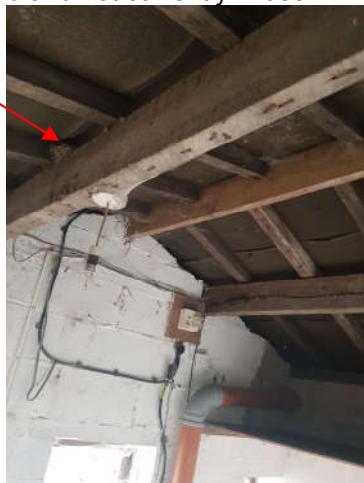
ROOF SPACE

There was no enclosed roof void in the building, the timber, truss, purlins and rafters was clearly visible and could be examined closely. All the timbers were in good condition with no signs of rot, cracks or crevices providing potential roost habitat. The felt was in poor condition but close inspection did not reveal any current or historic bat presence.

A swallows nest was present but it was old and not currently in use.
