Re: Proposed development at 83 Chatburn Road, Clitheroe BB7 2AT (central grid reference: SD 74850 42497)

Thank you for your request for a bat survey at the above site. I understand that the proposed development is for a rear single storey extension to the existing dwelling house.

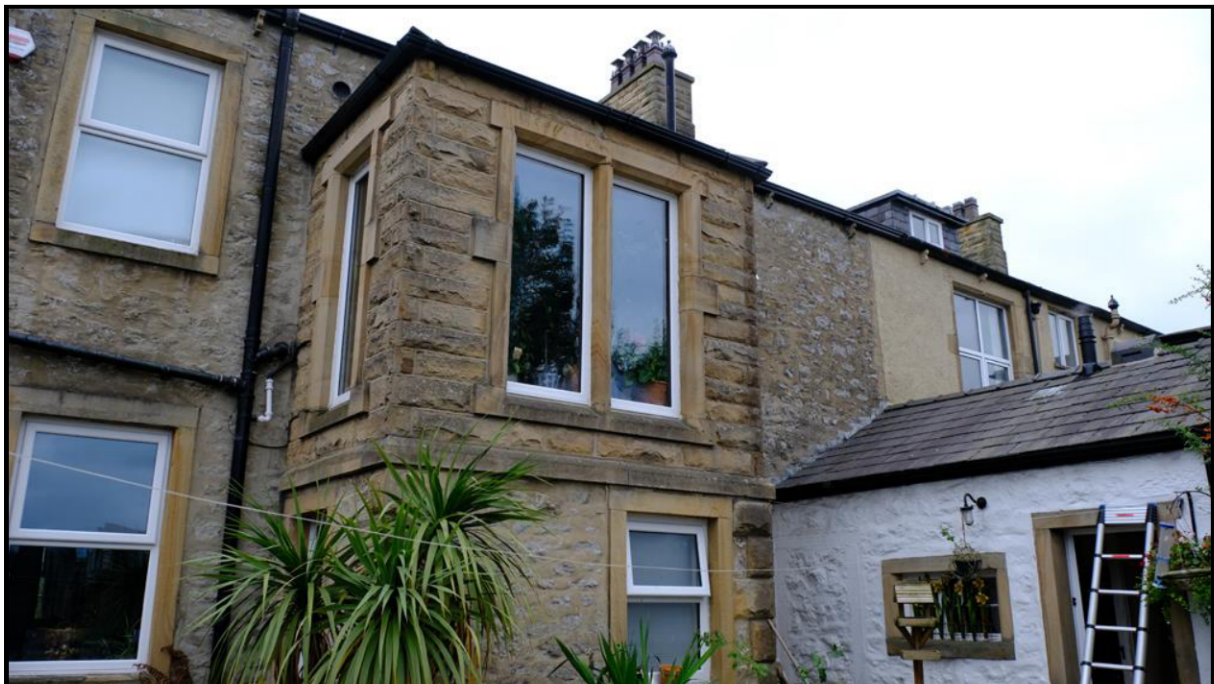
View of 38 Chatburn Road (rear elevation) showing location of proposed single storey extension

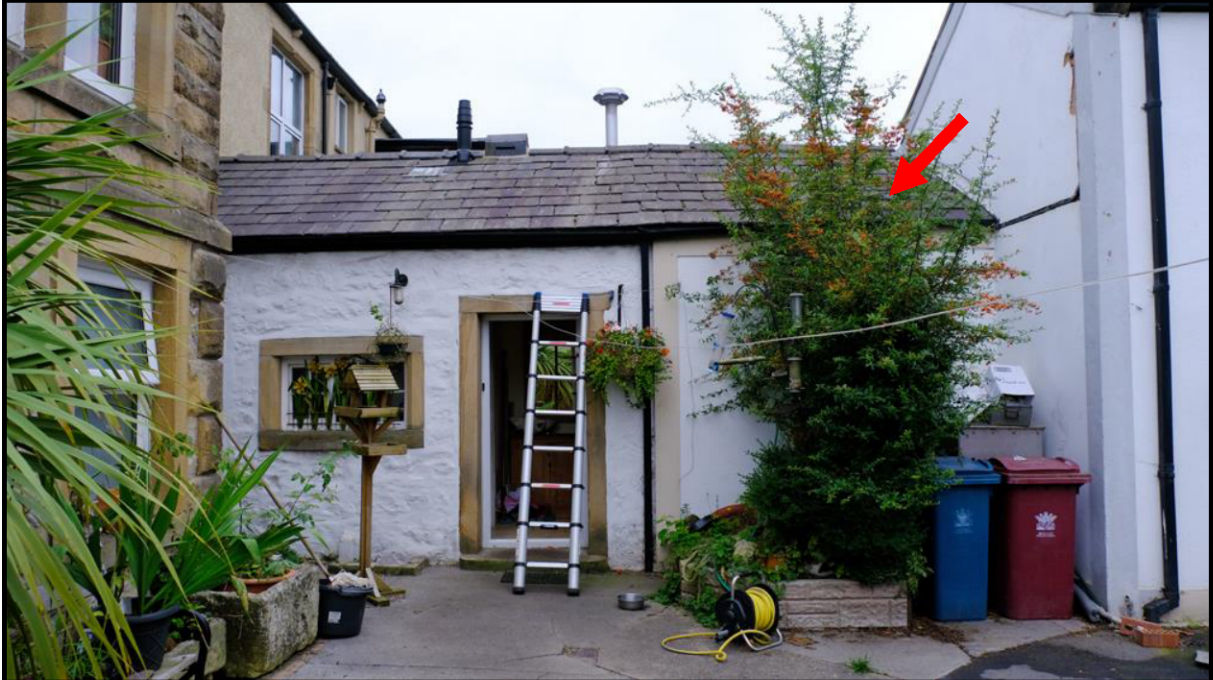
The roof of the single storey extension (utility room) is dual pitched and covered with slate. A small number of gaps associated with the natural fit of the slate are visible and there are a small number of gaps associated with the ridge. Two small roof voids were accessed and inspected. The void to the east contains a skylight, plastered internal walls, lath and plaster under-boarding and rockwool insulation on the floor. This roof void is well sealed apart from a single roof vent. Potential access by bats through this vent is very unlikely and in any case the level of light incursion due to the presence of the skylight makes roosting conditions for bats unsuitable.

The location of the proposed building extension lies with a hardstanding rear garden with planted shrubs and potted plants. Amongst these shrubs and lying directly adjacent to the proposed development area is a non-native invasive cotoneaster species.

View of single storey extension (utility room) showing slate roof coverings with occasional gaps present between slates and ridge. Cotoneaster plant growing in brick planter (red arrow)

Protected Species	Impacts /Predicted Impacts	Action Required
Bats	<p>It is advised that there is no evidence to suggest that bats pose a constraint to the proposed development.</p> <p>It is advised that there are potential roost features (gaps) suitable for bats associated with slate roof coverings. In this location and landscape setting, these features have low potential for bats to use throughout the year.</p> <p>All bat species are afforded full protection under The Conservation of Habitats and Species (Amendment) (EU Exit) Regulations 2019</p>	<p>Advice (mitigation): All personnel involved in proposed development works should be carefully advised about bats by a professional Ecologist, so that all works are undertaken with a clear understanding about legal aspects, precautions to be adopted and what to do if a bat is found. Prior to development.</p> <p>Advice (mitigation): As a precaution, it is advised that when removal or disturbance of potential roost features such roof coverings are to take place, this should be done carefully by hand. At all times.</p> <p>Advice (mitigation): If bats are found at any time during the development, work must stop until advice has been sought from an appropriately experienced Ecologist. If the development will affect bats, a licence may be required and suitable mitigation put in place. At all times.</p>

Non-native invasive plant species	Impacts /Predicted Impacts	Action Required
Cotoneaster species confirmed within garden planting	<p>It is advised that the proposed development will have to take account of non-native invasive plant species.</p> <p>Proposed works to the building will involve an amount of disturbance which could result in the spread of non-native invasive plant species which are listed on Schedule 9 of the Wildlife and Countryside Act 1981 (as amended).</p>	<p>Advice (mitigation): All personnel involved in the proposed development works should be made aware of the presence of non-native plant species and how to identify them, so that all works are undertaken with a clear understanding about legal aspects and working methods and precautions to be adopted. Prior to any work.</p> <p>Advice (mitigation): Where possible, leave all boundary and border plants in situ and avoid all activities that have the potential to disturb the ground/plants resulting in the further spread. If plants must be removed, they should be removed carefully by hand and all excavated material (soil and plants) should be removed from the site to a licensed landfill as controlled waste, or burnt on a bonfire where it will not cause nuisance to neighbours through excessive smoke or odour. Prior to and during any work.</p>

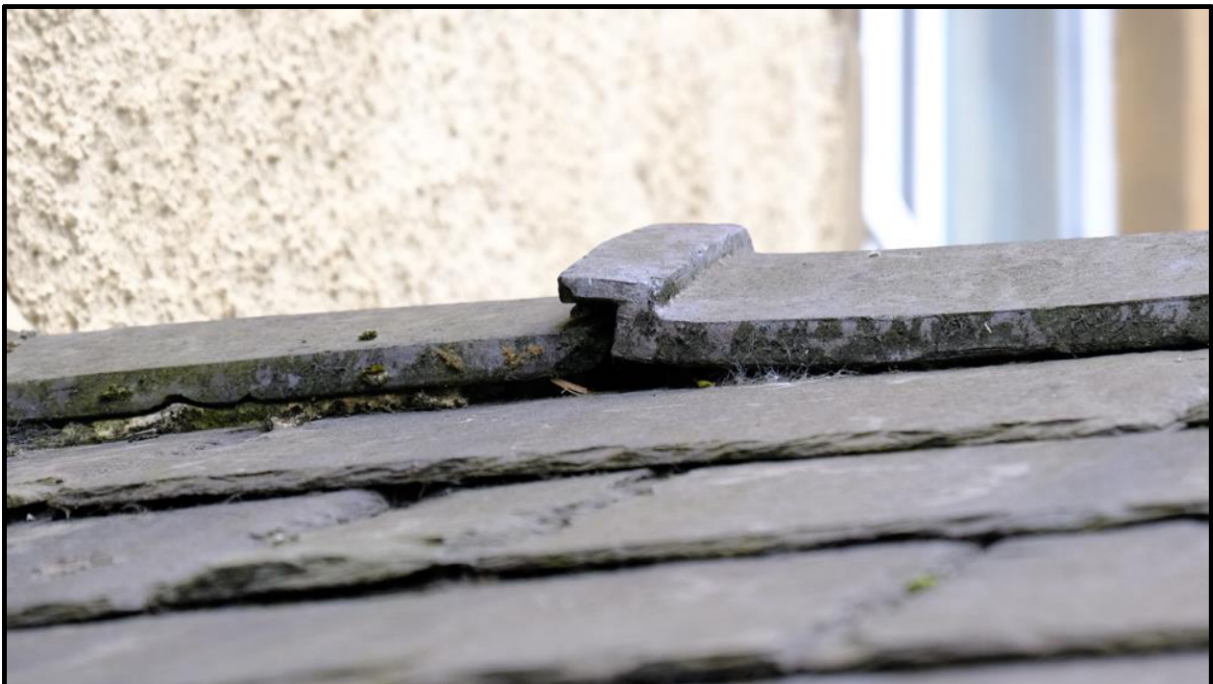
- Low potential – gaps associated with slate roof coverings on single storey extension (utility room)

Close up view of slate roof showing example gap at the ridge

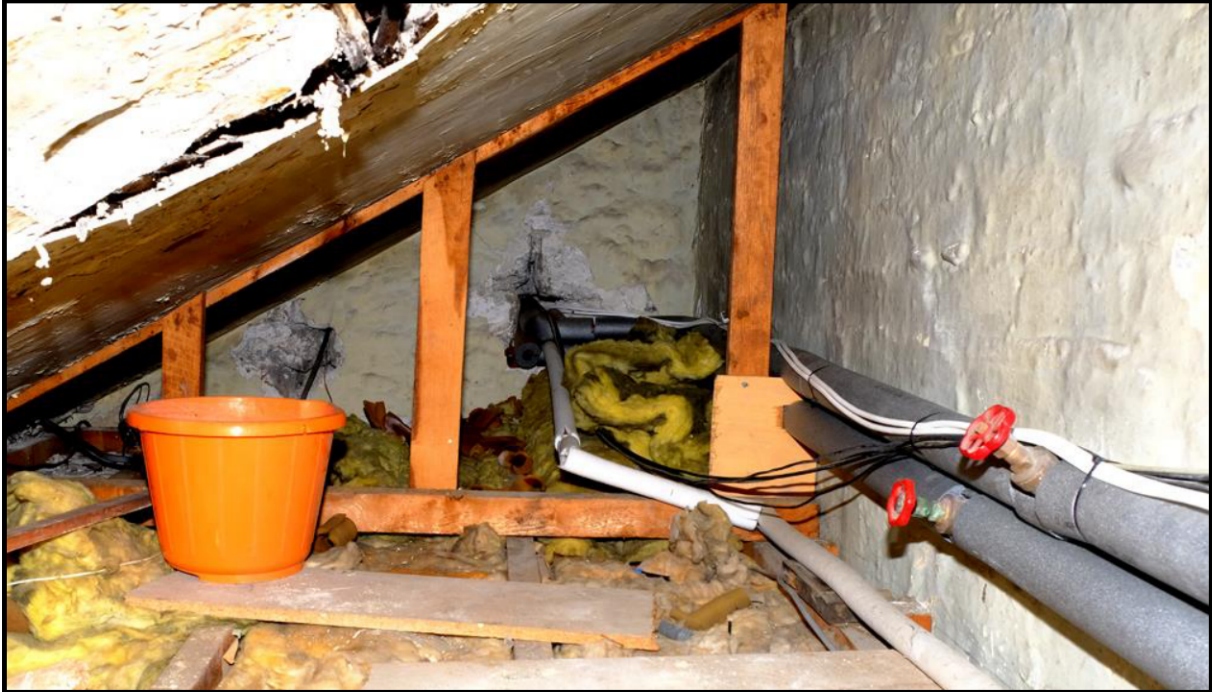
The second roof void to the west is smaller and darker. The roof is underlined with a modern roof membrane and plastic liner, there is a vertical crevice at the junction of the internal brick walls that could provide some use by bats but the whole void is well sealed with no potential access found.

Internal view of roof void above utility room (western end)

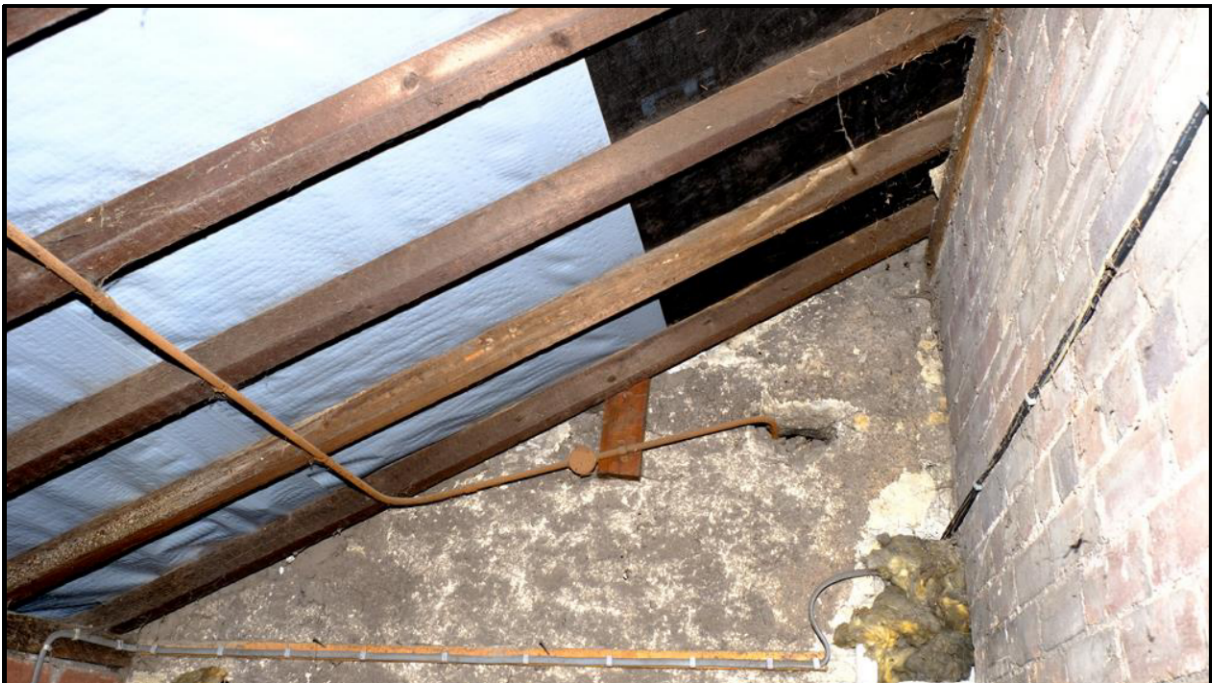
Internal view of roof void above utility room (eastern end)
