Preliminary Bat Roost Assessment Report

**4 Church Street,
Ribchester,
PR3 3XP**

12.07.2021

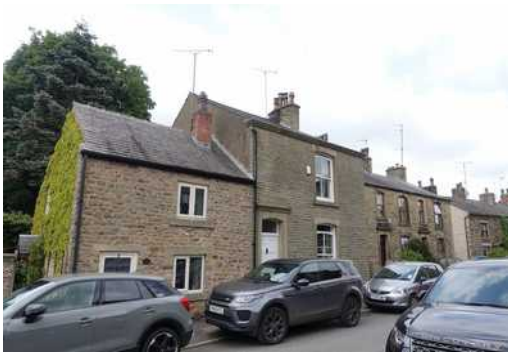
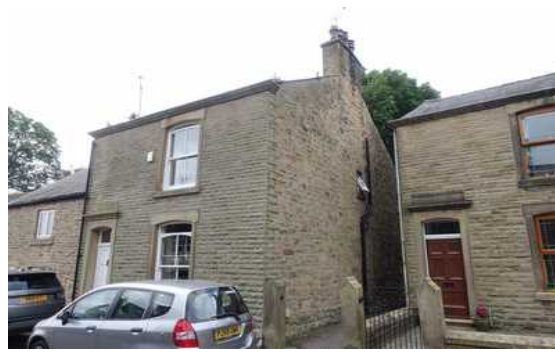
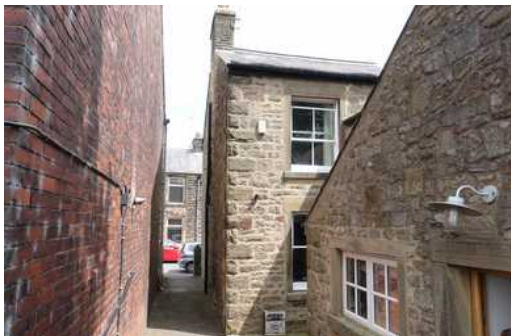
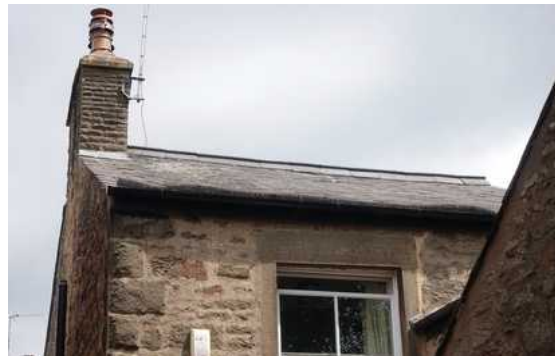
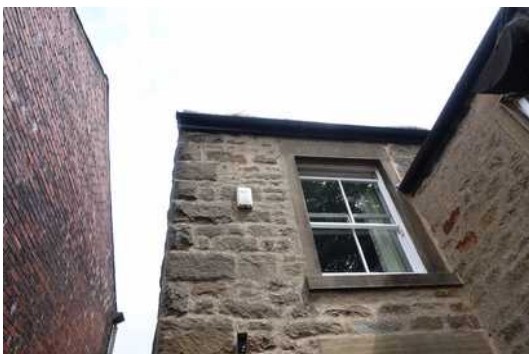
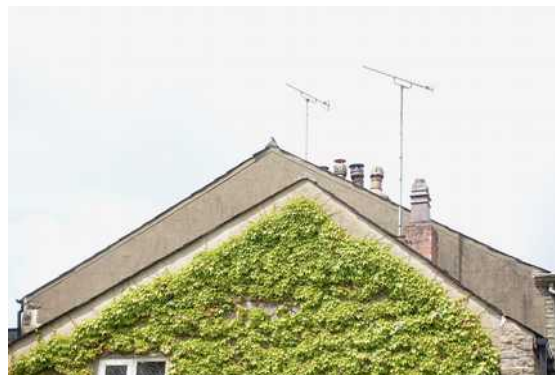
The property consists of a semi detached two storey house with a double pitched slate roof. External walls are well pointed with no obvious cavities, cracks, gaps or crevices present. The gables are well sealed. Fascia boards where present are close fitting with no obvious gaps present.

Roof slates are close fitting with no slipped, missing or lifted tiles present. The ridge tiles are pointed and well sealed.

The building can be considered to offer negligible roosting bat potential.
