**BAT SURVEY AT -
SEEDALLS FARM
EAVES HALL LANE
WEST BRADFORD**

DATE AND TIME OF VISIT
Scoping survey 9th Aug 2021 11.30 am
Emergence survey 10th Aug 2021 8.50 pm

REFERENCE NO. 6320

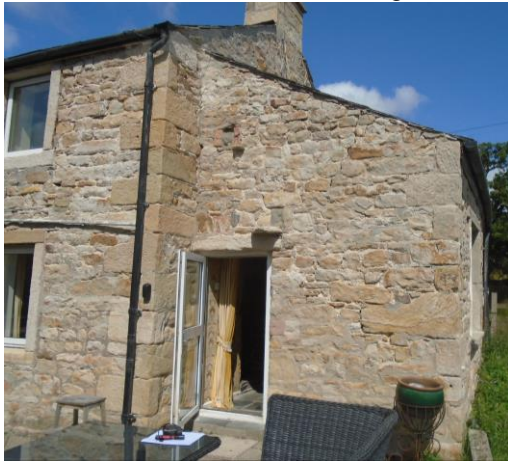
South elevation

The farmhouse is a linear building with a single storey lean to the eastern gable.

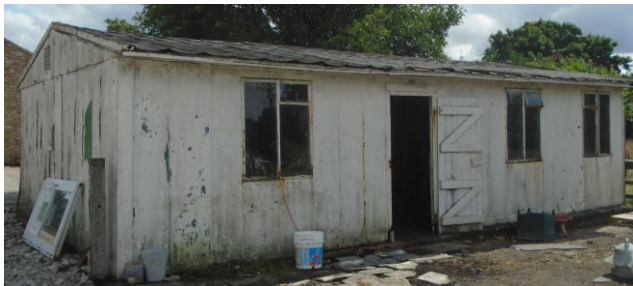
West elevation

The outbuilding is a single storey shed.

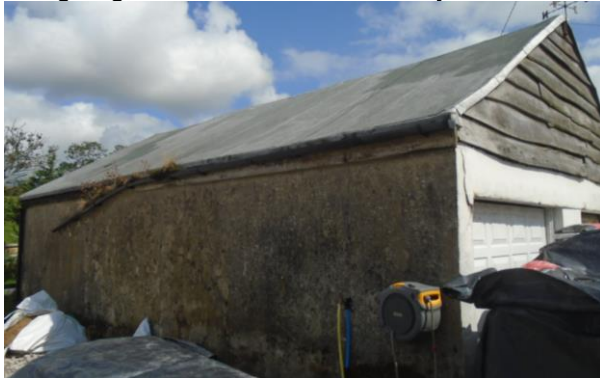
West elevation

The garage and stable block currently used for storage.

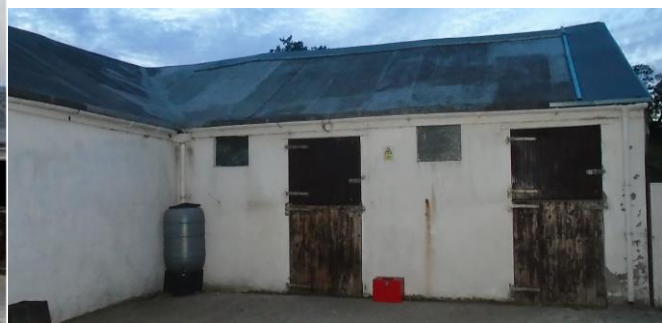
Dilapidated Bungalow

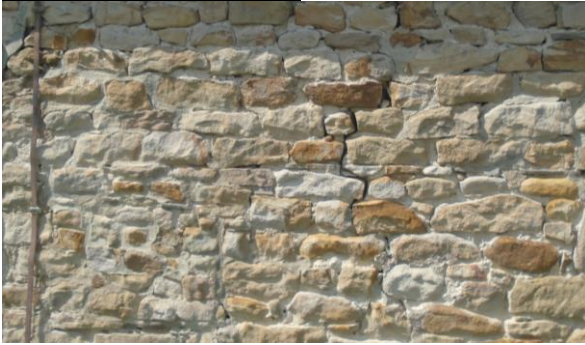
The house walls are random stone which has recently been sand blasted previously having had a white painted finish.

The stone work of the house gable and lean to is in good condition with some small recesses in the pointing due to the recent sand blasting. There are no access points into the building nor any crevices suitable for bat ingress.

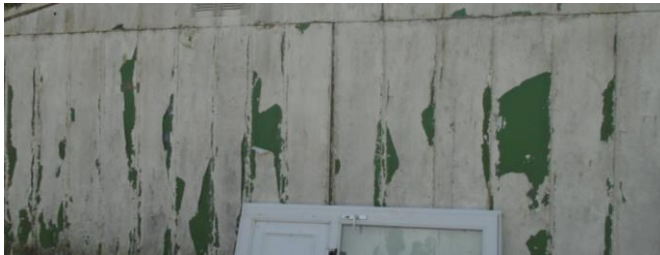
The outbuilding is a timber frame with a painted board finish.

The outbuilding walls whilst not in great condition do not provide any access points into the building or have any recesses or cracks with the potential to be used by bats.

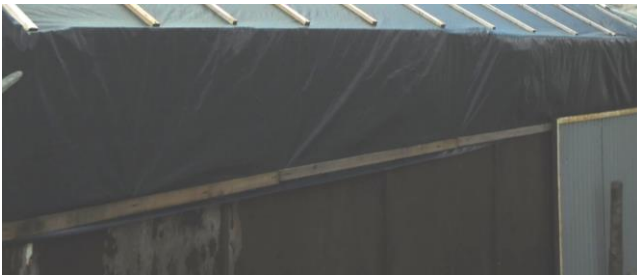
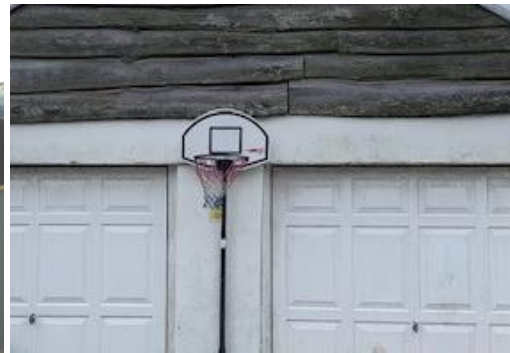
The Garage/ stable block is block work with a render finish, the front gable is timber boarding fixed to frame. The rear and side (east) elevation appear to be timber frame but are currently sheeted up .

The garage / stable block walls are in reasonable condition with the exception of the timber sections which are in a dilapidated state which may have some access potential although it was not possible to examine due to sheeting, which also serves to prevent access.

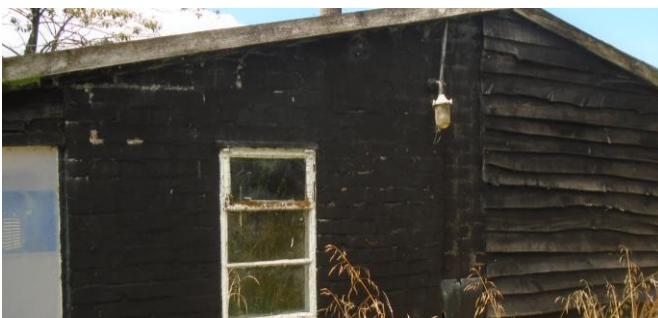
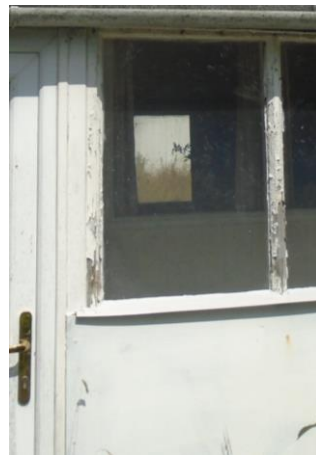
The Bungalow is a timber structure with a boarded either smooth or lapped finish.

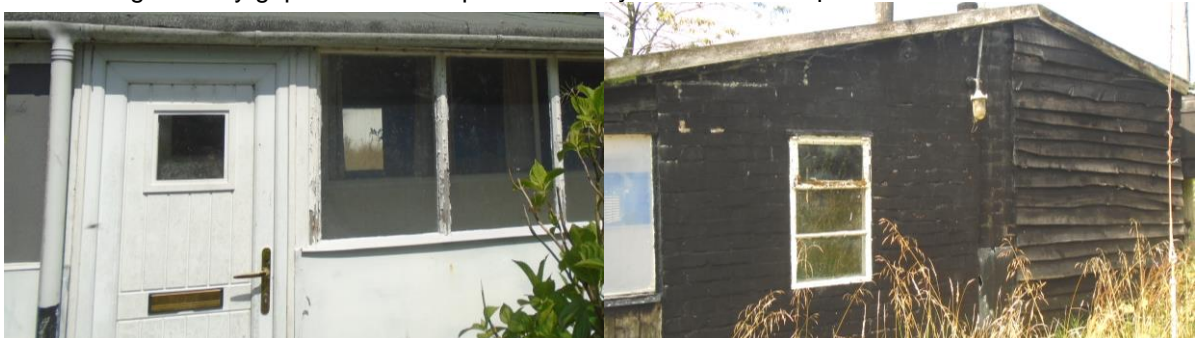
The Bungalow walls are generally dilapidated but the scale of the building meant that all the laps in the boarding and any gaps could be inspected closely. Bats were not present. .

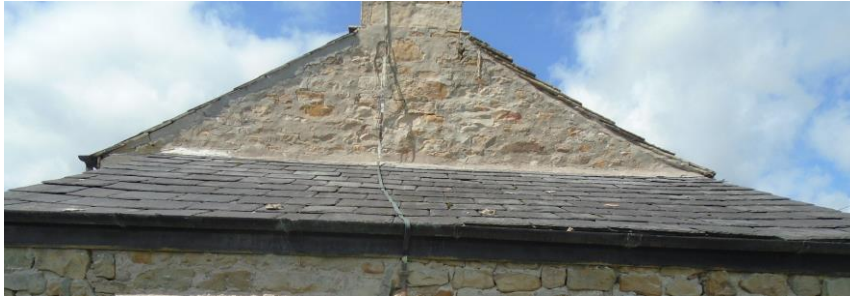
The house and lean to roof will be timber rafters and purlins, with a blue slate finish. The main roof will not be disturbed by the proposals. The lean - to roof had a ceiling but the void was not accessible. The roof is flashed to the adjoining wall and the verge is pointed. The timber fascia is fixed flush to the wall.

The lean to slate roof was in good condition with tight laps, pointed verges and flush fascia boards. The abutment with the wall was also tightly flashed. No access points, cracks or crevices.

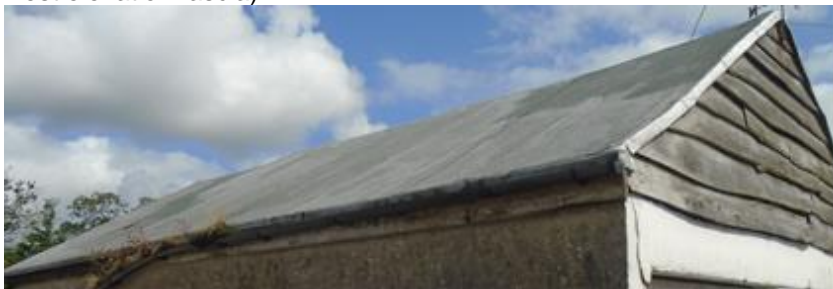
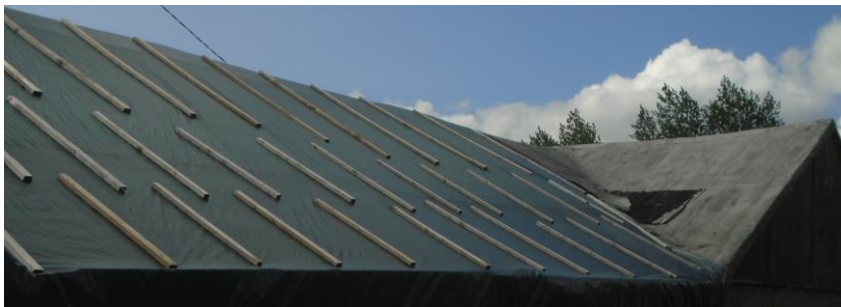
The garage / stable block is a timber structure, purlins, rafters etc with t and g sarking boards fixed over, the external finish is felt / membrane. Timber fascia's fixed flush to the walls.(slight gap behind west elevation fascia)

The Garage / stable block roof is not in good condition but it generally doesn't provide access points to the building nor any crevices suitable for bat ingress. With the exception of the tear in the felt adjacent to the valley in the rear (north elevation) however inspection showed that the edges were sealed and no voids were formed. The eaves did not provide any access points or crevices.

The small void behind the fascia on the west side could be fully inspected. No signs of bat ingress was found.

The Garage /stable block did not have an enclosed roof void all the structure was visible and easily examined. All timbers are in good condition with no signs of rot, cracks or crevices.

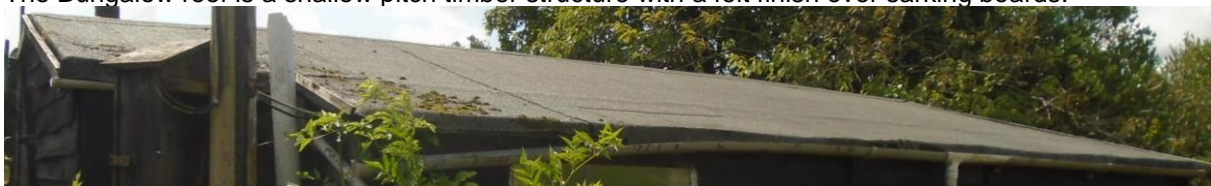
The Bungalow roof is a shallow pitch timber structure with a felt finish over sarking boards.

Timber barge boards to gables.

The bungalow did not have a roof void plasterboard was fixed to the underside of the sarking boards. There were no cracks or crevices with the potential to provide bat roost habitat. The external features to rear of the property and the roof space were the main focus of this scoping survey. The lead flashings, fascia soffits ridge slates, walls and any sills were visually examined for droppings, staining, grease marks or feeding remains. No evidence was found

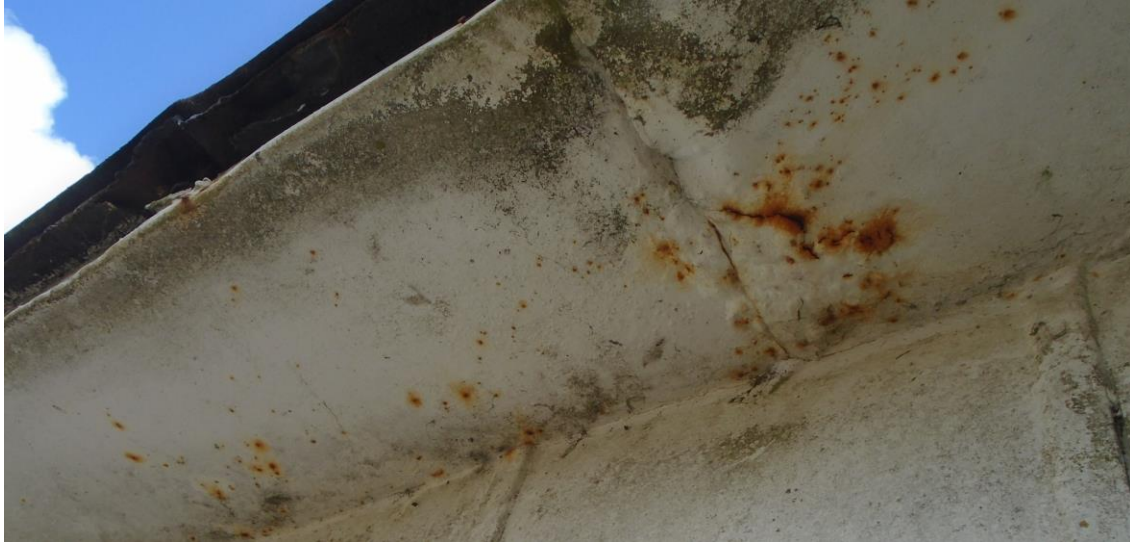
The outbuilding soffits generally do not allow access

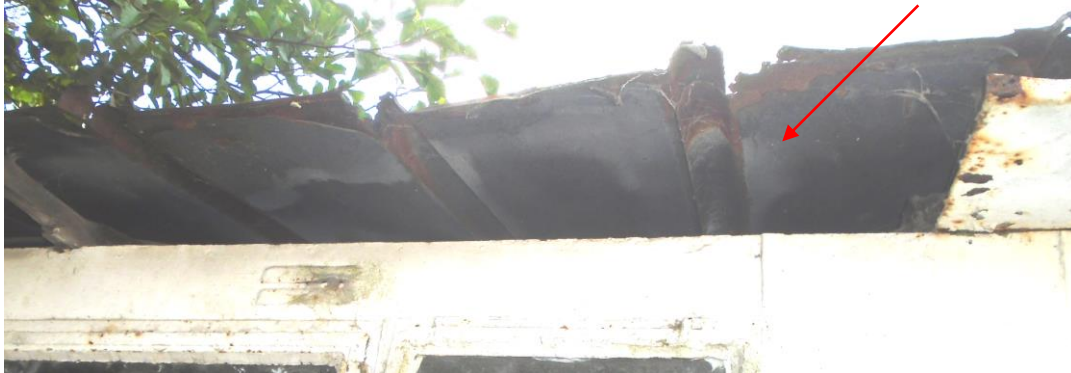
However the exception is a section on the east elevation over the window (see below)

The general roof covering although in poor condition it does not provide access to the interior.

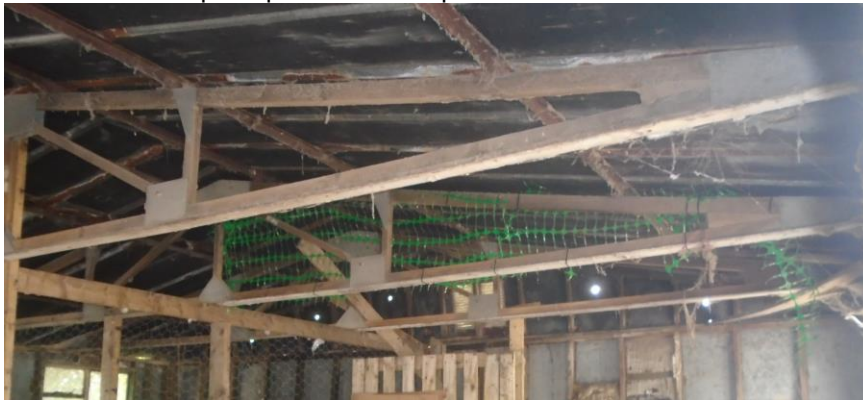
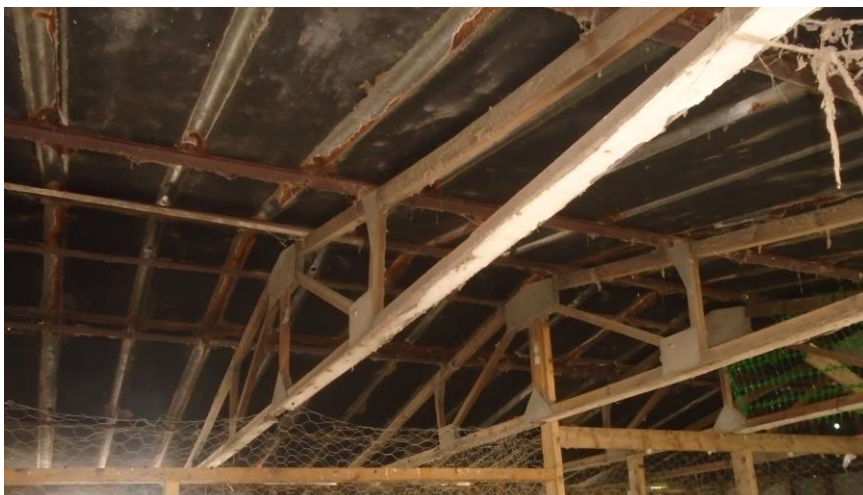
There was not an enclosed roof void in the Outbuilding all the structure was visible and easily examined. The space provided sub optimal roost habitat for bats.

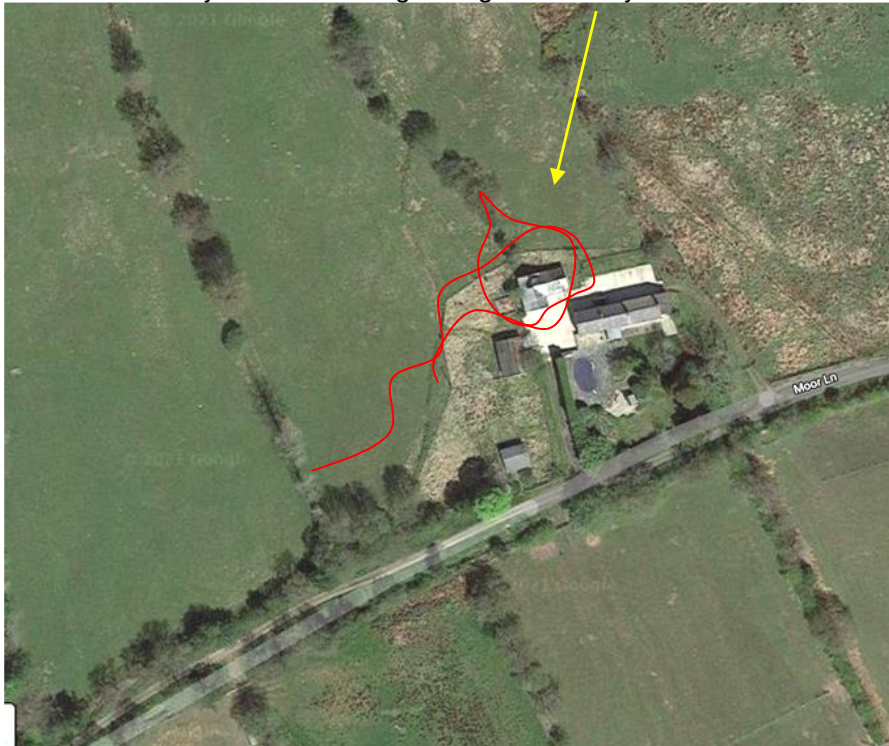
Line of bat activity recorded during emergence survey

Emergence survey: -10-08 -21 8.50 pm carried out during optimal weather conditions for bat activity. All buildings monitored. No activity was recorded until 9.15pm when a single bat appeared from the trees lining the track to the west, it proceeded to circle the garage / stable block occasionally diverting up the tree line heading north adjacent to the rear of the building. No further bat activity was recorded and emergence from any building did not occur. The survey continued until it was too dark to see.

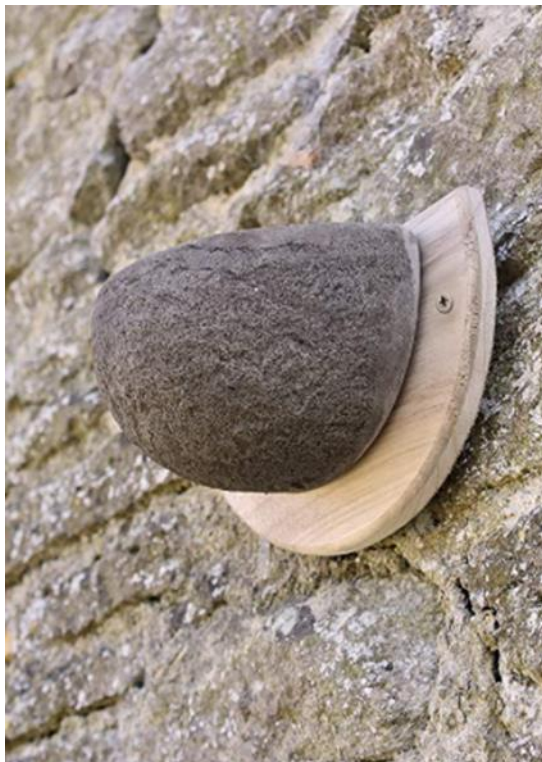
The buildings were checked for signs of nesting birds. All buildings were clear except Garage/ stable block which had a significant number of swallow nests internally adjacent to the rafters. At the time of the inspection no birds were present, none of the nests were currently in use and many were eroding.

The removal of this building will not impact on currently nesting birds but it is recommended that artificial nesting be incorporated in the eaves of the new buildings or within outbuildings. See below.
