21 Church Street,
Ribchester

Bat Survey Report

1st September 2021

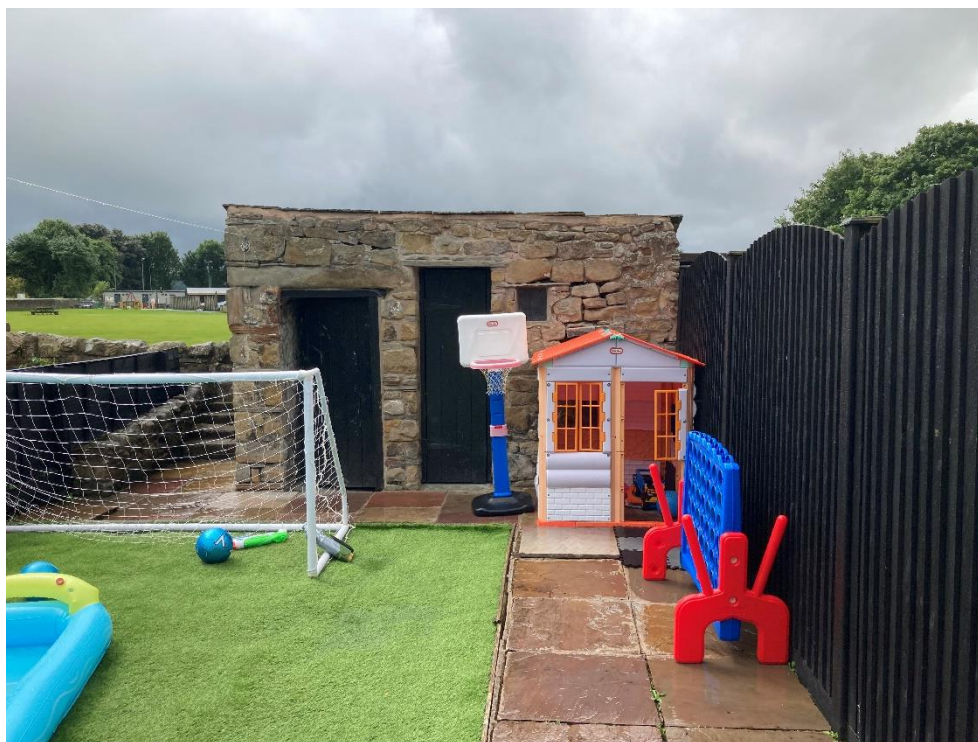
Photograph 1- Front (east face) of outbuilding

Most of the building exterior is well pointed however there are some larger unmortared crevices at the east face of the building (see Photograph 1) however these are located at a low height (below 2m). Any bat flight lines from the crevices would be obscured by an adjacent child's Wendy house. The crevices were fully inspected with a bright torch, the crevices were partially cobwebbed over and could be fully investigated. The crevices are relatively open and go back approximately 10cm into the structure of the outbuilding. No current or historical evidence of bats was found within the crevices. Given their low height, exposure and their obstructed nature, it is considered to be very unlikely that these features would be used by roosting bats.

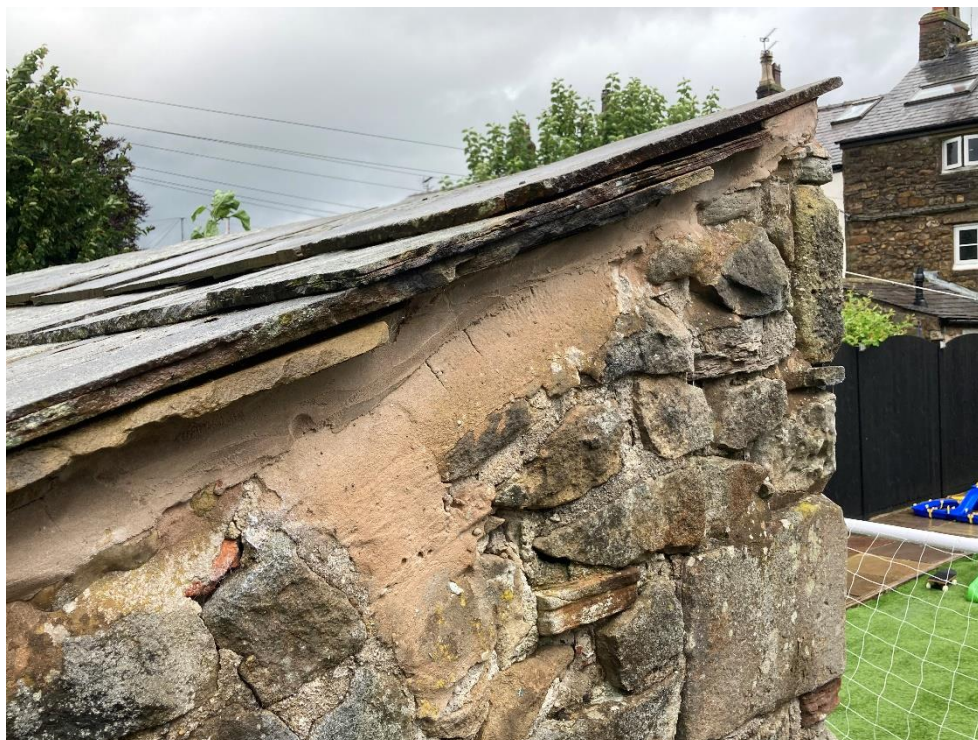
Photograph 2- View of gaps under roof slates

The outbuilding also has some minor crevices where the roof slates overlap one another, these provide an approximate 1cm wide crevices between some of the roof slates (see Photograph 2).

Given the low height of the slates and the roof in general, these could be fully inspected with an endoscope and torch. The slates were mostly cobwebbed over. The underside of the slates could also be investigated as the internal face of the roof is unlined. No current or historical evidence of bats was found between the slates. It is considered to be very unlikely that these features would be used by roosting bats.

The crevices between the roof slates are only located on the south face of the outbuilding as a neighbouring garden shed is located abutting the north face of the outbuilding and would block off any potential bat access points.

Nevertheless, it is recommended that a cautious approach is adopted during proposed works. Works to demolish the outbuilding would be carried out by hand. It is recommended that the roof slates are carefully lifted during demolition and checked beneath for any bats.

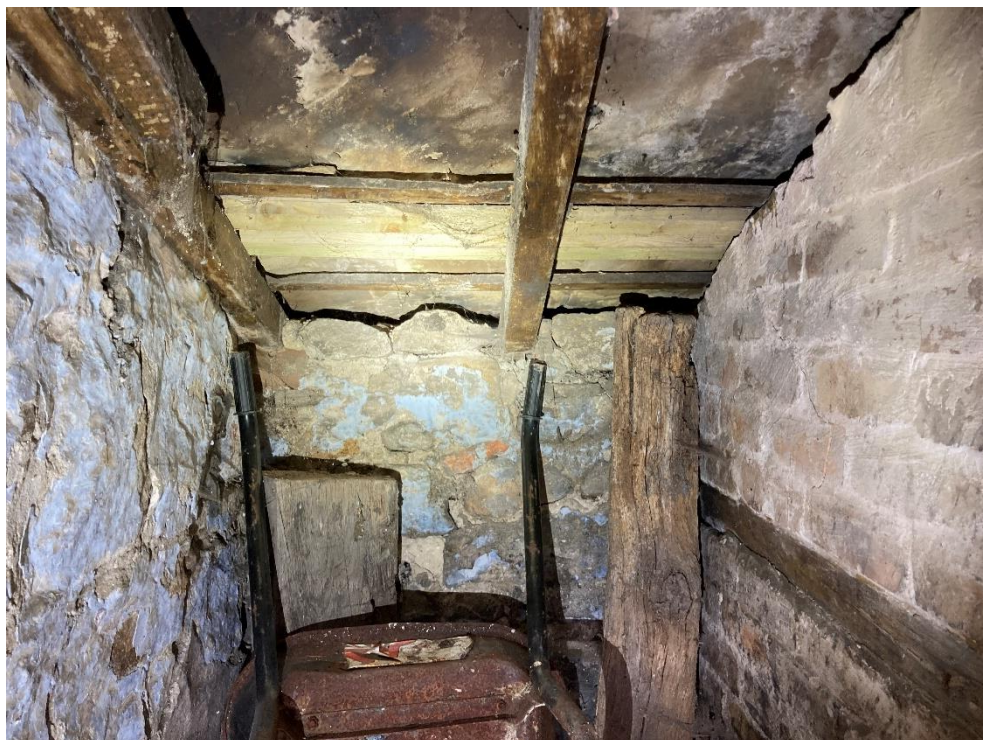
Photograph 4- Interior of shed

Internally, the outbuilding comprises of two small rooms. There are small doors to access the rooms which are kept closed and so there is no easy access for bats or birds to the building interior. The internal face of the roof is unlined therefore there is no roosting habitat offered between the roof slates and any felt lining. The rooms and the internal faces of the roof were observed to be heavily cobwebbed. The internal walls are well mortared.
