# **Preliminary Bat Roost Assessment Report**

**12 Beech Drive,  
Calderstones Park,  
Whalley,  
BB7 9RH**

**15.10.2021**

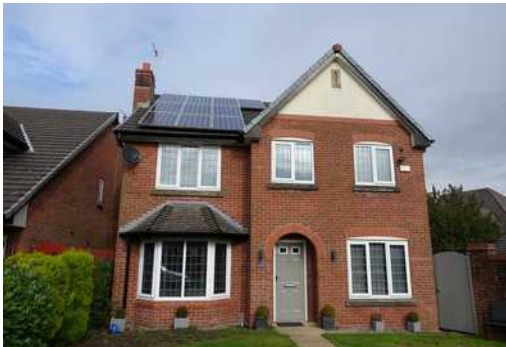
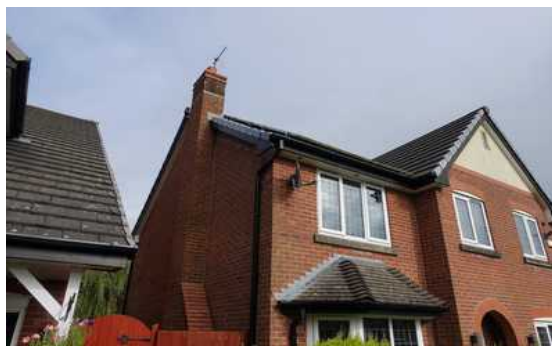
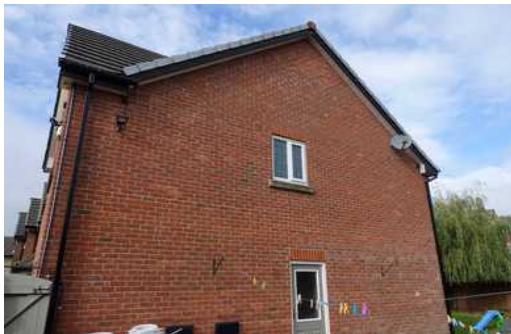
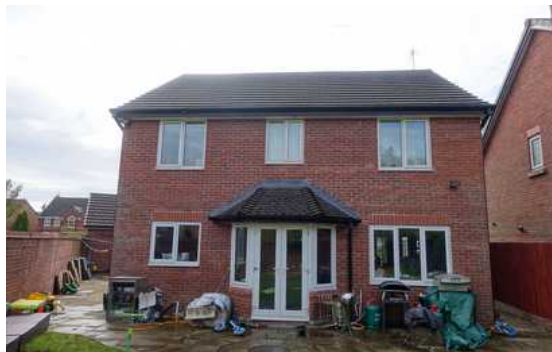
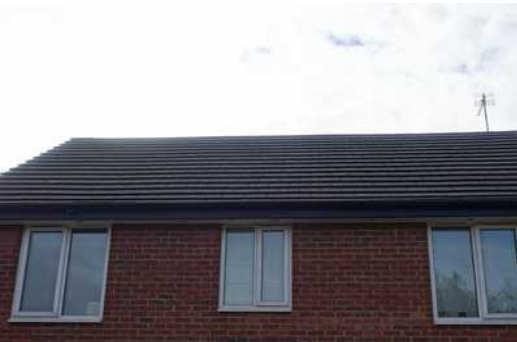
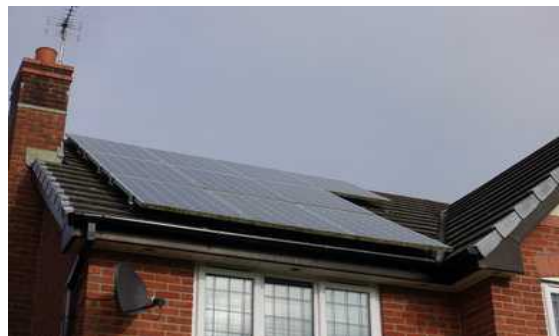
The property consists of a detached brick built house with a multi pitched tiled roof. External walls are pointed and well sealed with no obvious cavities, cracks, gaps or crevices present. The gables are pointed and well sealed. Upvc soffits are close fitting with no obvious gaps present.

Roof tiles are close fitting with no lifted, slipped, or missing tiles present. The ridge is pointed and well sealed. Soffits are close fitting. Lead flashing where present is close fitting. The property has solar panels fitted tot he front facing section of roof.

The building can be considered to offer negligible bat potential.
