**Re: Proposed development at 5 Milbeck Close, Longridge, PR3 3LQ (central grid reference: SD 59927 36119)**

Thank you for your request for a bat survey at the above site. I understand that the proposed development is for an extension above the garage and to the rear of the existing dwelling house.

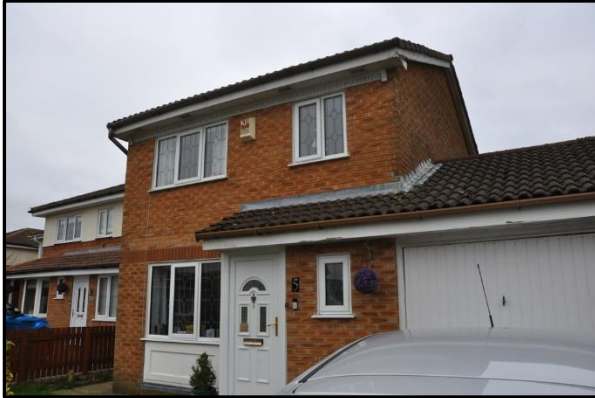
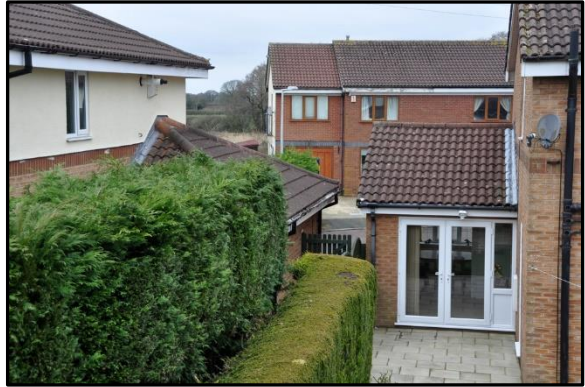
***View of 5 Milbeck Close front (north) elevation (lhs) and location of proposed extension rear (south) elevation (rhs)***

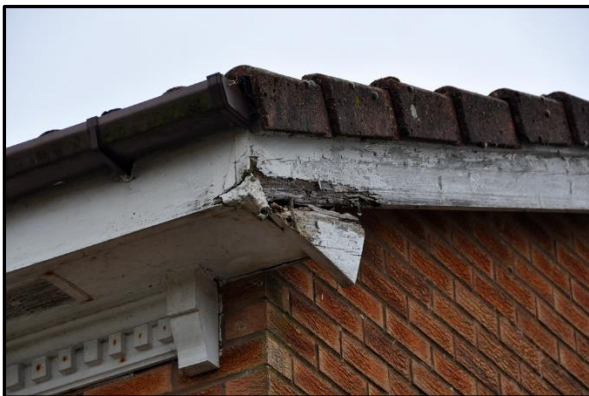
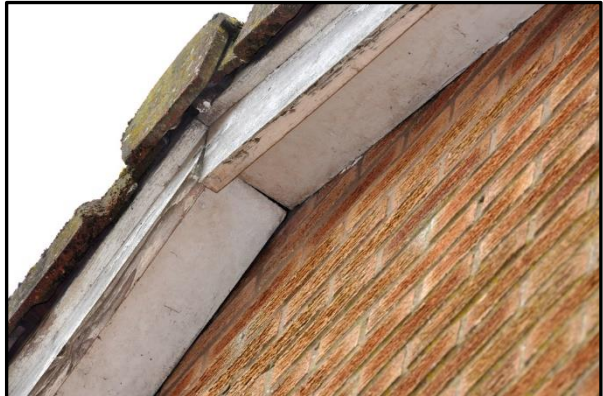
5 Milbeck Close comprises an occupied, detached, dwelling house with an adjoining single storey garage and rear conservatory. The walls are constructed of brick and the windows and doors are upvc; sealed tight with no gaps. The roofs above the dwelling house and the garage are dual pitched and covered with tight fitting, concrete profiled tiles. There are timber soffits along the roof edges and gables; the soffits have started to deteriorate and there are holes and gaps present at the roof corners and gable ends. There are also gaps along the verges where the roof tiles are uncapped and remain open. Some of the gaps associated with gable soffits and the roof verges have some limited potential for use by bats.

- Low potential – gaps associated with timber gable soffits to garage and dwelling house

***Example of gaps associated with roof corners (lhs) and gable soffits (rhs)***

Protected Species	Impacts /Predicted Impacts	Action Required
Bats	<p>It is advised that there is no evidence to suggest that bats pose a constraint to the proposed development.</p> <p>It is advised that there are potential roost features suitable for bats associated with timber soffits at the gable ends of the house and garage. In this location and landscape setting, these features have low potential for bats to use throughout the year.</p> <p>All bat species are afforded full protection under The Conservation of Habitats and Species (Amendment) (EU Exit) Regulations 2019</p>	<p><b>Advice (mitigation):</b> As a precaution, a pre-commencement bat survey by a suitably qualified Ecologist should be carried out immediately prior to any proposed works (this could include supervising contractors during a roof strip). A pre-commencement survey will help avoid unlawful disturbance to bats and bat roosts before any development takes place- it is therefore specified to be used as a final precautionary approach once planning permission has been granted. <b>Immediately prior to the development</b></p> <p><b>Recommendation (mitigation):</b> All personnel involved in proposed development works should be carefully advised about bats by a professional Ecologist, so that all works are undertaken with a clear understanding about legal aspects, precautions to be adopted and what to do if a bat is found. <b>Prior to development.</b></p> <p><b>Advice (mitigation):</b> If bats are found at any time during the development, work must stop until advice has been sought from an appropriately experienced Ecologist. If the development will affect bats, a licence may be required and suitable mitigation put in place. <b>At all times.</b></p>

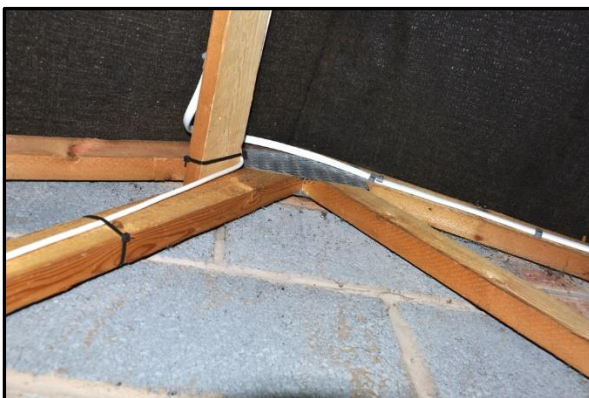
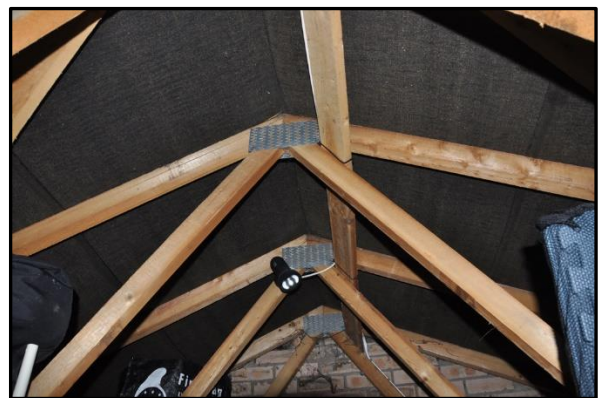
There are roof voids above the dwelling house and the garage. Both roof voids are underlined with intact, bitumastic liner. There are block interior walls, timber trussed roof supports and rock wool insulation. Both roof voids are used for storage and are cluttered.

No signs of bats were found in either roof void. Bird feathers are present in the roof void above the main house. A single house sparrow was calling from the property roof throughout the survey. The bird was observed carrying nesting material into the roof edge.

***View of roof garage roof void (lhs) and main house roof void (rhs) showing bitumastic roof liner, block and brick walls and timber truss supports***

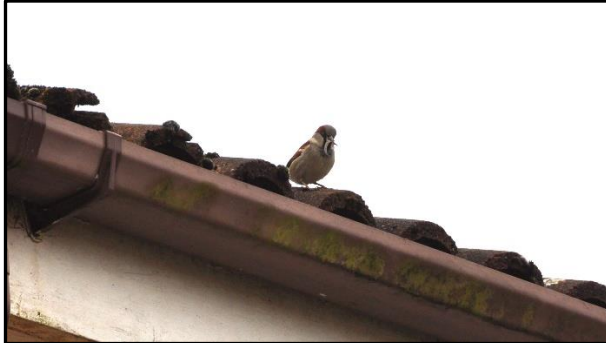
Bird feathers were found in the house roof void and a single prospecting house sparrow was seen investigating roof edges during the surveys.

There is high potential for nesting birds to be present within the roof edges during the nesting season (February to September).

***House sparrow observed prospecting during the survey and view of field adjacent to the rear garden***

Protected species	Impacts /Predicted Impacts	Action Required
Nesting birds	<p>It is advised that there is high potential for birds to be nesting within roof edges during the bird nesting season (February to September).</p> <p>Under the Wildlife and Countryside Act 1981 (as amended), wild birds are protected from being killed, injured or captured, while their nests and eggs are protected from being damaged, destroyed or taken.</p> <p>There is no provision under the Wildlife and Countryside Act 1981 (as amended) for licensing the disturbance of nesting birds or the destruction of nests which are in use for the purpose of development.</p> <p>If enforcement action were taken the developer would need to rely on the 'incidental result of an otherwise lawful operation' defence if it were not possible to avoid an offence being committed. This defence can only be tested in court and it is therefore important to ensure all possible mechanisms for avoiding an offence are considered.</p>	<p><b>Advice (mitigation):</b> It is advised that the most appropriate way to address the risk to nesting birds is: Avoid disturbance to the building during the nesting season.</p> <p>Or If works cannot be delayed the proposed work area should be carefully checked, immediately prior to works commencing. Checks should be carried out by a suitably experienced ecologist. If the risk of nesting birds remains, then monitoring for nesting bird activity should continue for the duration of works. <b>Prior to any work commencing (checks) and throughout works in nesting season (monitoring).</b></p> <p><b>Advice (mitigation):</b> If works are to be undertaken during the nesting season, all people working at the proposed development site should attend a toolbox talk delivered by an appropriately experienced person, to be made aware of the likelihood of encountering nesting birds and how to identify them, the legal protection of nesting birds and their own responsibilities as regards implementation of precautionary measures. <b>Prior to any work commencing.</b></p>

Protected species	Impacts /Predicted Impacts	Action Required
Nesting birds Continued		<b>Advice (mitigation):</b> If birds are found to be nesting within or in close proximity to the work area during proposed works, it will be necessary to stop and establish an exclusion area. The extent of the exclusion area, which should be determined by a suitably experienced ecologist, will depend on the bird species and the nature of the proposed works. <b>At all times.</b>
