**BAT SURVEY AT -
26 RIBBLE LANE
CHATBURN**

**DATE AND TIME OF VISIT
14th July 2021 2.30 pm**

REFERENCE NO. 6448

Conversion of existing roof space to form bedroom accommodation with new dormer to the rear and 2no new roof windows to front elevation.

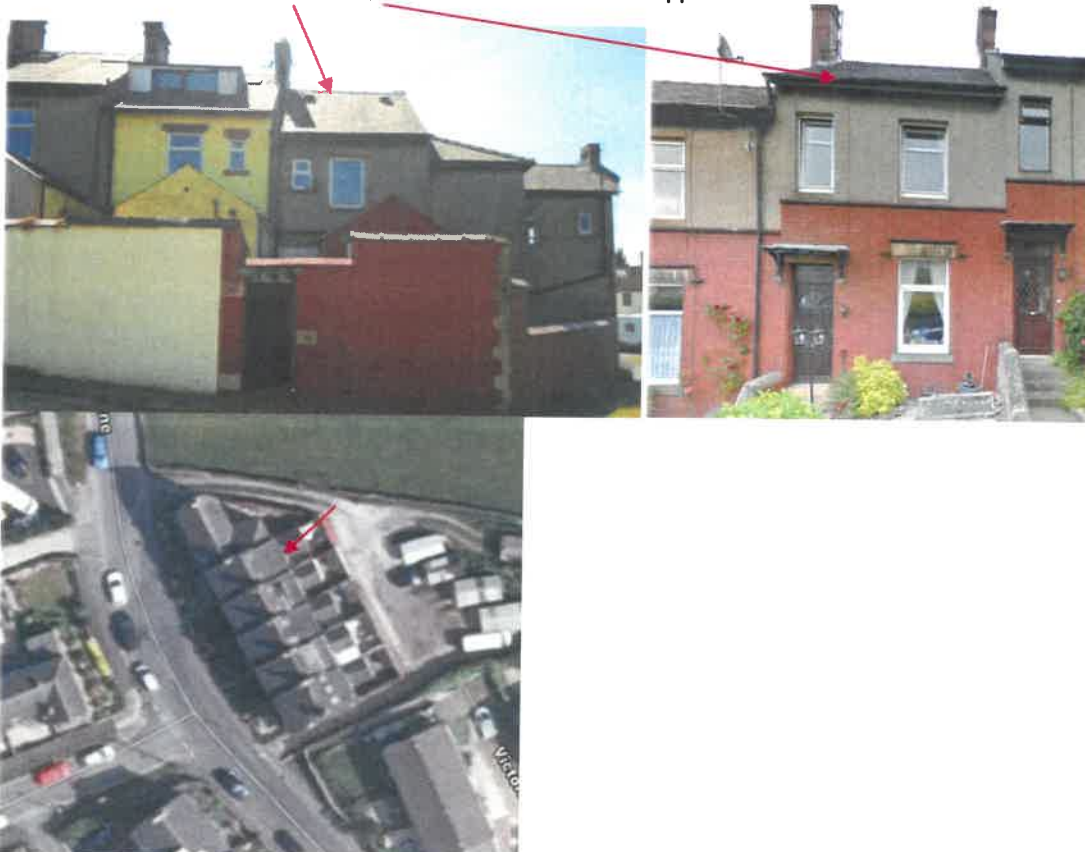
Mid terrace house probably dating 1920's . The terrace is stepped.

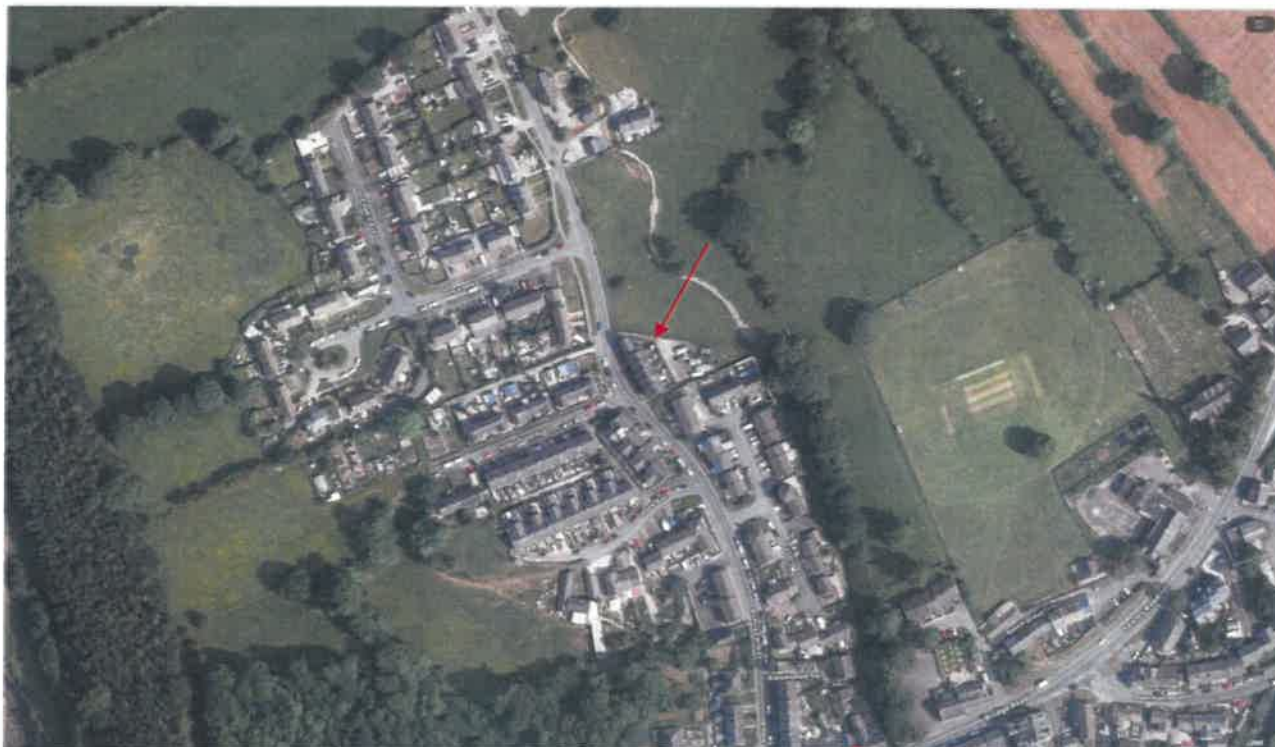
The house is located directly on the east side of Ribble lane on the edge of the main Chatburn settlement area.

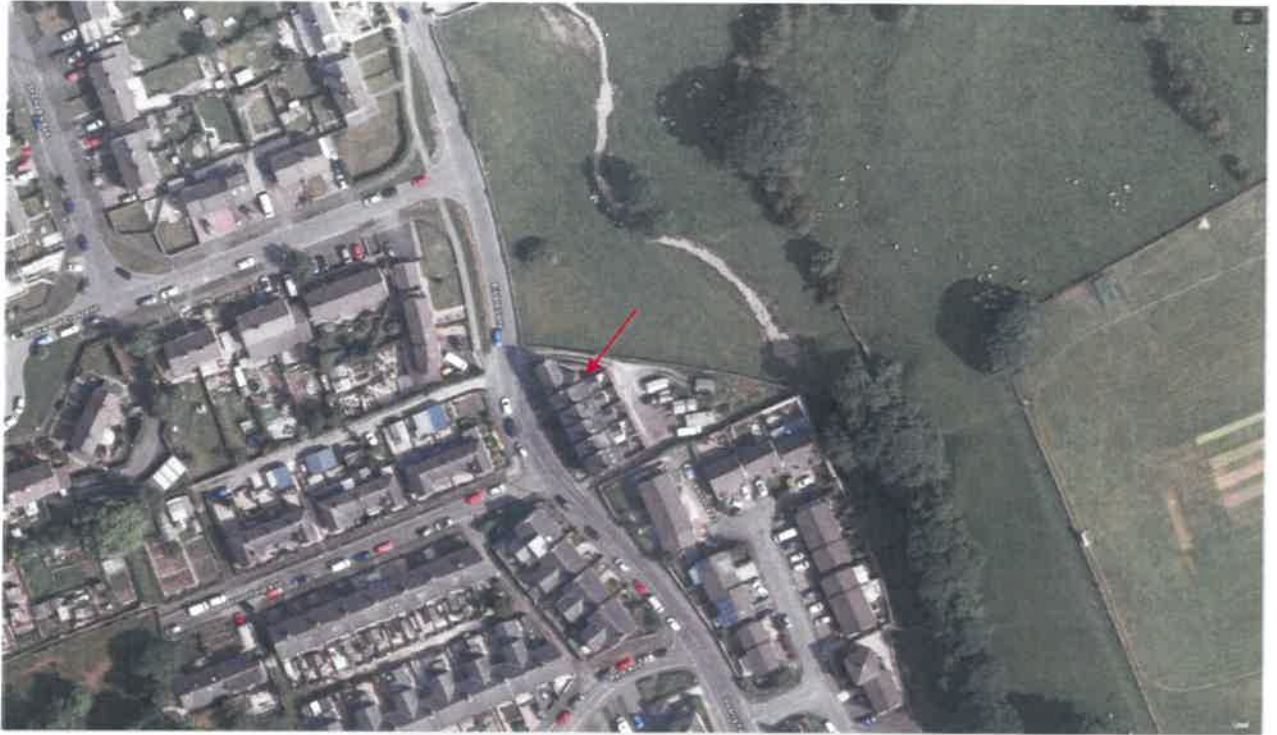
The location on the edge of the settlement area is considered to be rural with pasture land in very close proximity All the adjacent properties have minimal planting in the front gardens and rear yard areas. The surrounding pasture land is mainly boarded by hedgerow and trees, in the greater locality (approx 330m) to the west and south there are some substantial wooded areas which are adjacent to the quarry. At its nearest point the river Ribble runs 450m to the north, Chatburn brook runs 42 m to the north east , the brook is lined with broad leaf trees which forms a very well connected tree corridor to the greater area. The immediate area (50m radius) surrounding the house is not considered to provide high value forage habitat. The greater locality however is considered to provide optimal roosting and foraging potential.

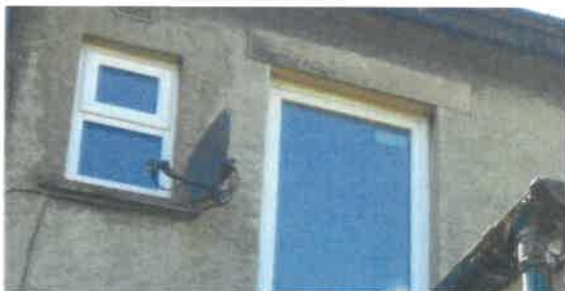
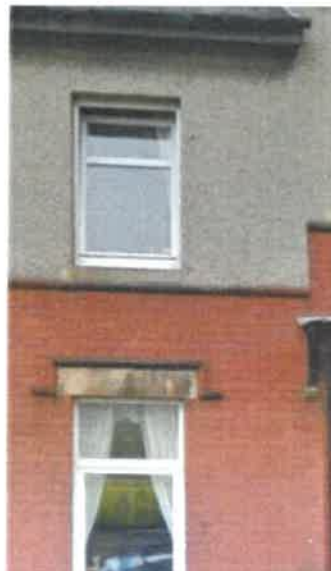
The walls are brick with a render finish to the rear elevation and at first floor level to the front elevation.

The walls are in reasonable condition and did not provide any access points to interior nor any cracks or crevices suitable for bat ingress.

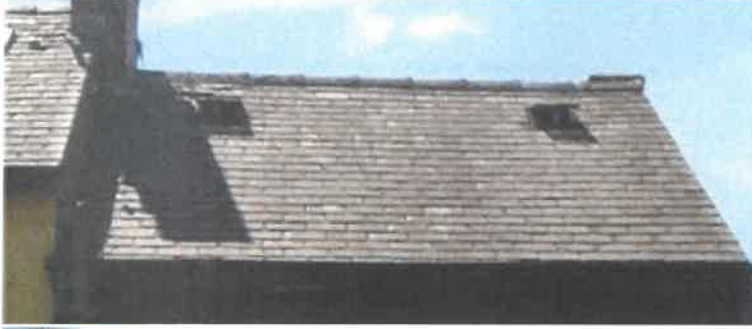
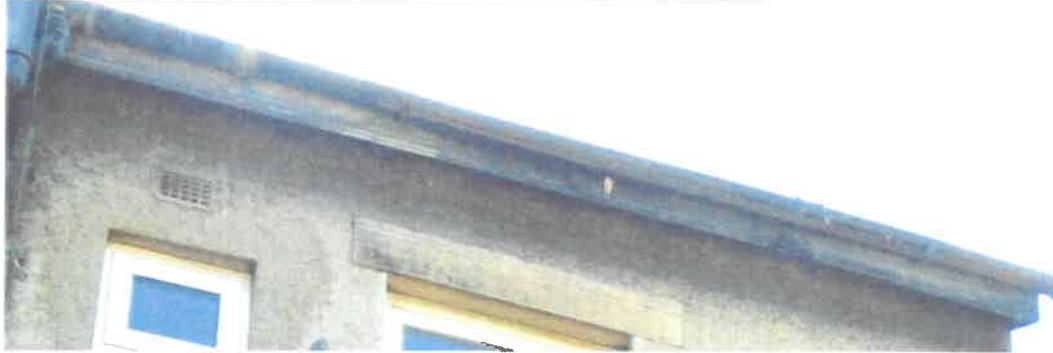
The roof is pitched ,flushed to the wall of no. 24 . It has 2 no roof windows in the rear pitch. The finish is blue slate with ridge tiles. The timber fascias are fixed to rafter ends, soffits are not present.

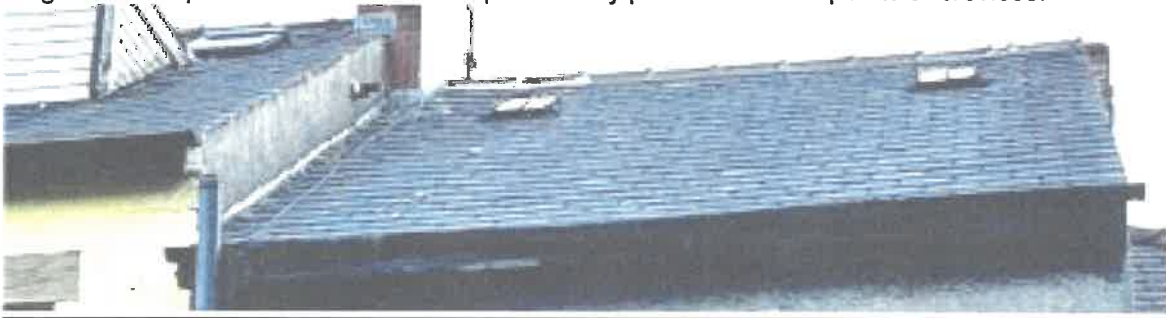
The roof was examined from ground level with the aid of binoculars. The slates were in reasonable all were in tact and tight fitting. The ridge tiles were well pointed and the lead flashings were tight fitting. The eaves where the rafters projected through the wall were well sealed with no access points. The verge was well pointed. The roof did not provide any potential access points or crevices.

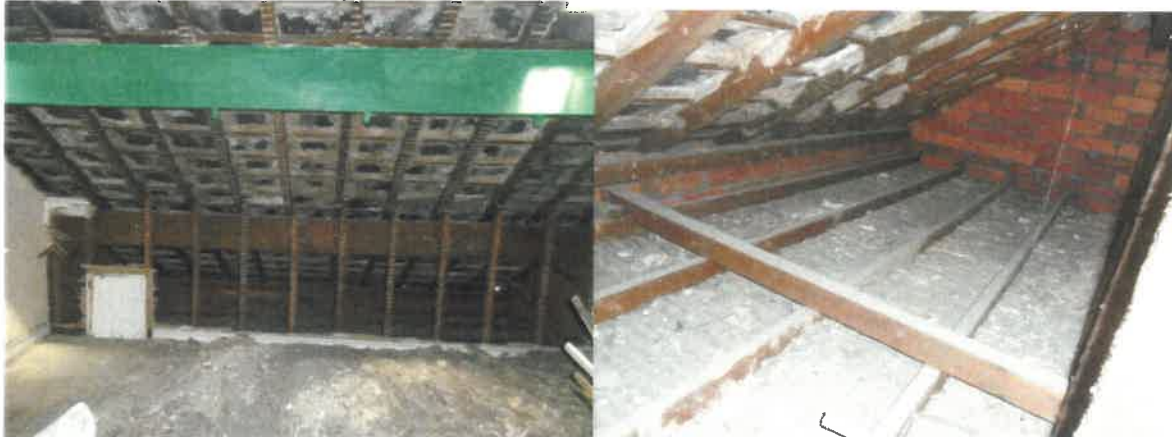
The roof void is accessed via an existing stair, it has a boarded floor and the rafters were lined to the underside with plaster board. Stripping out has commenced and the timber rafters, purlins and battens are visible. All were in reasonable condition with no signs of rot, cracks or crevices. There was no felt , the slates were pointed to the battens.

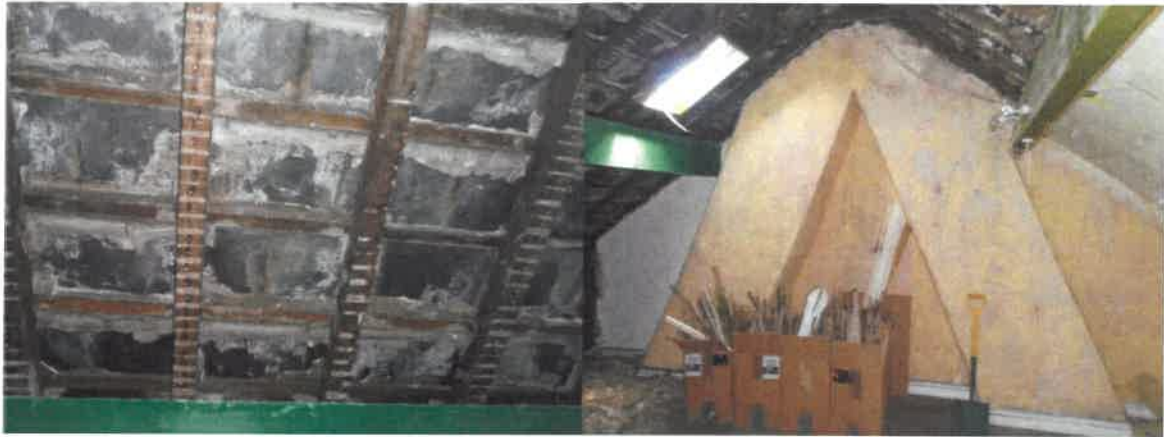
The eaves were clearly visible and there were no possible access points. The space did not provide any potential roost habitat for bats.
