# **Preliminary Bat Roost Assessment Report**

**2 Dunster Grove,  
Clitheroe,  
BB7 2QL**

**22.10.2021**

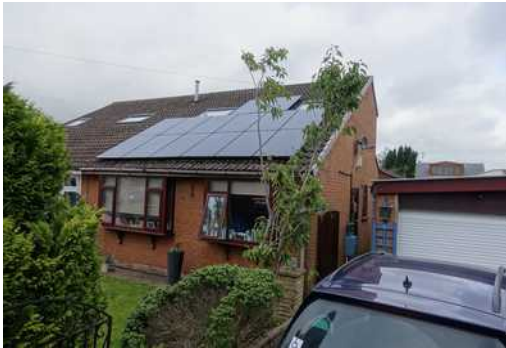
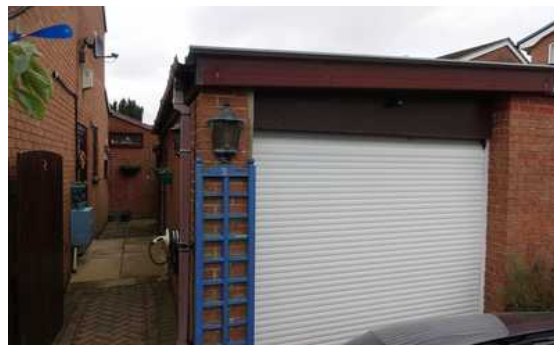
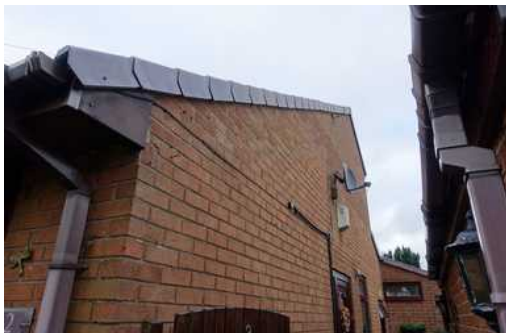
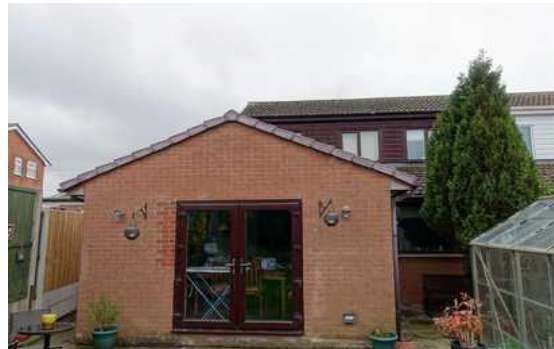
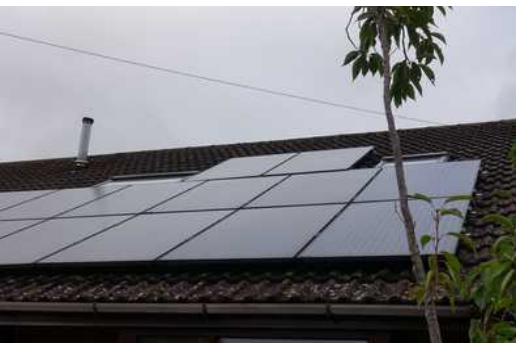
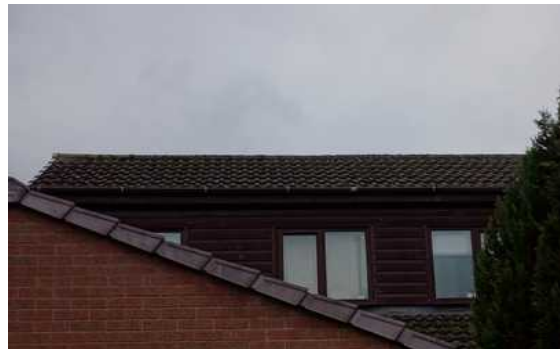
The property consists of a semi detached brick built bungalow with double pitched tiled roof with a single storey extension to the rear. A detached single garage with flat roof is present. Walls are well pointed with no cracks, crevices or cavities present. The gable end is pointed and sealed.

The roof has no missing, lifted or slipped tiles present. Ridge tiles are close fitting, pointed and well sealed. The property has solar panels present on the frontage.

The building can be considered to offer negligible bat potential.
