# **Preliminary Bat Roost Assessment Report**

**Outbuilding at Cowgill Farm,  
Gisburn Road,  
Sawley,  
BB7 4LH**

**21.06.2021**

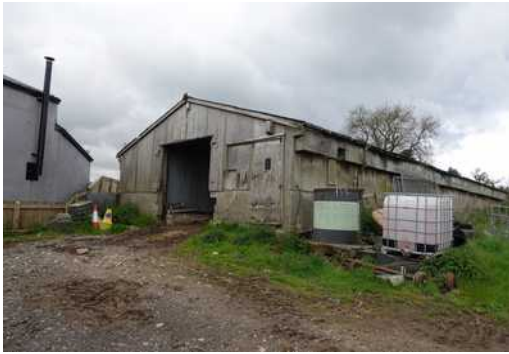
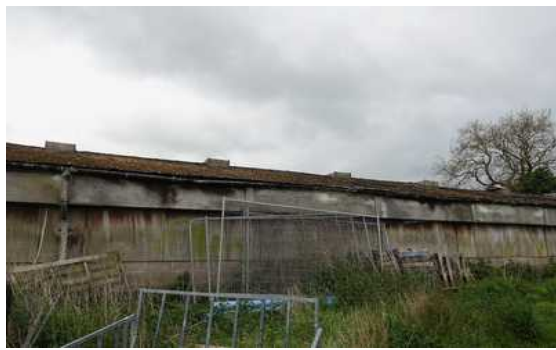
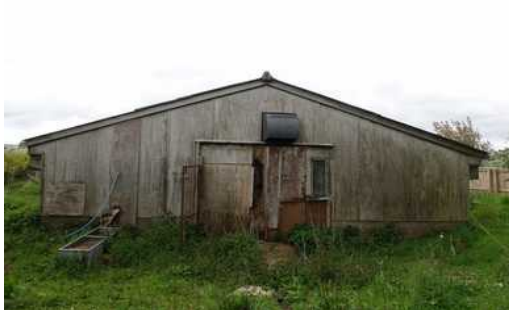
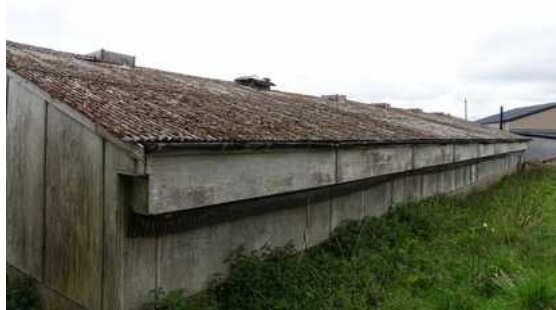
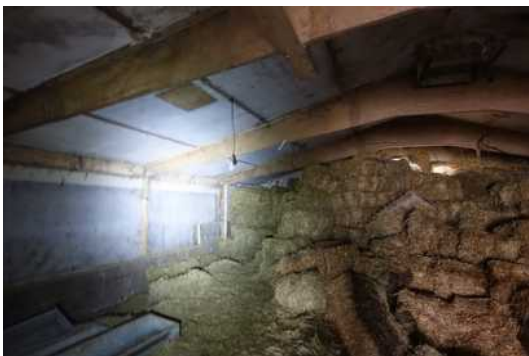
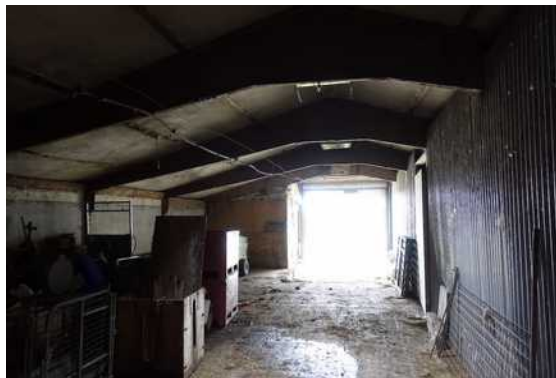
The property consists of a detached block, timber and corrugated metal built single storey outbuilding with a double pitch corrugated metal roof. External walls are single skin with no obvious cavities, cracks, gaps or crevices present. The outbuilding is open to the frontage and used for storage of farm machinery.

Roof panels are close fitting. The ridge is open to the interior.

The building can be considered to offer negligible roosting bat potential.
