## **BAT, BARN OWL & NESTING BIRD SURVEY AT**

**Spencers Farm, Bolton by Bowland**

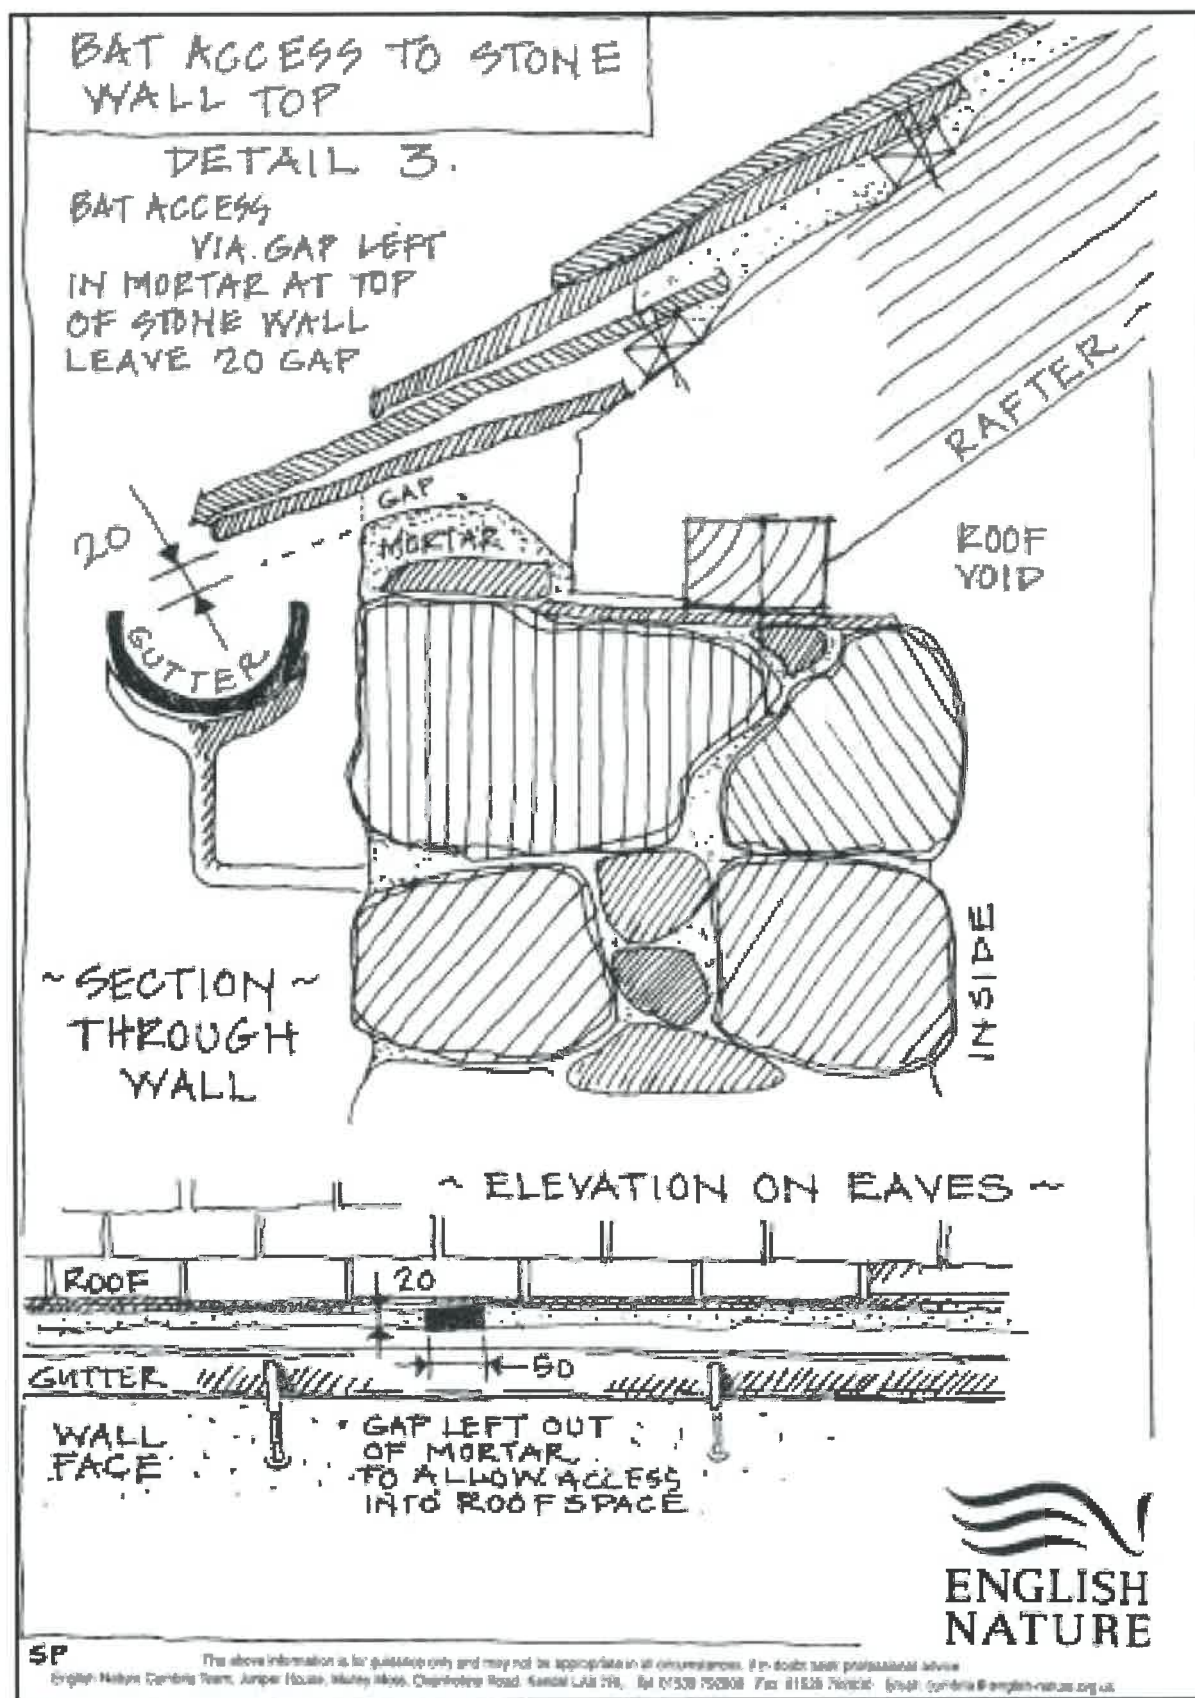
Figure 6 New roost site creation.

6. Remove all roof coverings by hand only.
7. Create at least 6 gaps along the eaves lines of the buildings which allow access to the wall tops under the eaves during any re-roofing which is undertaken. A plan for this type of roost is shown on Figure 6. These potential roost sites will be a significant improvement on existing site conditions.

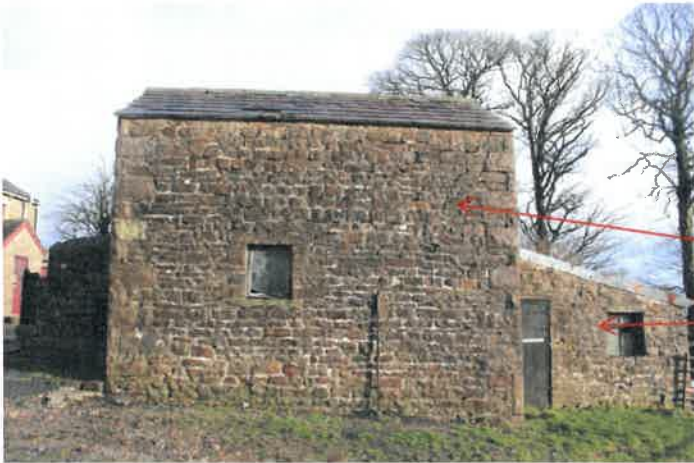
<p>Walls in excellent condition with mortar in good condition</p> <p>Granary</p> <p>Lean-to</p>

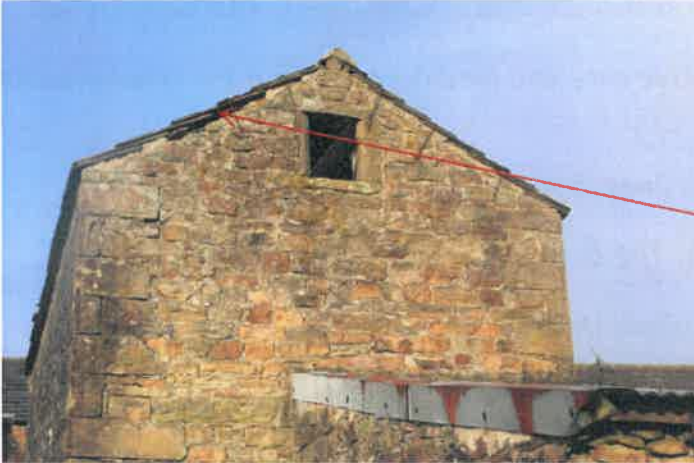
There are no soffit boxes present, the eaves of the north eastern and south western elevations were well sealed. However mortar was missing along the verges on both gable ends. The gaps where the mortar was missing were considered to be too wide and draughty to support roosting bats. Gaps were present between the stone wall and roof on the south eastern elevation of the lean-to, these gaps were also large and lead straight into the main structure. A low number of small gaps were identified between the metal verge covers and walls on the lean-to, these offer suboptimal roosting material for bats and the gaps identified were generally filled with dense cobwebs. There were no indications of roosting by bats in these areas.

<p>Large gaps on the verge of the gable ends</p>

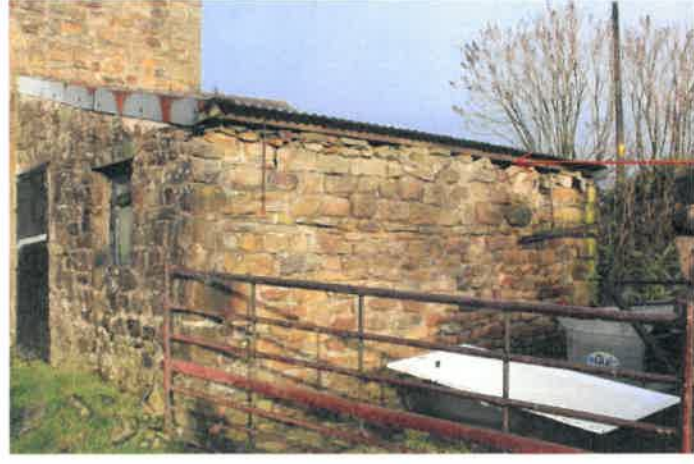
<p>Large gaps between stones and roof of the lean-to</p> <p>Roof constructed from corrugated metal sheeting which provides suboptimal roosting material</p>

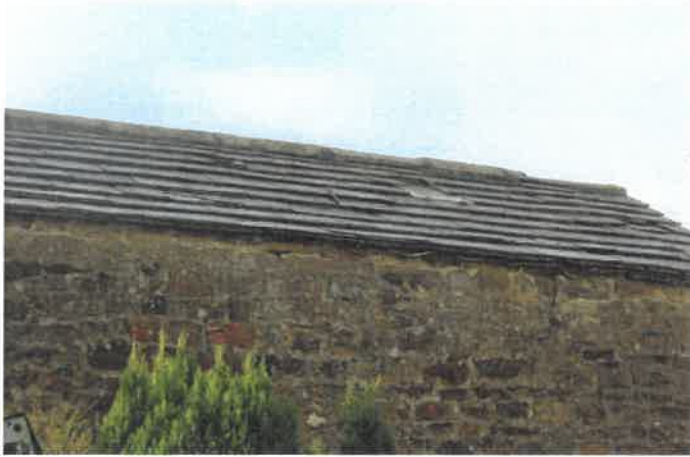
Gaps present under roof tiles and along the ridgeline

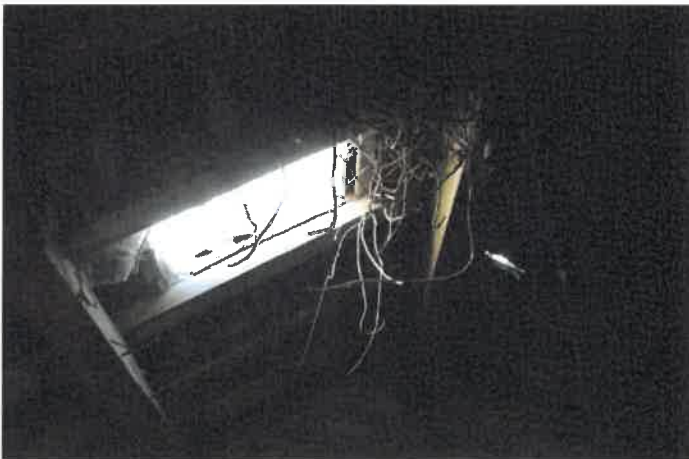
There was no roof void within the main granary building or lean-to. The timber beams in the granary and lean-to were in good condition with no rot, splits or gaps suitable for roosting or hibernating bats. The internal roof space of the granary was quite light due to the presence of a sky light, which reduces the suitability of the roof space to support roosting bats. There was ivy growing into the internal space through gaps under the roof tiles. The internal space was also very cobwebbed, as this area is no longer used. No indication of use by bats could be found.

No roof void present

Ivy growing into the internal space
