BAT SURVEY AT -

NORWOOD
YORK LANE
BLACKBURN

REFERENCE NO. 6450

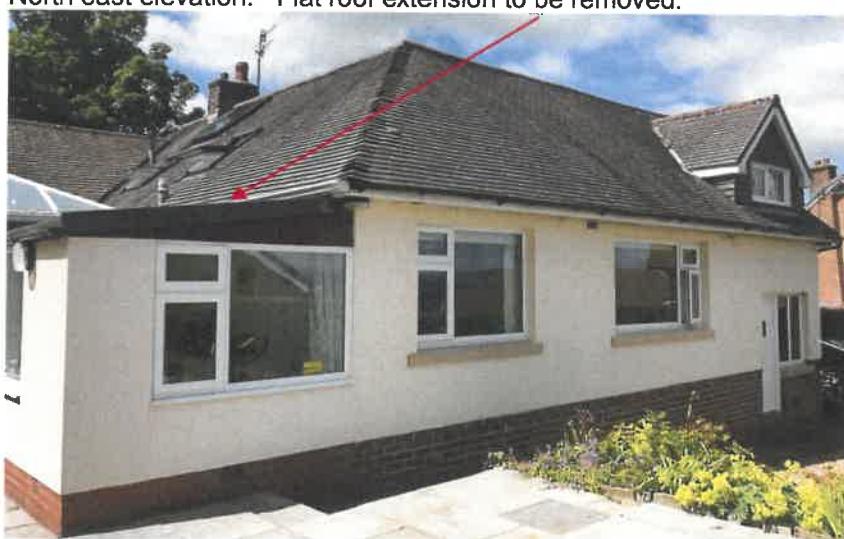
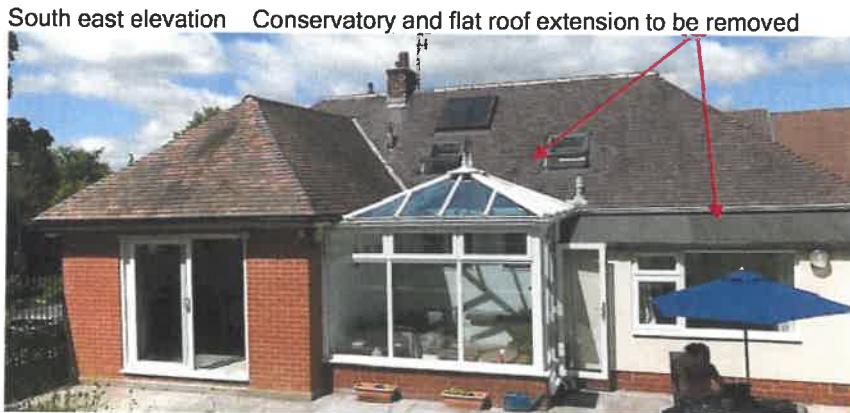
North east elevation. Flat roof extension to be removed.

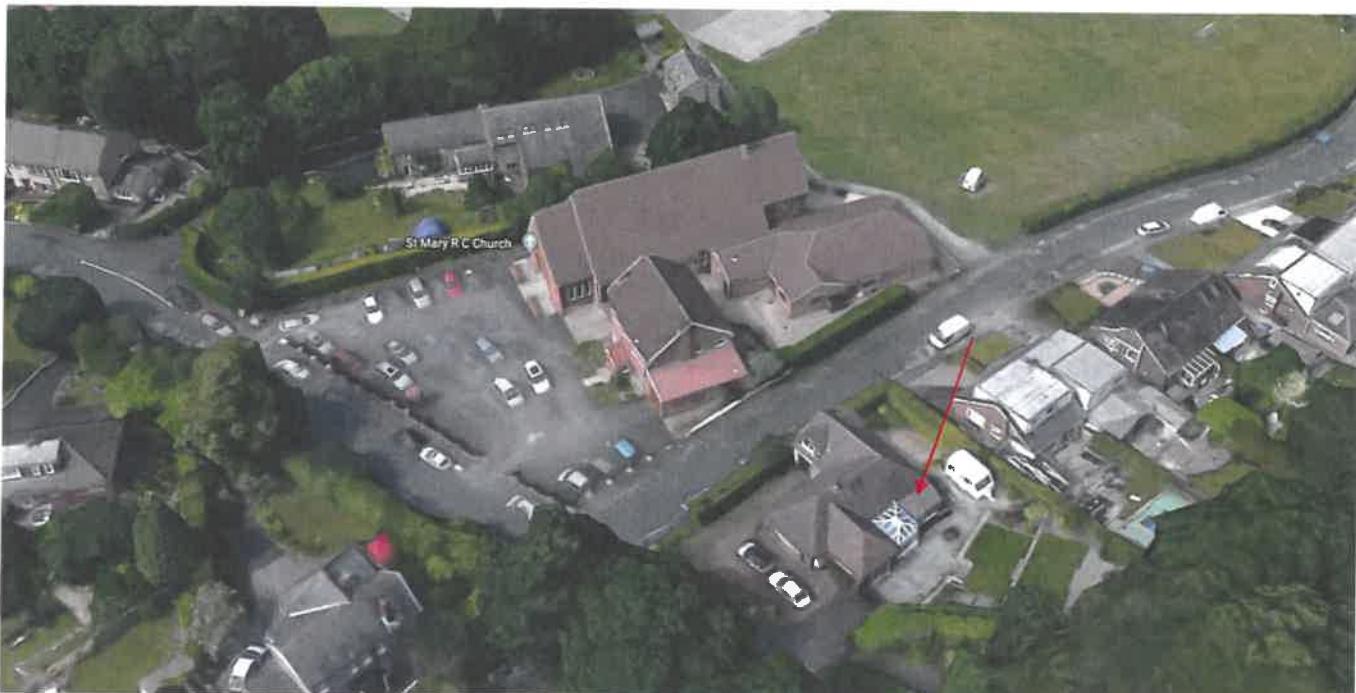
The house is set in a large garden with domestic planting and lawned areas. Properties surround the house on all sides with the exception of the south east boundary which is adjacent to a small wooded area which extends in a south easterly direction bordering York Lane which continues to be lined on both sides with mature trees.

A small pond is 391m to the south east which is the nearest area of standing water, there are no water courses within 1km.

The location does provide an optimal level of forage/ roost habitat.

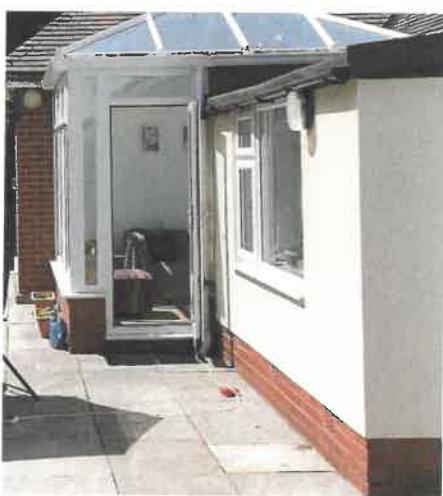
The walls are brick with some sections having a render finish with an exposed brick plinth.

The walls are in good condition as is the pointing there are no access points or crevices suitable for bat ingress.

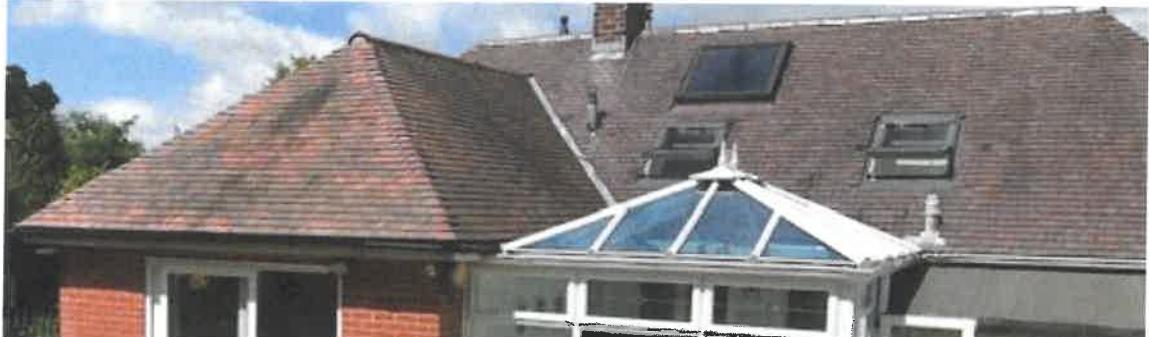
The roof is largely hipped with a gable to the north west adjacent to St Mary's Drive. There are 2no pitched dormers and roof windows all having a Rosemary tile finish. There is an overhang at the eaves with boarded soffits. The conservatory roof is a upvc frame with clear glass. The flat roof is felt.

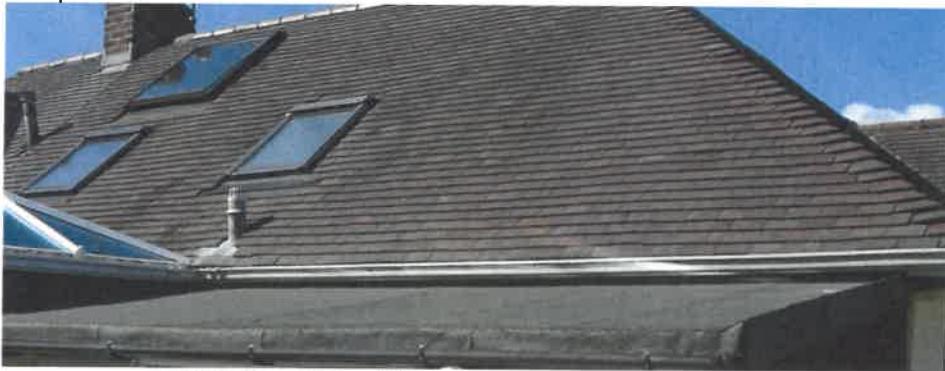
The roof tiles are in very good condition with no significant cracks or loose tiles. The ridge tiles are well pointed.

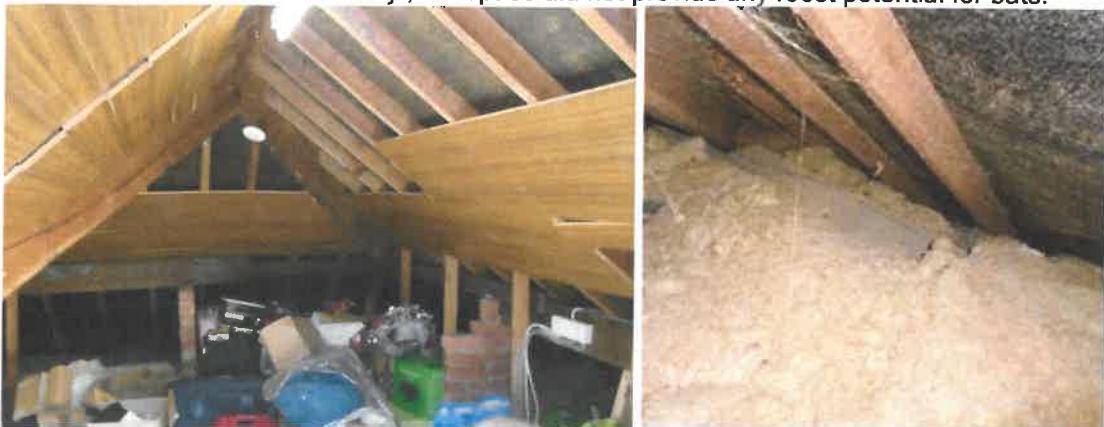
The roof space has been partially converted to form a room, there is an access hatch through to the remaining roof void. See below. The structure is timber rafters and purlins with felt underlay, some sections have a boarded finish to the underside of the rafters. The centre of the floor is boarded and used for storage. Insulation quilt is present at the edges.

All the surfaces were clean and free from any dropping or feeding evidence. The timbers were in good condition as was the felt underlay, the space did not provide any roost potential for bats.
