**BAT SURVEY AT -
84 WHALLEY ROAD
CLITHEROE**

**DATE AND TIME OF VISIT
8th June 2021 9.30am**

REFERENCE NO. 6410

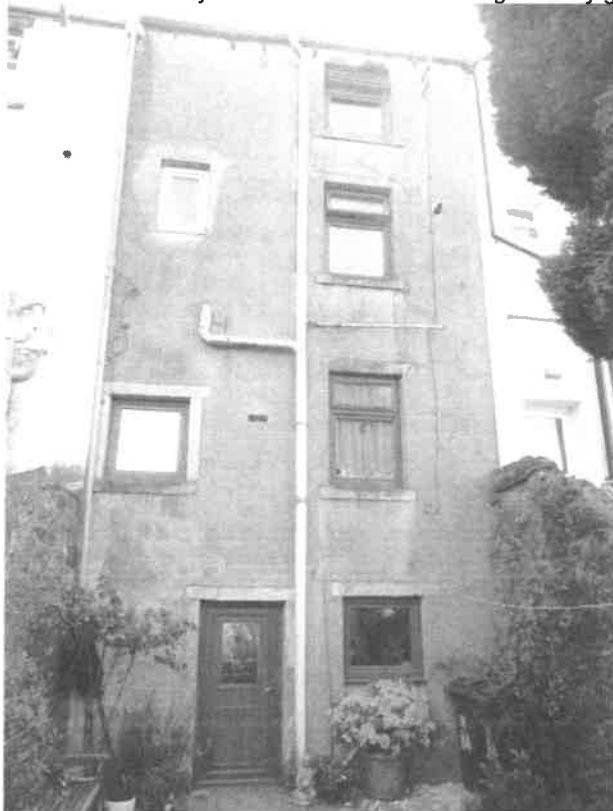
Rear elevation

A terraced 4 storey house with a detached single storey garage at the end of the garden.

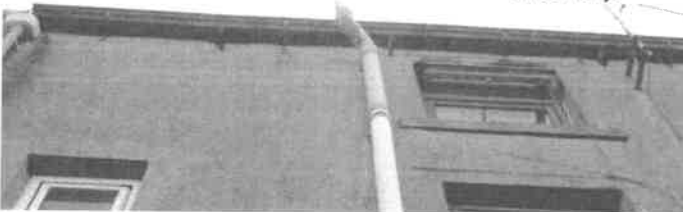
House

The house walls are stone with a smooth render finish and stone sills and heads. The garage walls are prefabricated concrete with a pebble dash finish externally.

The render on the walls of the house is in excellent condition with no possible access points.

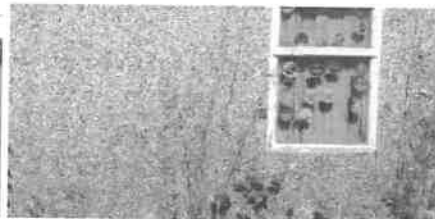
Garage walls

The garage walls are in perfect condition with no possible access points.

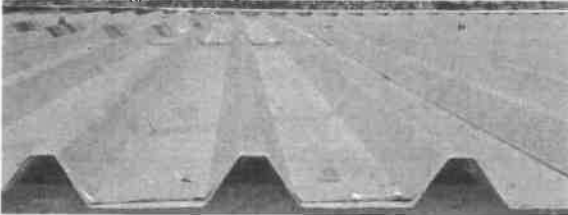
The Garage roof sheets were very tight fitting and in good condition, access points were formed in the rear elevation in the corrugations.

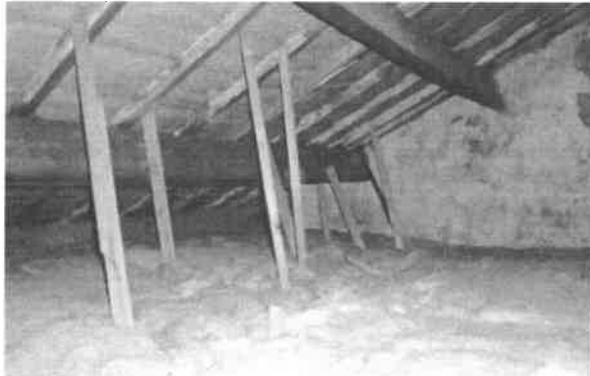
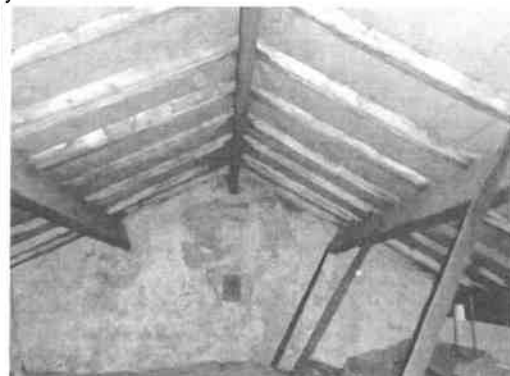
The house roof void was accessible, the timber purlins and rafters were in reasonable condition with no areas of rot or cracks/crevices. The underlay is very new indicating the house has been re-roofed relatively recently. The insulation quilt is very clean with no dropping or insect remains. The space did not provide any potential roost habitat and no evidence of current or historic use by bats could be found.

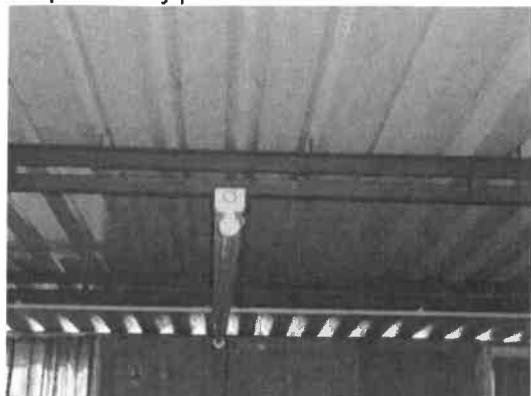
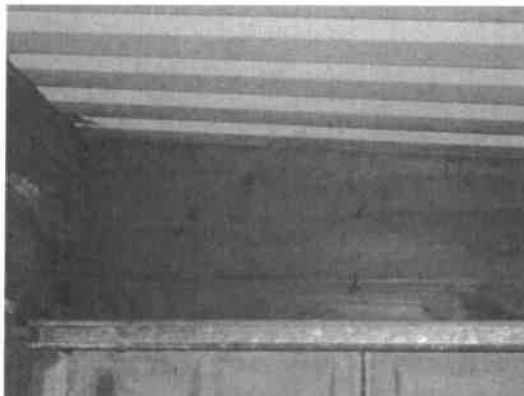
The garage roof did not have an enclosed void, the sheets were fixed directly to steel purlins. The structure did not provide any potential roost habitat.
