Report of Preliminary Bat Roost Assessment at 143 Pastureland Drive, Billington, Clitheroe, Lancashire BB7 9LJ

You instructed us to undertake a preliminary bat roost assessment (also referred to as the; “PRA, survey, report”) at the above-named property (also referred to as the; “site, building, structure”). The survey was undertaken on 24th November 2021. My qualifications and experience along with those of the reviewer of this report are summarised at the end of this report.

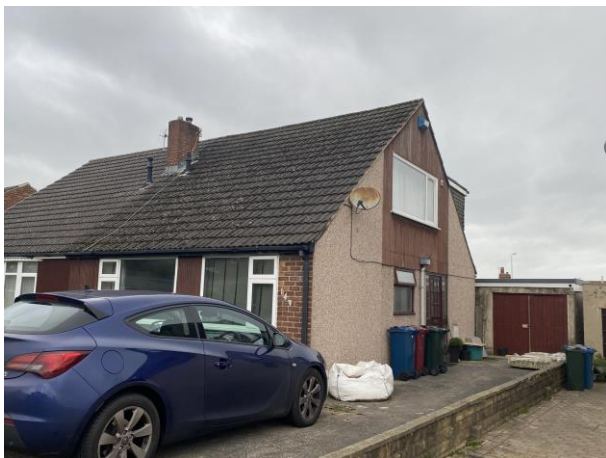
Figure 1: Front elevation

The survey building is double-storey, brick-built, semi-detached dwelling with a pitched roof clad in inter-locking concrete roof tiles. The brickwork around the building appears in an excellent condition with no gaps or cracks suitable for crevice-dwelling bats. The eastern gable-end of the building is clad in a pebbledash rendering which appears in a good condition with no gaps or cracks suitable for roosting bats. There is also some wooden cladding present on the gable-end and on the southern elevation wall, which appears tight-fitting with no suitable bat roosting sites. The windows and doors are either wooden or UPVC framed and are tight-fitting with no bat roosting sites. The roof structure appears in a good condition with tight-fitting inter-locking roof tiles, with no raised or missing tiles providing suitable roosting habitat for crevice-dwelling bats or providing access into the loft space for void-dwelling bats. There is a chimney located on the roof of the survey building which contains no suitable bat roosting features. There is lead flashing around the base of the chimney which appears tight-fitting. The roof verge along the gable-end is in a good condition with no missing mortar providing suitable roosting habitat. The building eaves are tight-fitting with no gaps suitable for roosting bats. There is a flat-roof dormer on the rear elevation roof structure. The roof

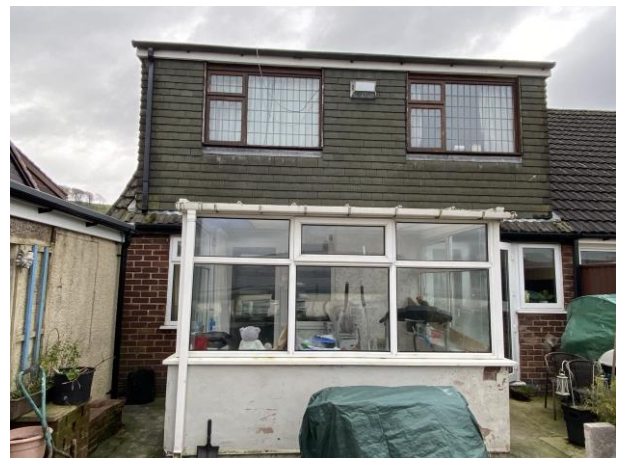
Figure 2: Rear elevation

of the dormer is clad in bitumen felt which appears tight-fitting and therefore provides no suitable bat roosting features. There are hanging tiles present across the dormer which are tight-fitting providing no suitable bat roosting habitat. There is a UPVC bargeboard present around the dormer which appears tight-fitting with no suitable bat roosting sites. There is a single-storey conservatory-style extension on the rear elevation of the building. This has a brick-built base with UPVC glass walls and roof. It offers no suitable bat roosting habitat.

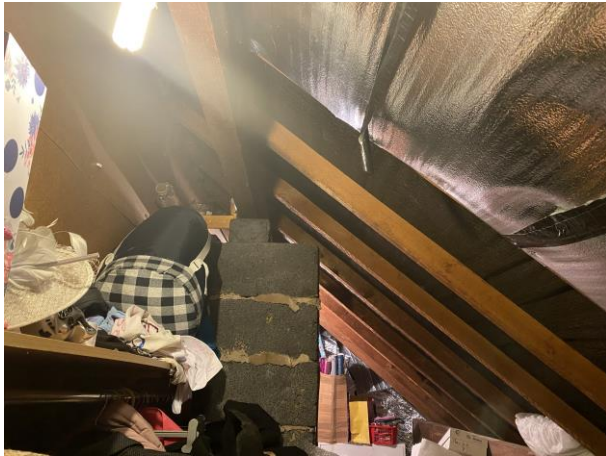
Figure 3: Crawl space

Internally there is one loft space located within the main roof void of the survey building, as well as a small crawl space located at the front of the building. The internal roof structure is constructed from modern timber beams with a bitumen felt lining. Woollen insulation is present across the loft space and crawl space. The loft space and crawl space both appear to be tight-fitting with no daylight entering through the roof structure or along the eaves or gable-end, indicating a lack of bat access points. Both spaces are unlikely to offer suitable habitat for void-dwelling bats due to the small height of the spaces resulting in a lack of space for bat warm-up flights.
