Preliminary Bat Roost Assessment

Site: 60 Hacking Drive, Longridge, PR3 3FP

29th October 2021

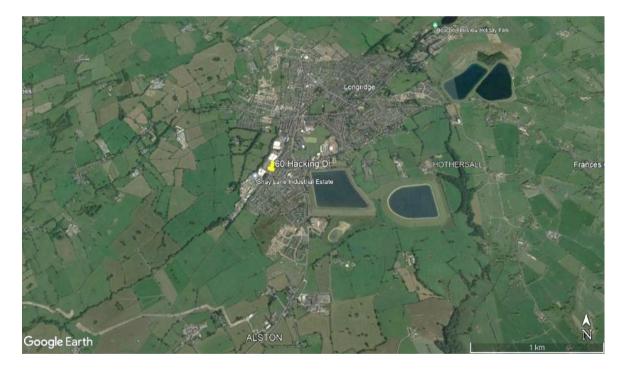
The site is located to the south Longridge within a residential area and adjacent to Shay Lane Industrial area, Set in a wider rural landscape of pasture and meadows with hedges, with small areas of deciduous woodland and the reservoirs to the east, all features which could be used for foraging and commuting by bats.

Figure 1: Aerial photo of site, showing surrounding landscape structure

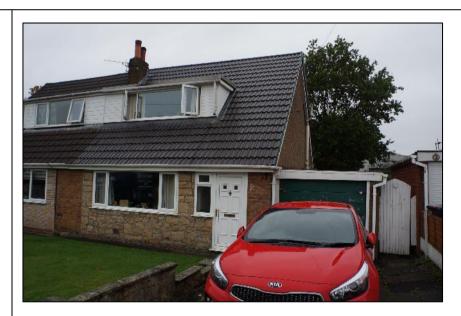
Photo 1: East (front) elevation.

The building is a two-storey brick and block cavity built residential property in a reasonable state of repair.

The uPVC windows around the property are in good repair and close fitting.

All mortar and brickwork is sound with no gaps or missing sections.

All eaves and fascia boards are close fitting uPVC and in reasonable condition.

The fascia board is well sealed to the wall, not affording any gaps for bats to roost behind.

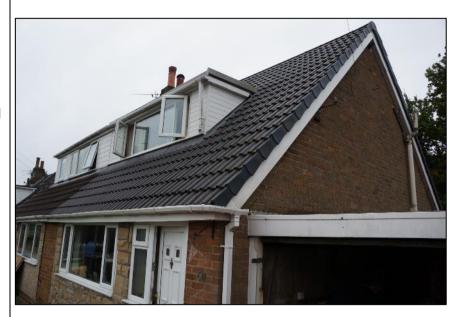
Photo 2: dual pitched roof with dorma windows

The dual-pitched roof ridge runs north to south, and is clad in man-made tiles, with a large dorma window set in.

The roofing tiles are in a good state of repair with no visible gaps or missing, slipped tiles, having recently been renewed.

The lead is in good condition, and is close fitting to all substrates.

On the north elevation is a single storey single garage with a flat felt covered roof, up and over door and uPVC fascia board

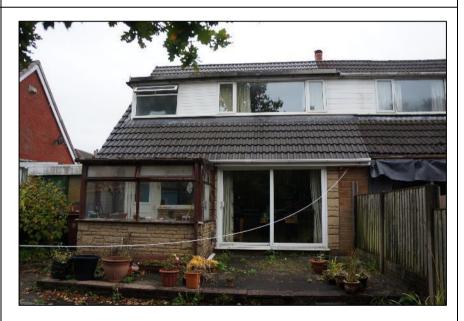
Photo 3: West elevation showing small conservatory to be removed.

On the west elevation is a small timber framed conservatory, in a poor condition with rotting timber frames.

There is a full length dorma on the west facing roof pitch with a felted flat roof.
All leadwork around the property is sound, with no gaps or crevices suitable for roosting bats.

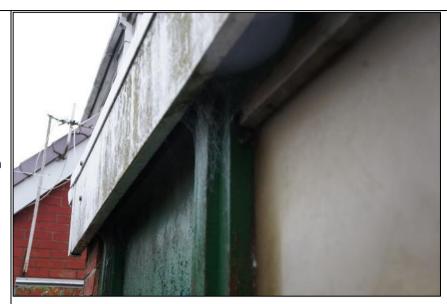
Photo 4: West elevation showing small conservatory to be removed.

The single height garage has a timber framed window to the west elevation. Although it is starting to rot, there are no gaps in the frames. The garage fascia boards are all close fitting and well-sealed to the brickwork behind, with no gaps or crevices suitable for roosting bats.

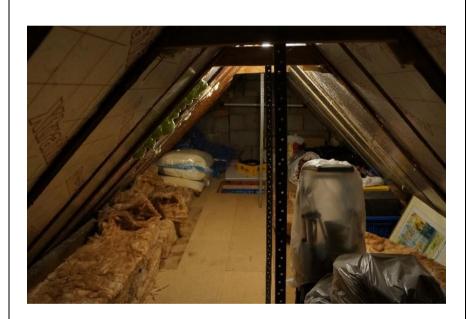
Photo 5: Internal view of roof structure.

Internally a roof void was accessible for inspection.

The space is dry, and the roofing materials appear in an excellent state of repair.

The underside of the roofing materials is lined with foam insulation panels.

There was no daylight showing through any point at the wall cap or eaves.

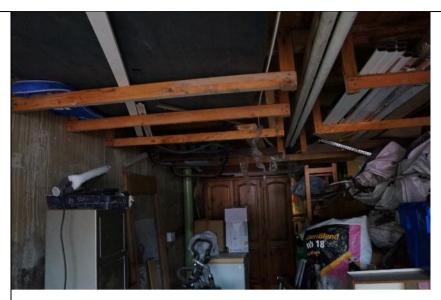
Photo 6: Internal view of garage space.

The interior of the garage was dry and appears well sealed.

All surfaces were checked for bat droppings or urine stains.
