DAYTIME BAT SURVEY

1 SOUTHPORT BARN COTTAGES, SAWLEY, LANCASHIRE

NOVEMBER 2021

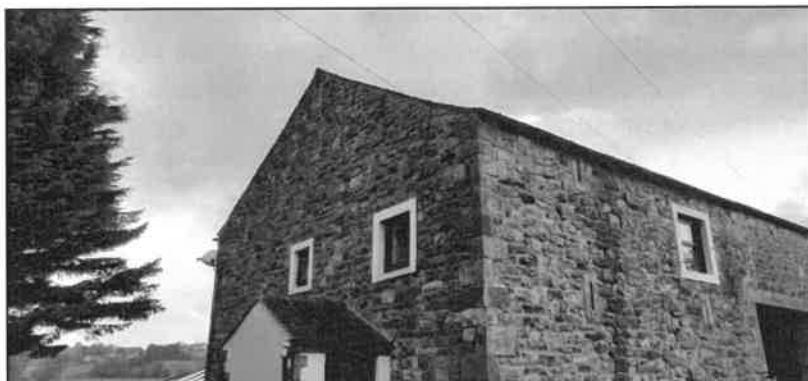
3.2 The external walls are in excellent condition. The stonework on the front and side elevations of the property is all in place and intact with complete mortar (see Photograph 1). The pebbledash on the rear elevation of the property is in good condition and free from cracks or damage (see Photograph 2). The window and door frames are flush to the surrounding masonry, offering no cavities for bats to roost within.

Photograph 1 showing the walls on the front and side elevations

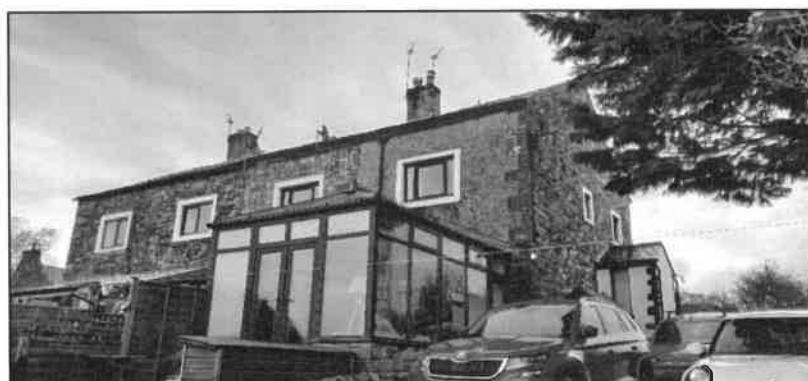
Photograph 2 showing the rear elevation of the property

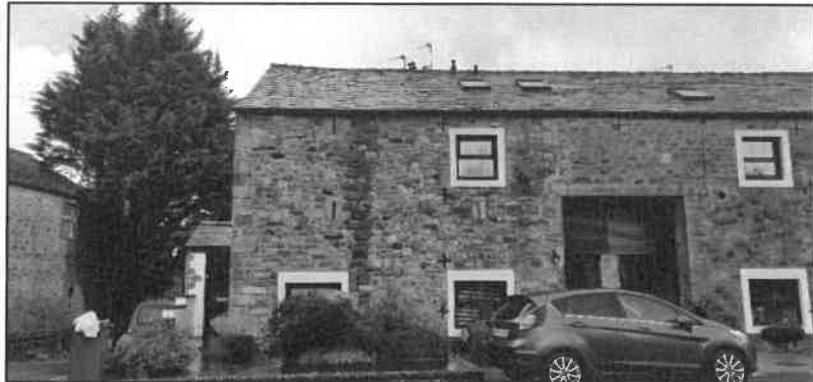
3.3 The roof of the building is pitched and covered with slate tiles. These are all in position and lie flush to one another. The ridge tiles are all in position and well-sealed with mortar (see Photograph 3).

Photograph 3 showing the roof of the building

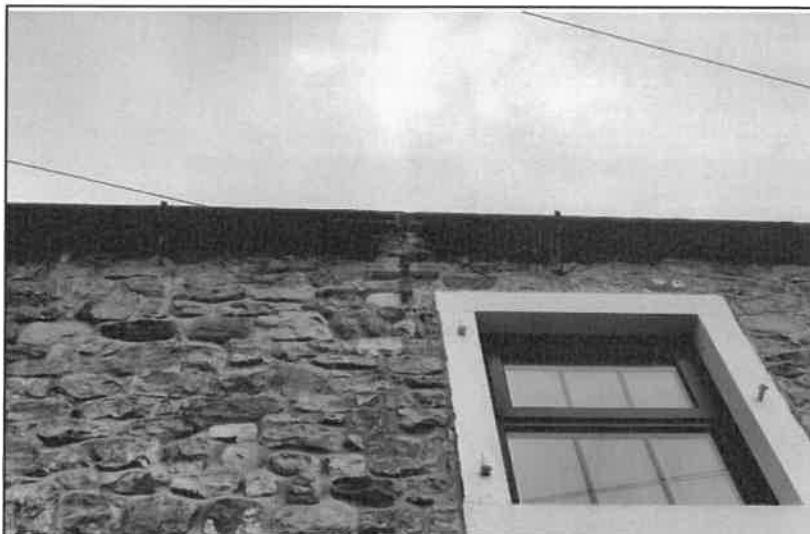
3.4 Visible gaps are present beneath the eaves of the roof at the front of the property, creating potential access points for bats (see Photographs 4 and 5).

Photograph 4 showing a gap underneath the eaves of the roof

- 4.1 Evidence of bat activity in the form of a small number of bat droppings was found in the roof void of 1 Southport Barn Cottages. The property has gaps at the roof eaves, which would allow bat access into the roof void. The roof void is in use and lit by strip lighting. Gaps do occur within the internal stone and brickwork. Given the small amount of evidence found, it is considered the building is unlikely to support a bat roost of high conservation value, such as a maternity roost.

- 4.2 The building is considered to offer moderate bat roost suitability. Further bat survey work is required to determine if an active roost is present, and if so, the species of bat and the type of roost present. It is recommended that a minimum of two dusk emergence/dawn re-entry surveys are undertaken at the building at an optimal time of year (between May and September).

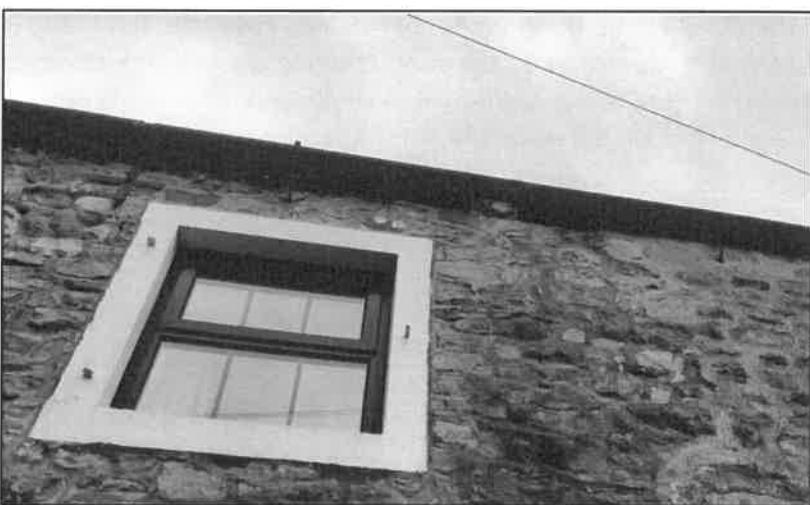
Photograph 5 showing another gap underneath the eaves of the roof

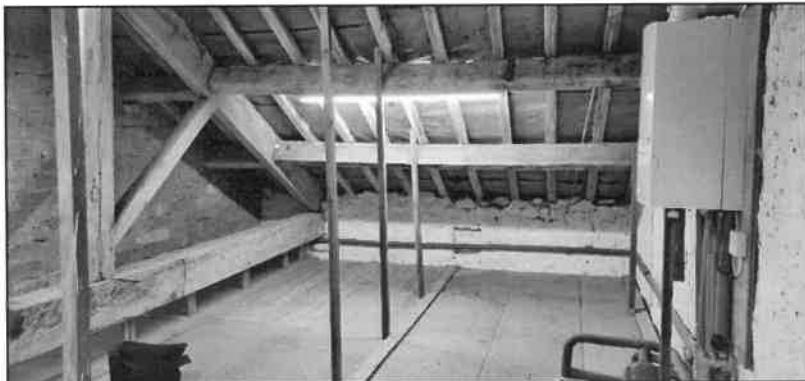
3.5 The internal living spaces are in use and do not offer suitable bat roosting habitat. The building has one large and accessible roof void, which covers the expanse of the roof space. The roof void houses the boiler and is lit by strip lighting. The wooden roof joists are mostly intact, without gaps or cracks for bats to use (see Photographs 6 and 7). The roof is lined throughout, and this is complete, with no significant tears or rips.

Photograph 6 showing the roof void

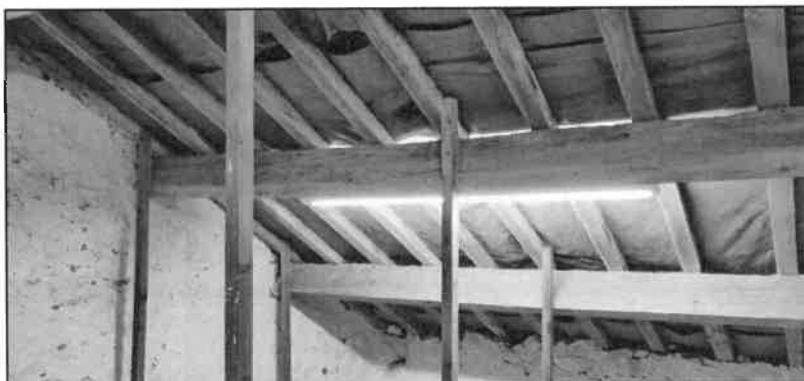
Photograph 7 showing the roof joists

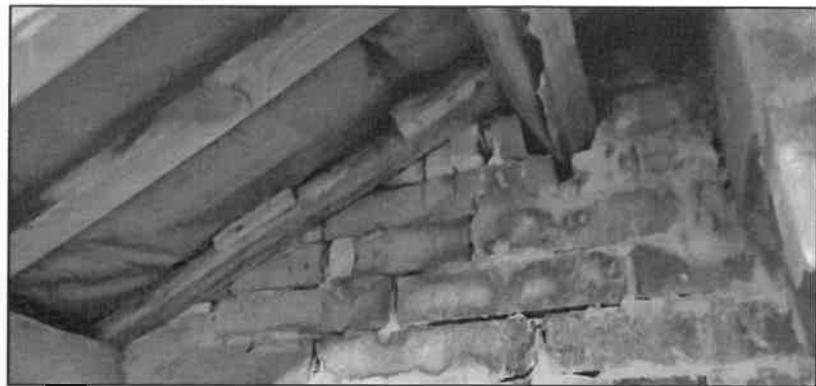
3.6 The roof void is insulated to the floor and timber boards cover the floor. The internal brickwork and stonework do not meet the roof, creating cavities (see Photographs 8 and 9). No daylight is present at the roof edges. A small amount of bat droppings (<10) were found inside the void, scattered on the floor. A small number of rodent droppings were also found.

Photograph 8 showing cavities in the brickwork around the timber

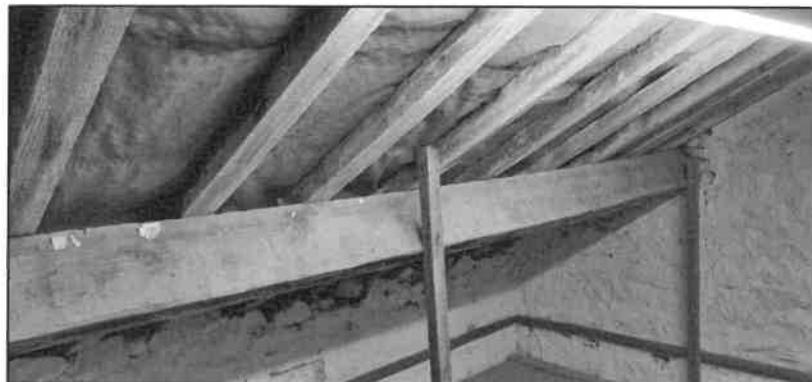
Photograph 9 showing cavities in the stonework
