# **Preliminary Bat Roost Assessment Report**

**3 Portfield Bar,  
Whalley,  
BB7 9DL**

**04.12.2020**

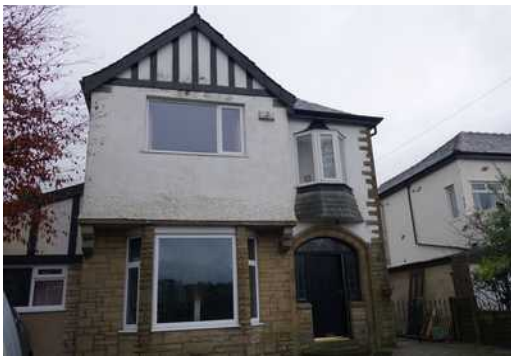
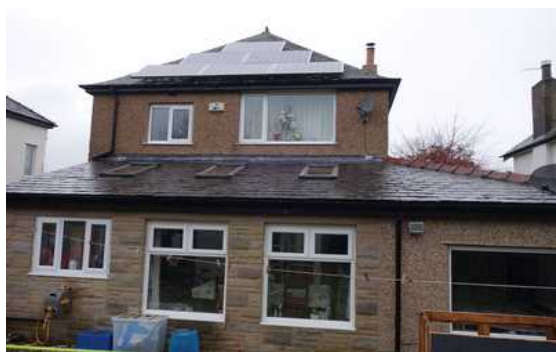
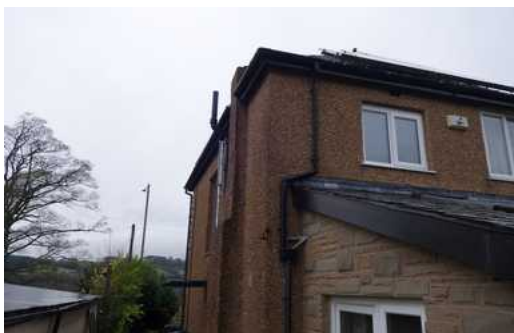
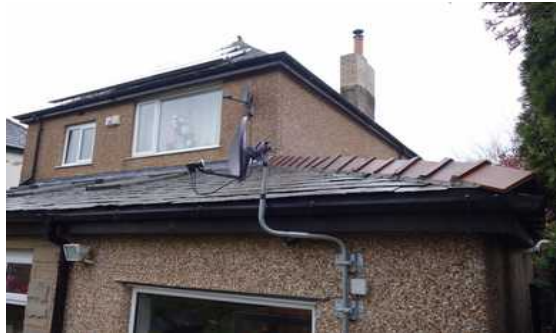
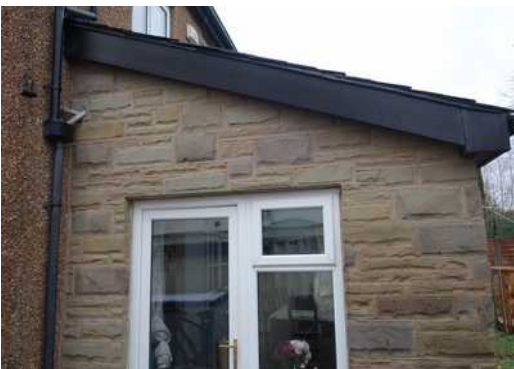
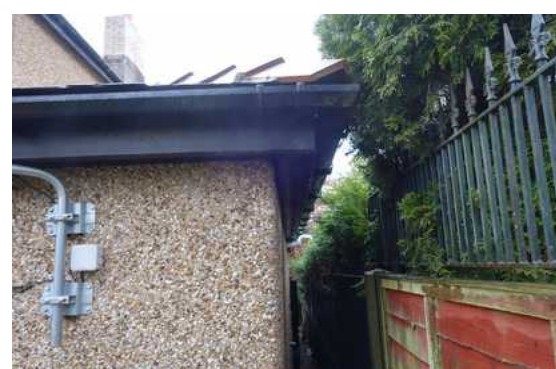
The property consists of a detached two storey house with hipped slate roof, a single storey single pitched roofed extension is present to the rear and north side of the property.

External walls are rendered and partially pebble dashed with no obvious cracks, gaps or crevices present. The eaves are pointed and well sealed. Roof slates are close fitting with no slipped, lifted or missing tiles present. The ridge is pointed and well sealed.

The single storey extension has well sealed upvc soffits and fascia boarding is close fitting.

The buildings can be considered to offer negligible roosting bat potential.
