**BAT SURVEY AT -
1 LANE ENDS
SABDEN**

DATE AND TIME OF VISIT
14 th Oct 2021 5.15 pm

REFERENCE. Mr and Mrs A. Read

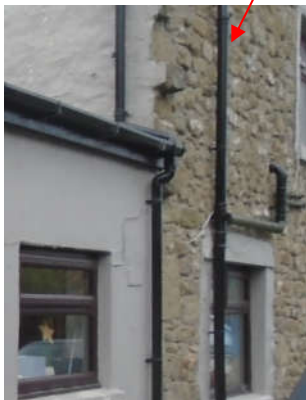
The original house walls are natural random stone with a rendered rear wall, The outrigger and the conservatory base wall is brick/block render. The dormer has horizontal timber boarded finish front and slate hung sides.

All walls are in good condition with no cracks, crevices or access points suitable for bat ingress. The timber dormer boarding was examined from the ground level with binoculars, all boards were tight fitting, no gaps or rotten wood was observed.

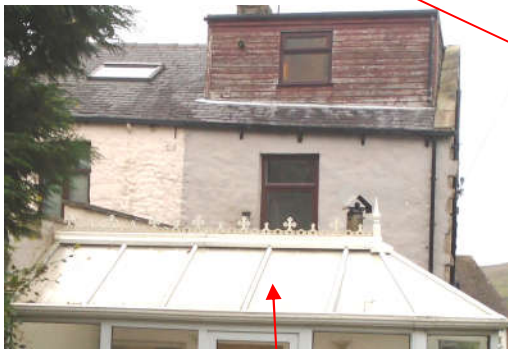
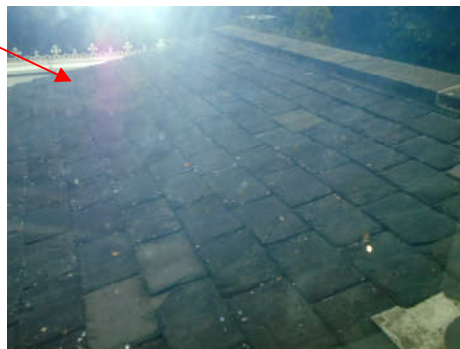
The house roof is pitched with a slate finish and stone verge to the gable. No fascias were present. The outrigger roof was a mono pitch with blue slate finish with vented fascia to the eaves and lead flashed to wall.

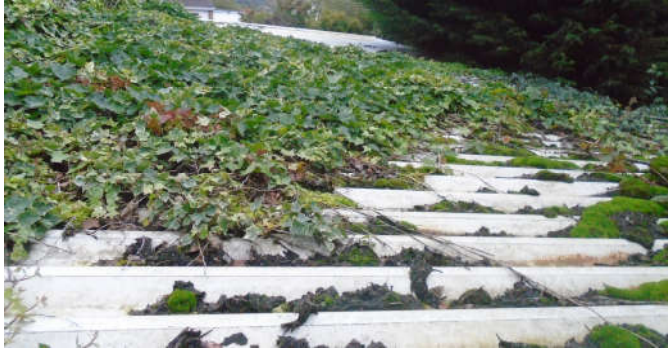
The Conservatory roof is clear polycarbonate sheets and upvc frame.

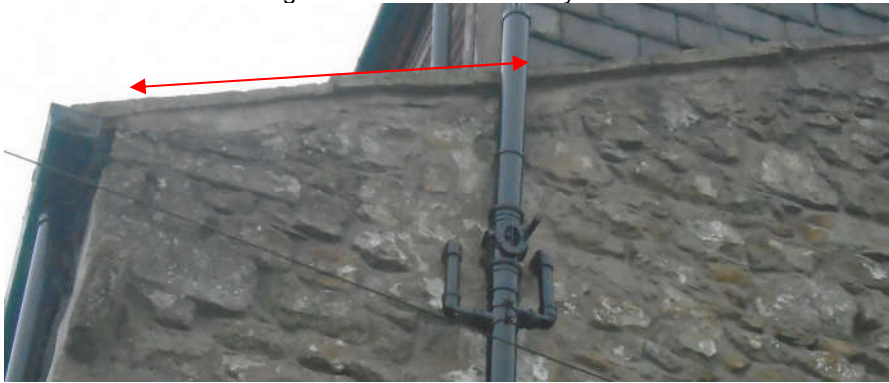
The main roof was examined from ground level with binoculars, the slates were tight fitting with well pointed ridge tiles. The verge stones were well pointed . No access points were evident. The section of the roof verge which will be affected by the scheme.

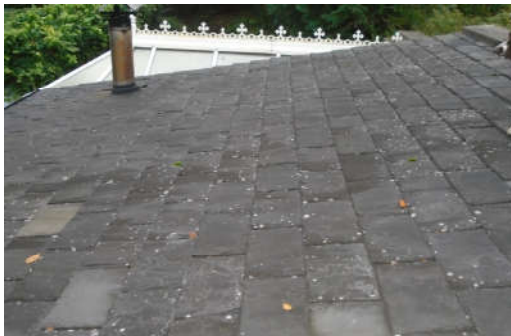
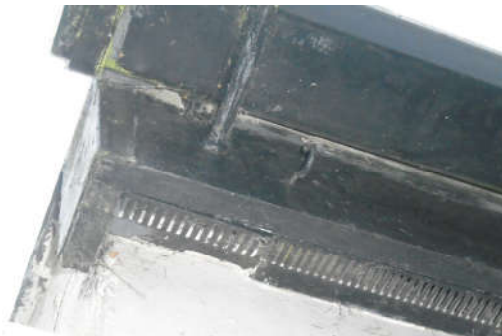
The lean to roof was observed from a window opening, all the slates were very tight fitting, the flashings at the abutment with the wall were in very good condition and tight fitting. The fascias at the eaves are in good condition with a grille vent soffit , all tight fitting with no access points.

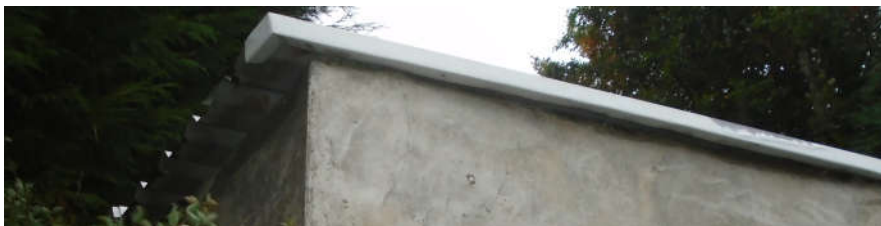
The steel sheets on the garage roof were in good condition with tight laps but had extensive ivy coverage. Access points were not evident nor were there any crevices suitable for bat ingress.

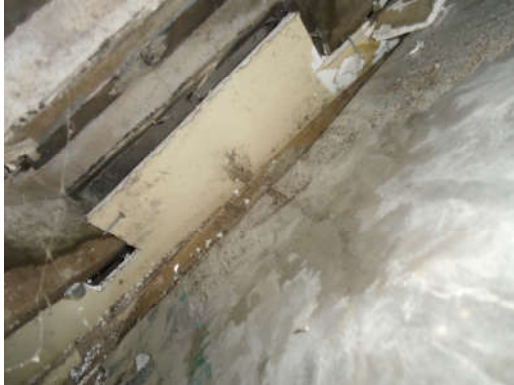
The main roof void has been converted to provide accommodation , however there was a small accessible void to the front elevation eaves. It was inspected from a small access hatch ,the timber rafters were visible there was no underlay present and the ceiling joists had a boarded finish. The timbers were in reasonable condition. The small section which was visible did not have any evidence of bat presence.

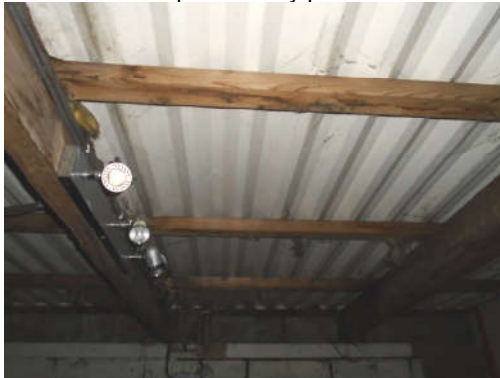
The garage roof was steel sheet fixed over timber joists and purlins. The structure could be closely examined and found not to provide any potential roost habitat for bats.

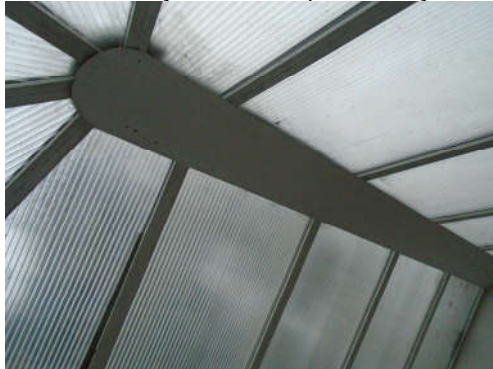
The conservatory roof did not provide any did not provide any roost habitat for bats.
