**BAT SURVEY AT -**  
GRANNY ANNEX/ GARAGE at  
COCKERHAM HALL  
SACCARY LANE  
MELLOR

REFERENCE NO. 6490

### **Single storey extension to existing granny annex and conversion of the garage below to form additional bedroom accommodation.**

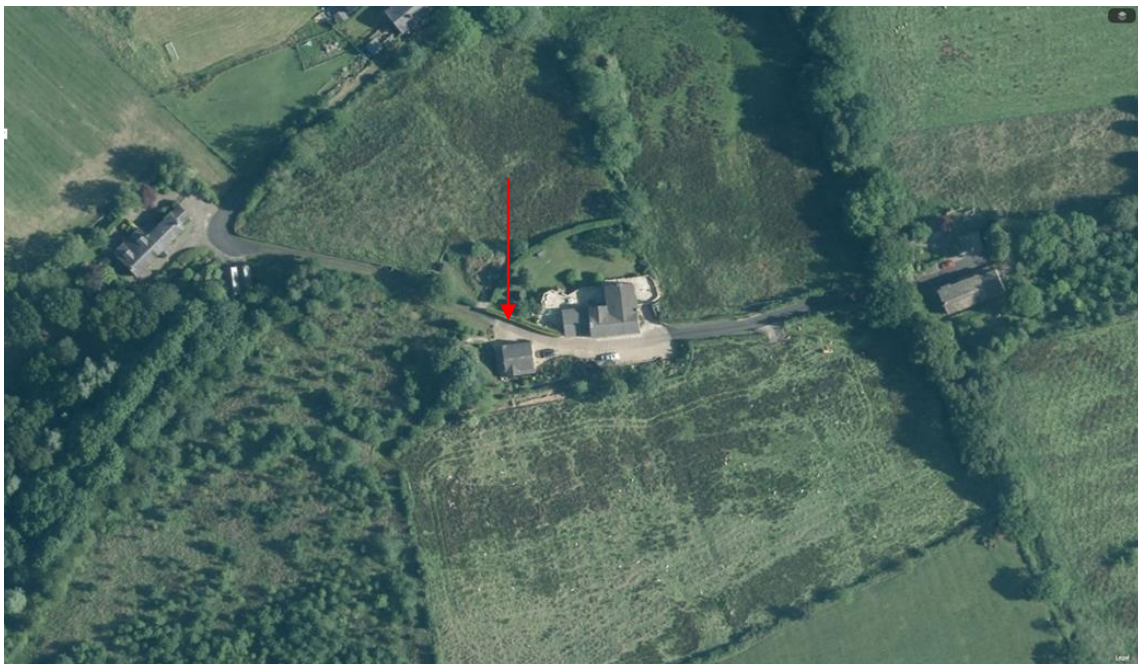
The building is located adjacent to a plantation immediately to the west, the plantation extends to the south west and there is a further plantation which starts to the north east and continues in that direction. the pastureland which surrounds the site is mainly bound by hedgerow which provides good potential forage and commute routes / corridors to the good forage potential in the greater locality.

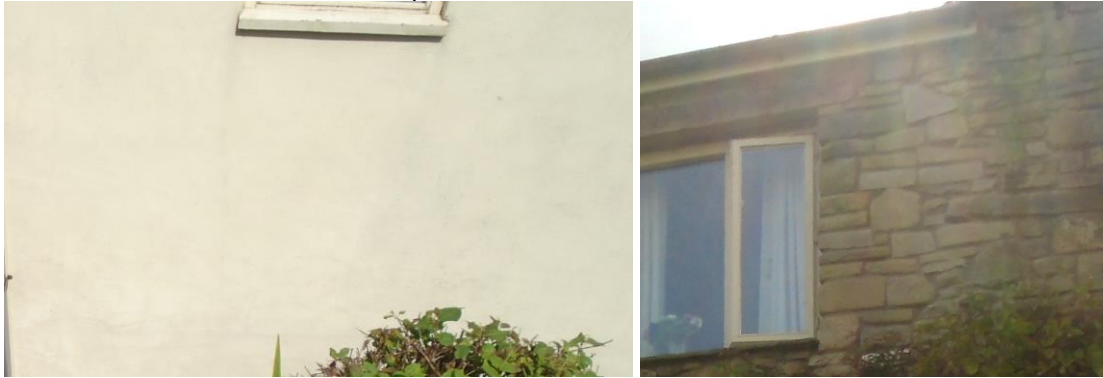
The front east and side north elevation is random stone with recessed pointing the rear west and side are blockwork with a smooth, painted render finish.

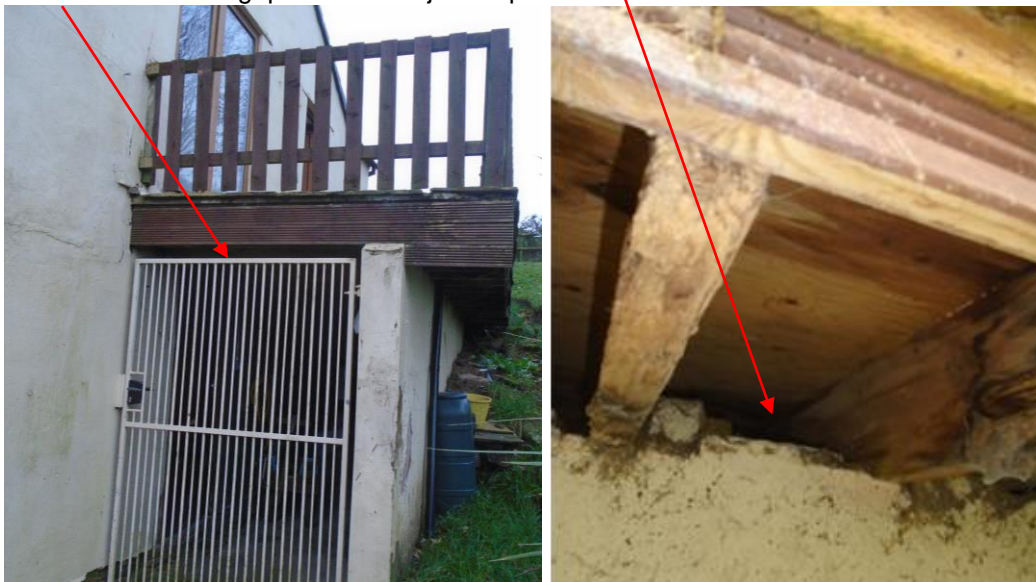
No access points, cracks or crevices in the walls. The store area under the terrace area is open to the north and there are gaps where the joists span over the side wall.

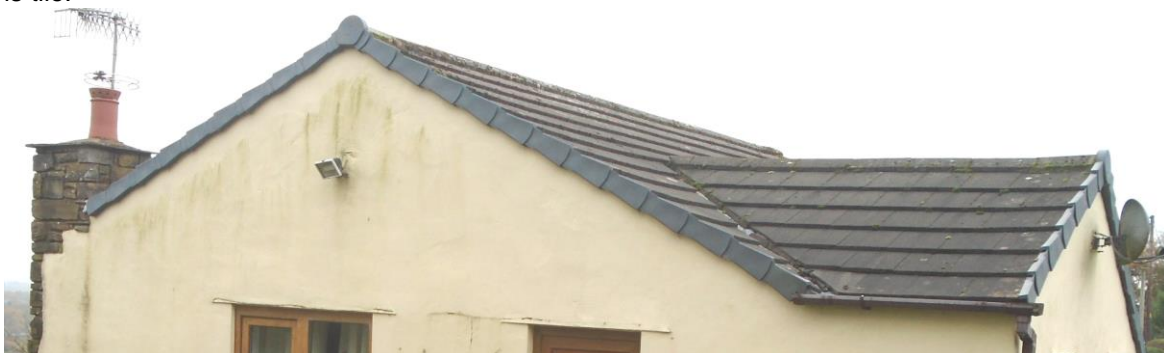
The roof is a traditional pitch with a small side gable. There is a upvc verge trim to the south and west gables. Pointed verge to the East elevation and flush timber fascia's to the north elevation. The finish is tile.

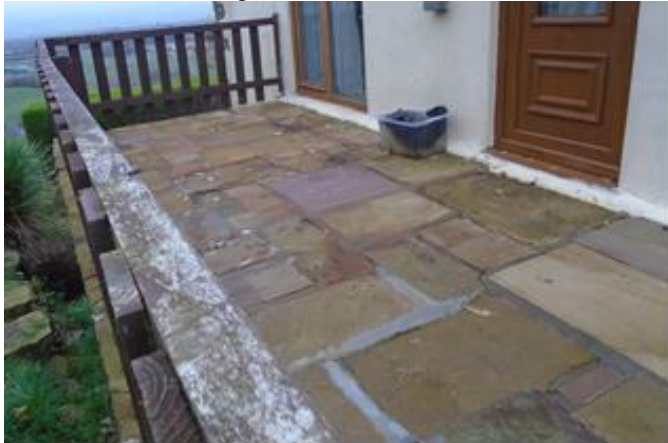
The roof / terrace over the open store is stone paving over a timber deck and joists. With decking board trim to the edge .

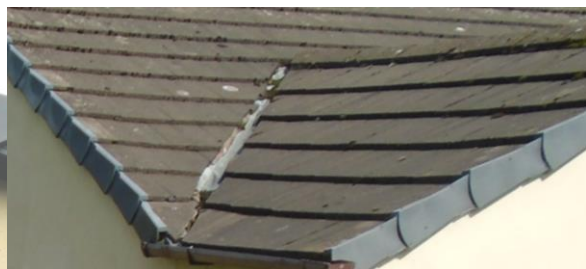
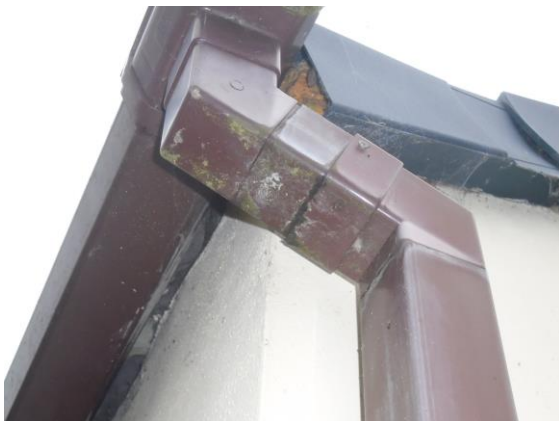
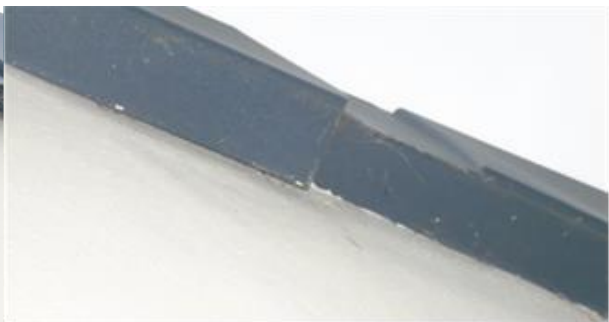
The upvc trim to the west gable was examined closely from a ladder all joints were tight fitting and no access points were found. The tiles are very tight fitting. No access points nor any crevices with the potential to provide suitable roost habitat for bats.

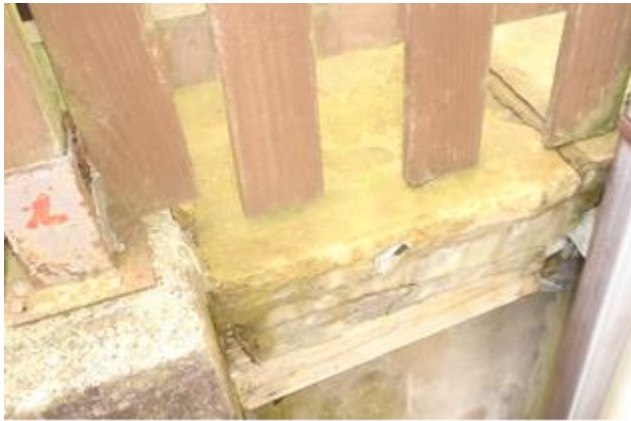
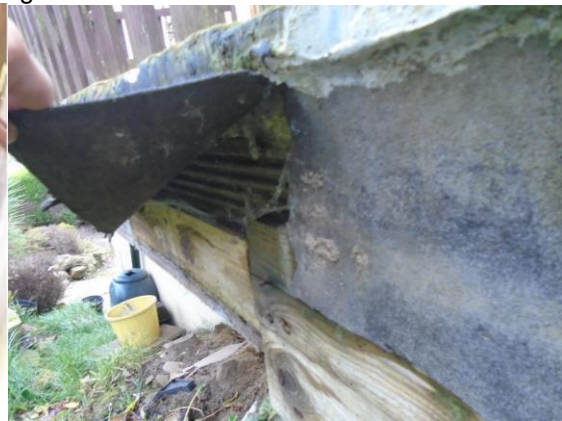
The terrace was not accessible to bats nor was the edge trim.

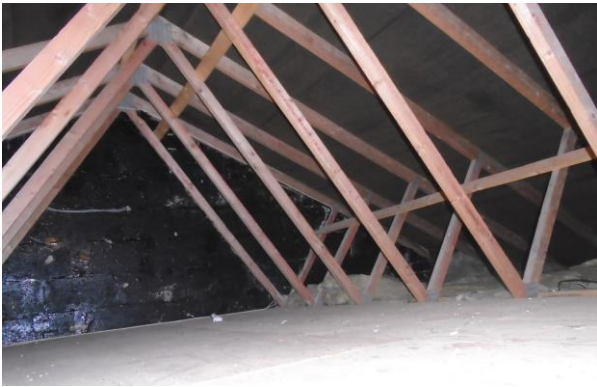
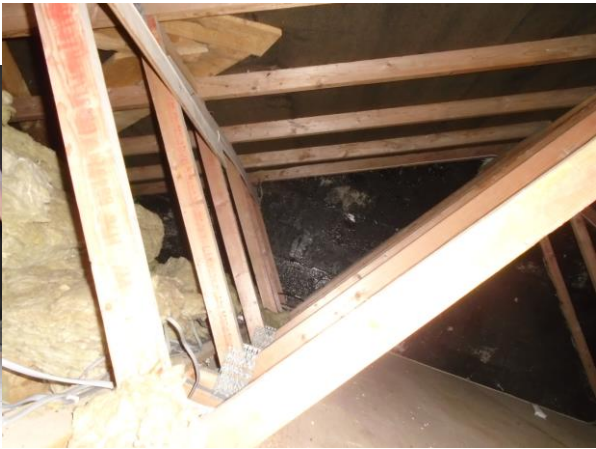
The roof void was accessed via a hatch, the floor was mainly boarded with insulation to the sides. It was timber trusses with roof felt over. The space was clean with no dropping or substantial insect remains evident. The timbers were in good condition as was the felt. The space provided a sub optimal roost potential for bats.

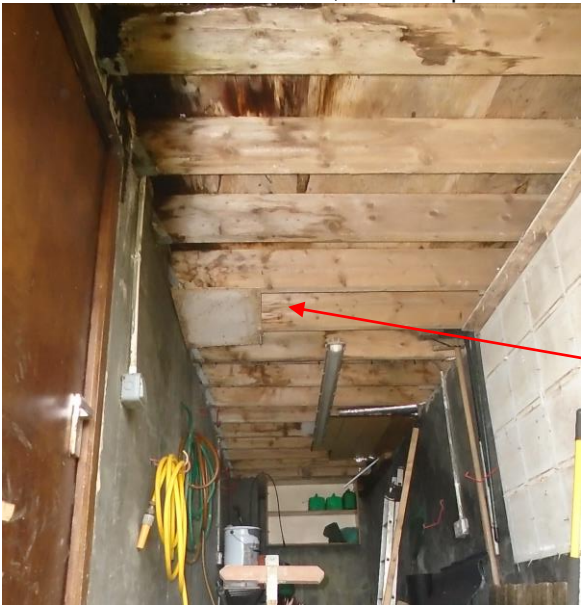
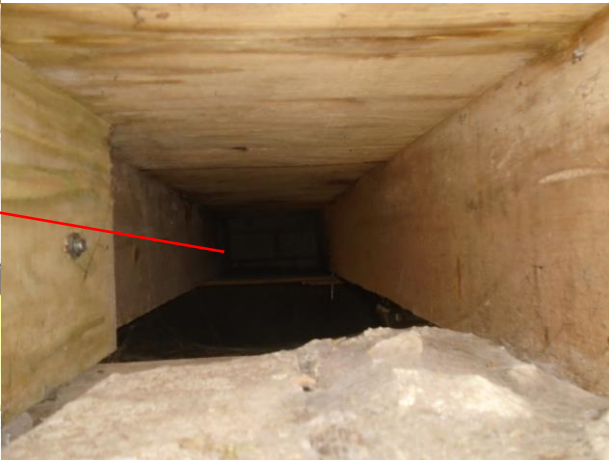
The underside of the terrace roof was timber boarding over timber joists. crevice had been formed by a board being fixed under the joists ( see below) however as can be seen the space is not used . No crevices were in the timbers, no roost potential whatsoever.
