# Preliminary Bat Roost Assessment Report

**The Old Manor House,  
Rimington Lane,  
Rimington,  
BB7 4DT**

**02.12.2021**

**Report prepared by:  
Dave Anderson  
Batworker.com**

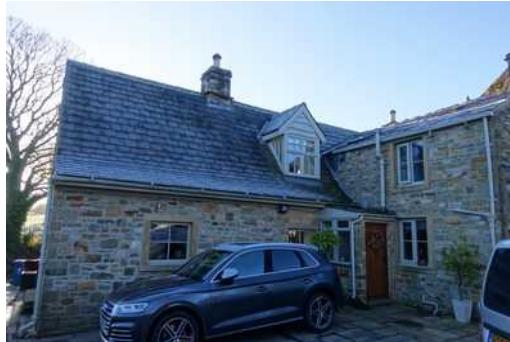
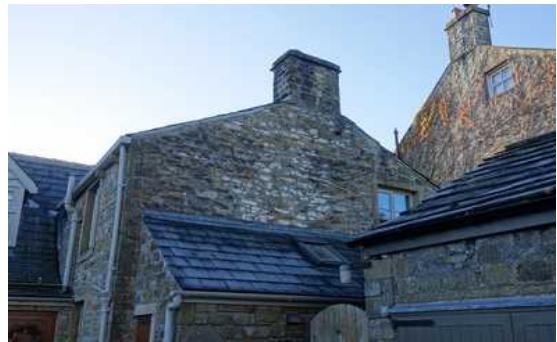
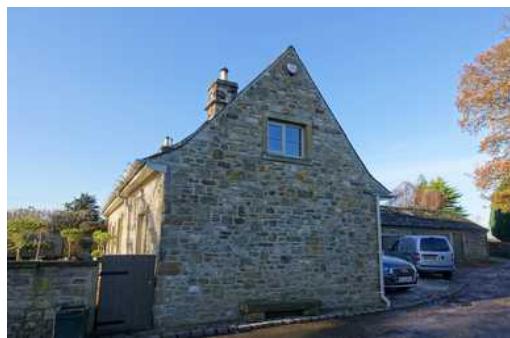
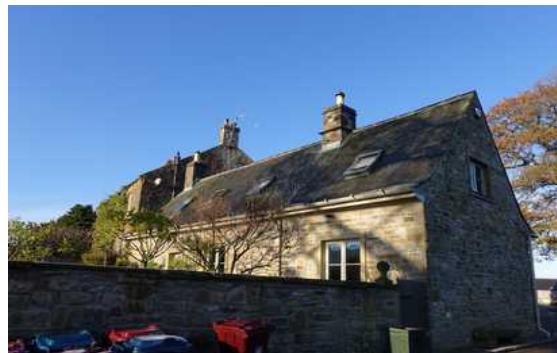
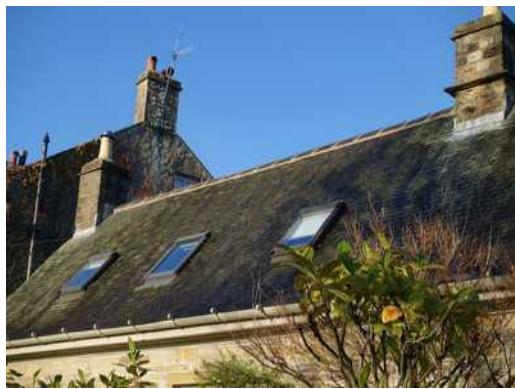
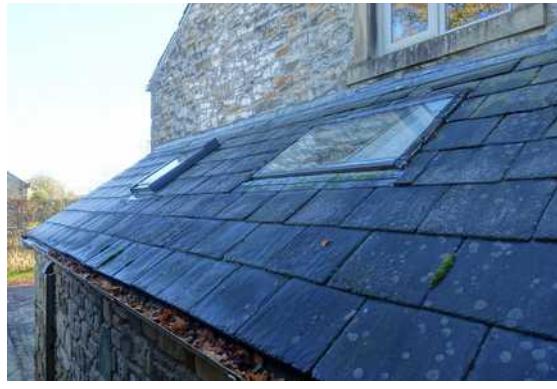
The property consists of a two storey detached stone built house with a double pitched slate roof. The property has an adjoining two storey extension on the north. External walls are well pointed with no cracks, crevices or cavities present. The gable ends are well pointed and sealed. Eaves are well sealed with no obvious gaps present. Fascia boarding where present is close fitting.

The roof is in good condition with no missing, lifted or slipped slates present. The ridge is well sealed. A dormer is present on the north eastern roof section.

The building can be considered to offer negligible bat potential.
