**Re: Proposed development at Rose Cottage, Sandy Bank, Chipping, PR3 2GA**

Thank you for your request for bat surveys regarding a proposed development at the above site. I understand that proposal is for a two-storey extension to the north east elevation.

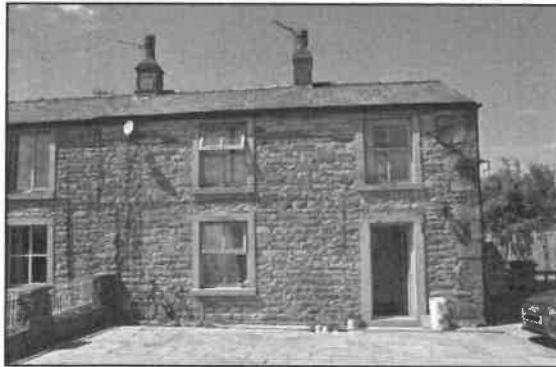
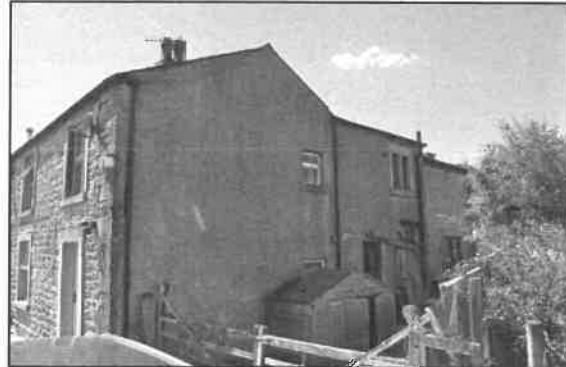
The original cottage has been re-roofed and the slate roof coverings associated with all the extensions are also in a good state of repair with very few visible gaps. There are, however a series of gaps at the roof edges, particularly at the gables on the north east, and on the middle roof section along the north east elevations. There are also gaps along the wall top behind a timber fascia on the front (south) elevation. These gaps are suitable for use by bats throughout the year and some of the gaps are also suitable for use by nesting birds throughout the nesting season (February to September). Signs of nesting birds (droppings) were found below the fascia on the front elevation. Timber fascias associated with building extensions to the rear of the property are tight fitting with no gaps present.

***View of Rose Cottage south east (lhs) and north east (rhs) elevations***

Protected Species	Impacts /Predicted Impacts	Action Required
Bats	<p>It is advised that there is no evidence to suggest that bats pose a constraint to the proposed development.</p> <p>It is advised that bats could utilise gaps associated with roof edges. There are open roof edges along the north east elevation where the work is proposed and bats were recorded in close proximity to the house during the emergence survey.</p> <p>It is our professional judgement that there <u>is</u> a reasonable likelihood of bats roosting at another time.</p> <p>All bat species are fully protected under the Wildlife and Countryside Act 1981 (as amended) and the Conservation of Habitats and Species Regulations 2017. This legislation has been amended by the Conservation of Habitats and Species Regulations (Amendment) (EU Exit) Regulations 2019 which continues the same provision for European protected species, licensing requirements, and protected areas continue after Brexit.</p>	<p><b>Advice (mitigation):</b> A pre-commencement bat survey by a suitably qualified and experienced Ecologist should be carried out immediately prior to any proposed works. Depending on the time of year when the works are undertaken this should include:</p> <ol style="list-style-type: none"> <li>1. A single dusk emergence or dawn re-entry survey during the bat active season (April to October) Or</li> <li>2. A close inspection of potential roost features e.g. from scaffolding or cherry picker.</li> </ol> <p>This survey will help to avoid unlawful disturbance to bats and bat roosts before any development takes place- it is therefore specified to be used as a final precautionary approach once planning permission has been granted. <b>Immediately prior to the roof works</b></p> <p><b>Advice (mitigation):</b> All people working at Rose Cottage should be made aware of the likelihood of encountering bats and should be made aware of the legal protection of roosting bats and their own responsibilities as regards implementation of precautionary measures. <b>Prior to the commencement of development.</b></p>

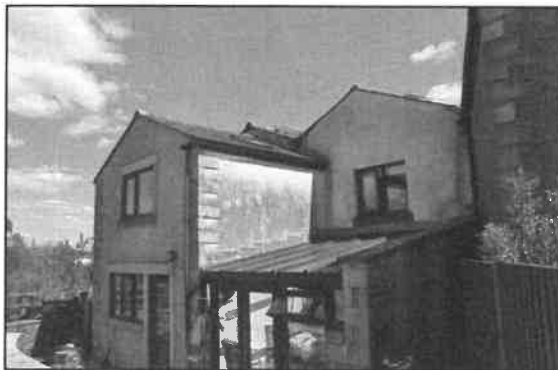
No nesting birds were found during the survey, birds signs were found below the fascia on the south east elevation.

***Rear view of Rose Cottage, north west elevation (lhs) and bird droppings below south east fascia (rhs)***

Protected species	Impacts /Predicted Impacts	Action Required
Nesting birds	<p>It is advised that signs of nesting birds (droppings) have been found along the south east elevation.</p> <p>It is our professional judgement that there <b>is</b> a reasonable likelihood of birds nesting in the building and garden boundary vegetation during the bird nesting season (March to August).</p> <p>Under the Wildlife and Countryside Act 1981 (as amended), wild birds are protected from being killed, injured or captured, while their nests and eggs are protected from being damaged, destroyed or taken.</p>	<b>Advice (mitigation):</b> All people working at Rose Cottage should be made aware of the likelihood of encountering nesting birds and should be made aware of the legal protection of nesting birds and their own responsibilities as regards implementation of precautionary measures. <b>Prior to any work commencing.</b>

Protected species	Impacts /Predicted Impacts	Action Required
Nesting birds		<p><b>Advice (mitigation):</b> It is advised that the most appropriate way to address the risk to nesting birds is:</p> <ul style="list-style-type: none"> <li>• Avoid disturbance to the building and/or boundary vegetation during the nesting season</li> <li>Or</li> <li>• If works cannot be delayed Rose Cottage should be carefully checked, immediately prior to works commencing. Checks should be carried out by a suitably experienced ecologist. If the risk of nesting birds remains, then monitoring for nesting bird activity should continue for the duration of works.</li> </ul> <p><b>Prior to any work commencing (checks) and throughout works in nesting season (monitoring).</b></p> <p><b>Advice (mitigation):</b> If nesting birds are found close enough to cause unlawful activities during development works, it will be necessary to delay works or seek advice as to whether or not any development can proceed lawfully at that time. Under these circumstances, work must stop until advice has been sought from an appropriately experienced Ecologist.</p> <p><b>Prior to and during works.</b></p>

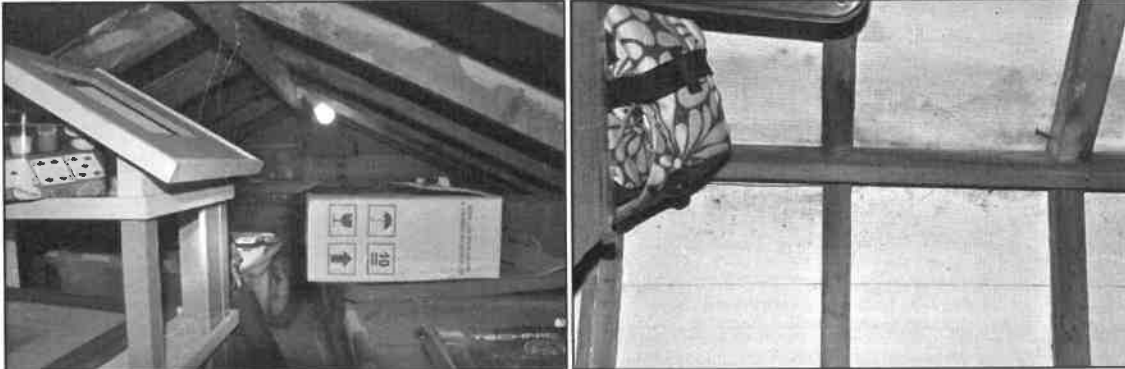
Two shallow roof voids associated with the original cottage were partly accessible for an internal inspection. Both roof voids are shallow, cluttered spaces constructed on timber roof supports, boarded floors and underlined with a modern roof membrane.

***View of roof void showing shallow, cluttered space (lhs) and modern roof membrane (rhs)***

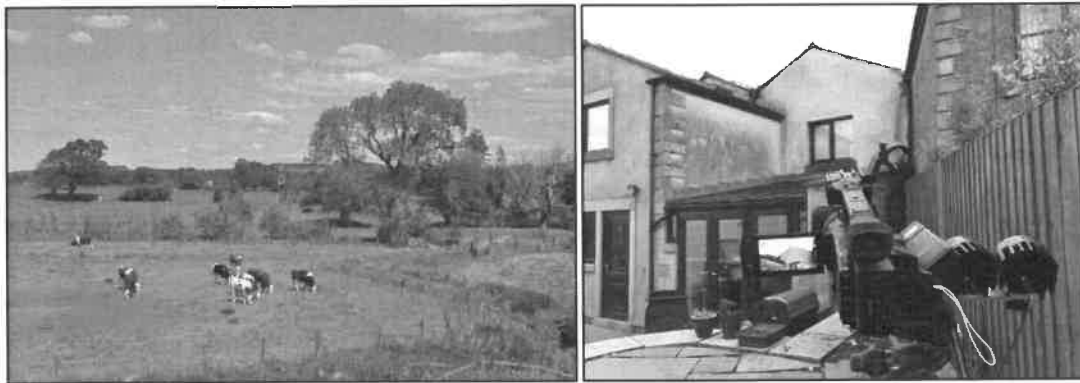
- 1 x Elekon Batlogger – Real time full spectrum
- Bat echolocation was recorded onto the internal device on both detectors during the surveys.
- Canon XF-100 and Sony HDR-XR 520VE camcorders (set on 0 lux Nightshot), with two IRLight6 infra-red illuminators, were focussed on potential roost features throughout the emergence surveys to assist with observations. All activity was recorded onto the removable media cards or internal hard drives of the camcorders for further analysis.

***View of pasture field to the immediate east (rhs) and example of Infrared camera equipment used during emergence surveys (lhs)***
