Land at Chipping Lane, Longridge  
Hydraulic Assessment

**APPENDIX F: ISIS OUTPUTS: PROPOSED SCENARIO SCHEMATIC,  
LONG-SECTION AND CROSS-SECTIONS**

## **APPENDIX G: FLOOD MODELLER OUTPUTS: SENSITIVITY TESTING**

Ground Investigation Report  
(Phase 2)

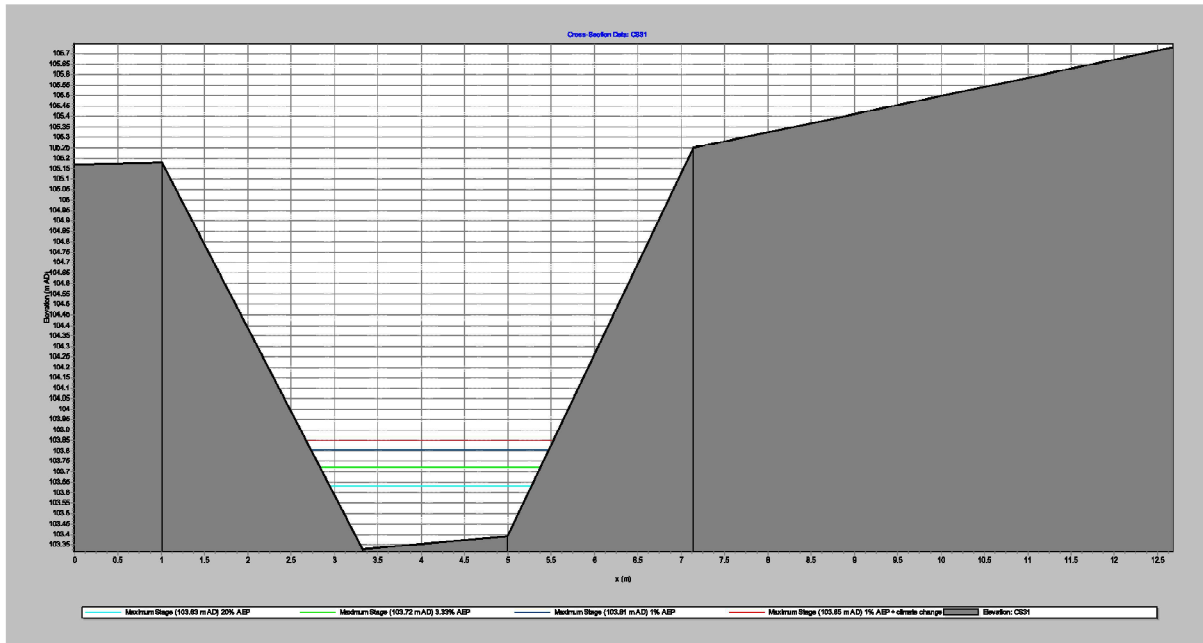
Figure E.29 Peak levels at cross section CS31

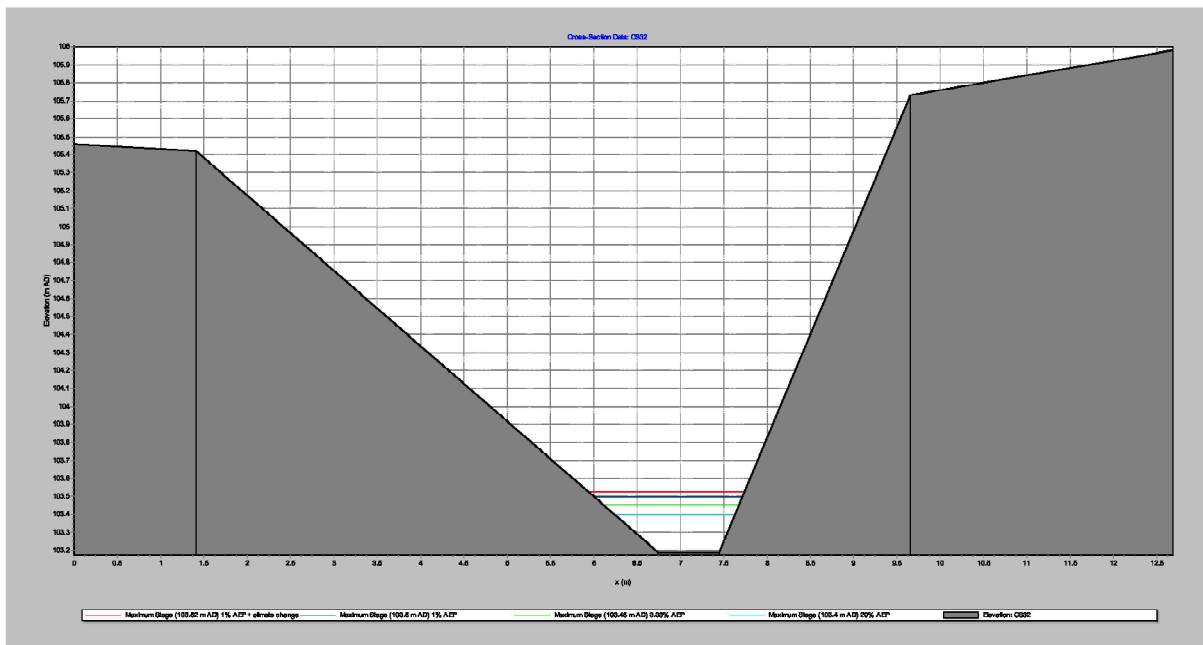
Figure E.30 Peak levels at cross section CS32

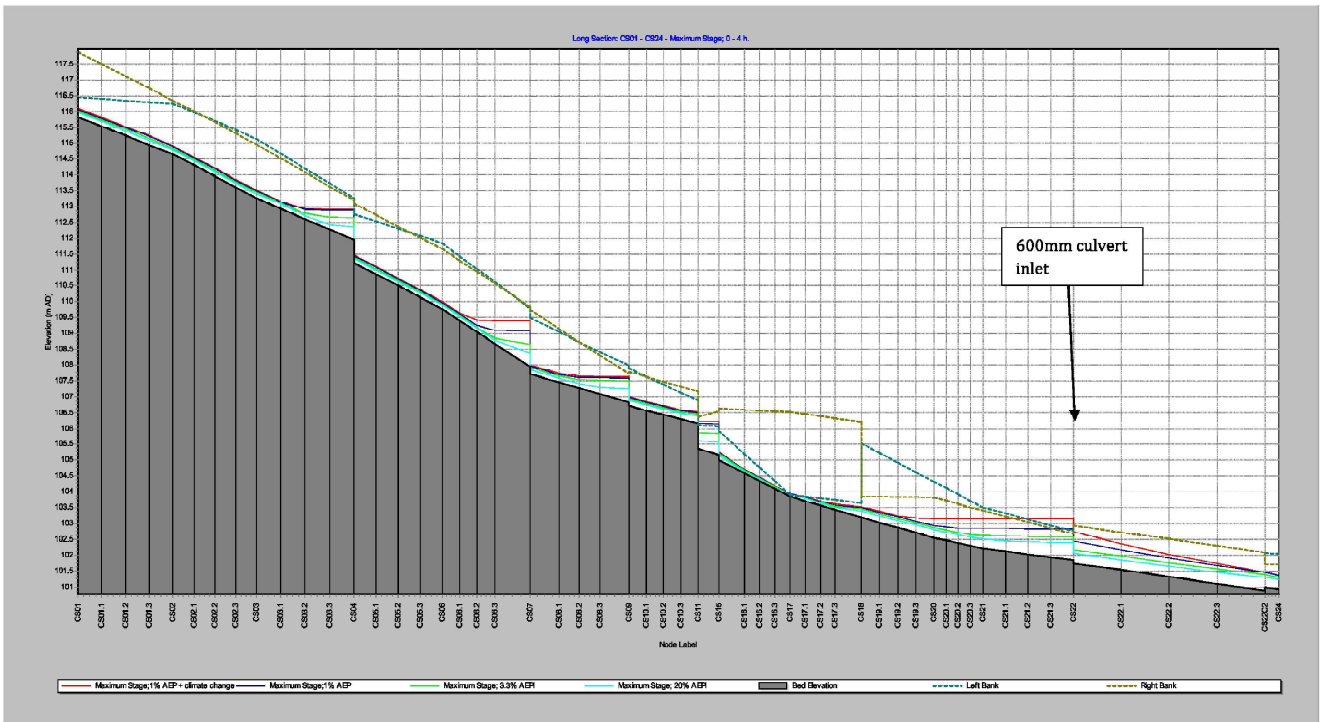
Figure E.15 Long section CS01 to CS24

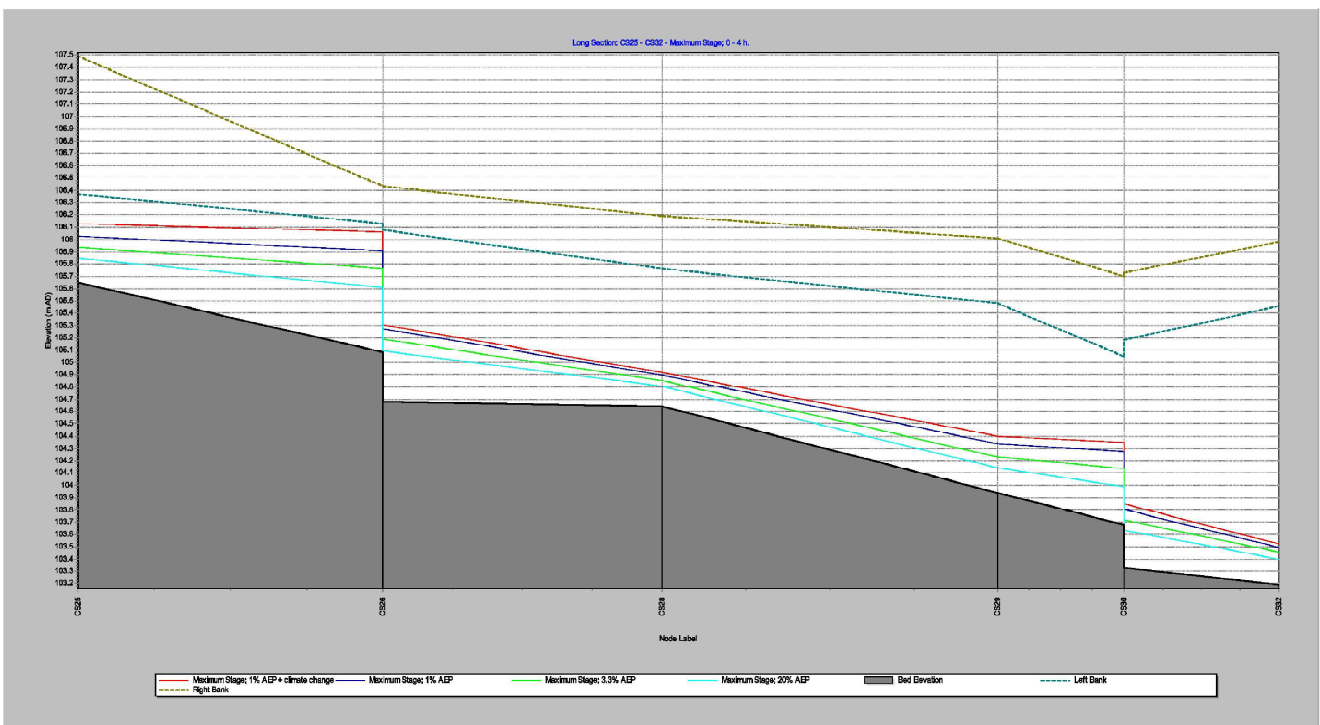
Figure E.15 Long section CS25 to CS32

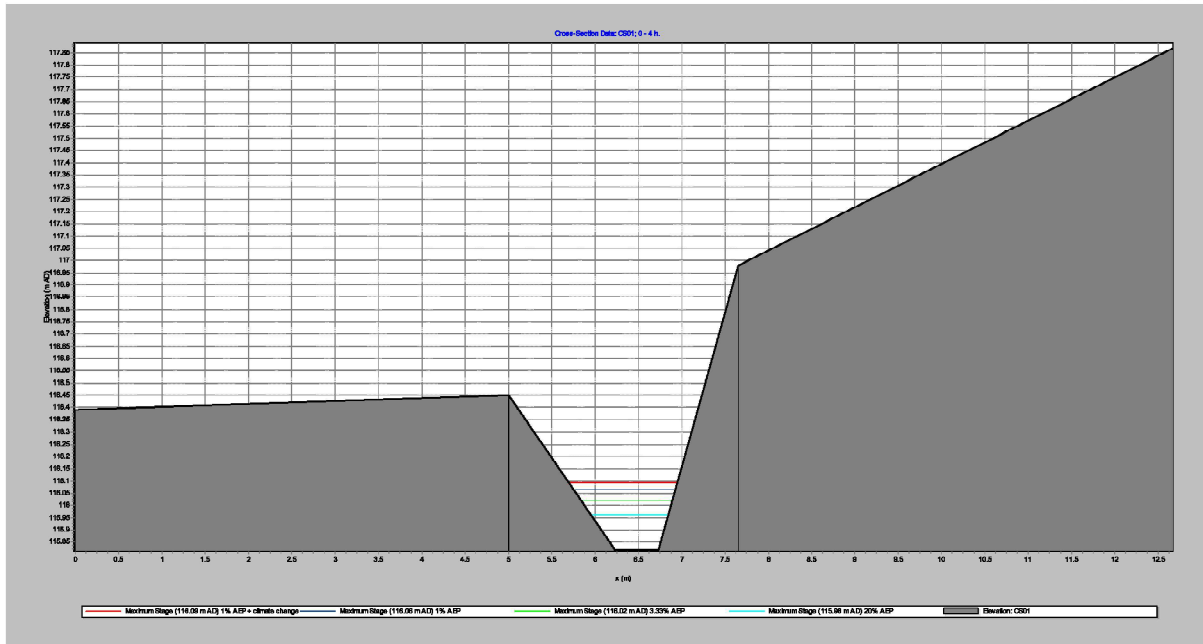
Figure F.1 Peak levels at cross section CS01

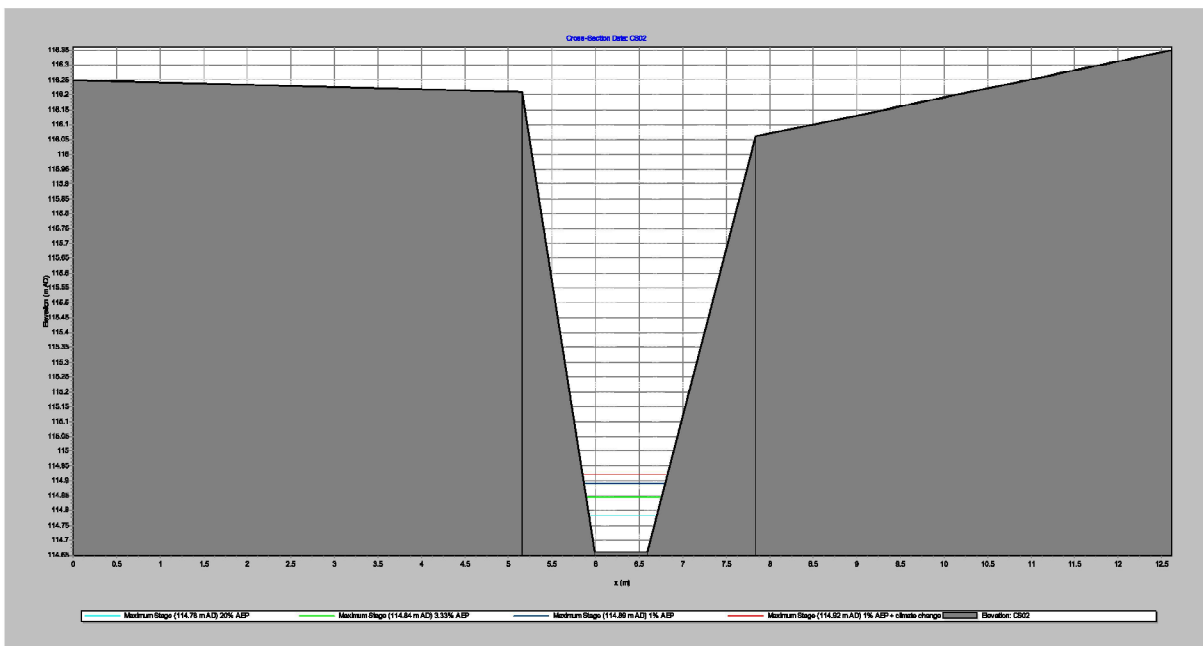
Figure F.2 Peak levels at cross section CS02

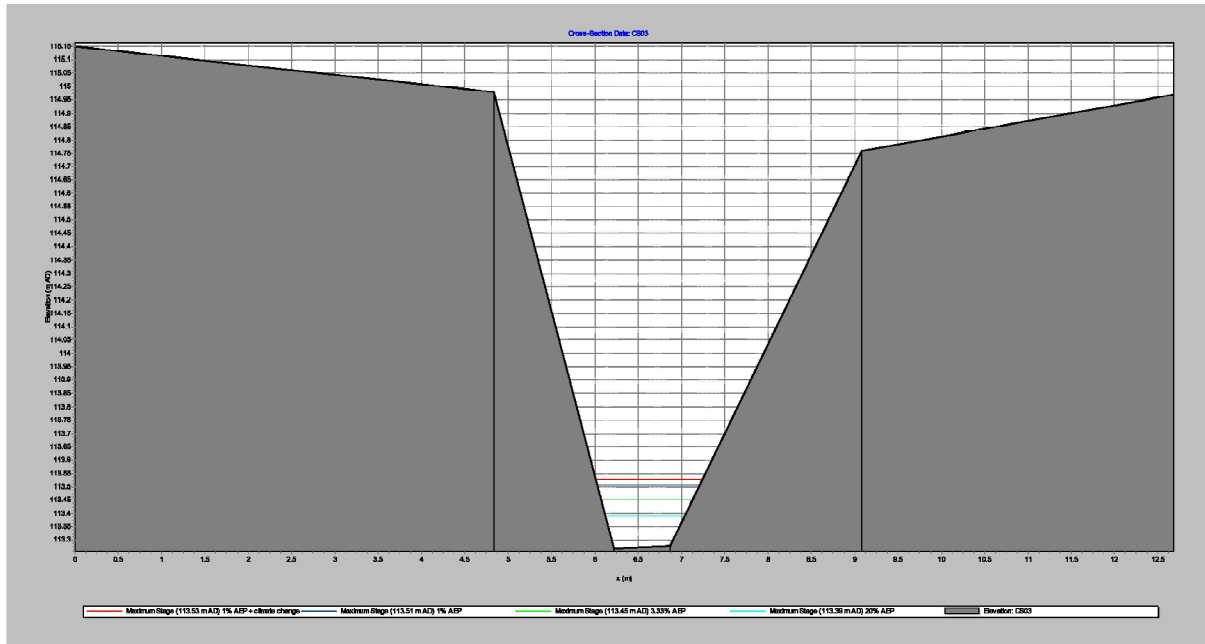
Figure F.3 Peak levels at cross section CS03

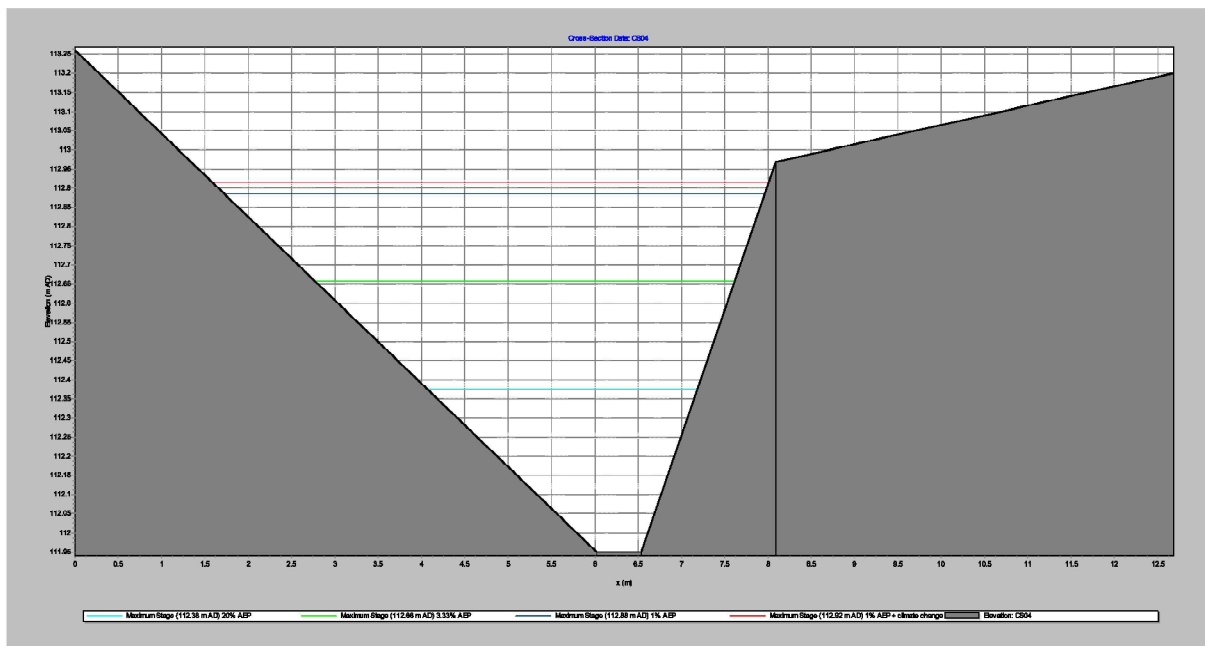
Figure F.4 Peak levels at cross section CS04

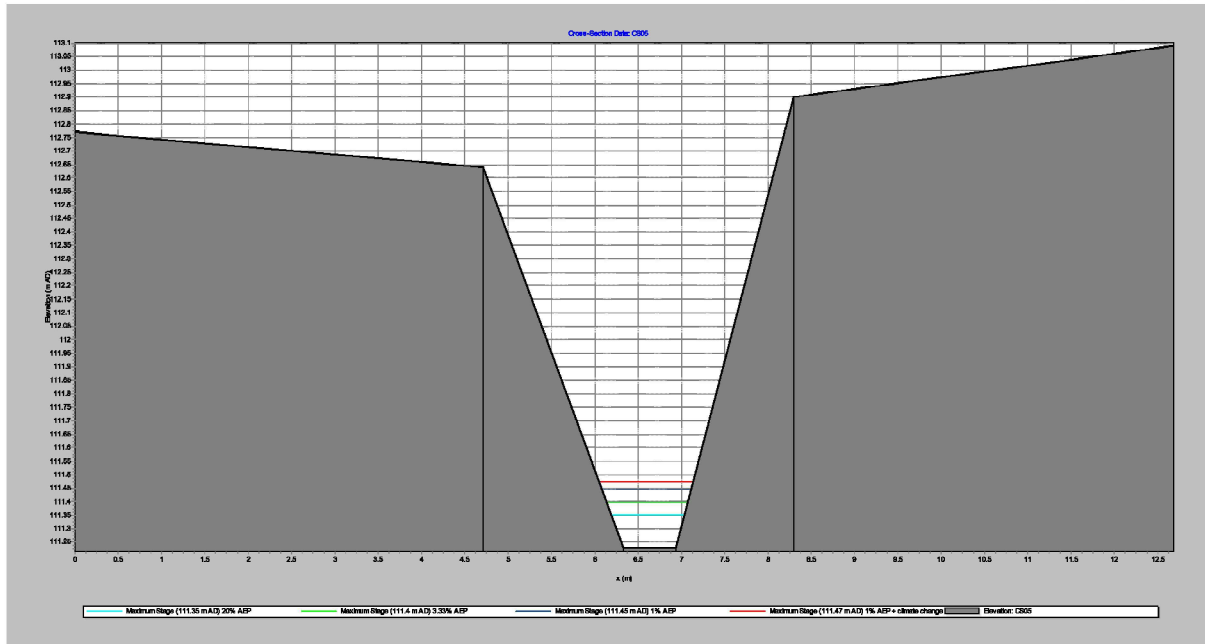
Figure F.5 Peak levels at cross section CS05

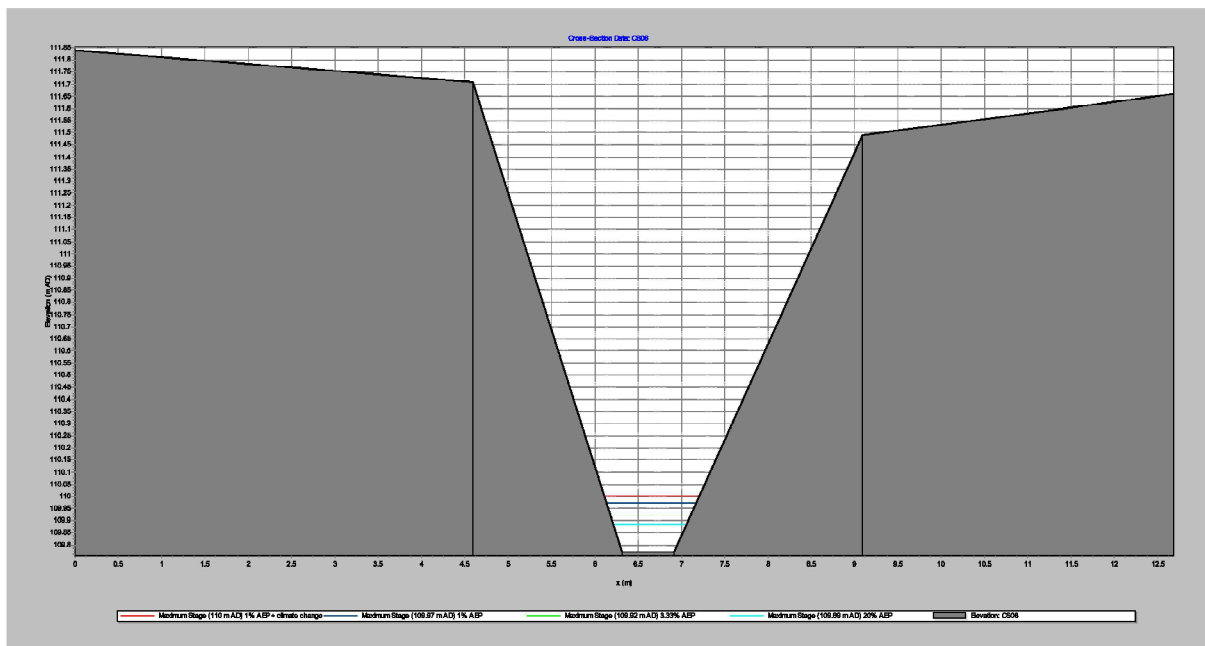
Figure F.6 Peak levels at cross section CS06

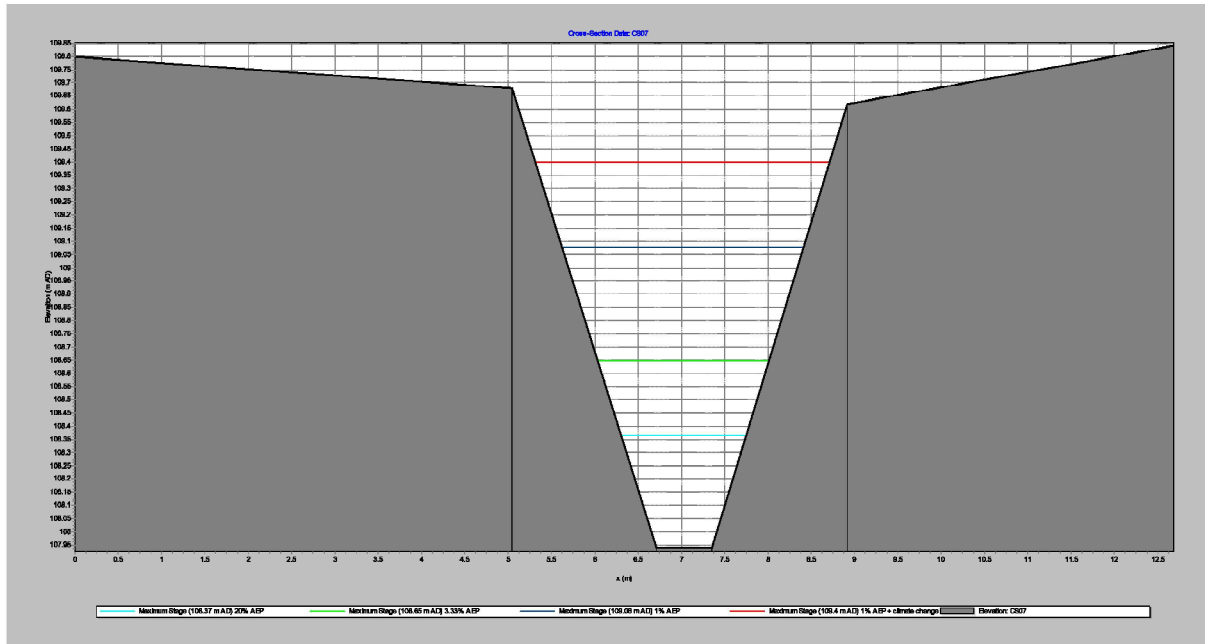
Figure F.7 Peak levels at cross section CS07

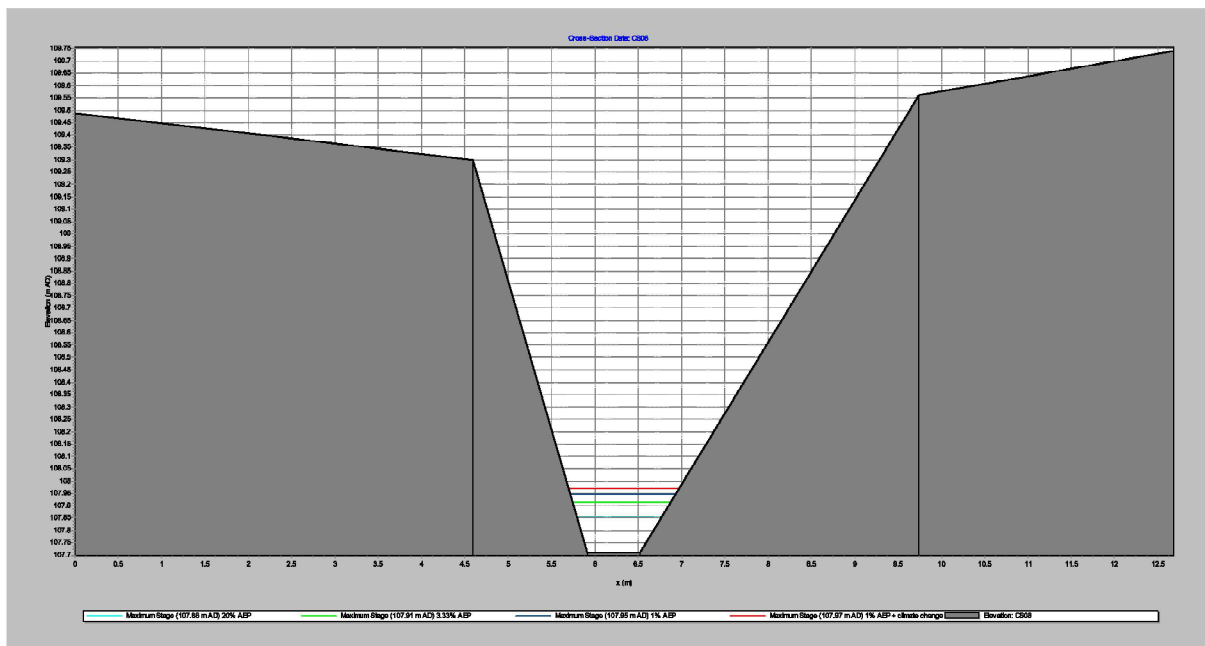
Figure F.8 Peak levels at cross section CS08

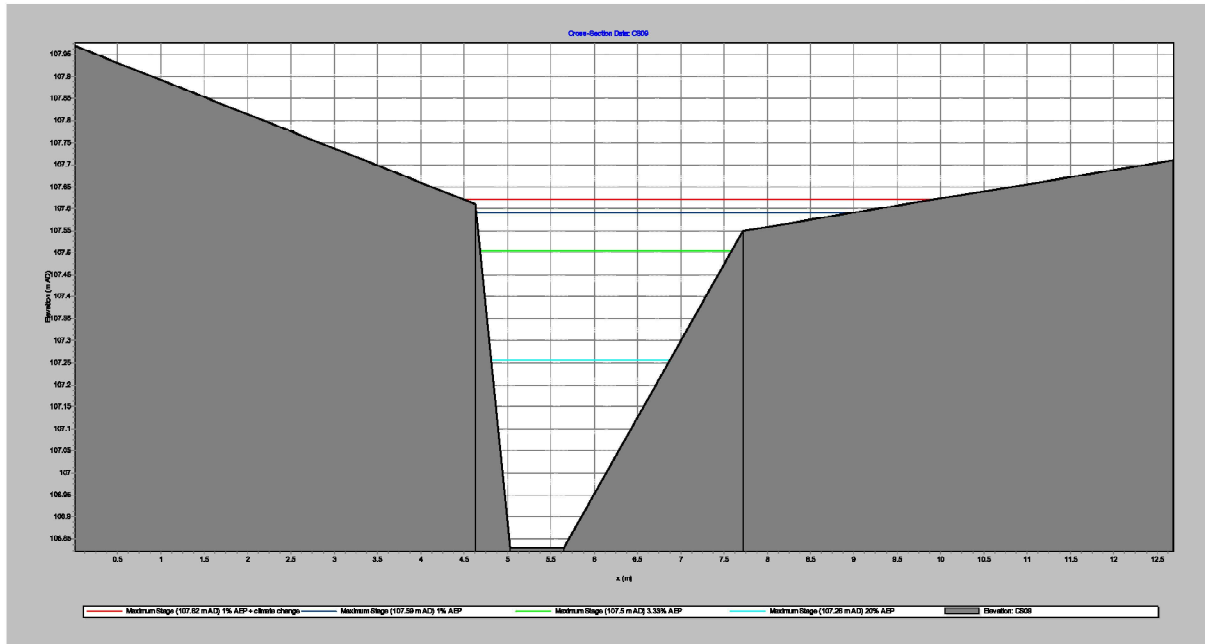
Figure F.9 Peak levels at cross section CS09

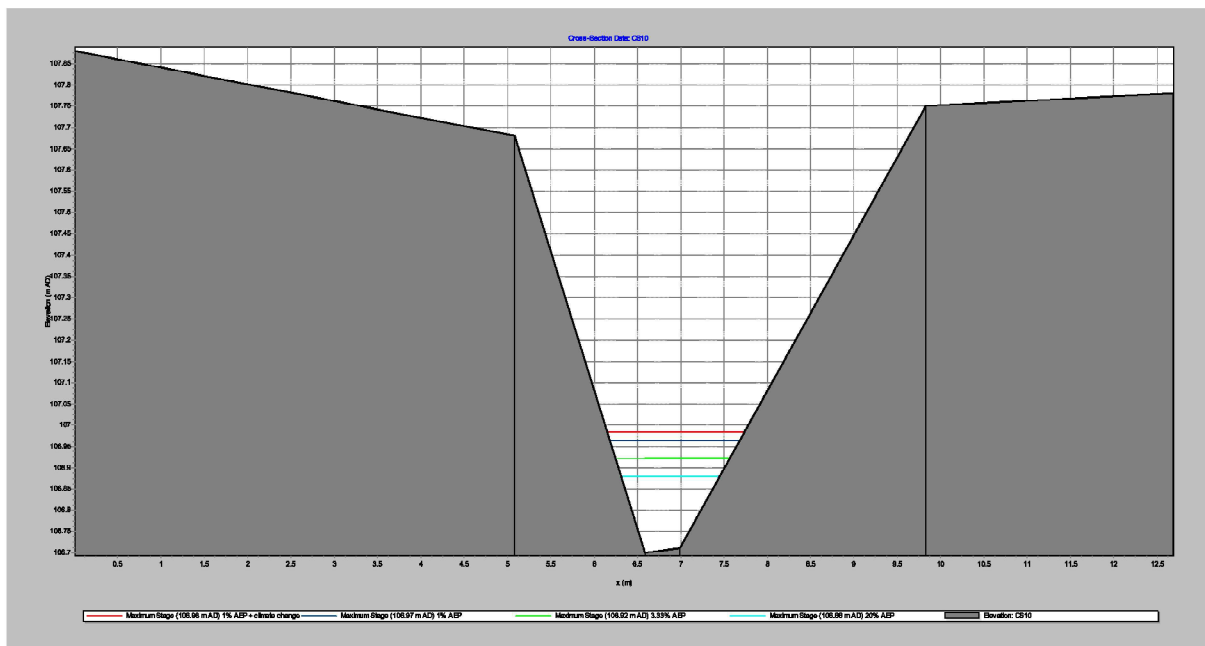
Figure F.10 Peak levels at cross section CS101

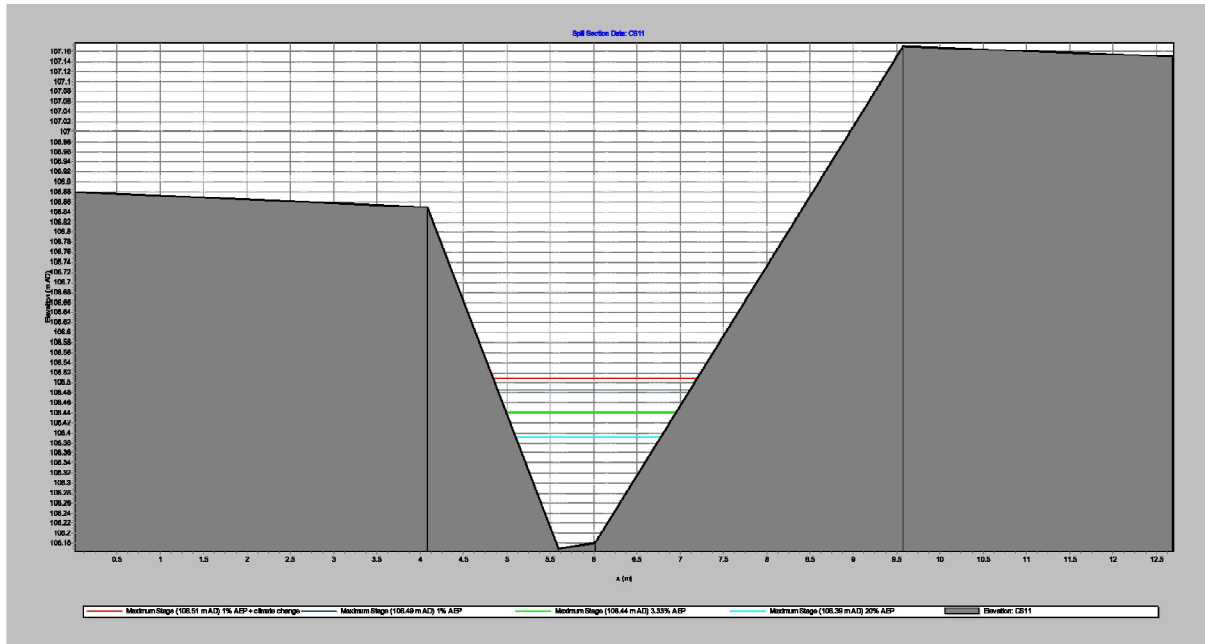
Figure F.11 Peak levels at cross section CS11

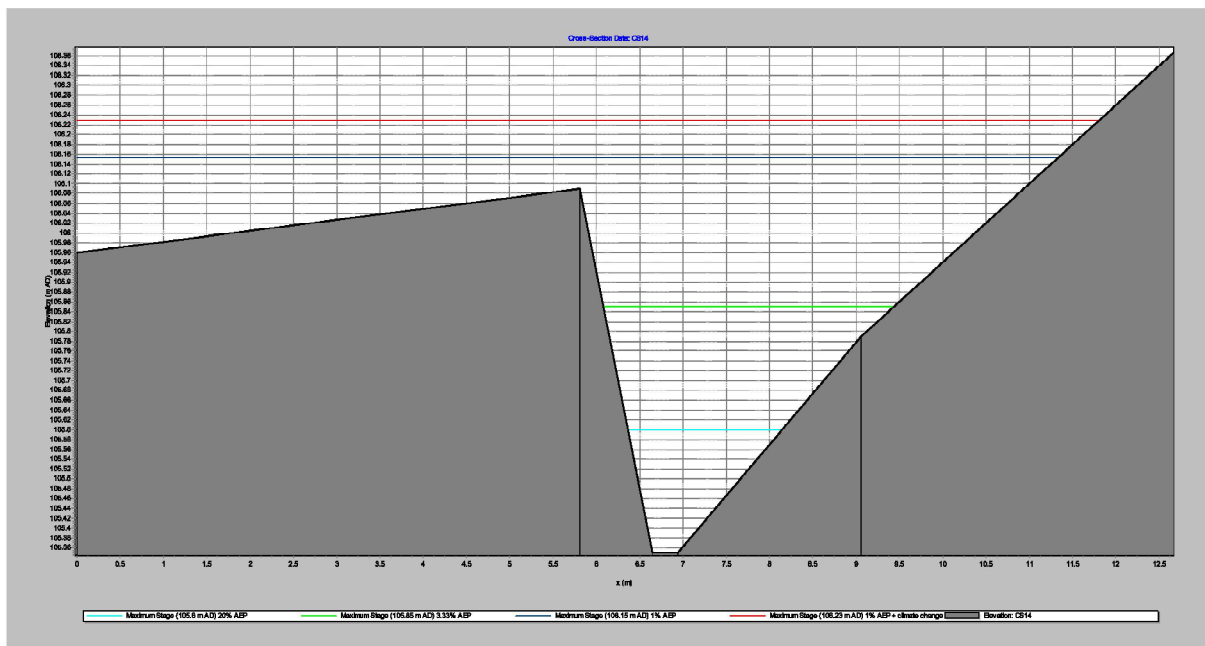
Figure F.12 Peak levels at cross section CS14

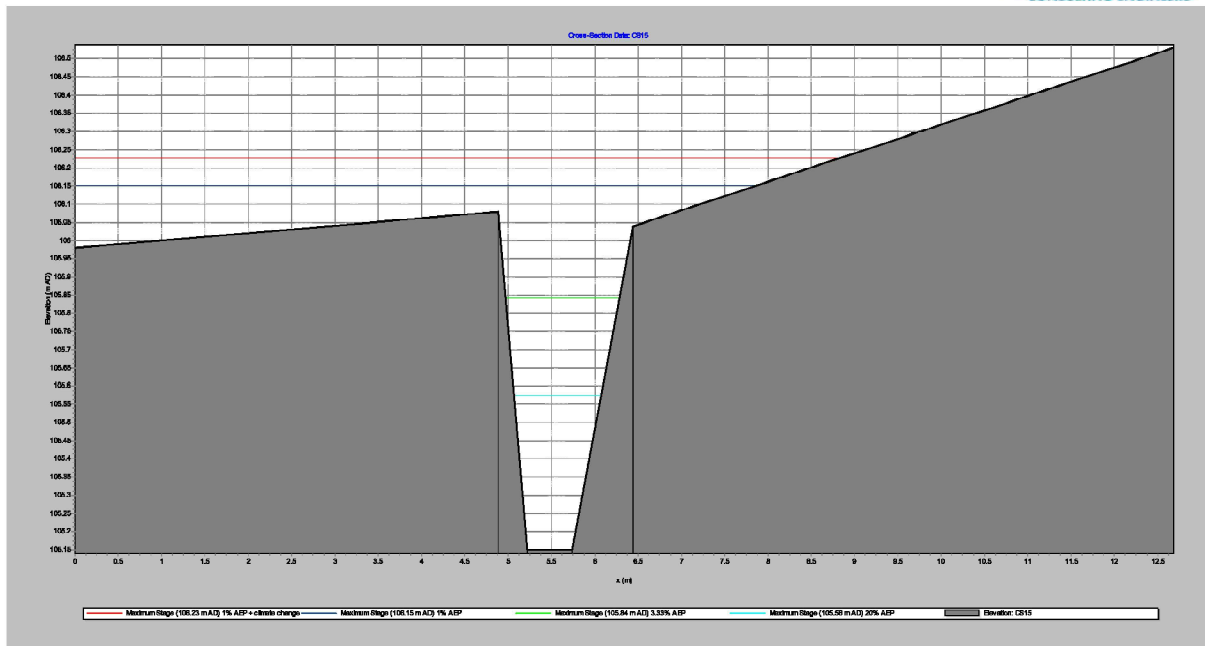
Figure F.13 Peak levels at cross section CS15

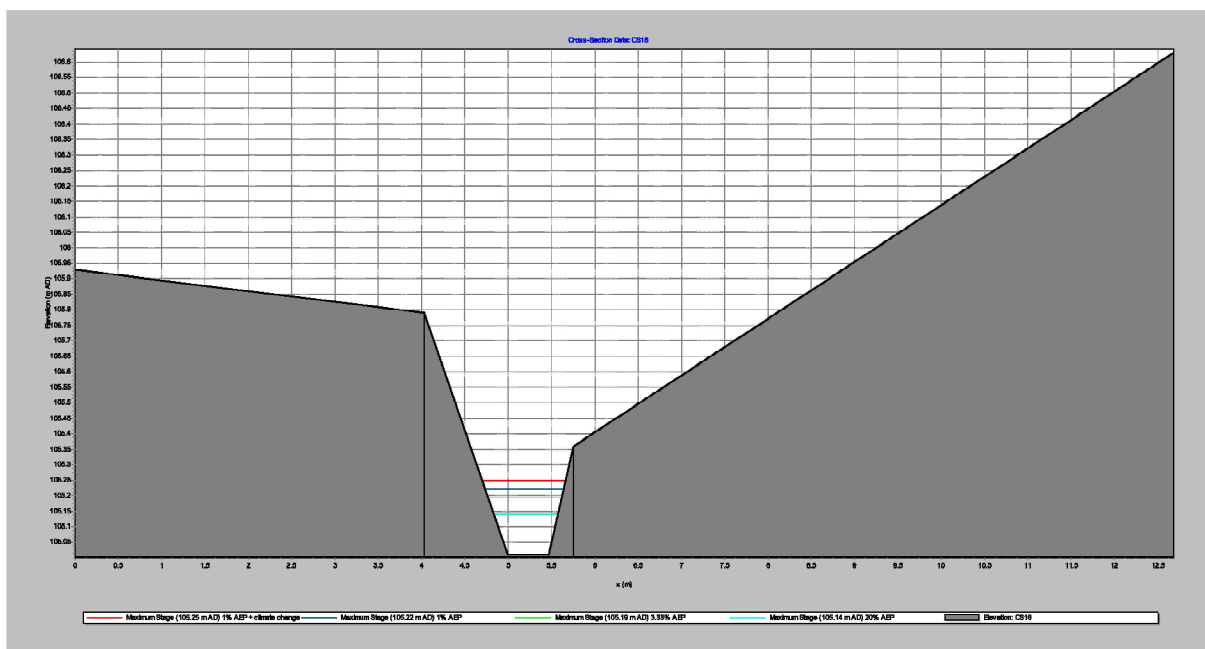
Figure F.14 Peak levels at cross section CS16

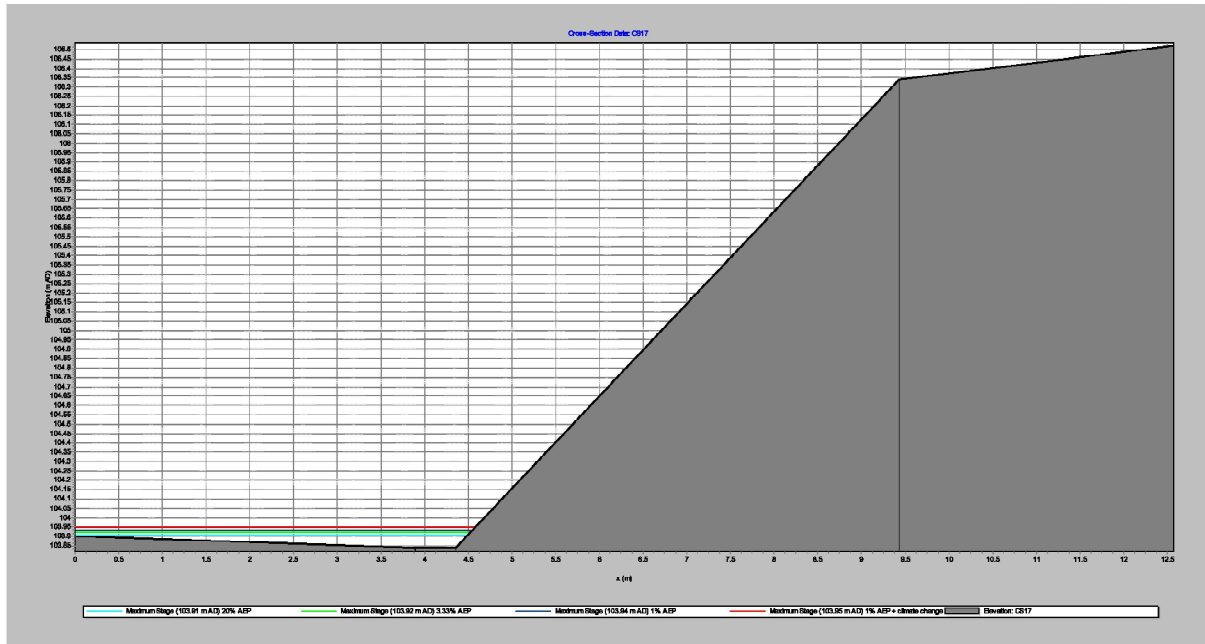
Figure F.15 Peak levels at cross section CS17

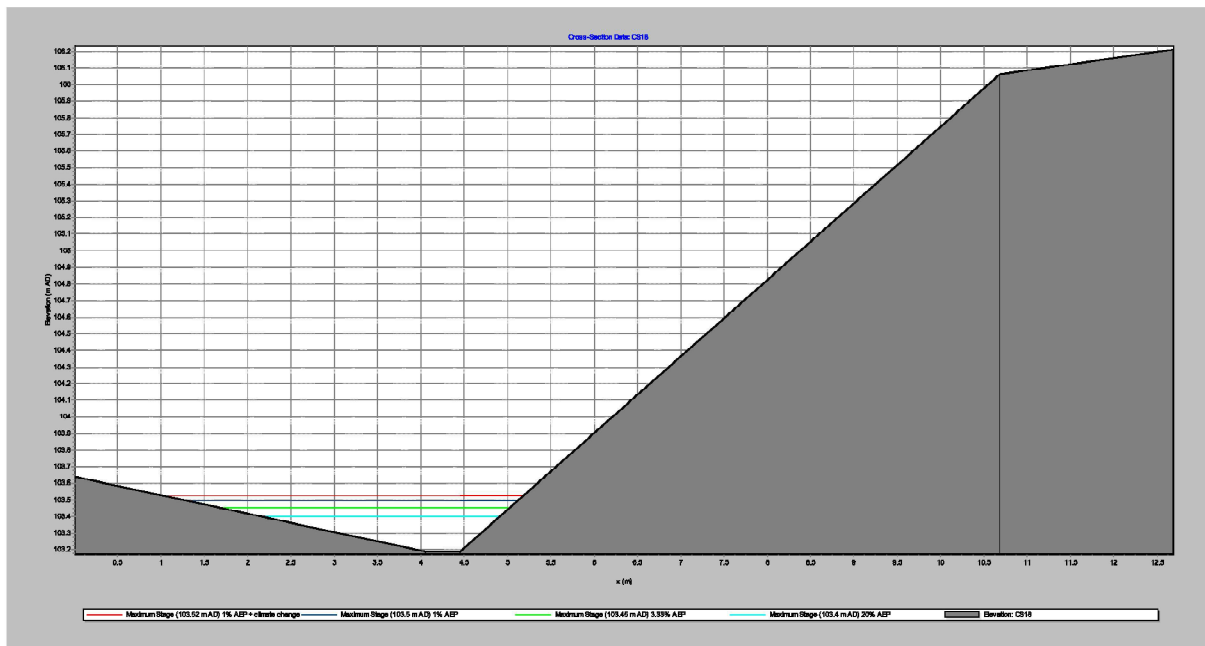
Figure F.16 Peak levels at cross section CS18

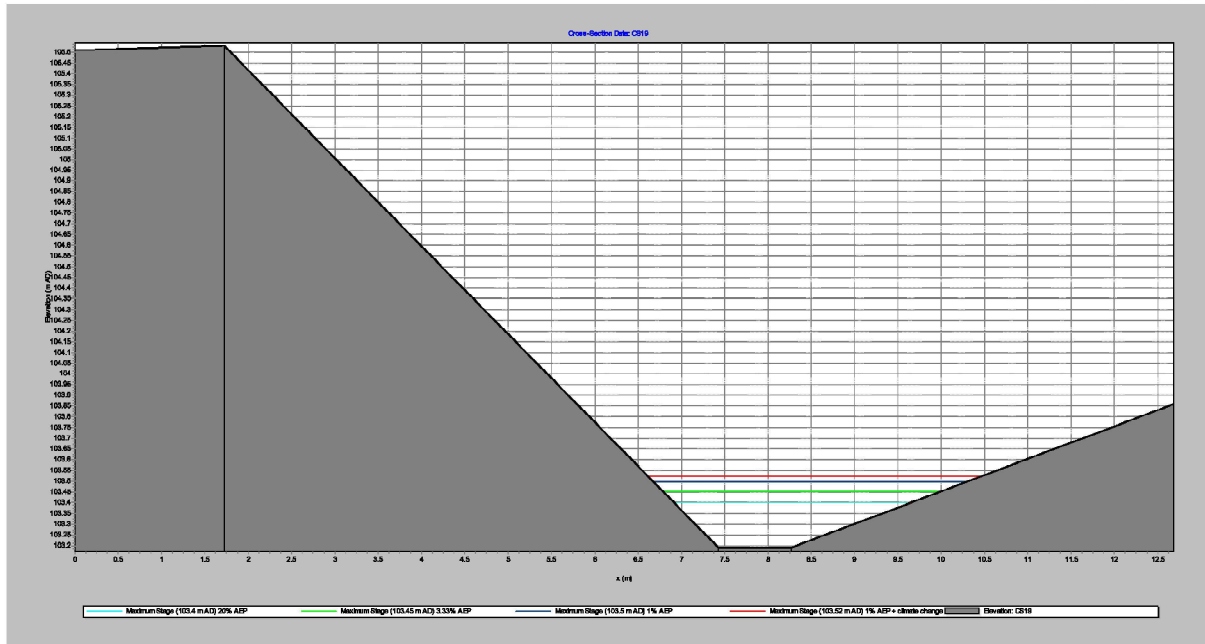
Figure F.17 Peak levels at cross section CS19

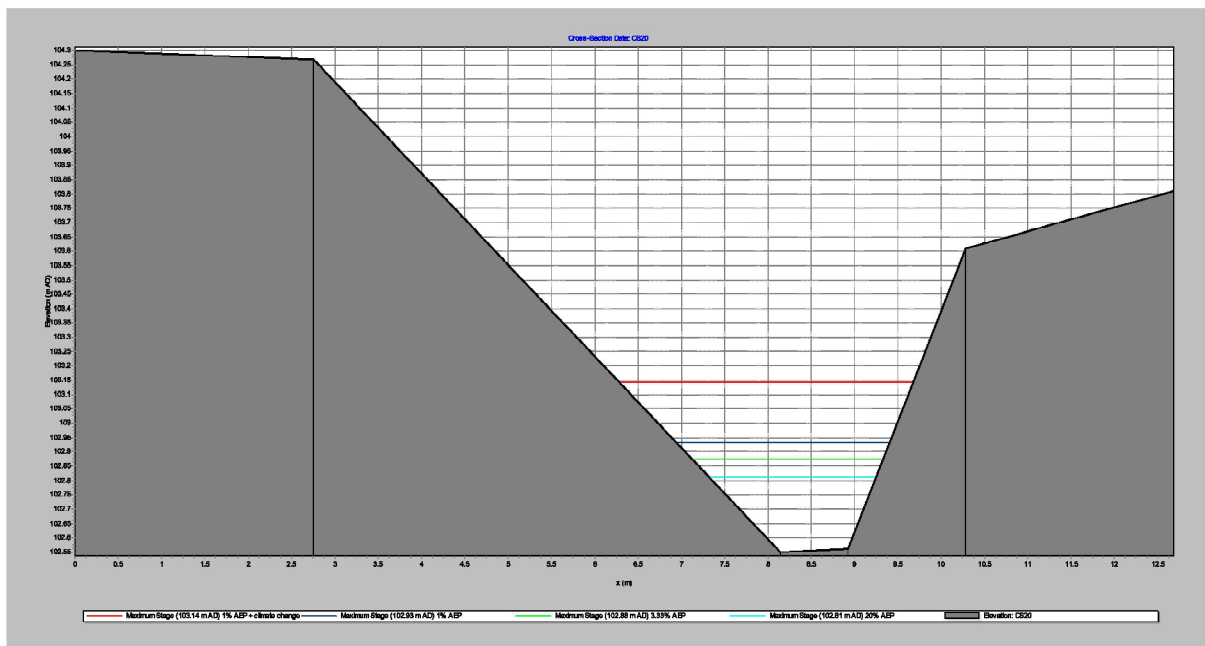
Figure F.18 Peak levels at cross section CS20

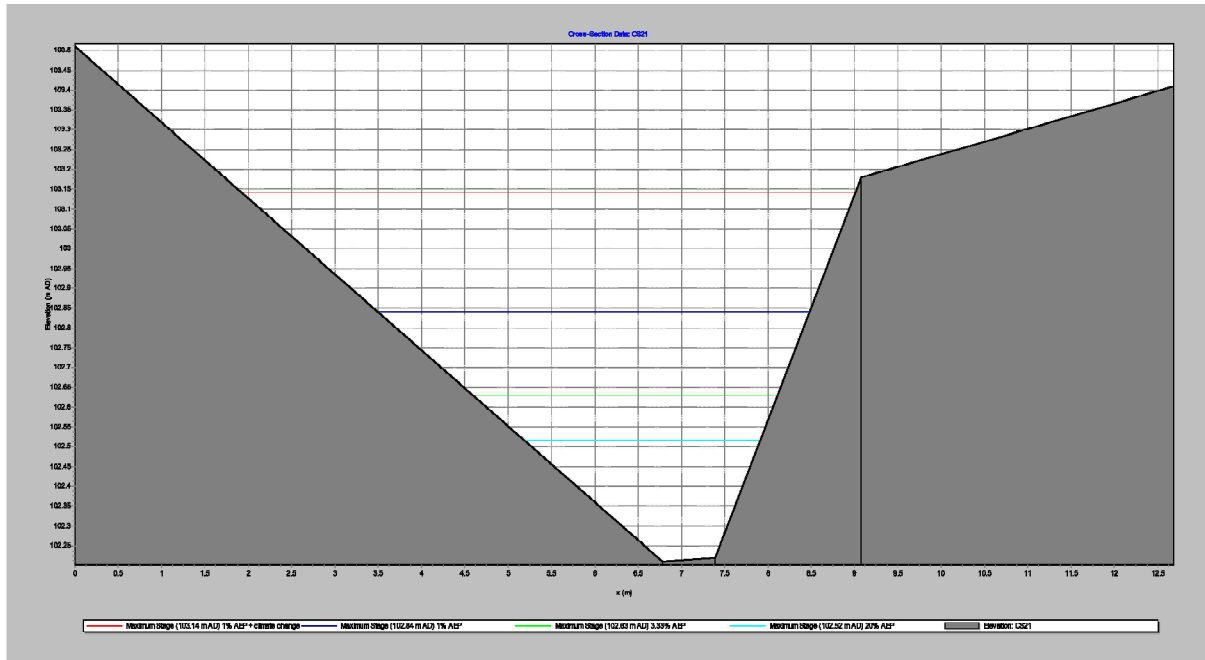
Figure F.19 Peak levels at cross section CS21

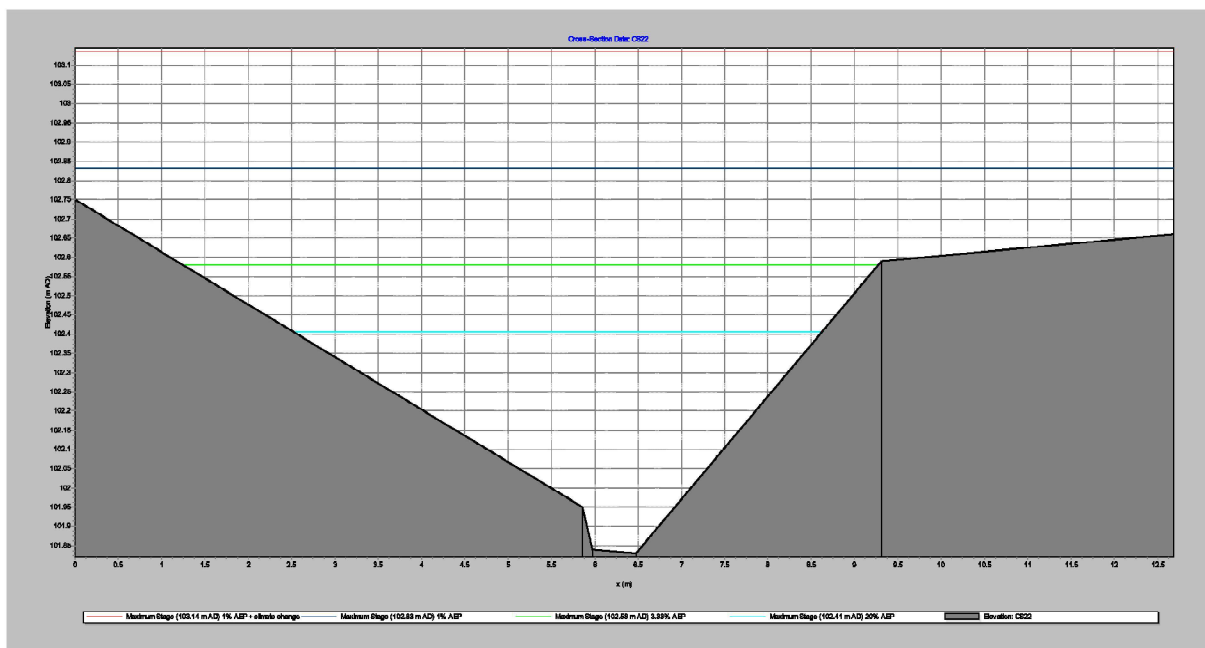
Figure F.20 Peak levels at cross section CS22

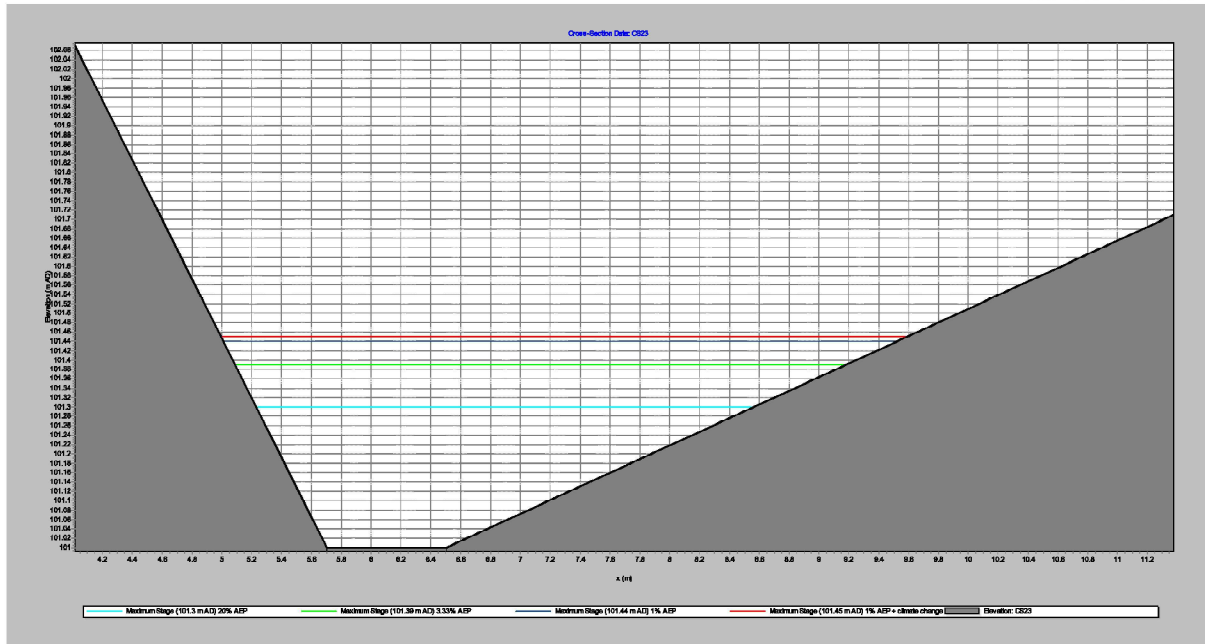
Figure F.21 Peak levels at cross section CS23

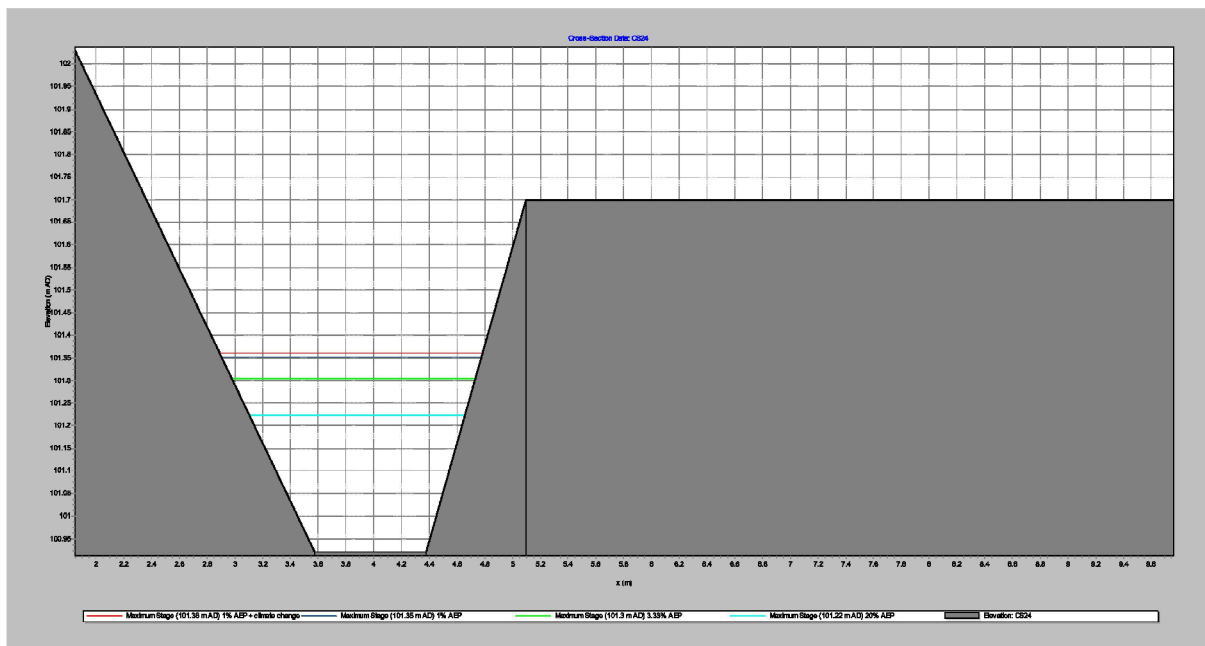
Figure F.22 Peak levels at cross section CS24

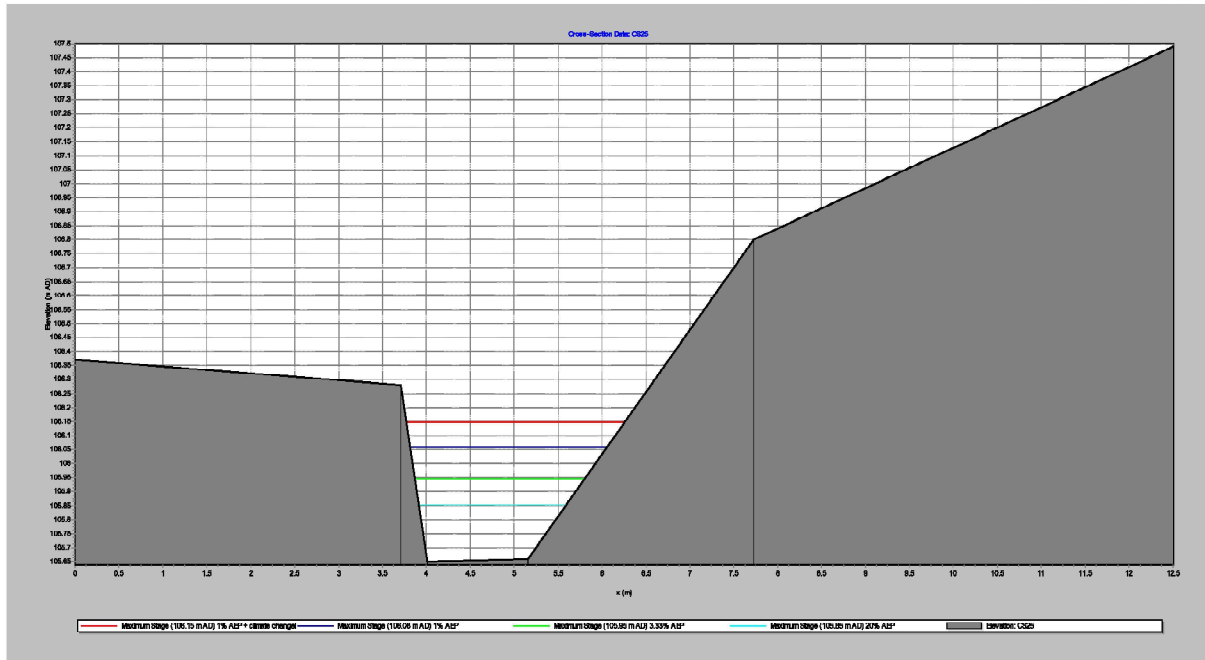
Figure F.23 Peak levels at cross section CS25

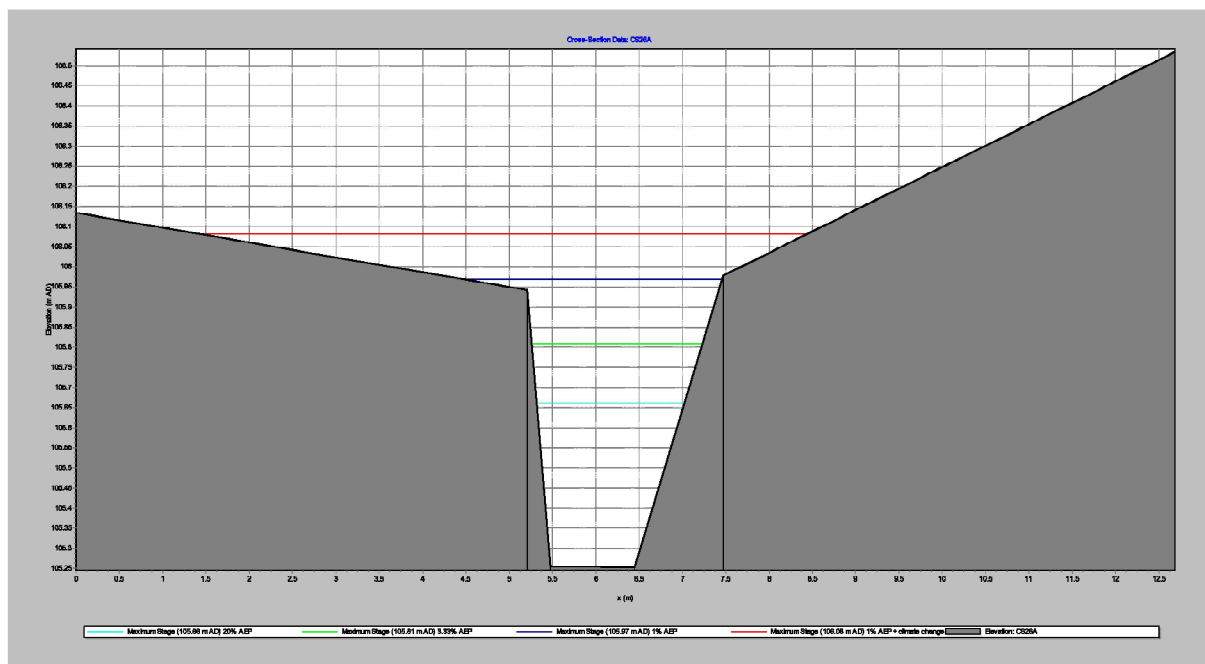
Figure F.24 Peak levels at cross section CS26

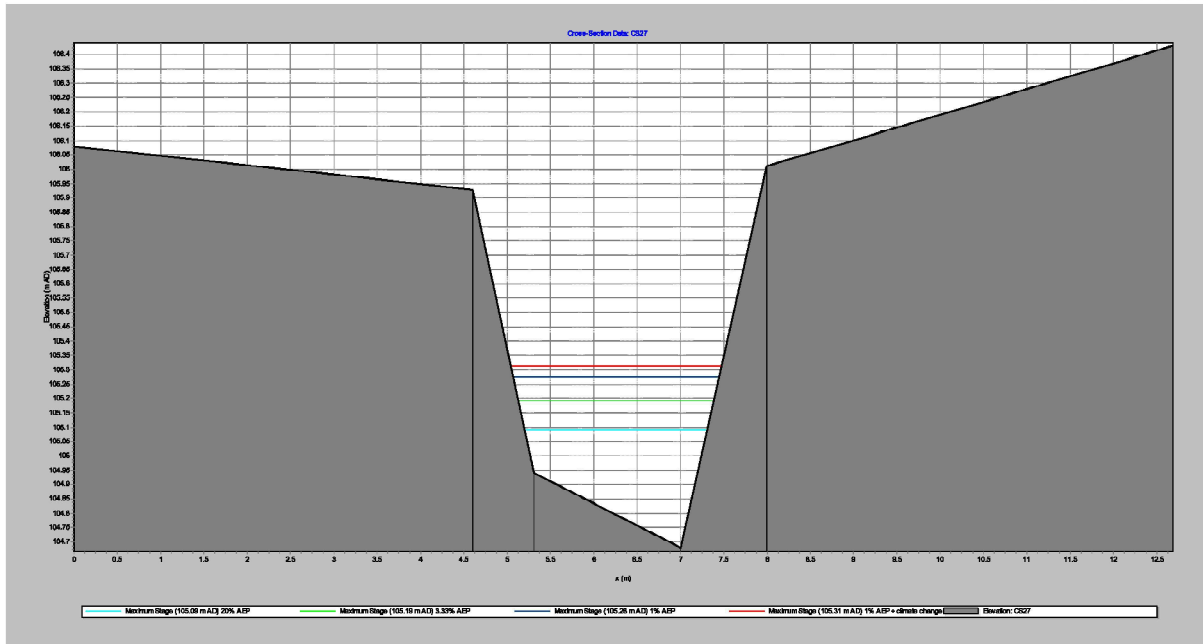
Figure F.25 Peak levels at cross section CS27
