Land at Chipping Lane, Longridge  
Hydraulic Assessment

**APPENDIX F: ISIS OUTPUTS: PROPOSED SCENARIO SCHEMATIC,  
LONG-SECTION AND CROSS-SECTIONS**

## **APPENDIX G: FLOOD MODELLER OUTPUTS: SENSITIVITY TESTING**

Ground Investigation Report  
(Phase 2)

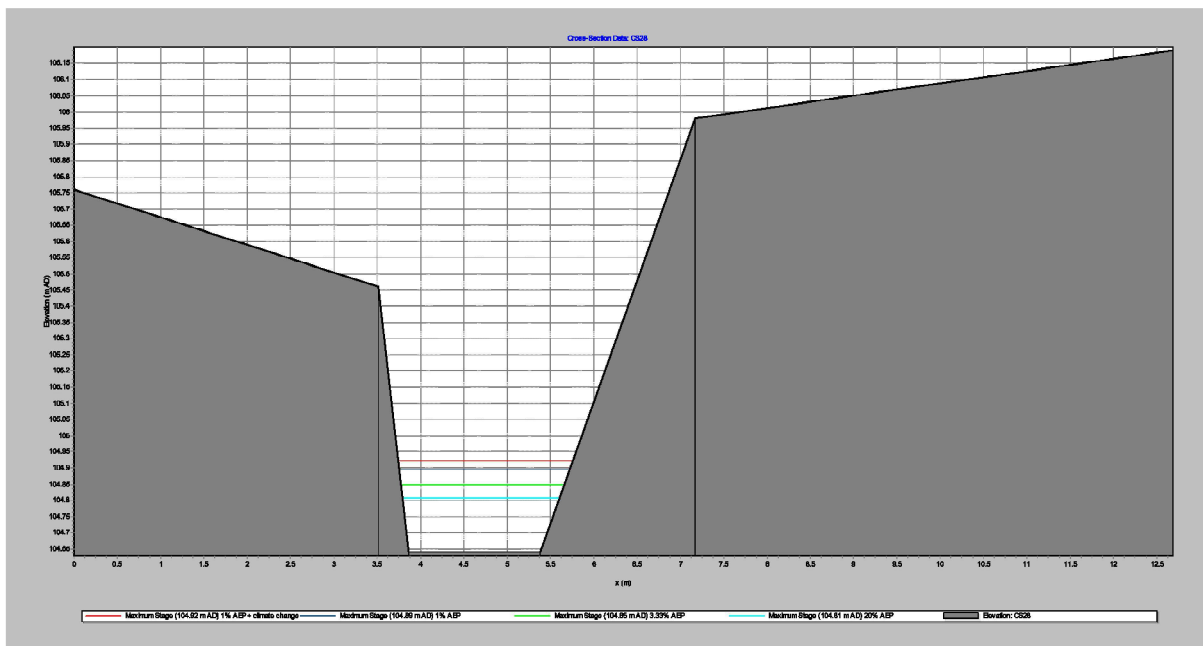
Figure F.26 Peak levels at cross section CS28

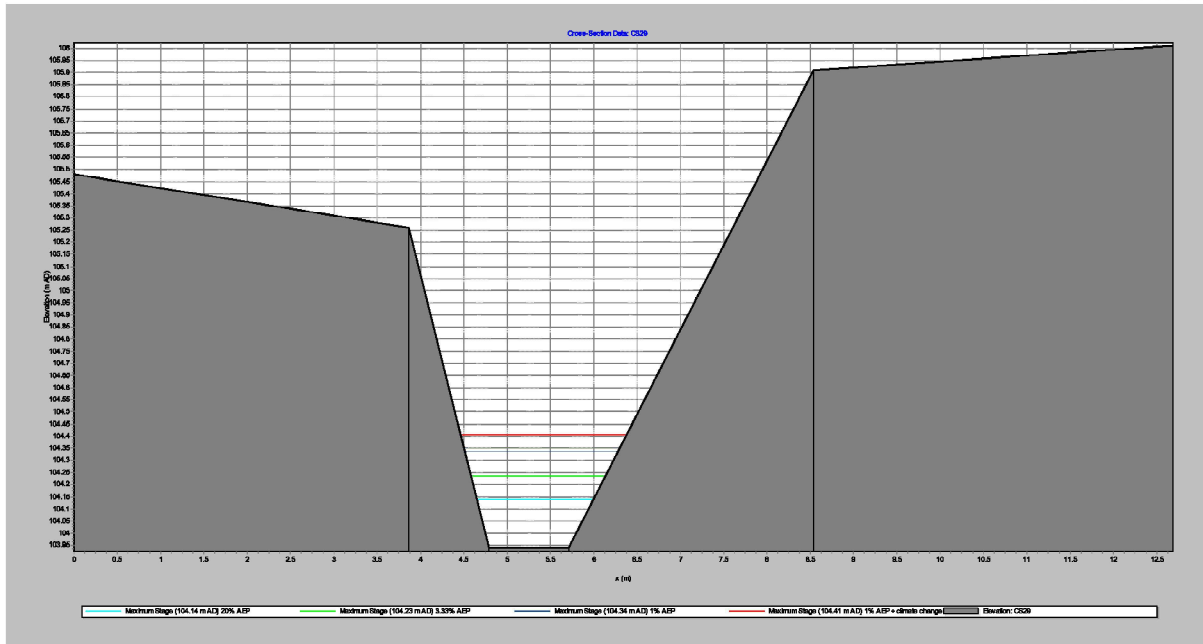
Figure F.27 Peak levels at cross section CS29

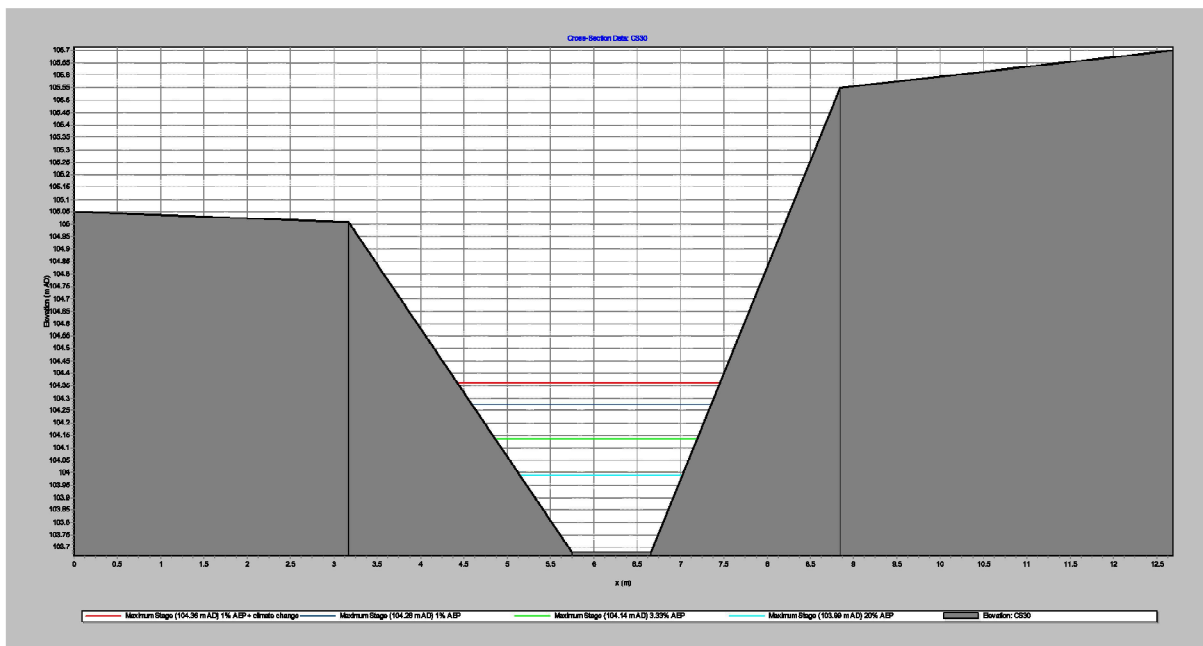
Figure F.28 Peak levels at cross section CS30

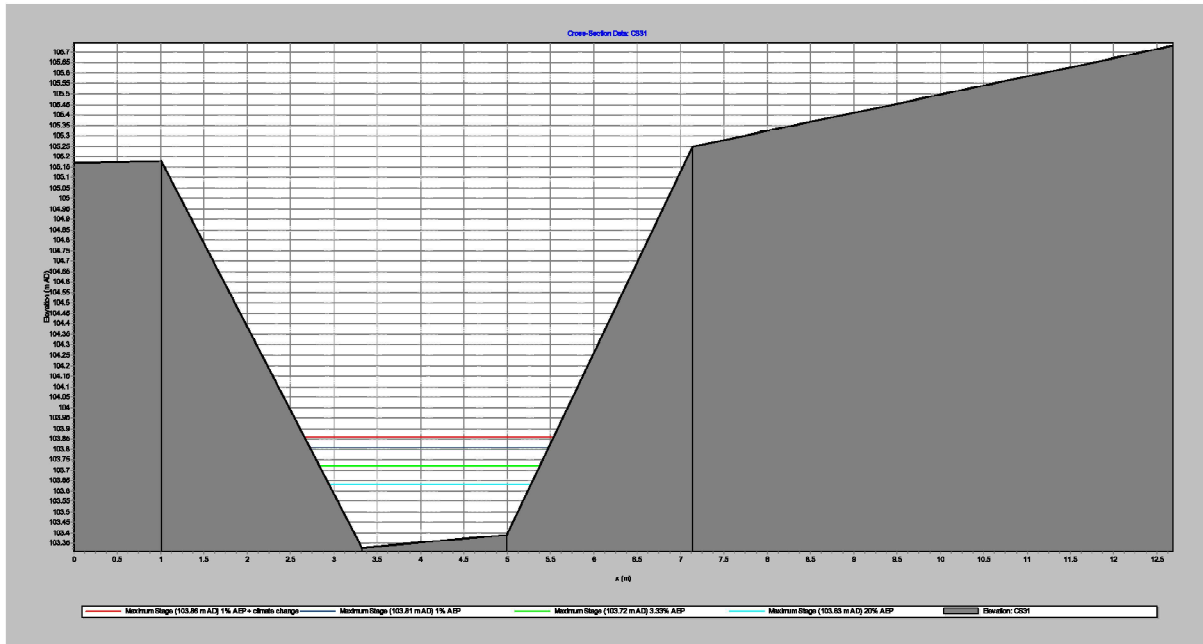
Figure F.29 Peak levels at cross section CS31

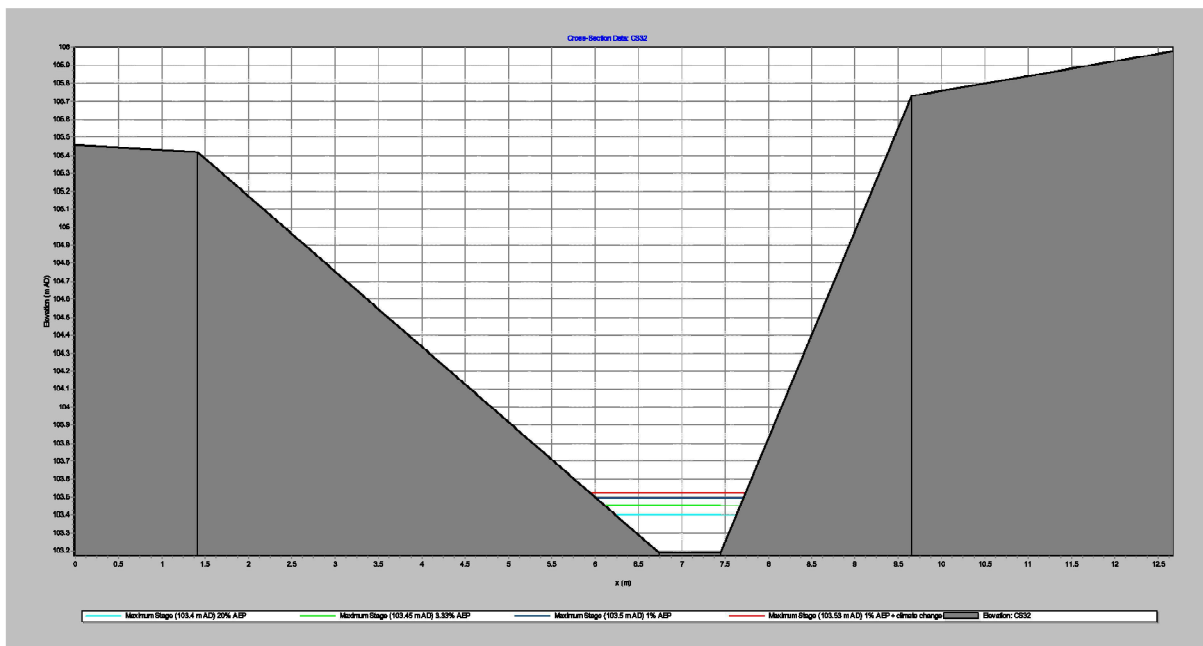
Figure F.30 Peak levels at cross section CS32

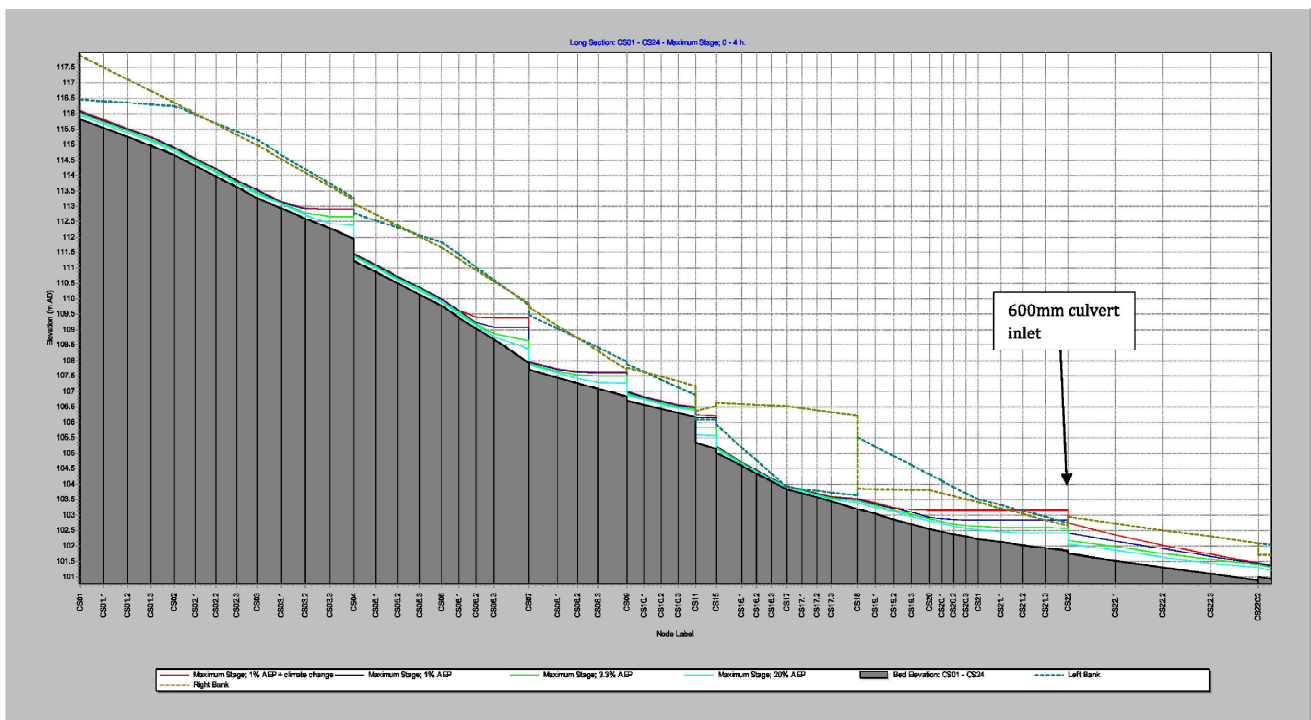
Figure F.31 Long section CS01 to CS24

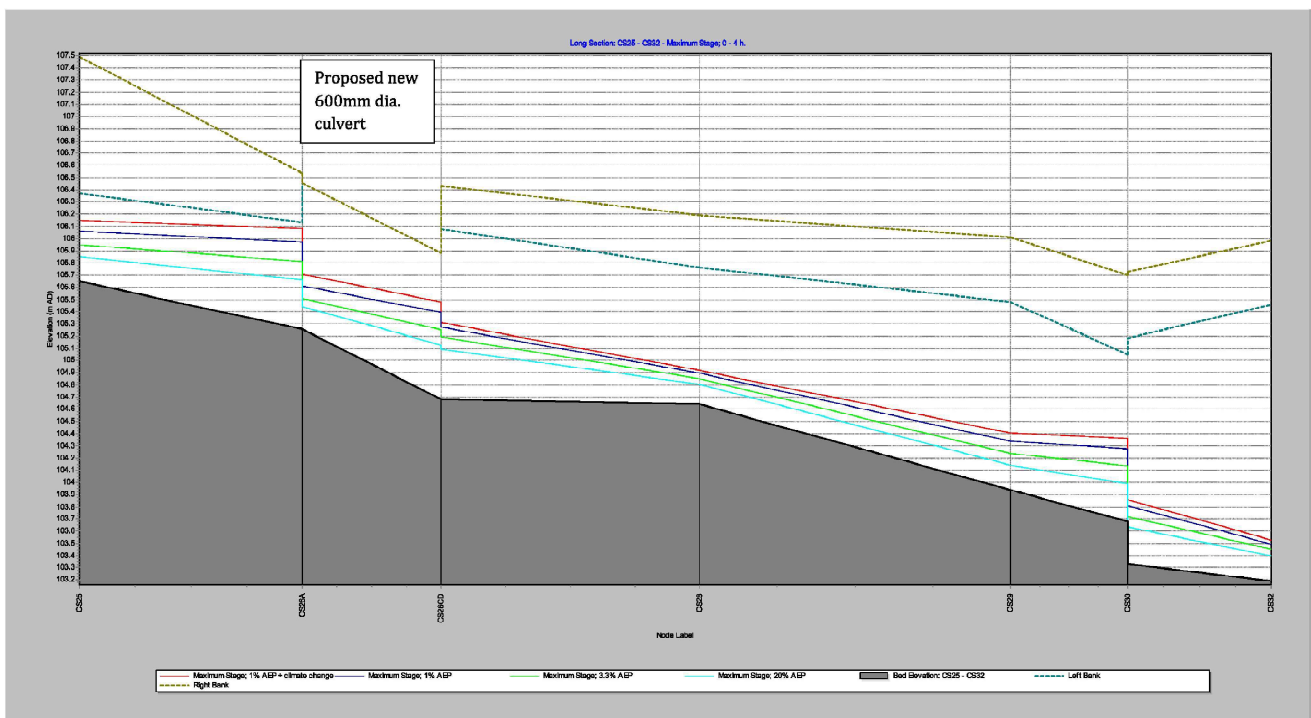
Figure F.32 Long section CS25 to CS32

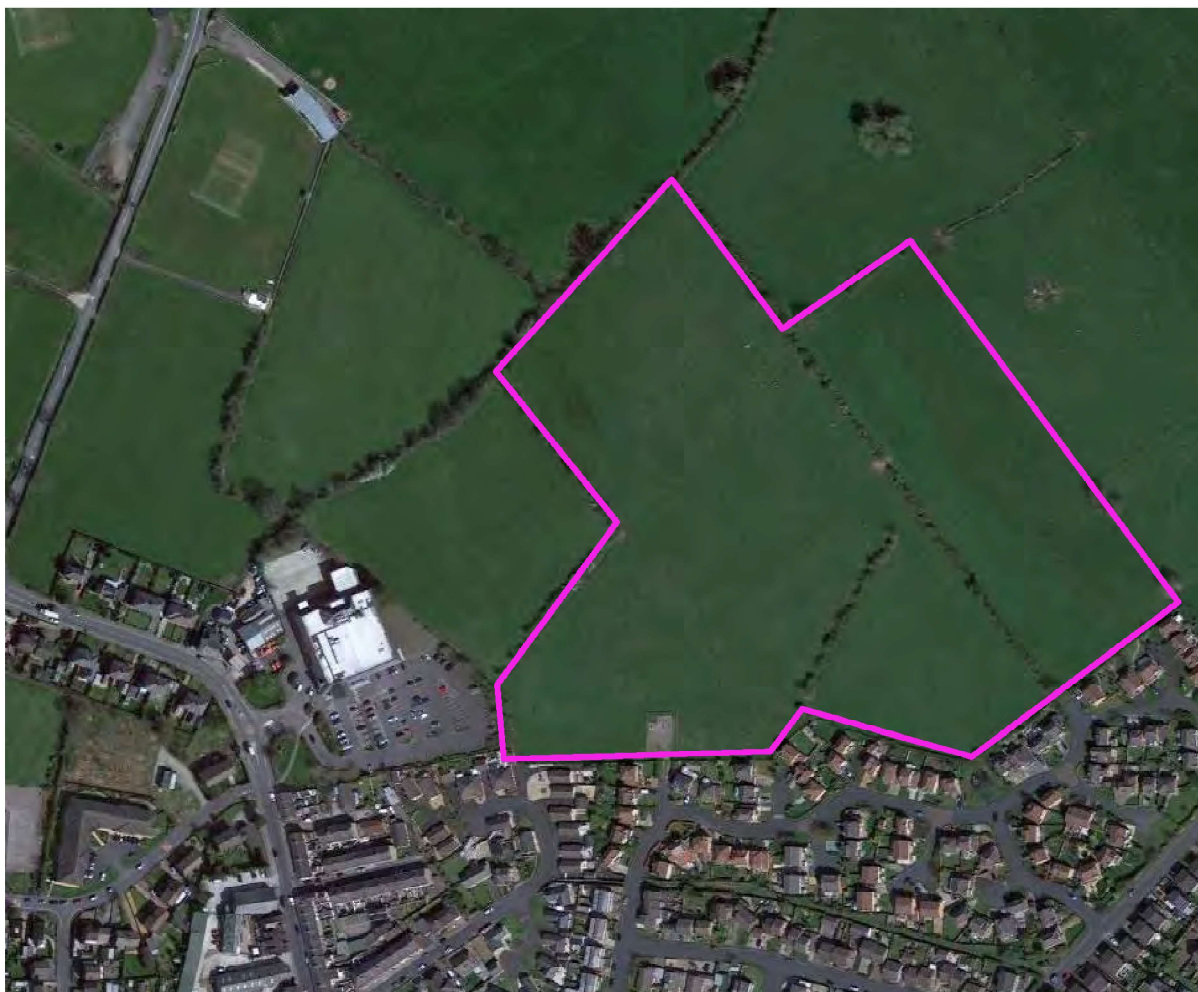
## Aerial photograph of site

Approximate Phase 2 site boundaries edged in pink
