# **Preliminary Bat Roost Assessment Report**

**Swift's Hardware,  
53-57 Berry Lane,  
Longridge,  
PR3 3NH**

**03.11.2021**

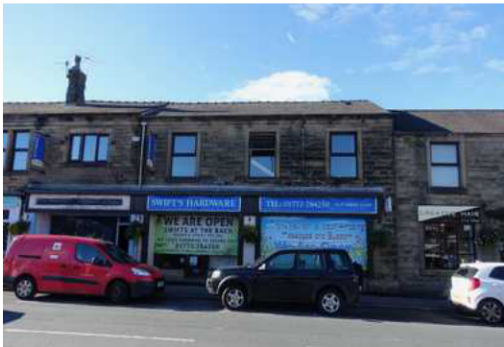
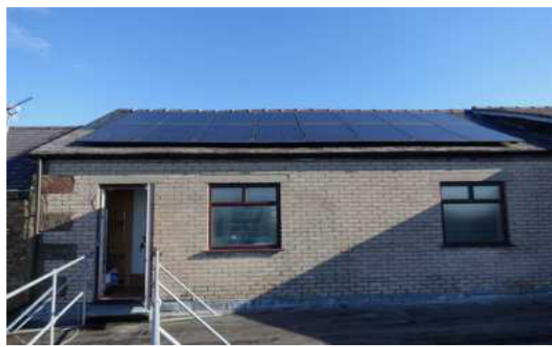
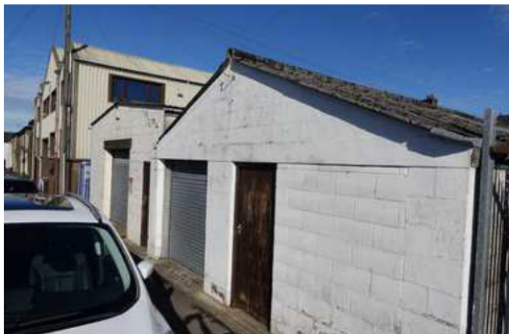
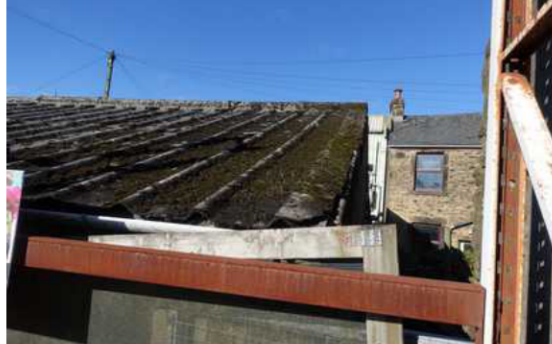
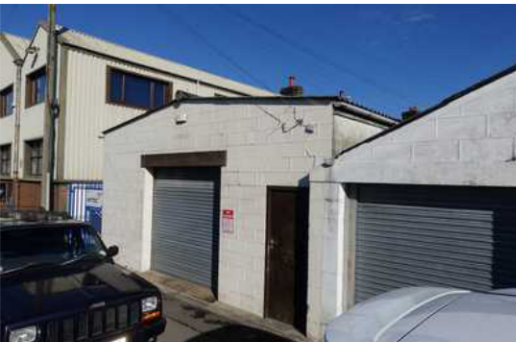
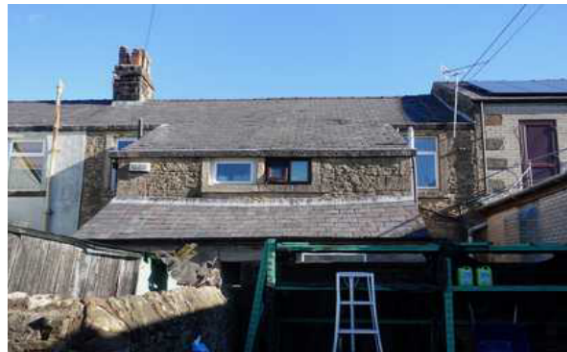
The property consists of a terraced two storey stone built shop with a double pitched slate roof, solar panels are present on the south facing roof section. The property has a flat roofed single storey extension present to the rear. The main building is currently empty having suffered smoke and fire damage. The roof has no missing, lifted or slipped slates present. Lead flashing is close fitting, pointed and well sealed.

Two adjoining store buildings are present with a concrete block construction and single skin fibreboard roofing panels.

The buildings can be considered to offer negligible bat potential.

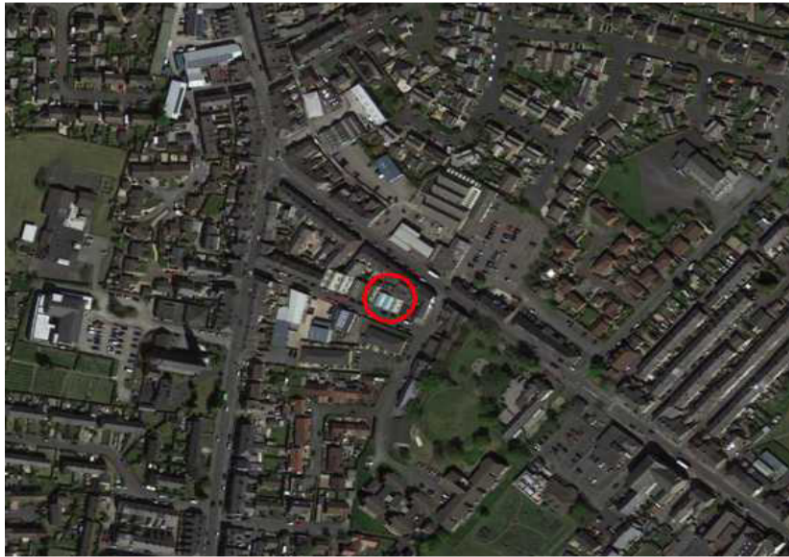
## Habitat

The property is located in an urban position dominated with limited surrounding habitat. An area of amenity grass with scattered mature deciduous trees is present to the east. Connectivity to the wider landscape is poor. Bat foraging potential is low.
