**SUNDERLAND PEACOCK ARCHITECTS**

**BAT SURVEY  
OUTBUILDING at  
TWINBROOKS FARM  
UPBROOKS  
CLITHEROE**

**DATE AND TIME OF VISIT  
10<sup>th</sup> May 2021 1.30pm  
19<sup>th</sup> May 2021 9.00pm**

**REFERENCE NO. 5765**

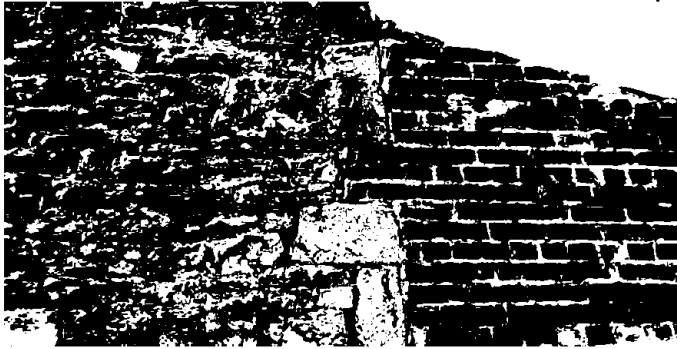
The main building walls are random natural stone with flush pointing. The lean to has brick walls.

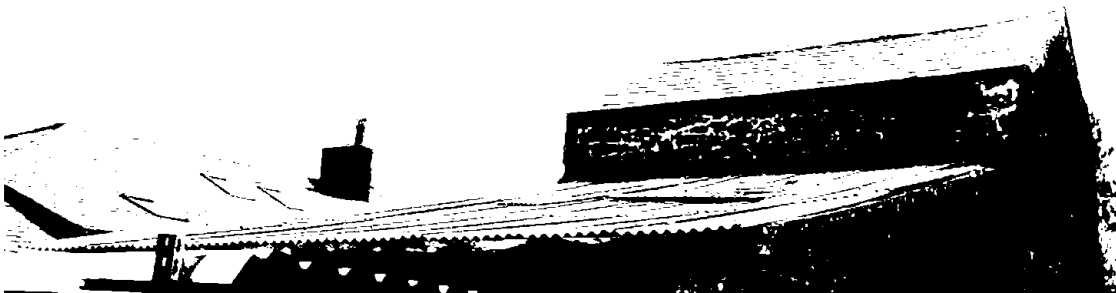
The pitched roof was examined from ground level with the aid of binoculars. The blue slate finish is in good condition with no gaps or slipped slates. The ridge tiles are well pointed with no cracks. The roof does not provide any access points to the interior nor any cracks or crevices accessible to bats.

The lean to roof is corrugated fibre cement sheet, it is in poor condition with some missing and slipped sheets. The interior is accessible to bats however the sheets do not provide any potential roost habitat.

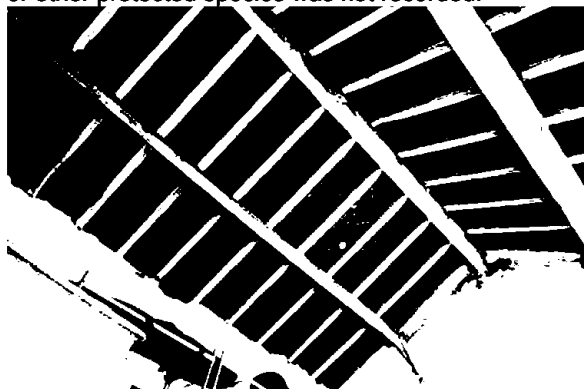
Main pitched roof did not have an enclosed roof space and was examined from the first floor level the structure appeared relatively new, the timbers and underlay were in excellent condition free from any cracks, crevices or rot. The eaves were inspected to ensure there were no access points. Evidence of current or historic use by bats or other protected species was not recorded.
