Preliminary Bat Roost Assessment Report

**10 and 11 Church View,
Gisburn,
BB7 4HG**

03.01.2022

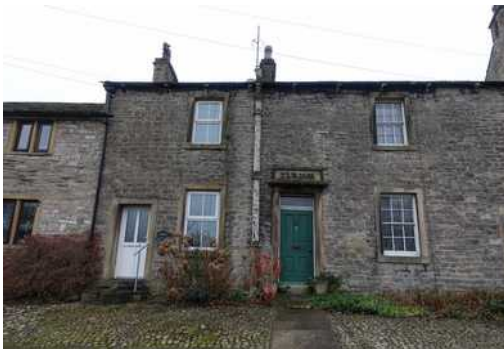
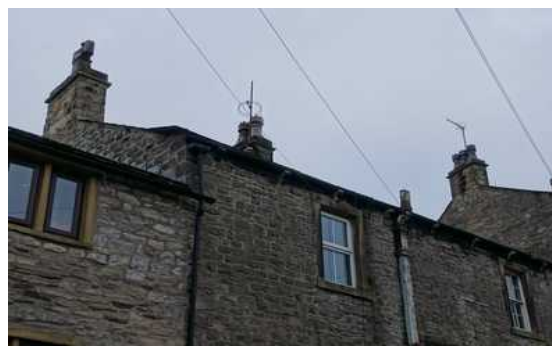
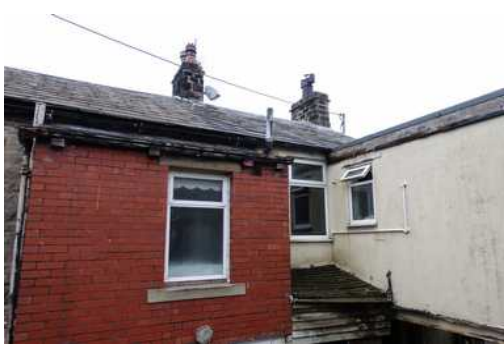
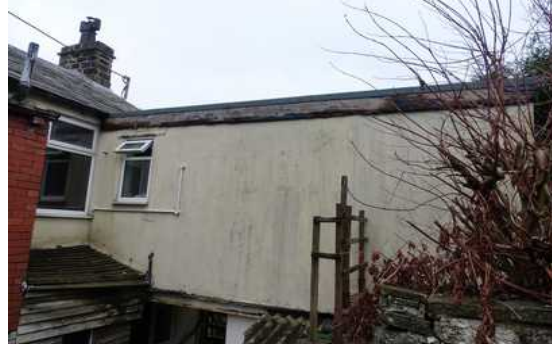
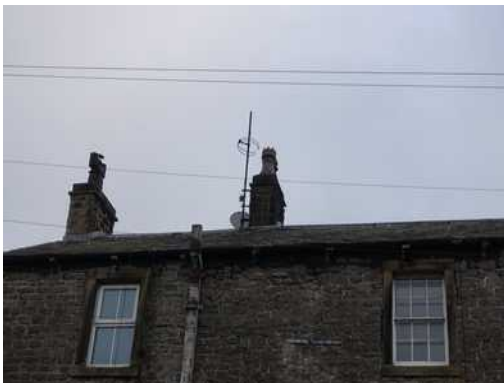
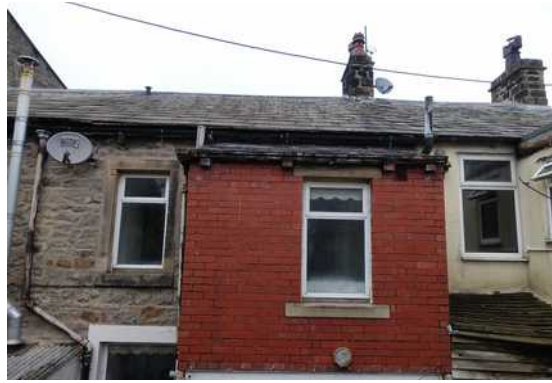
The property consists of a stone built terraced cottage with double pitched slate roof. A two storey brick extension and single storey flat roofed extension adjoins the property to the rear. External walls are well pointed and partially rendered with no cracks, crevices or cavities present. The gable end is pointed and sealed.

The roof is in good condition with no missing, lifted or slipped slates present. The ridge tiles are well sealed. Fascia boards where present are close fitting and well sealed.

The building can be considered to offer negligible bat potential.

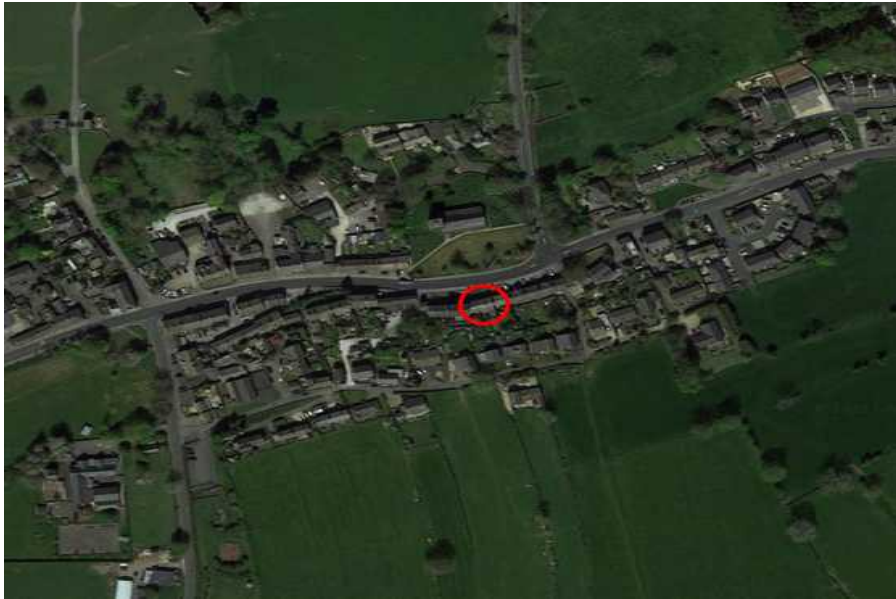
Habitat

The property is located in a semi rural position with surrounding habitat a mosaic of mature domestic gardens and improved and semi improved grassland with limited scattered deciduous tree cover present on field boundaries. Connectivity to the wider landscape is low. Bat foraging potential is low.
