# **Arboricultural Impact Assessment Overview**

in Relation to Proposed Light Industrial Development at

**William Pye Ltd, Chapel Quarry,  
Chapel Hill Trading Estate, Longridge,  
Lancashire, PR3 3BU**

November 2021

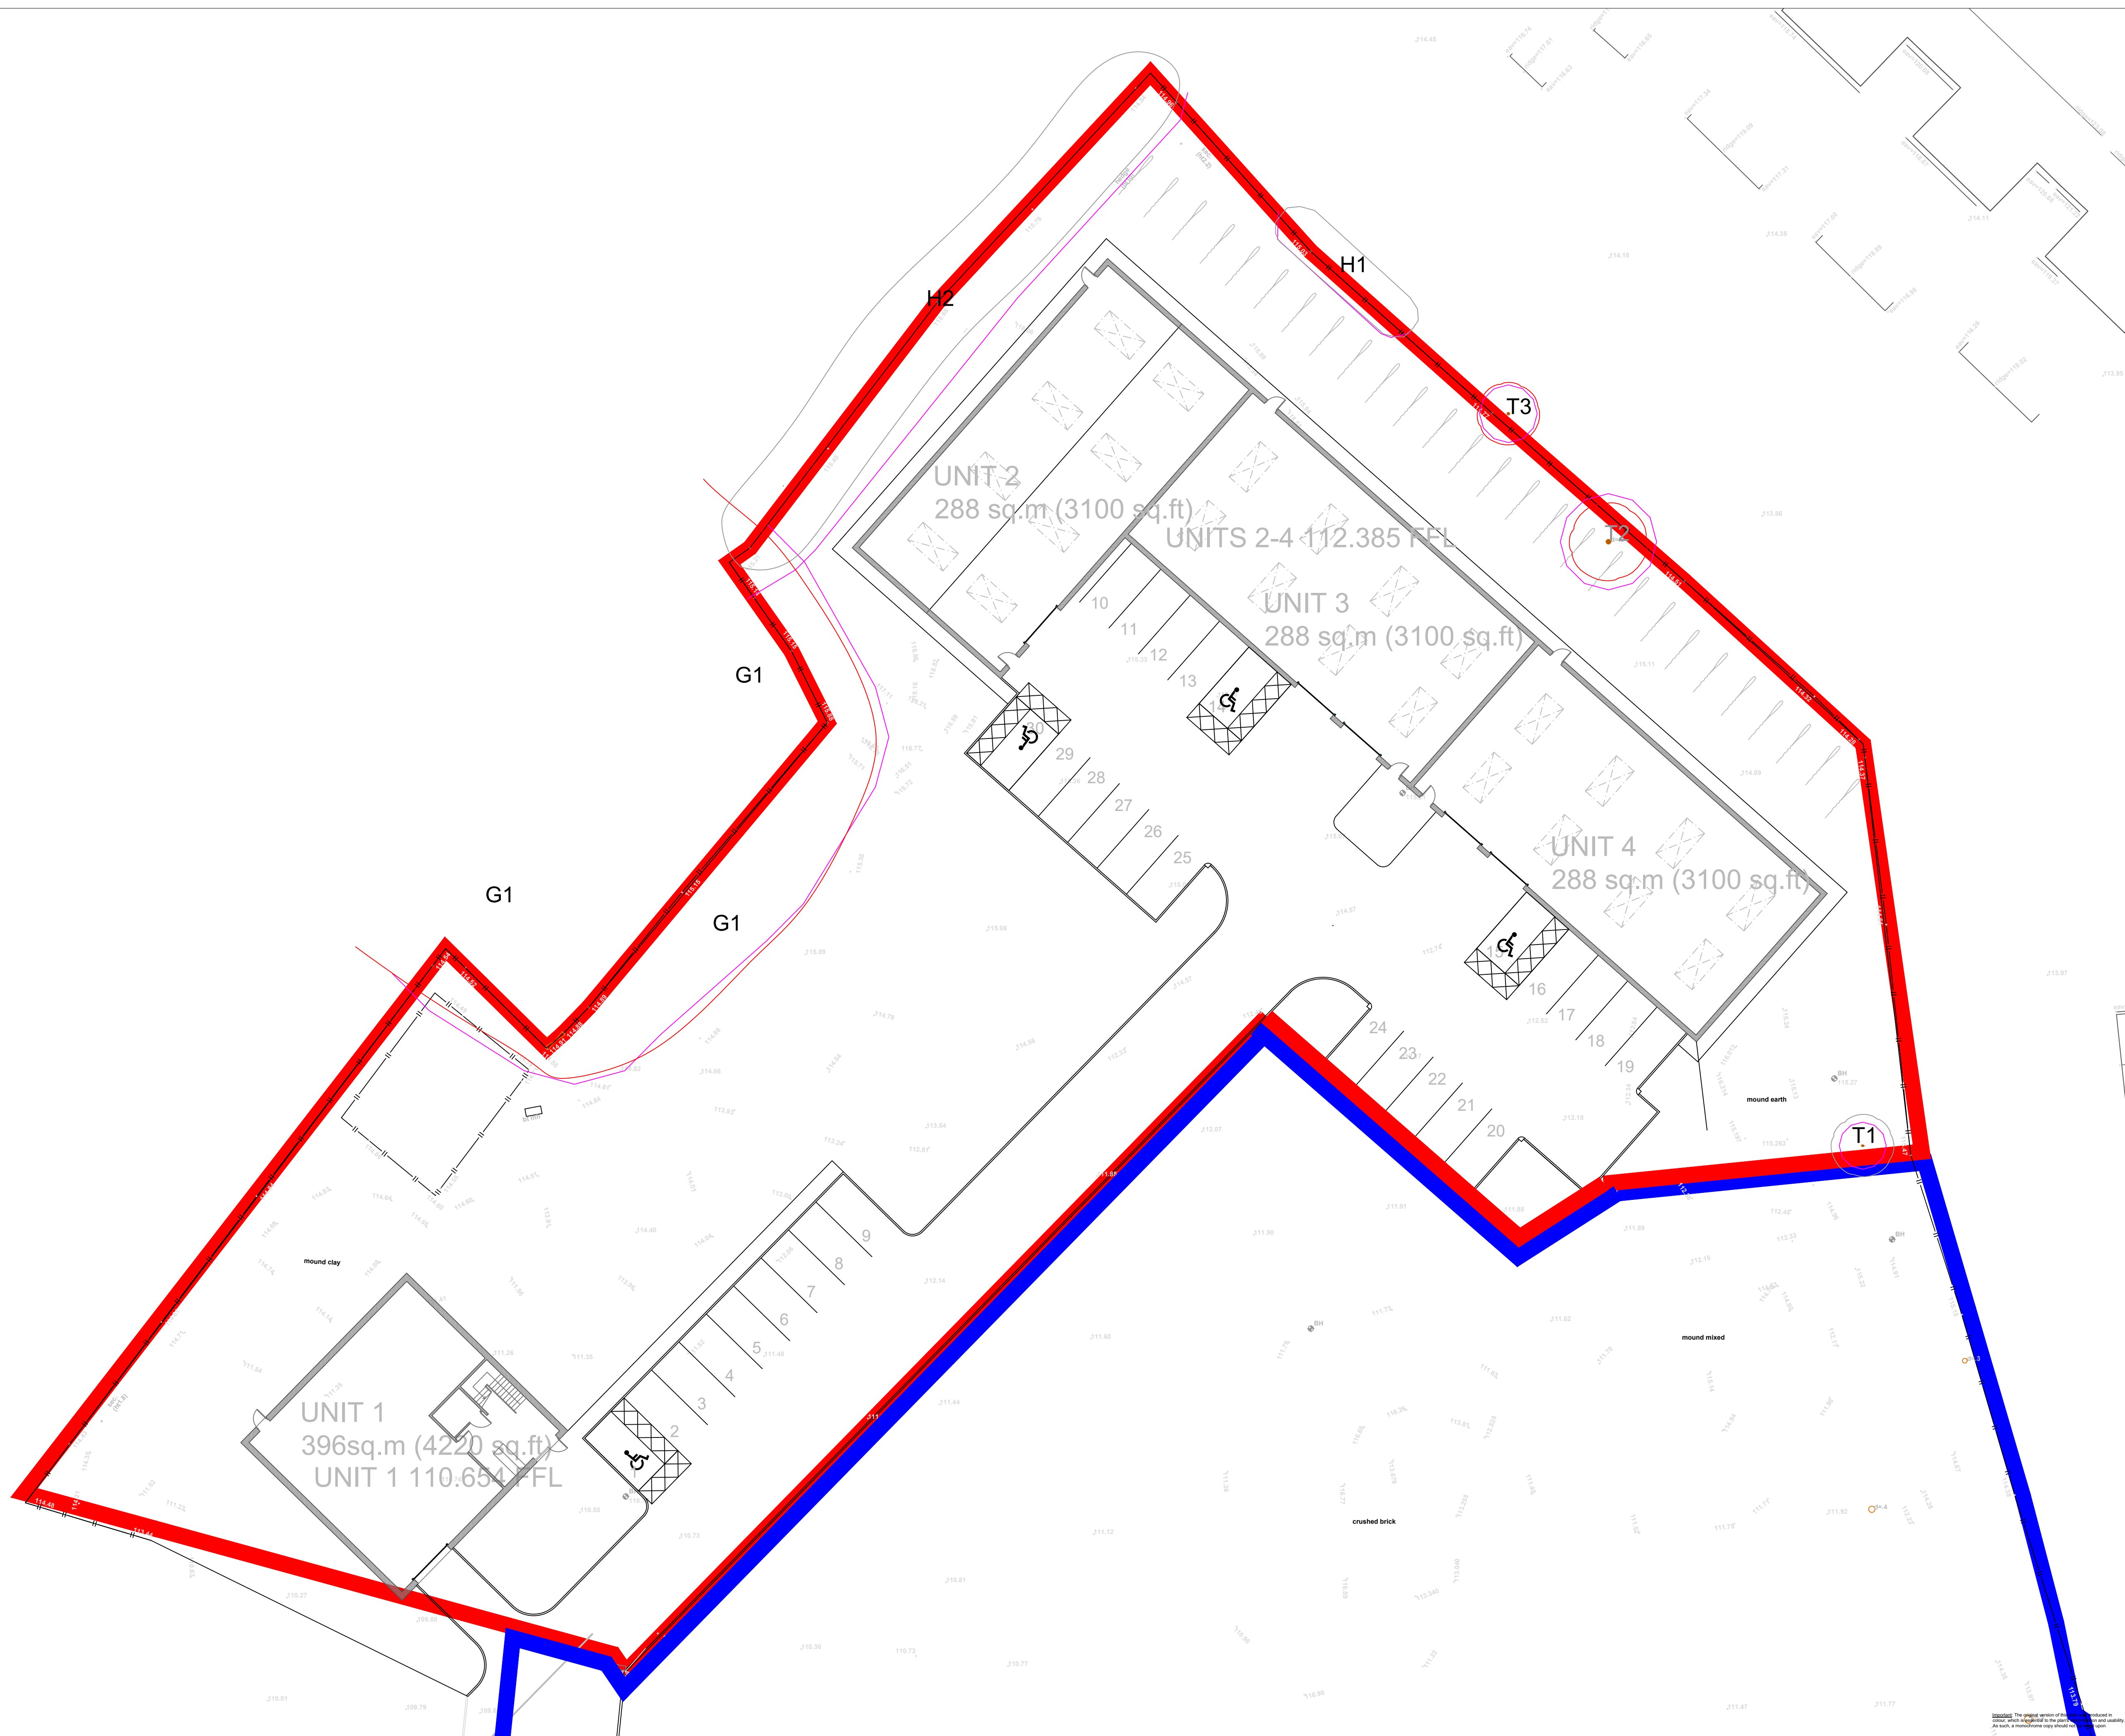
**Title:**  
**TREE IMPACT PLAN**  
in Relation to Proposed Light Industrial Development

Note 1: The stem locations of trees T1 and T3, group G1, and hedges H1, were not included on the topographical survey plan provided, and their locations, including the extent of the groups and hedges, were subsequently plotted by the arboricultural supervisor at the time of the survey using GPS, along with, where possible, measurements from existing site features. As such, the plotted locations of these trees and the extent of these groups and hedges cannot therefore be considered to be wholly accurate.

Note 2: Trees with their identifying numbers labelled in (1) are proposed for removal in the context of the proposed development.
