**BAT SURVEY AT -
ABBAY HOUSE
WORSTON**

REFERENCE NO. 6198

Demolition of garage prior to constructing new single storey extension

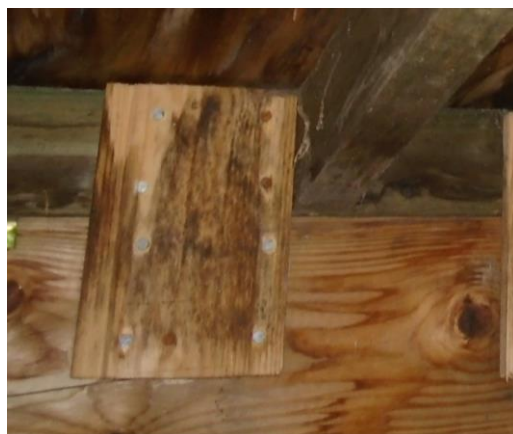
Interior of single skin timber wall to open store

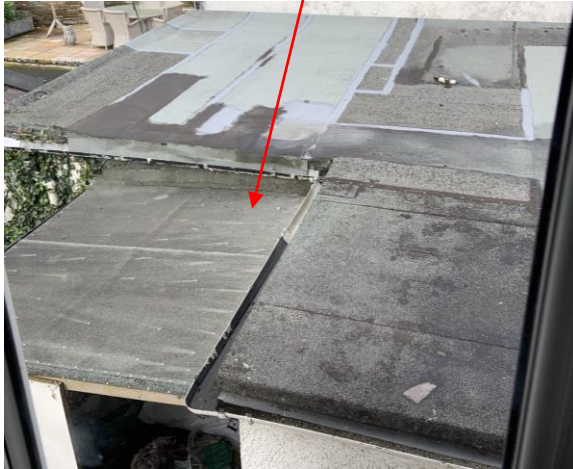
The roof is flat with a patchwork of bitumus felt covering. The open shed roof is set below the main roof felt fixed over timber deck as before.
