# Preliminary Bat Roost Assessment Report

**2 Howcroft Cottage,  
Stopper Lane,  
Rimington,  
BB7 4EJ**

**20.08.2021**

**Report prepared by:  
Dave Anderson  
Batworker.com  
[Dave@Batworker.com](mailto:Dave@Batworker.com)  
07894 338290**

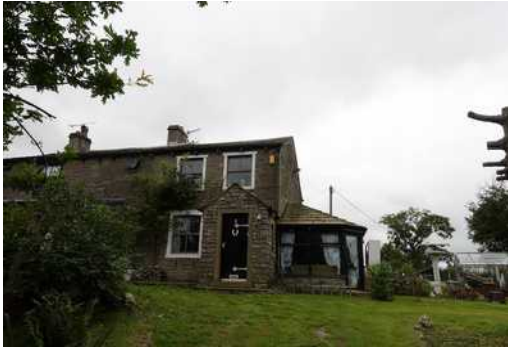
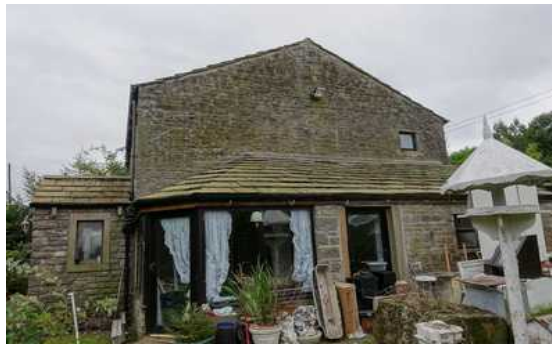
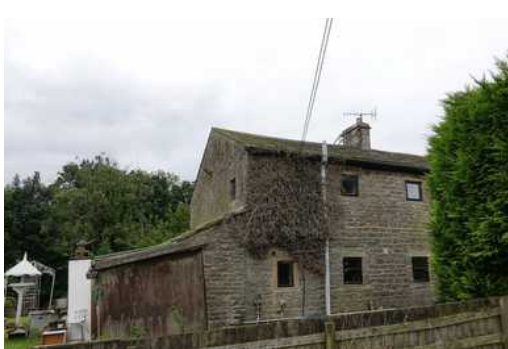
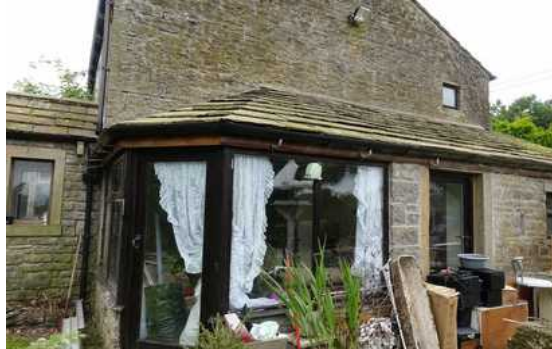
The property consists of a semi detached stone built two storey house with a double pitched slate roof, a single storey extension is present on the gable end. External walls are well pointed with no obvious cavities, cracks, gaps or crevices present. The gables is pointed and well sealed.

Roof slates are close fitting with no lifted, slipped, or missing slates present. The ridge is pointed and well sealed. Lead flashing where present is close fitting.

The building can be considered to offer negligible bat potential.
