**Dale Hey Bungalow,  
Preston Road,  
Ribchester,  
Preston,  
Lancashire.  
PR3 3XL**

**Survey & Assessment in Respect of Bat Species  
and Nesting Birds (including Barn Owl).**

**20<sup>th</sup> January 2022**

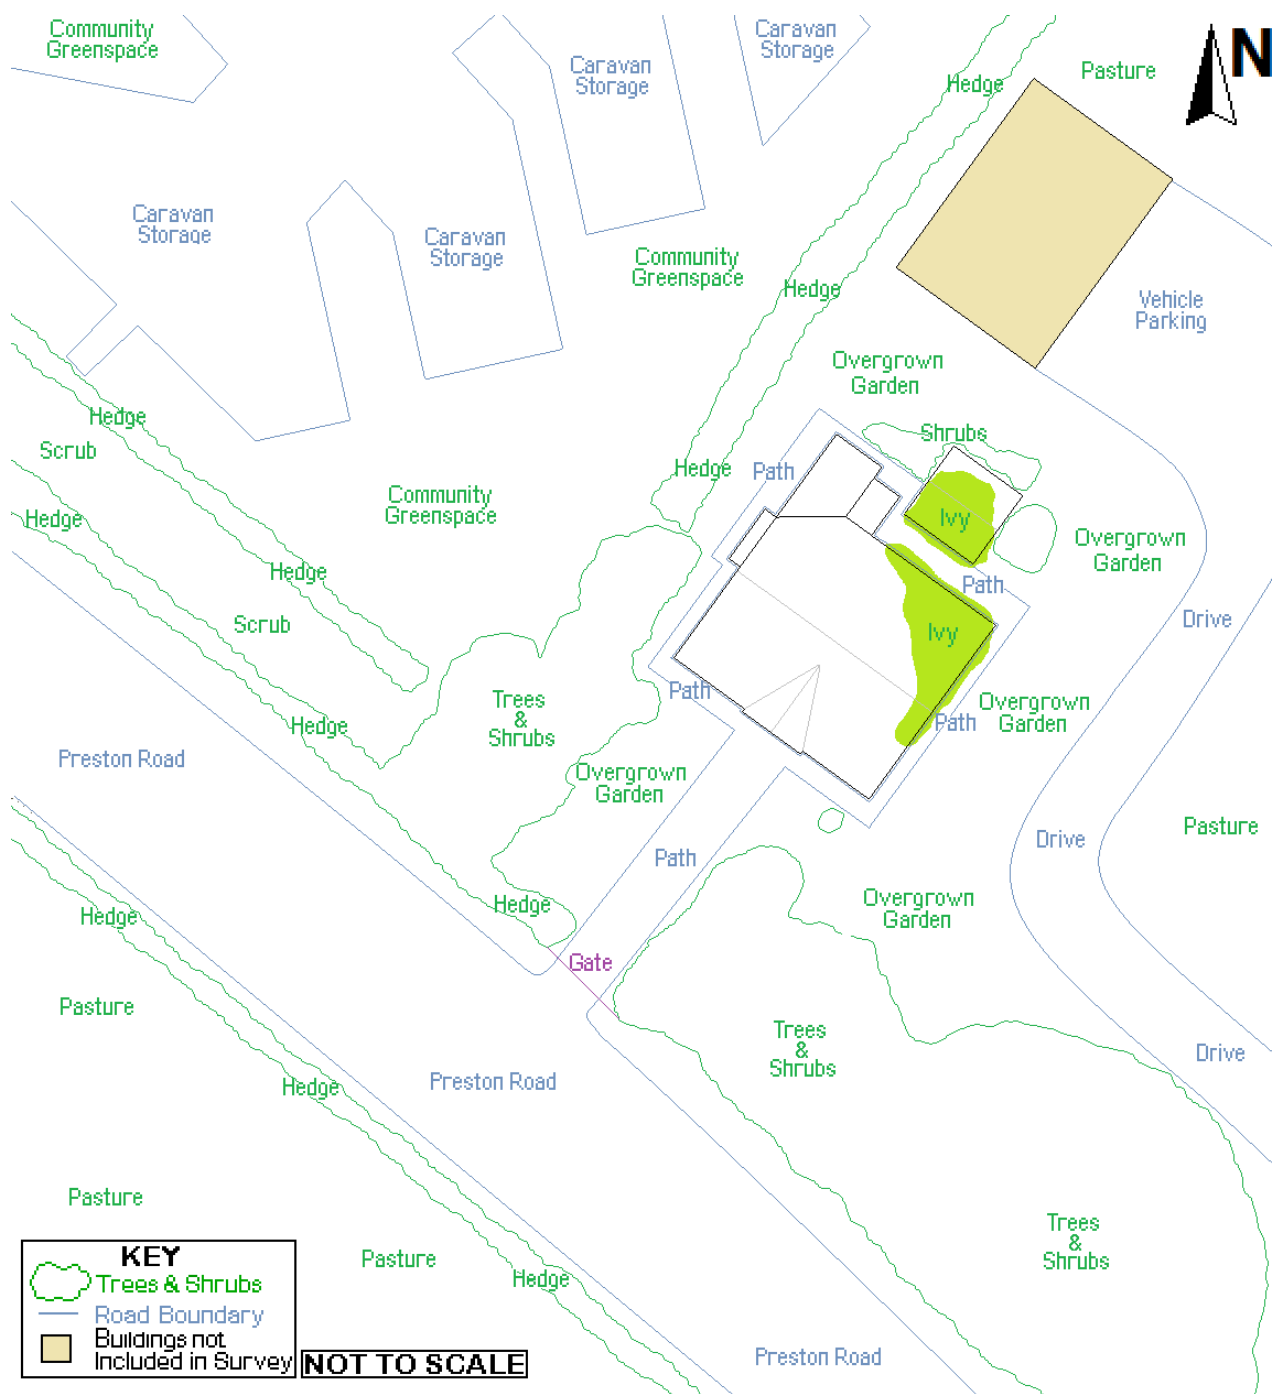
**Fig 3 – Main Plan of Area**

The bungalow was a rectangular single-story structure, lying in a north-west to south-eastern orientation. It was constructed with an inner skin of brick, and an outer skin of concrete block, a large part of which was covered in a pebble-dash render. It had a pitched roof covered in slates but there was neither insulation nor underlining, (refer to **figs 3, 4 and 5**, and **photos 1 to 26**).

There were two dormer windows and an entrance porch positioned centrally within the southern elevation, and another bay window attached to the western elevation. All of these were connected internally to the bungalow, but with no searchable roof voids beneath their sloping slate covered roofs, (refer to **figs 3, 4 and 5**, and **photos 1 to 14**).

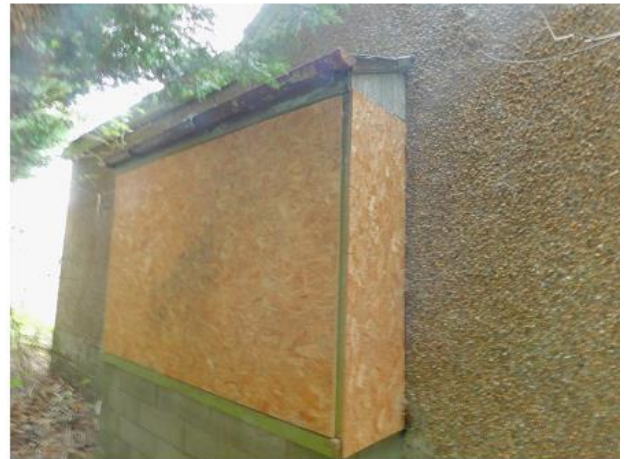
**PHOTO 12**  
**Western Elevation of Kitchen Extension**

Attached to the western corner of the bungalow and connected to it internally was a rectangular, single storied kitchen extension, built from pebble-dash coated materials, and with a uninsulated slate covered roof that continued the pitch of the main roof, but with no roof void, (refer to **figs 3, 4 and 5**, and **photos 12 to 18 and 25**).

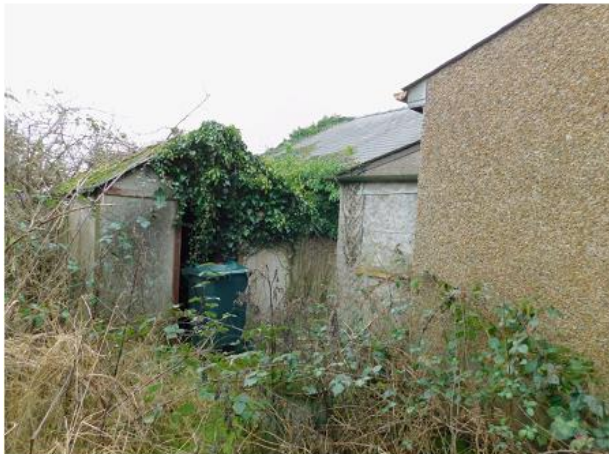
**PHOTO 17**  
**North-western Corner of Bungalow**

Positioned along the northern elevation and connected externally to both this elevation, and the eastern elevation of the kitchen extension, and connected internally to the latter, was a square, single-storied utility extension. This was constructed from concrete block, with a sloping, corrugated plastic sheeting roof, with neither insulation nor roof void, (refer to **figs 3, 4 and 5**, and **photos 17 to 19, 21 and 26**).

The outhouse was empty and hadn't been used for considerable amount of time, and although it was fairly sound, it was unheated, uninsulated and would be draughty and cold throughout most of the year, and therefore was deemed unsuitable for either daytime roosting bats, or breeding bats. It was also concluded that the building would be penetrated by frost and inclement weather in winter, thus making the building unsuitable for hibernating bats, and therefore the outhouse was concluded to offer negligible bat roosting potential, (refer to **figs 3, 4 and 5**, and **photos 17, 23 and 27 to 33**).

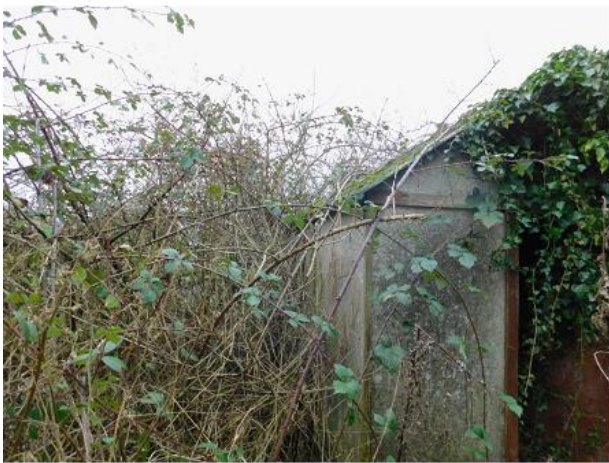
**PHOTO 27**  
**North-western Corner of Outbuilding**

- The main door was missing from the doorway in the western elevation, however neither bat droppings, invertebrate prey remains, any urine staining, nor bats themselves were found anywhere within the outbuilding, and it was concluded that bats do not use the outbuilding for either daytime bat roosting, breeding, or for hibernation, (refer to **figs 3, 4 and 5**, and **photos 17 and 28**).
- The remains of an old bird's nest was found on top of a timber roof beam, and also signs of bird splash was found on the beam itself. However, due to the age of the nest, and the state of its deterioration, it was impossible to ascertain which bird species had made the nest. It was determined however, that the nest had not been used during recent years, and it was

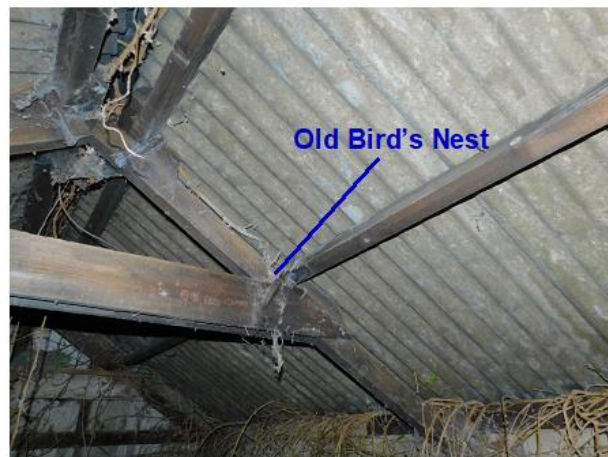
**PHOTO 33**  
**Southern Part of Outbuilding Roof**

thought that this future potential bird nesting would be lost, when the building is demolished, (refer to **figs 3, 4 and 5**, and **photos 33**).

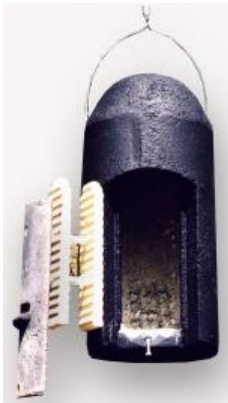
### Schwegler 1FD Bat Box

This Schwegler 1FD bat box has been developed specifically for smaller bats. The interior and the type and size of the entrance hole match the requirements of smaller species. It features a special layout inside the domed roof, an increased interior height, and two grooved internal wooden front panels with precise spacing between them.

These boxes are to be erected as recommended by the Bat Conservation Trust guidelines which state that

- Ideally, erect the boxes facing so they face in different directions, to provide a range of temperature conditions. For example, boxes facing from south-east to south-west allow the sun to fall on each box for part of the day. During very hot days a south-facing box may overheat, but the other boxes should have some shade during the day.
- Bat boxes should be located close to a linear vegetation feature such as a tree line or hedgerow or to lines of buildings. Some bat species use these features for navigation between their roosting site and feeding ground and to avoid flying in open and exposed areas.
- Ensure that tree branches or other items will not impede the bats’ approach to the box – clear away underneath the box so the bats can land easily before crawling into the box.
- Boxes should be erected at a height of approximately 4m above ground level
