BAT SURVEY AT

Holden Clough Nursery,
Bolton-by-Bowland

1. EXECUTIVE SUMMARY

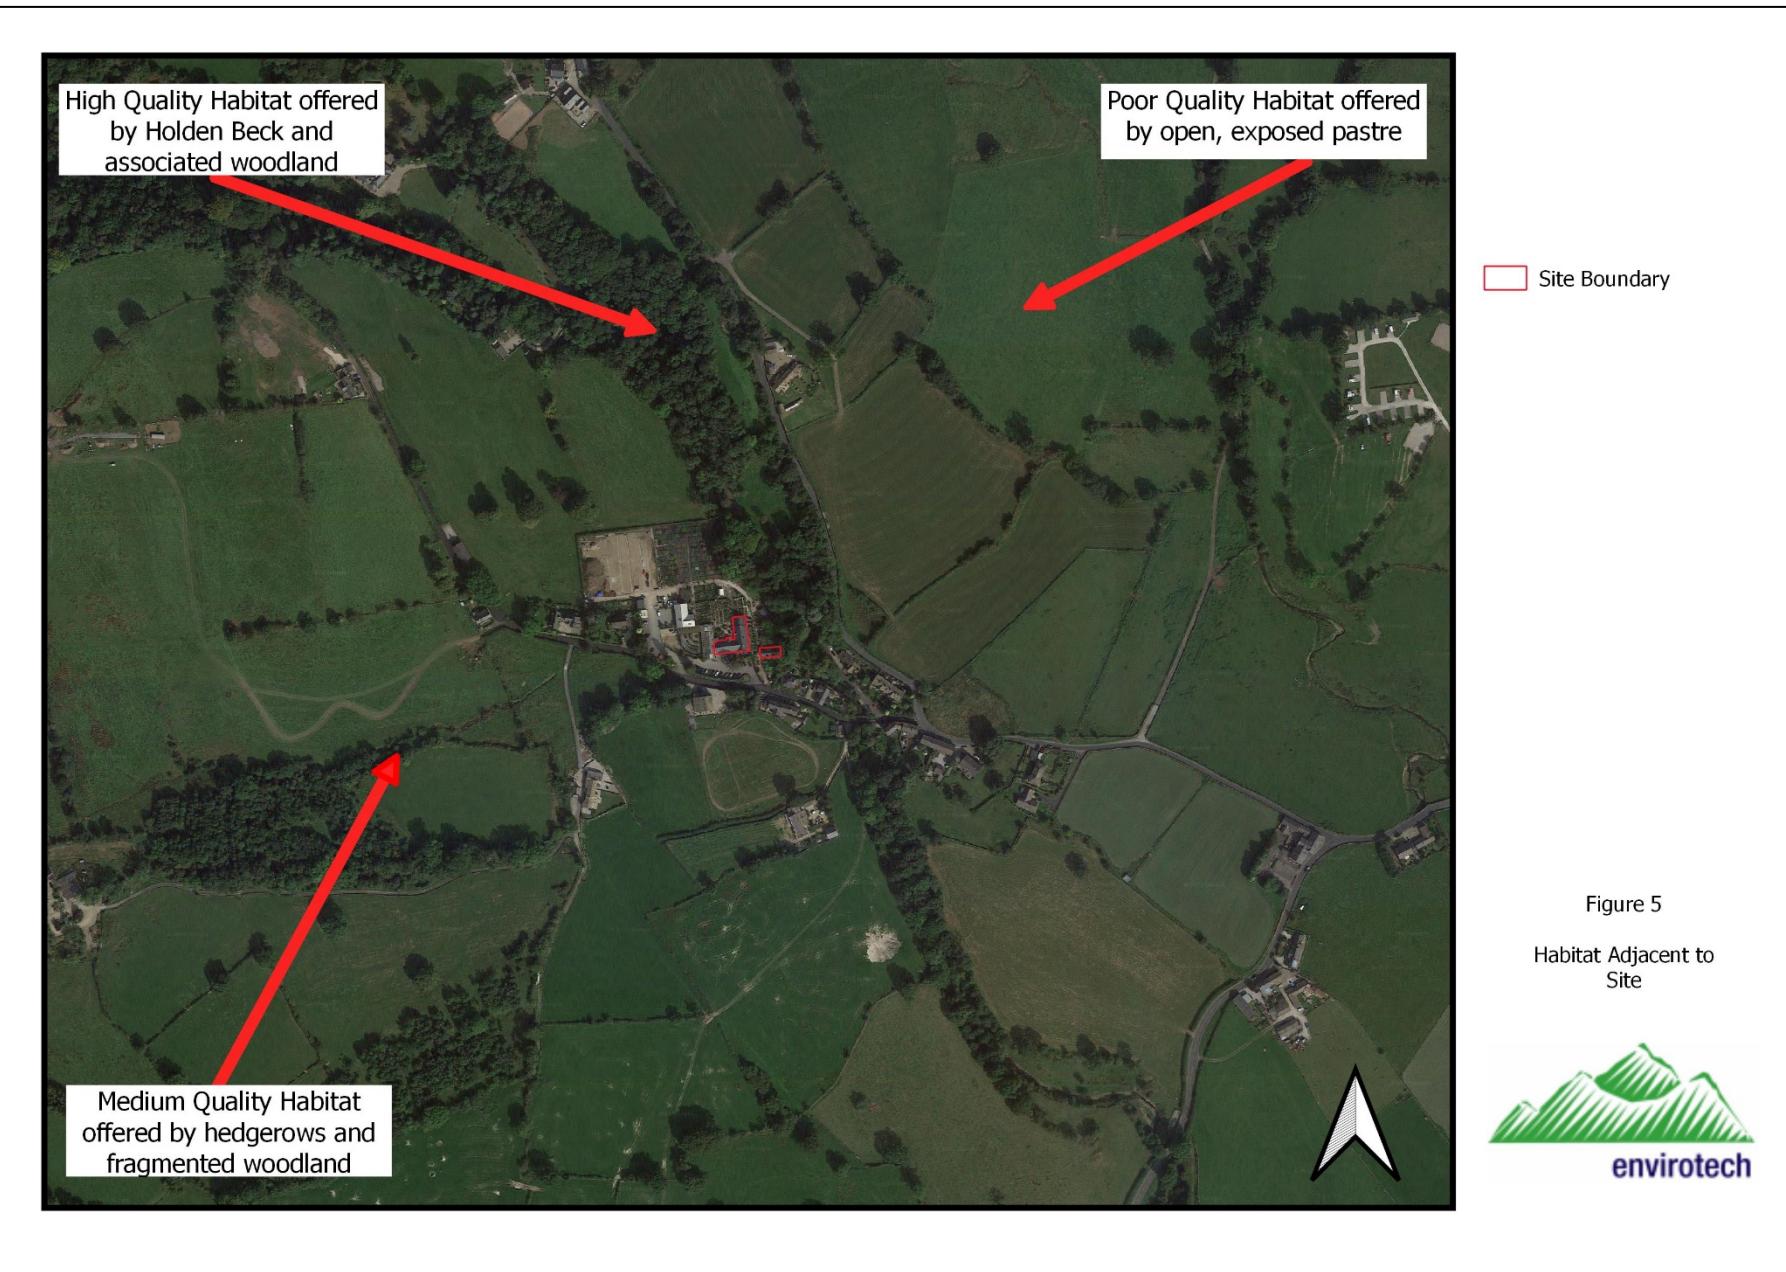
The habitat at and adjacent to the site was assessed from satellite imagery this was then ground truthed, Figure 5.

The habitat on and adjacent to the site identified from satellite images was ground truthed. Details of the habitats found on and adjacent to the site are detailed in Figure 5.

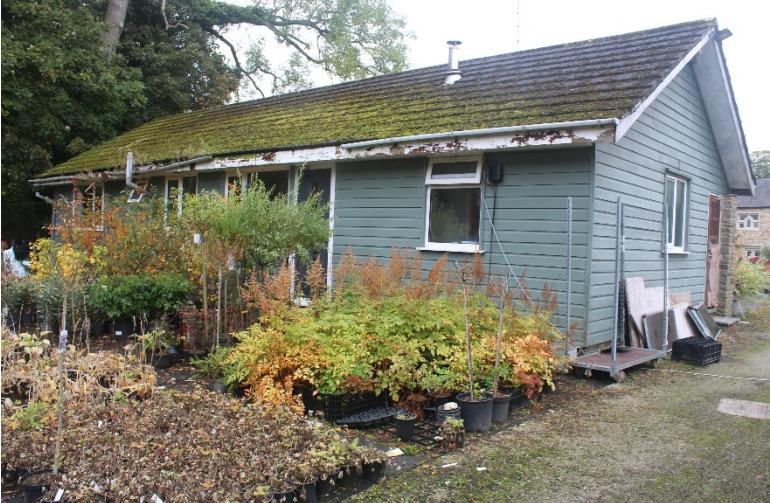
The walls of the building are made from natural stone and wood panelling and are in good condition. There are no structural gaps or cracks, the pointing between the stone is in excellent condition. A horizontal gap is however present between the wood panelling near the apex of the west gable.

The timber fascia and soffits around the wall tops of the building are in a poor condition and there are numerous splits and crevices which could allow bat access. The building condition overall has deteriorated since 2018.

<p>Building 1 The Bungalow</p> <p>Roof well sealed, with covering of moss</p> <p>Timber cladding well sealed</p>

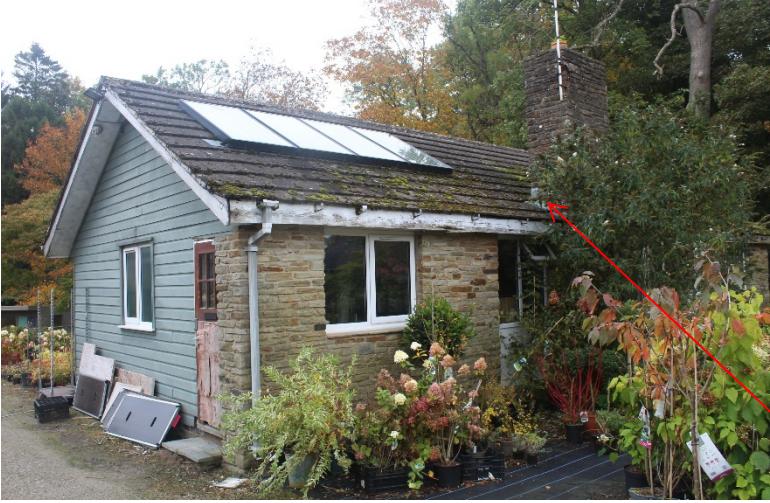
<p>In 2018 bats emerged from gaps beneath chimney flashing, now more obscured due to growth of Buddleia.</p>

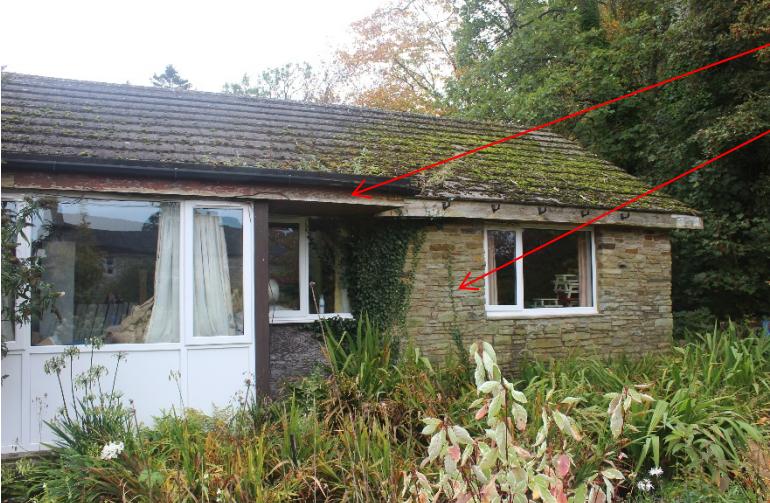
<p>Gaps around porch remain, from where bats emerged in 2018.</p> <p>Stonework remains well sealed</p>

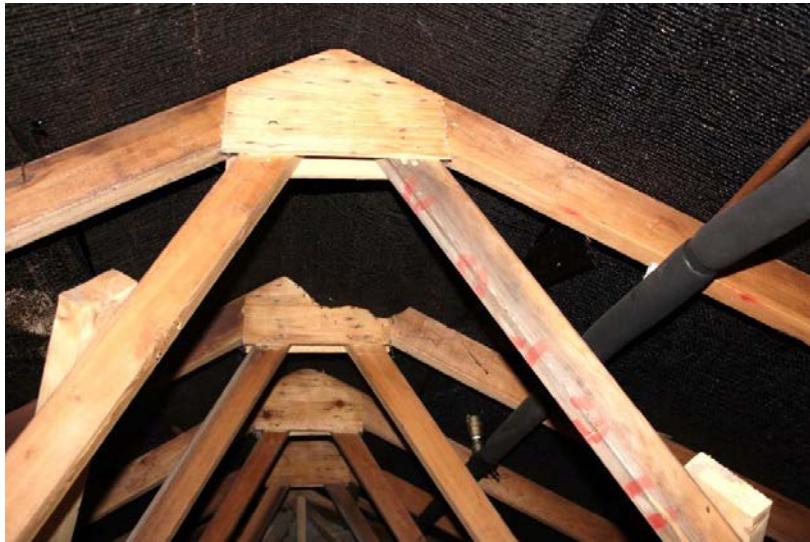
Droppings were found in void of Building 1. These were DNA tested in 2018 and results returned as Natterer's bat droppings

The site survey found evidence of bats roosting in Building 1, the Bungalow and further bat activity surveys are required for this building prior to any works/demolition.

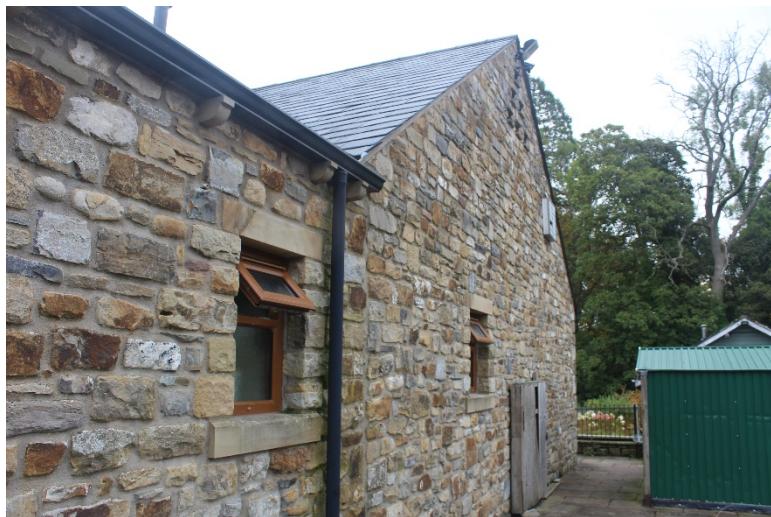
Building 2 The Tearoom

The walls of the building are stone-faced and are in excellent condition. There are no structural gaps or cracks, the pointing between the stone is in excellent condition. The more recent extension to the north is currently lacking stone facing, but walls are sealed blockwork. Netting on the western elevation of the new extension covers recently mortared blockwork.

Walls and roof well sealed overall

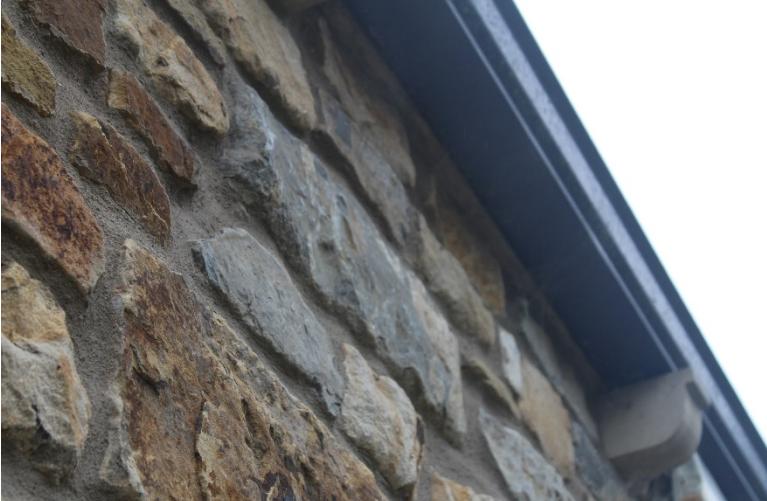
<p>Very narrow gabs behind guttering covered cobwebs</p>

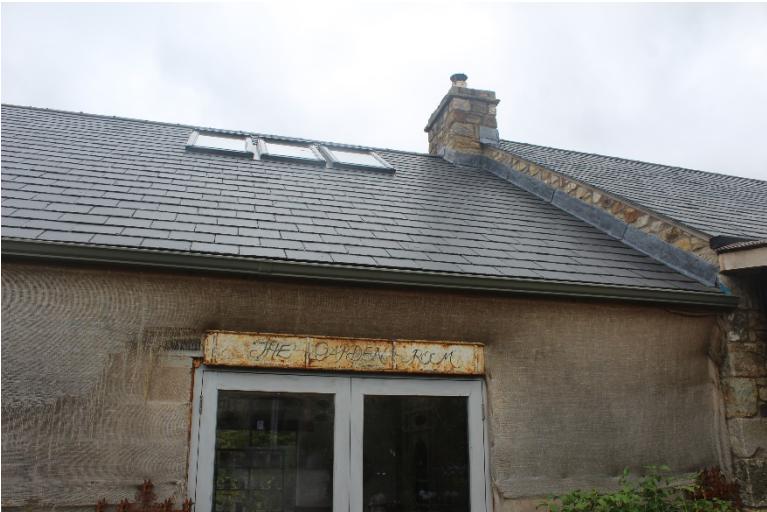
To summarise this large building is in very good condition and well sealed except small gaps under flashing on the gable wall tops around chimneys and some small verge gaps. Bats were confirmed as present roosting at gable apexes in 2018. These areas will be unaffected by the current proposals.

<p>Previously identified roost site unaffected by current proposals</p>

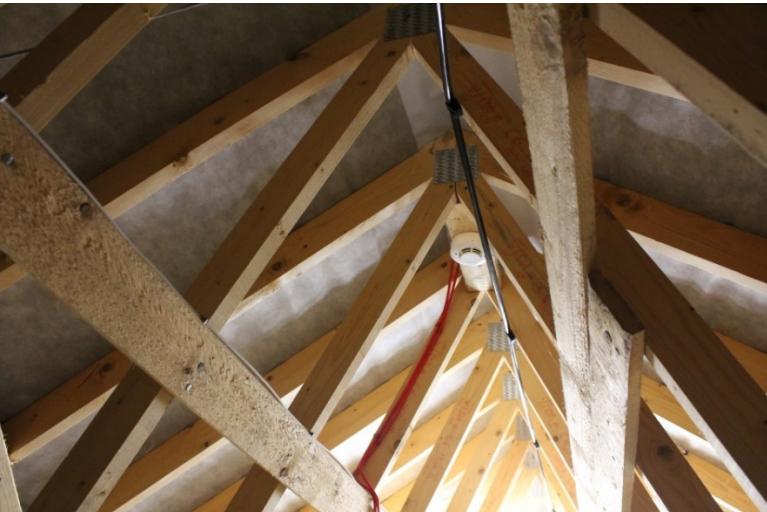
<p>Roof void found to be very clean.</p>
