# Preliminary Bat Roost Assessment Report

**Barn at Higher Lickhurst Farm,  
Bowland With Leagram,  
PR3 2QT**

**15.01.2022**

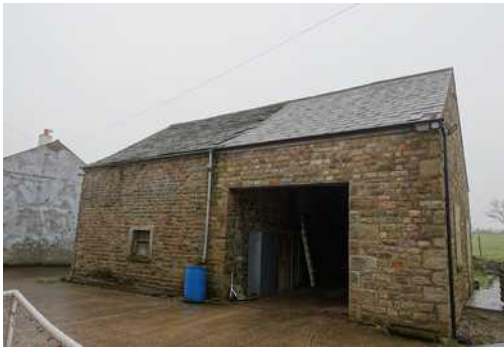
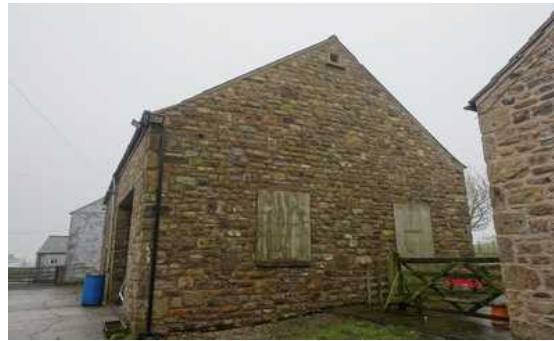
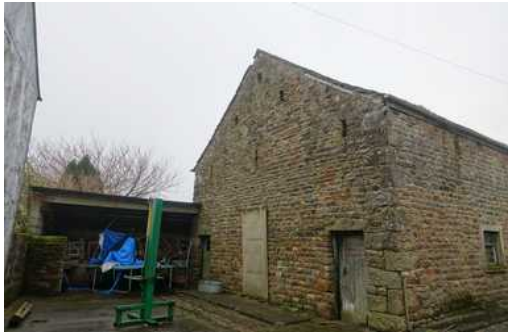
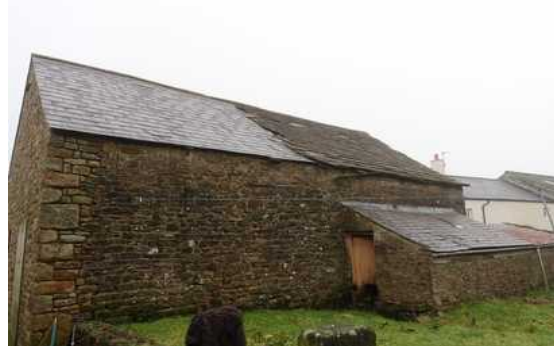
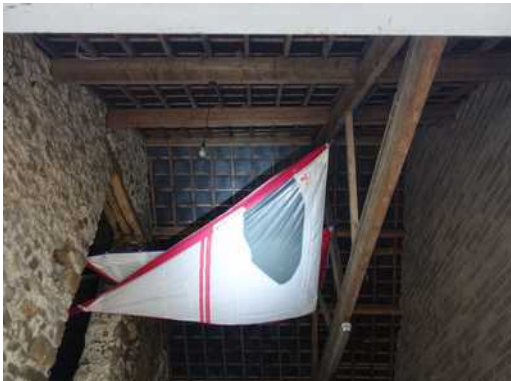
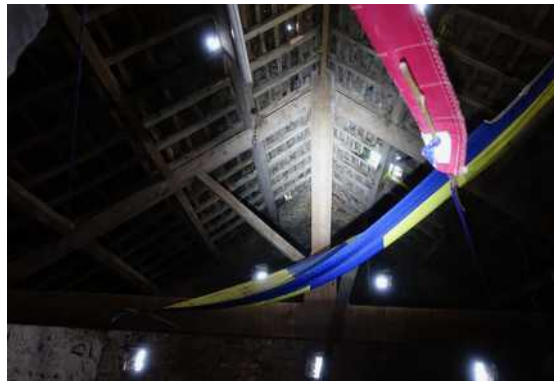
The property consists of stone built two storey detached barn with double pitched slate roof. A single storey single pitched roofed extension is present to the rear of the property. External walls are well pointed with no cracks, crevices or cavities present. The northern gable end is well pointed and sealed, the southern gable end has pointing missing along the wall top. The northern roof section is in good general condition with no missing, lifted or slipped slates present. The ridge tiles are generally well sealed. The southern stone slate section of the roof has multiple slipped, missing and lifted slates present.

The property can be considered to offer moderate bat potential.

The building was assessed as offering moderate roosting potential with obvious gaps or crevices suitable for roosting bats within roof areas.

Scattered droppings and feeding remains, consistent with Natterer's or brown long eared bats using the barn to forage were recorded within the southern hay loft section of the barn.
