Re: Proposed development at 21 Knowsley Road, Wilpshire, BB1 9PX (central grid reference: SD 68607 31995)

Thank you for your request for a bat survey at the above site. I understand that the proposed development is for single and upper extensions to the existing dwelling house.

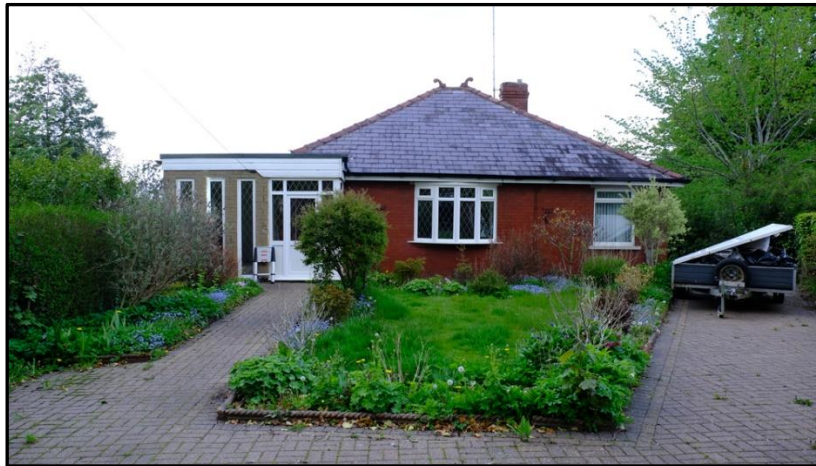
View of 21 Knowlsey Road showing front (south) elevation

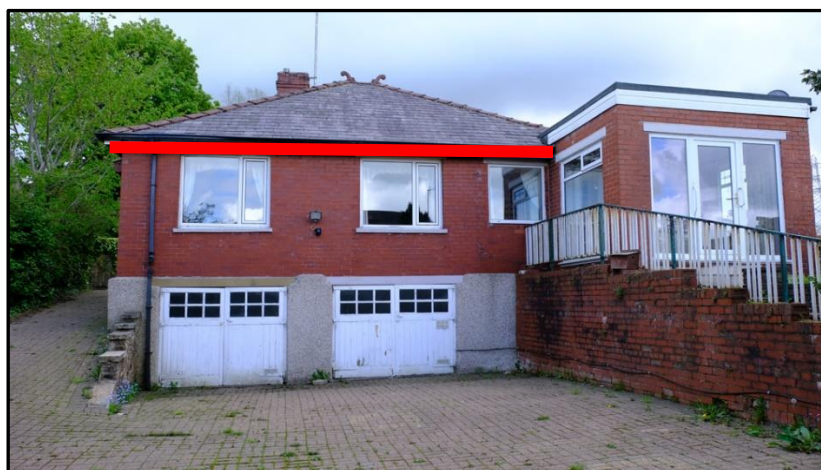
- Low potential – gaps associated with roof coverings, northern roof edge, and flat roof fascia boards
- Hibernation roosting - gaps associated with roof coverings and northern roof edge.

View of rear (north) elevation. Red line indicates gaps present along roof edge

Protected Species	Impacts /Predicted Impacts	Action Required
Bats	<p>It is advised that there is no evidence to suggest that bats pose a constraint to the proposed development.</p> <p>It is advised that there are potential roost features (gaps) suitable for bats associated with roof coverings, northern roof edges and flat roofed fascia boards. In this location and landscape setting, these features have low potential for bats to use throughout the year.</p> <p>All bat species are afforded full protection under The Conservation of Habitats and Species (Amendment) (EU Exit) Regulations 2019</p>	<p>Advice (mitigation): All personnel involved in proposed development works should be carefully advised about bats by a professional Ecologist, so that all works are undertaken with a clear understanding about legal aspects, precautions to be adopted and what to do if a bat is found. Prior to development.</p> <p>Advice (mitigation): As a precaution, it is advised that when removal or disturbance of potential roost features such roof coverings are to take place, this should be done carefully by hand. At all times.</p> <p>Advice (mitigation): If bats are found at any time during the development, work must stop until advice has been sought from an appropriately experienced Ecologist. If the development will affect bats, a licence may be required and suitable mitigation put in place. At all times.</p>

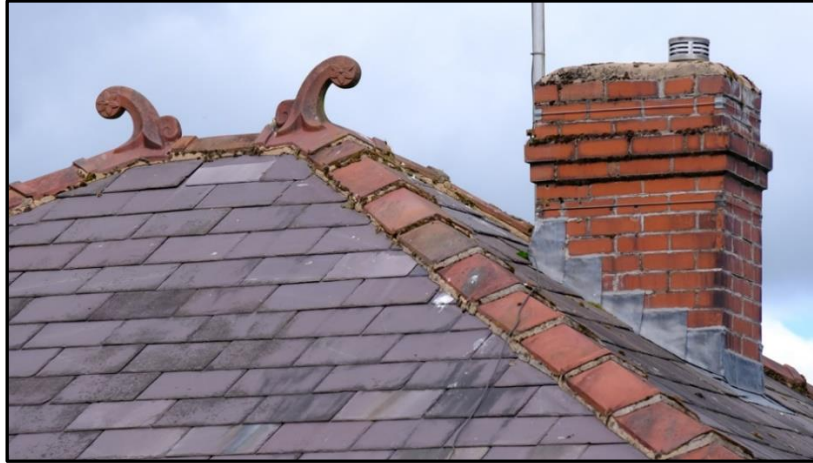
View of roof coverings and lead flashing on chimney, all good condition with few gaps visible.

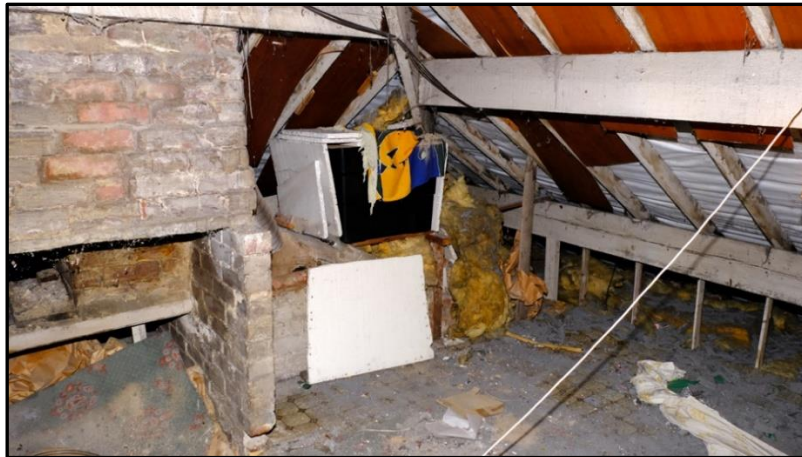
There is an accessible roof void above the main dwelling. The roof is underlined with modern roof membrane and part under boarded with laminated timber panels. The floor is part boarded and rock wool insulation is present. The roof void is open, uncluttered and heavily cobwebbed and extensive mouse and rat droppings were also found. A small amount of natural light spillage is present along the north elevation, consistent with gaps observed during the external inspection. No signs of use by bats or nesting birds were observed within the roof void.

Internal view of roof void showing brick chimney, modern roof liner and wood panel underboarding the roof structure

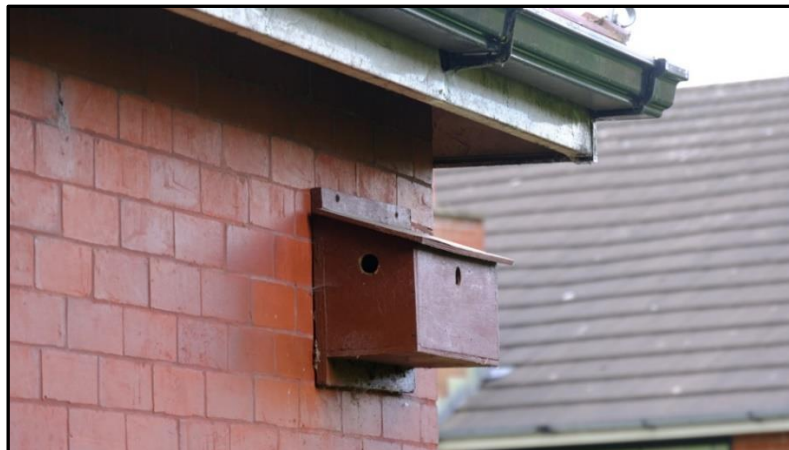
An active house sparrow nest was observed within a nest box, attached to the east elevation. Blue tit, great tit, wren, dunnock and robin were all observed singing and foraging within the garden during the survey.

Nest box on east elevation, occupied by nesting house sparrows

Protected species	Impacts /Predicted Impacts	Action Required
<p>Nesting birds</p> <p>House sparrows confirmed nesting</p>	<p>It is advised that there is high potential for birds to be nesting within the building, nest boxes and garden vegetation during the bird nesting season (February to September).</p> <p>Under the Wildlife and Countryside Act 1981 (as amended), wild birds are protected from being killed, injured or captured, while their nests and eggs are protected from being damaged, destroyed or taken.</p> <p>There is no provision under the Wildlife and Countryside Act 1981 (as amended) for licensing the disturbance of nesting birds or the destruction of nests which are in use, for the purpose of development.</p> <p>If enforcement action were taken the developer would need to rely on the 'incidental result of an otherwise lawful operation' defence if it were not possible to avoid an offence being committed. This defence can only be tested in court and it is therefore important to ensure all possible mechanisms for avoiding an offence are considered.</p>	<p>Advice (mitigation): It is advised that the most appropriate way to address the risk to nesting birds is: Avoid disturbance to the building, nest boxes and vegetation during the nesting season.</p> <p>Or</p> <p>If works cannot be delayed the proposed work area should be carefully checked, immediately prior to works commencing. Checks should be carried out by a suitably experienced ecologist. If the risk of nesting birds remains, then monitoring for nesting bird activity should continue for the duration of works. Prior to any work commencing (checks) and throughout works in nesting season (monitoring).</p> <p>Advice (mitigation): If works are to be undertaken during the nesting season, all people working at the proposed development site should attend a toolbox talk delivered by an appropriately experienced person, to be made aware of the likelihood of encountering nesting birds and how to identify them, the legal protection of nesting birds and their own responsibilities as regards implementation of precautionary measures. Prior to any work commencing.</p>

Protected species	Impacts /Predicted Impacts	Action Required
Nesting birds Continued		Advice (mitigation): If birds are found to be nesting within or in close proximity to the work area during proposed works, it will be necessary to stop and establish an exclusion area. The extent of the exclusion area, which should be determined by a suitably experienced ecologist, will depend on the bird species and the nature of the proposed works. At all times.

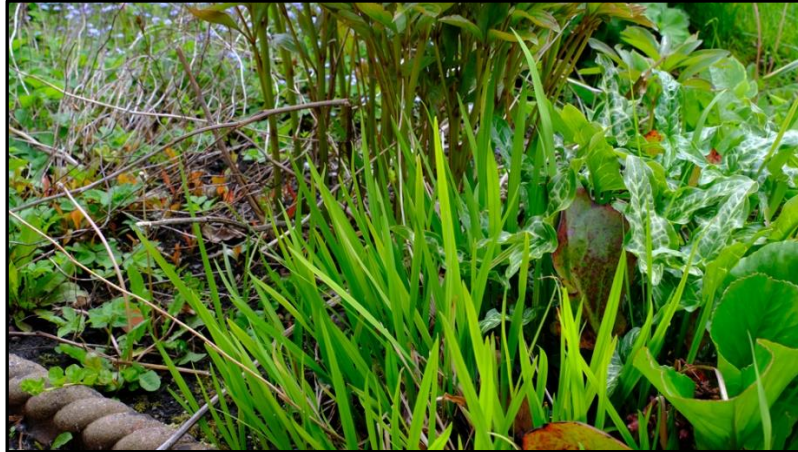
The property lies within an established garden which has not been recently managed. There are numerous flowering plants and shrubs, including a number of plants listed on the Schedule 9 non-native species list. These include Montbretia, Rhododendron and Wall Cotoneaster amongst the garden planting. Himalayan balsam is also present within Showly Brook immediately adjacent to the proposed development site

Example of Montbretia present amongst garden planting

Non-native invasive plant species	Impacts /Predicted Impacts	Action Required
Cotoneaster, Montbretia and rhododendron species confirmed within the garden planting. Himalayn Balsam is present within Showley Brook	It is advised that the proposed development will have to take account of non-native invasive plant species. Proposed works to the building will involve an amount of disturbance which could result in the spread of non-native invasive plant species which are listed on Schedule 9 of the Wildlife and Countryside Act 1981 (as amended).	Advice (mitigation): All personnel involved in the proposed development works should be made aware of the presence of non-native plant species and how to identify them, so that all works are undertaken with a clear understanding about legal aspects and working methods and precautions to be adopted. Prior to any work. Advice (mitigation): Where possible, leave all boundary and border plants in situ and avoid all activities that have the potential to disturb the ground/plants resulting in the further spread, including the boundary adjacent to Showley Brook. If plants must be removed, they should be removed carefully by hand and all excavated material (soil and plants) should be removed from the site to a licensed landfill as controlled waste, or burnt on a bonfire where it will not cause nuisance to neighbours through excessive smoke or odour. Prior to and during any work.

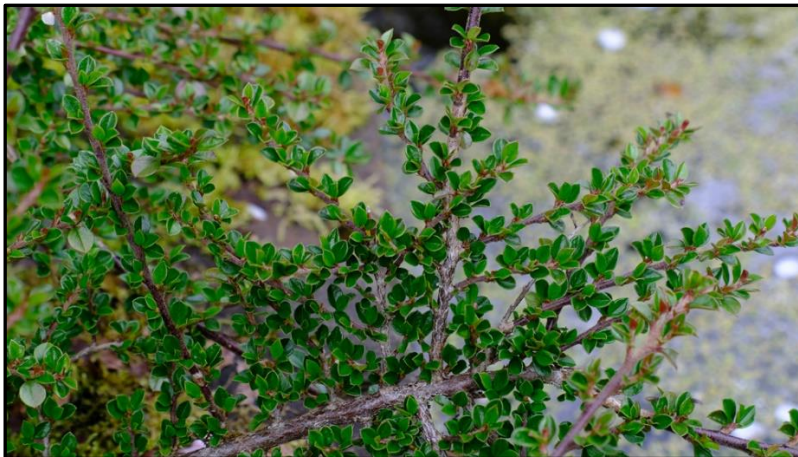
Example of Wall cotoneaster present amongst garden planting

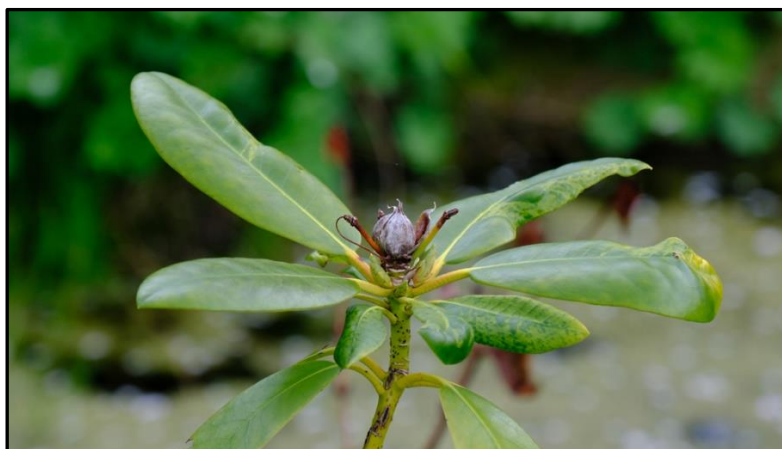
Example of Rhododendron present amongst garden planting
