**BAT SURVEY**  
OUTBUILDING at  
TWINBROOKS FARM  
UPBROOKS  
CLITHEROE

REFERENCE NO. 5765

Demolition of an outbuilding, prior to construction of 3no single storey dwellings.

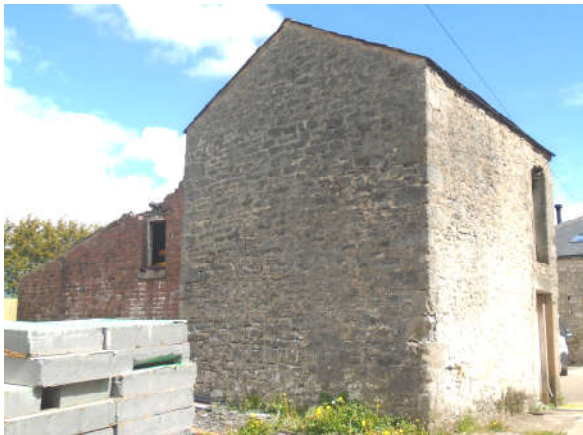
South and west elevation

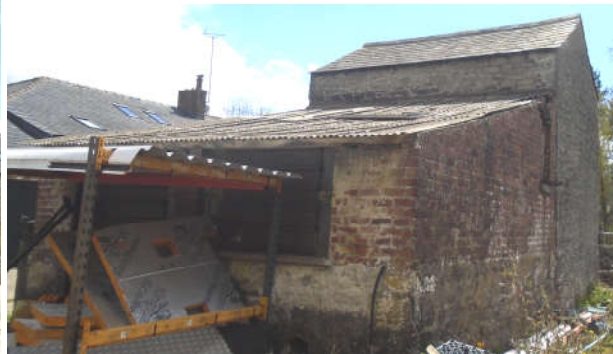
Rear north elevation

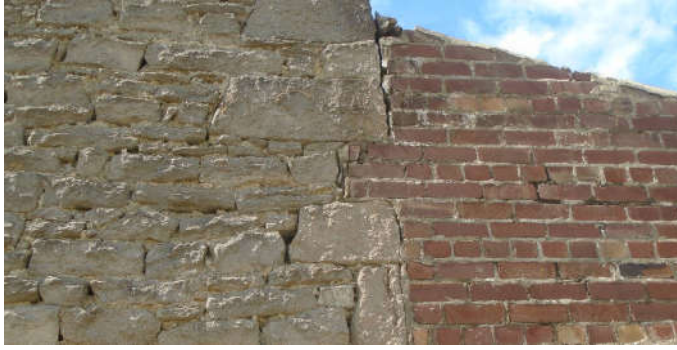
The main building walls are random natural stone with flush pointing. The lean to has brick walls.

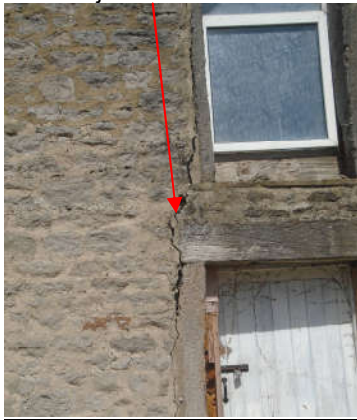
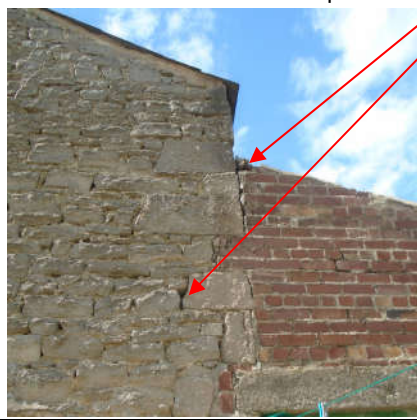
The front elevation pointing is generally in tact with the exception of a crack to the left hand side of the door and window jamb.

The east elevation has a couple of cracks/ crevices

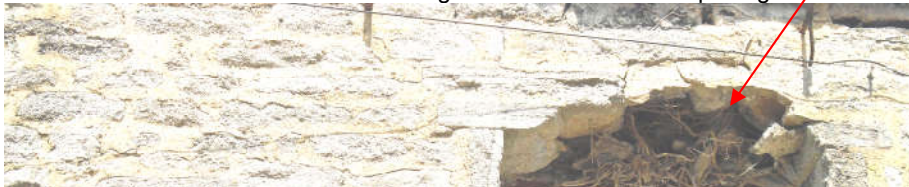
The head of the front window was missing and has some historic plant growth.

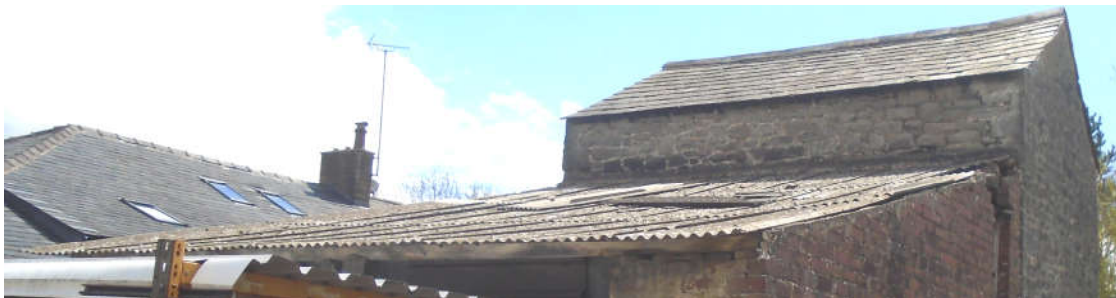
The pitched roof was examined from ground level with the aid of binoculars. The blue slate finish is in good condition with no gaps or slipped slates. The ridge tiles are well pointed with no cracks. The roof does not provide any access points to the interior nor any cracks or crevices accessible to bats.

The lean to roof is corrugated fibre cement sheet, it is in poor condition with some missing and slipped sheets. The interior is accessible to bats however the sheets do not provide any potential roost habitat.

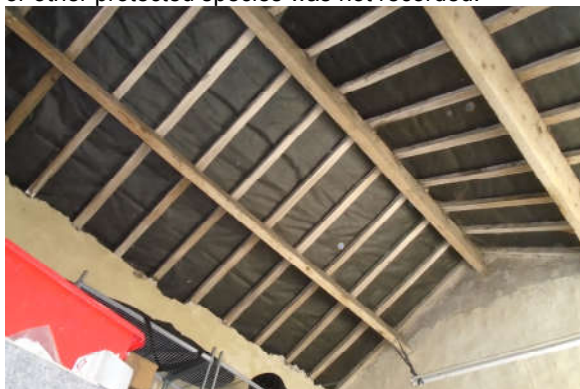
Main pitched roof did not have an enclosed roof space and was examined from the first floor level the structure appeared relatively new, the timbers and underlay were in excellent condition free from any cracks, crevices or rot. The eaves were inspected to ensure there were no access points. Evidence of current or historic use by bats or other protected species was not recorded.

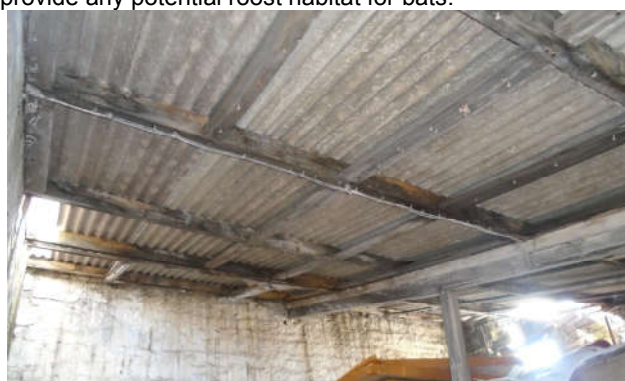
The lean to roof does not have an enclosed roof void, it has a timber supporting structure with corrugated sheets fixed directly over. Although the building was not fully accessible the structure was totally visible. The roof did not provide any potential roost habitat for bats.
